ATSB TRANSPORT SAFETY REPORT
Rail Occurrence Investigation RO-2008-005
Final

Derailment of Train 5PS6

Bates, South Australia

19 April 2008

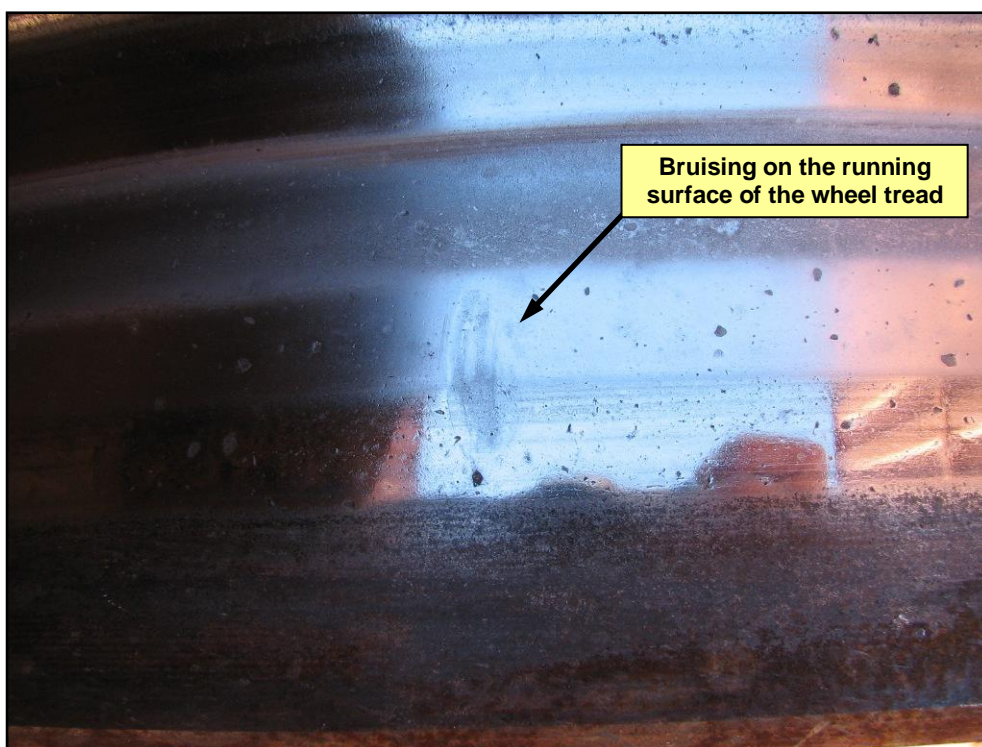
Figure 3: Bruising on the wheel tread (Wagon RRGY07144Q)

Evidence of wheel tread bruising was found on a number of left side wheels (referenced by the direction of travel) on wagons between the locomotives and the first derailed wagon (24th behind the locomotives). It should be noted that all wheels could not be examined in their entirety and evidence of bruising could only be sighted where the wheel tread surfaces were easily viewed. Figure 3 illustrates an example of the bruising, found on the first freight wagon behind the locomotives (Wagon RRGY07144Q).

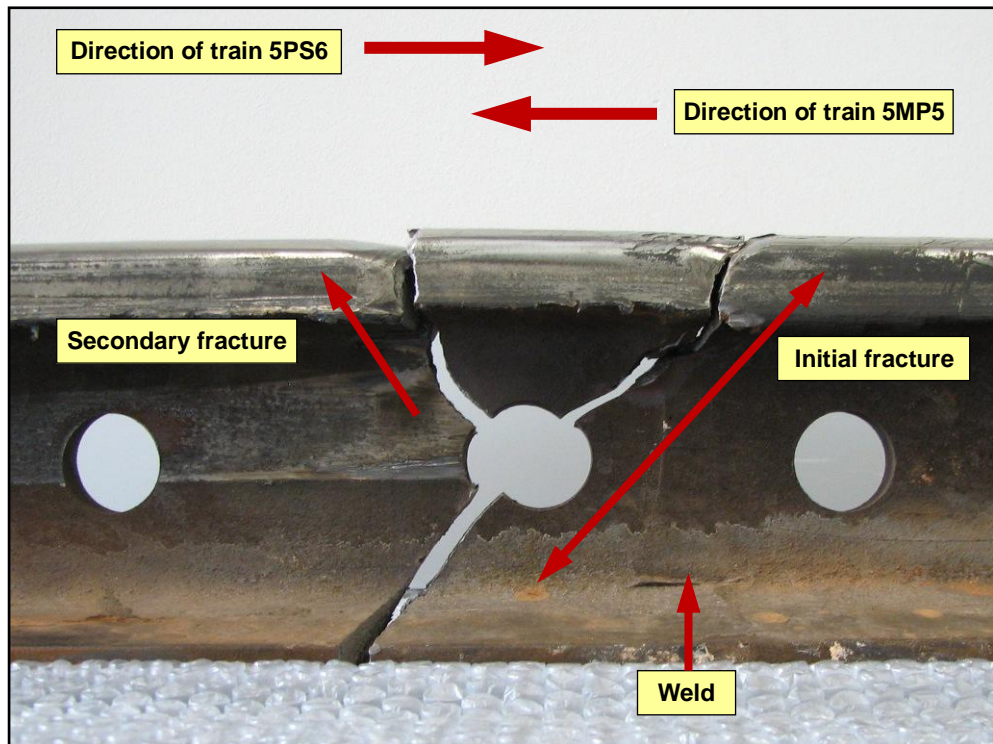
Figure 4: Broken rail

Examination of the track near the point of derailment found evidence of rail fracture. The pieces of rail were recovered and placed in their original configuration, allowing investigators to conduct an initial on-site examination of the fracture surfaces and determine a likely sequence of failure.

The fractured section of rail contained a welded joint between two sets of three bolt-holes, originally drilled to allow joining of the rail using bolted fishplates⁵. The rail fractured through the bolt-hole immediately adjacent to the weld. It was also evident that the fracture occurred immediately adjacent to a sleeper. The ATSB took possession of a short section of rail from either side of the fracture to allow metallurgical examination of fracture surfaces and steel properties. Examination of the track near the point of derailment found evidence of rail fracture. The pieces of rail were recovered and placed in their original configuration, allowing investigators to conduct an initial on-site examination of the fracture surfaces and determine a likely sequence of failure. illustrates the welded joint and the rail fractures (initial and secondary) after the rail was recovered and examined.

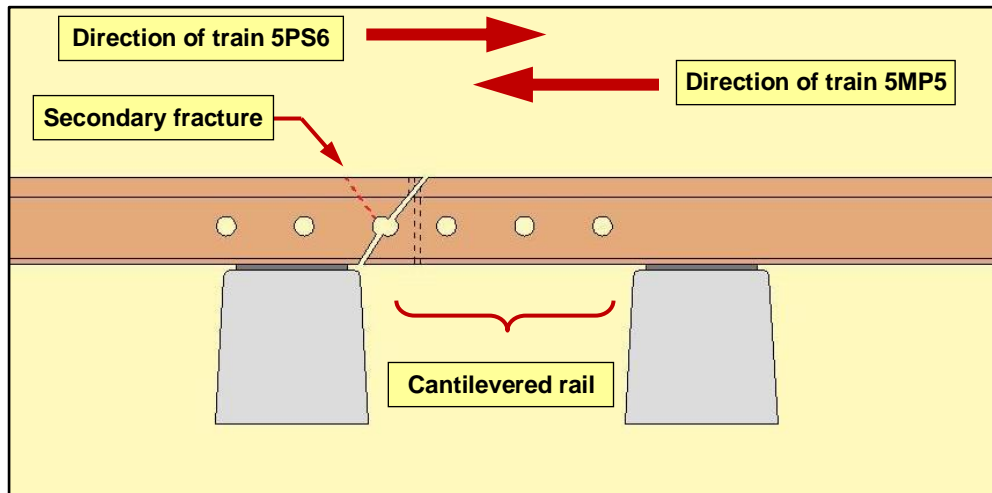
Figure 5: Fracture & sleeper configuration

- It is likely that the rail remained in this state until train 5PS6 approached from the west.
- The initial fracture occurred near the edge of a sleeper, leaving a cantilevered length of rail supported by one sleeper (Figure 5). This significantly increased the compressive force borne by that sleeper as train wheels passed over the fracture.

- As the wheels of train 5PS6 passed over the fracture and onto the cantilevered rail, the impact forces are likely to have caused the progressive failure of the concrete sleeper.

- Similarly, the load exerted on the trailing edge of the rail leading into the fracture is likely to have caused the secondary fracture and subsequent ejection of a small section of rail.

- Once a section of rail was missing, the impact forces on the rail would have increased significantly, causing the progressive failure of rail and sleepers until wagons inevitably derailed.

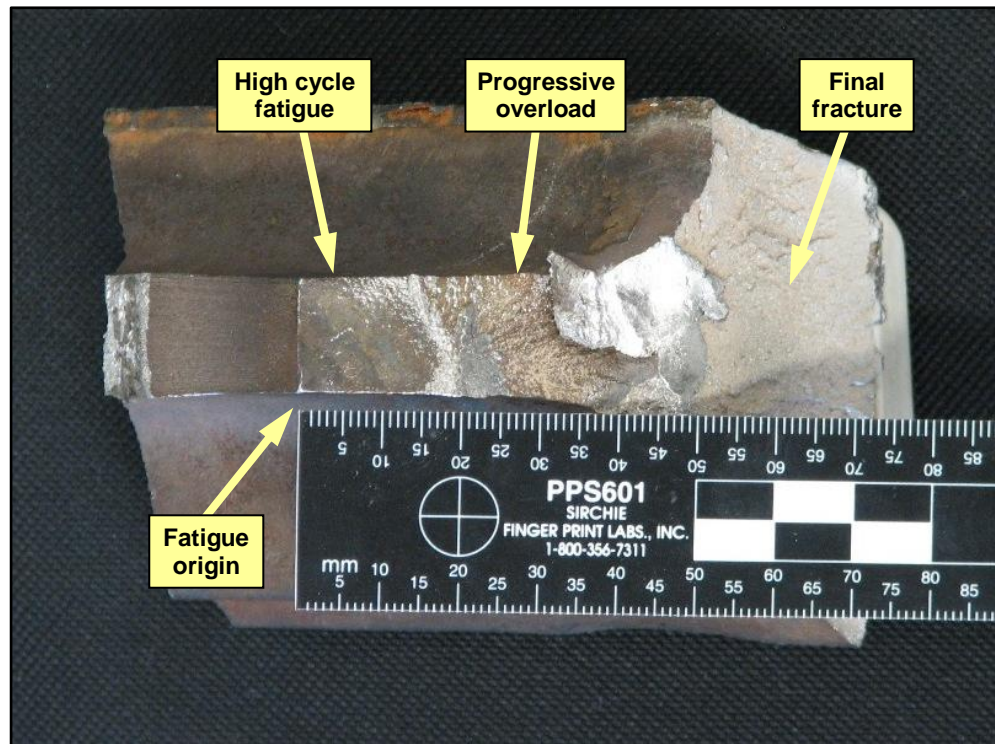
Figure 6: Fracture surface

Examination of the fracture surface of the failed section of rail, found a substantial fatigue crack extending from the bolt-hole towards the weld. Three distinct regions were evident on the fracture surface (Figure 6):

- High cycle fatigue – The fracture surface adjacent to the bolt-hole exhibited beach (crack arrest) marks radiating from one corner (fatigue origin). The surface was relatively smooth and indicative of a high cycle fatigue crack. This region was almost 20 mm in length and was oxidised, indicating that the crack had existed for some time prior to the derailment.

- Progressive overload – As the crack progressed through the rail, the fracture surface became rougher and consistent with a progressive overload or low cycle fatigue. This region extended to the start of the weld, about 45 mm from the fatigue origin. The surface showed very low levels of oxidisation, indicating that this phase of cracking had developed over a relatively short period of time.

- Final fracture – The final fracture through the rail head and foot was matt grey/silver in appearance and occurred at or about the time of the derailment.

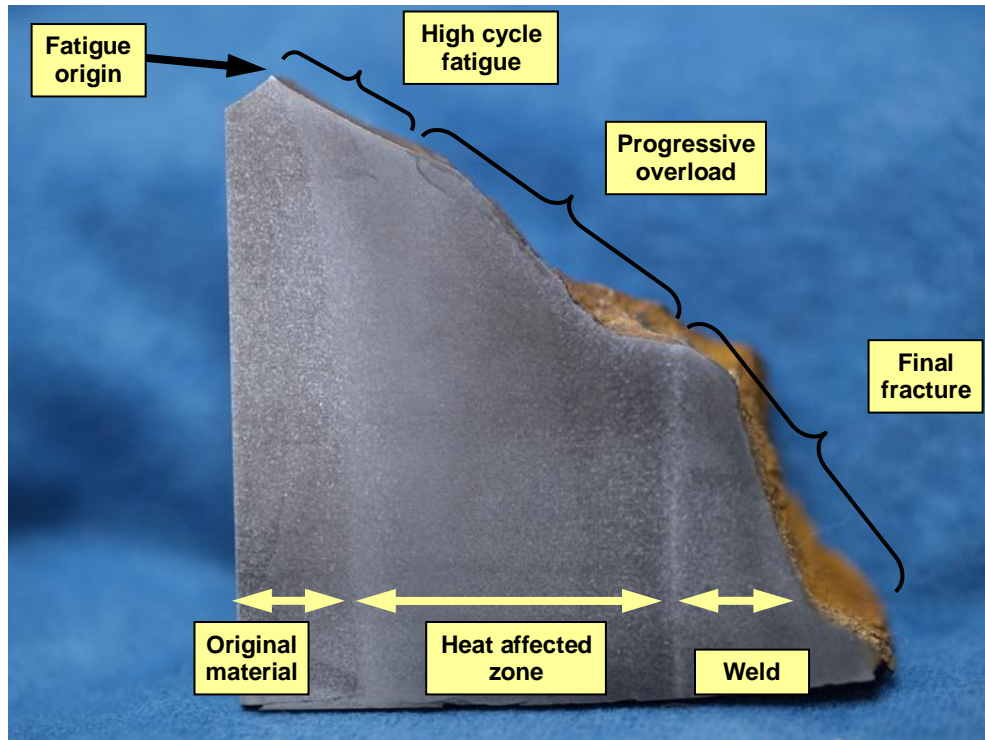
Figure 7: Longitudinal cross section through fracture surface

A longitudinal cross section was taken through the fracture surface and etched in 2% Nital⁶ solution. The etched surface showed transitions between the microstructures relating to the original rail condition, the weld between rails, and the weld heat affected zone (HAZ) between the two. It was found that the transition between the original metal and the HAZ coincided with the fatigue origin at the bolt-hole (Figure 7).

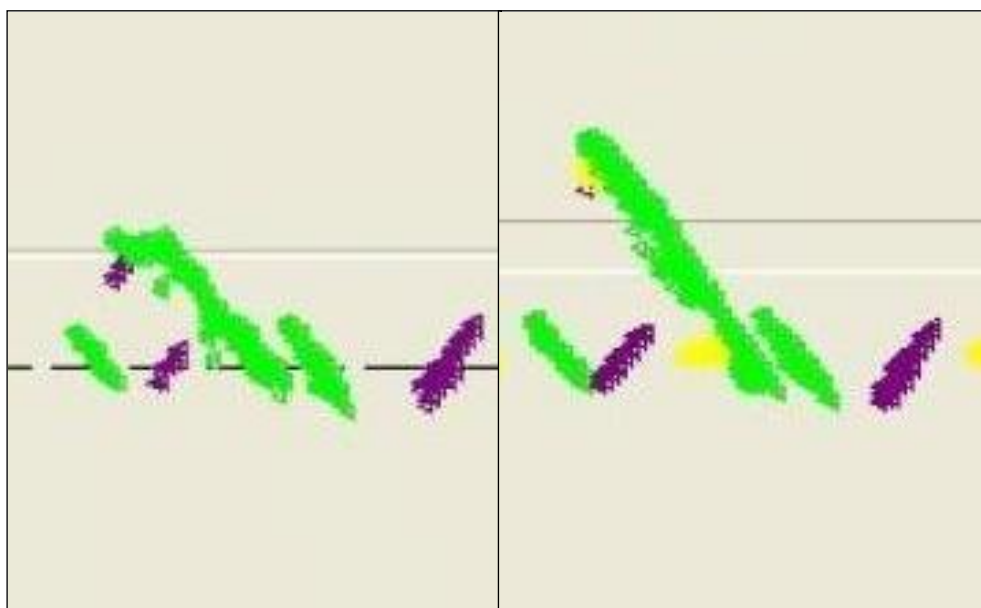
Figure 11: Comparison – 712.285 km point (left), 1680.813 km point (right)

Figure 11 compares the ultrasonic echo pattern detected near the 712.285 km point (Bates derailment site) with another echo pattern detected near the 1680.813 km point (about 95 km east of Parkeston, near Kalgoorlie, WA). The latter was referred to the chase car for examination and sizing. This echo pattern, which is slightly longer than that detected at Bates, was assessed as a suspected bolt-hole crack and sized at approximately 20 mm in length.

Even if the echo pattern detected at the 712.285 km point (Bates) was referred to the chase car for sizing, it is possible that the suspected defect may not have been reported for any maintenance response since its measured size may have been assessed as below the response 20 mm threshold documented in the ARTC CoP. However, in this case the rail completely failed 3 days later, even though the bolt-hole crack apparently did not exceed 20 mm in length.
