**ATSB TRANSPORT SAFETY REPORT**  
Occurrence Investigation Report AO-2007-070  
Final

**Leading edge device failure**  
**Norfolk Island**  
**29 December 2007**  
**VH-OBN, Boeing 737-229**

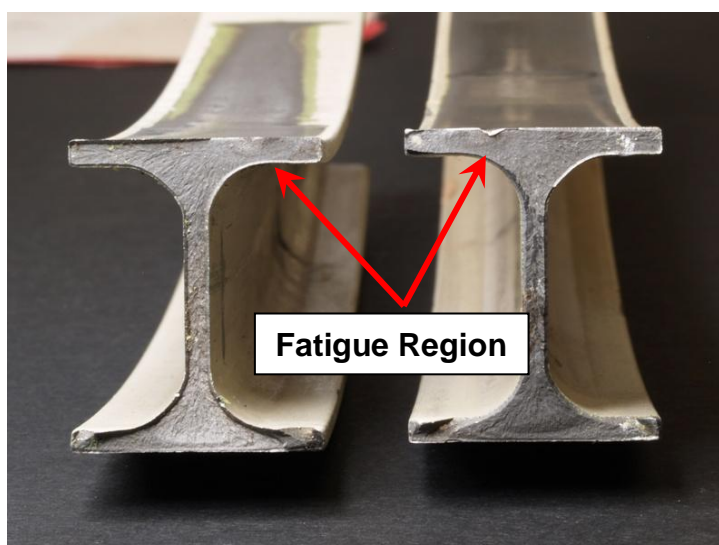
A visual examination of the fracture surfaces showed evidence of a fatigue crack that extended across a substantial portion of the lower flange<sup>15</sup> (Figure 3). A series of machining marks were also observed on the upper and lower track surface. Those marks were considered to be associated with the manufacture of the track. Optical and scanning electron microscopy revealed that the fatigue crack origin was adjacent to the area where two of these machining marks intersected.

**Figure 3: Inverted mating halves of the Slat Track fracture**

The inboard main slat track failed as a result of a fatigue crack that initiated and propagated on the lower rolling surface. Measurements taken of the track indicated that the failure occurred about 15 mm forward of the leading upper track roller,

The orientation of the associated fatigue region along the machining marks indicated that the marks probably acted as a local stress concentrator. The fatigue initiation point was potentially also influenced by the pitting of the rolling surface. The machining marks were a normal product of the manufacturing process, and were also evident on the aircraft's other slat tracks that did not fail.

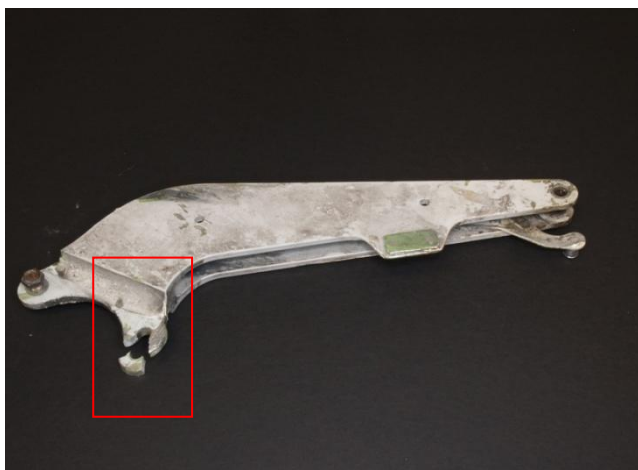
The inboard auxiliary track was found to have failed in ductile overload through one of its bolt holes. That bolt hole had also elongated in the direction of the liberated section. The material around the bolt hole was scored, consistent with the movement of the track in the support (Figure 4).

**Figure 4: Inboard auxiliary track showing failed bolt hole (highlighted)**

Similarly, the appearance of the inboard auxiliary track failure was consistent with a rapid overload fracture.

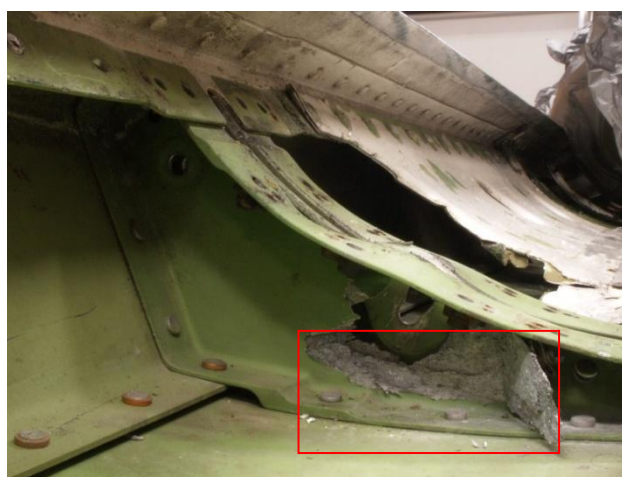
One of the support ribs on the outboard auxiliary track had failed as a result of extensive exfoliation corrosion<sup>16</sup>. The corrosion was centred adjacent to the cadmium-plated steel bolt that attached the track to the slat ribs. The remaining rib failed through the bolt hole, which had fractured up to the rib flange. The flanges on both ribs had buckled outwards and were fractured along their length (Figure 5).

**Figure 5: Outboard auxiliary track attachment corrosion**

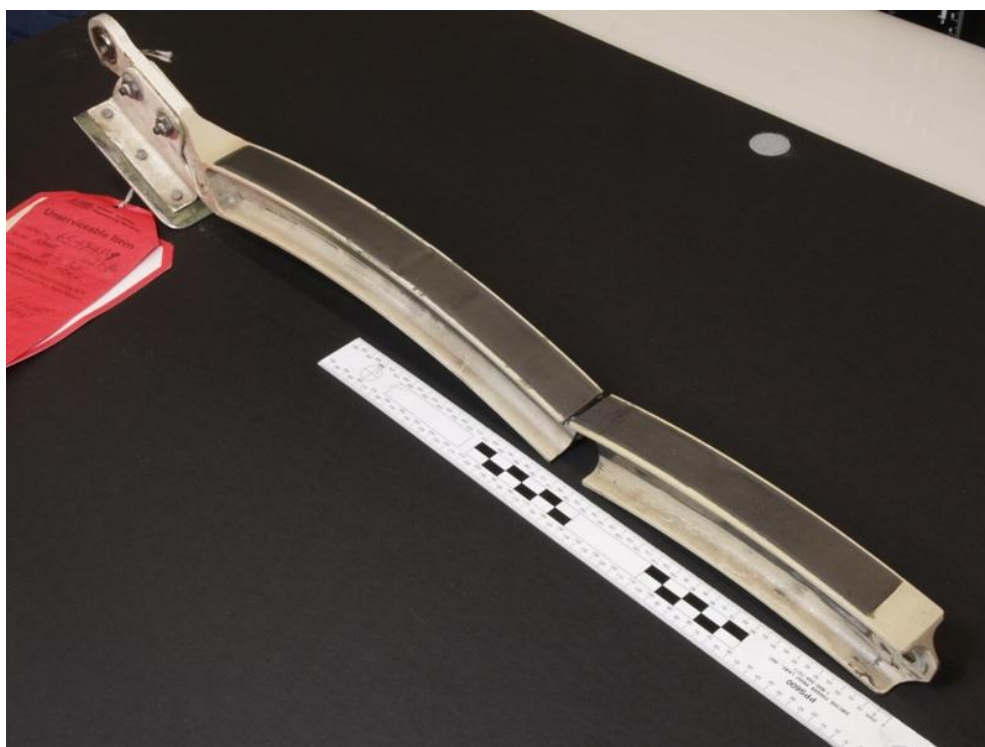
The inboard main track assembly had fractured close to the mid-span position. Areas of heavy wear on the rolling surfaces consistent with the location of the main track rollers were observed. The most significant wear was associated with the upper track rollers when the slat was in the fully-retracted position. The outboard main track showed similar wear patterns, but was otherwise undamaged.

**Figure 2. Failed inboard main slat track.**

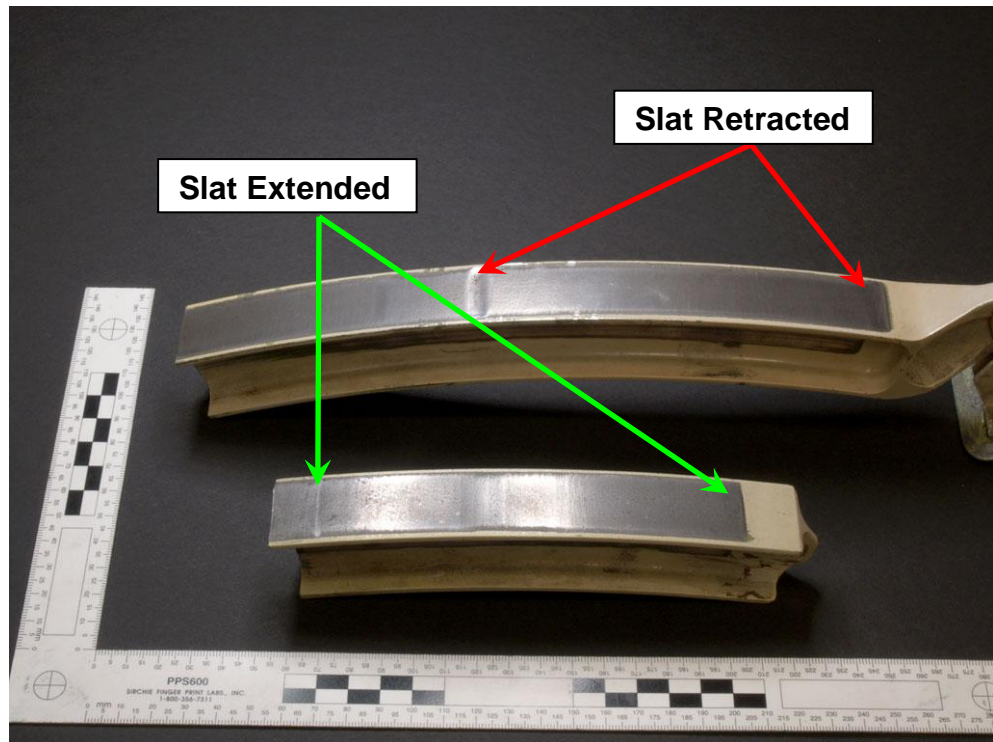
Figure 3. Main upper track roller wear marks

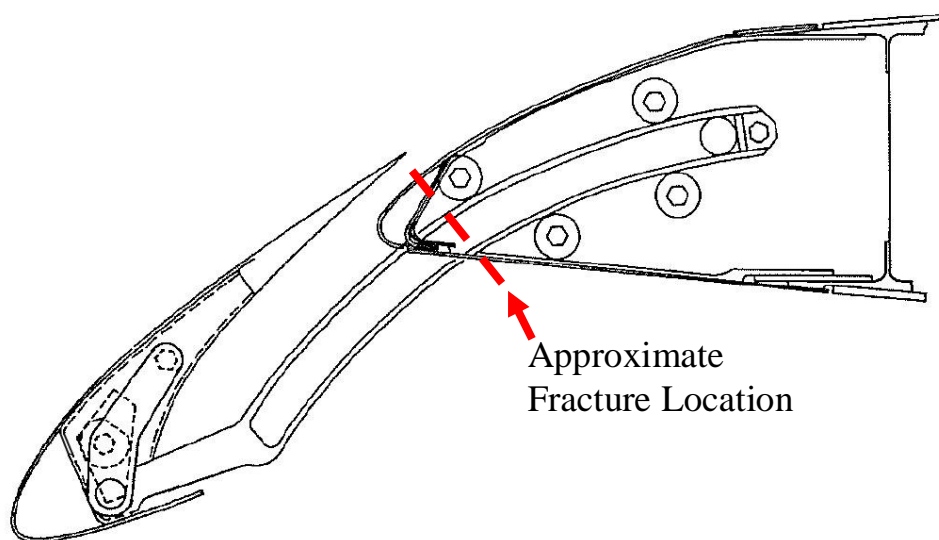
with the slat in the fully-extended position. The failure occurred at a location considered to be the maximum load point when fully extended due to the generation of lift and upward forces acting on the slat in that position.

Figure 4. Fully extended slat indicating fracture location\*

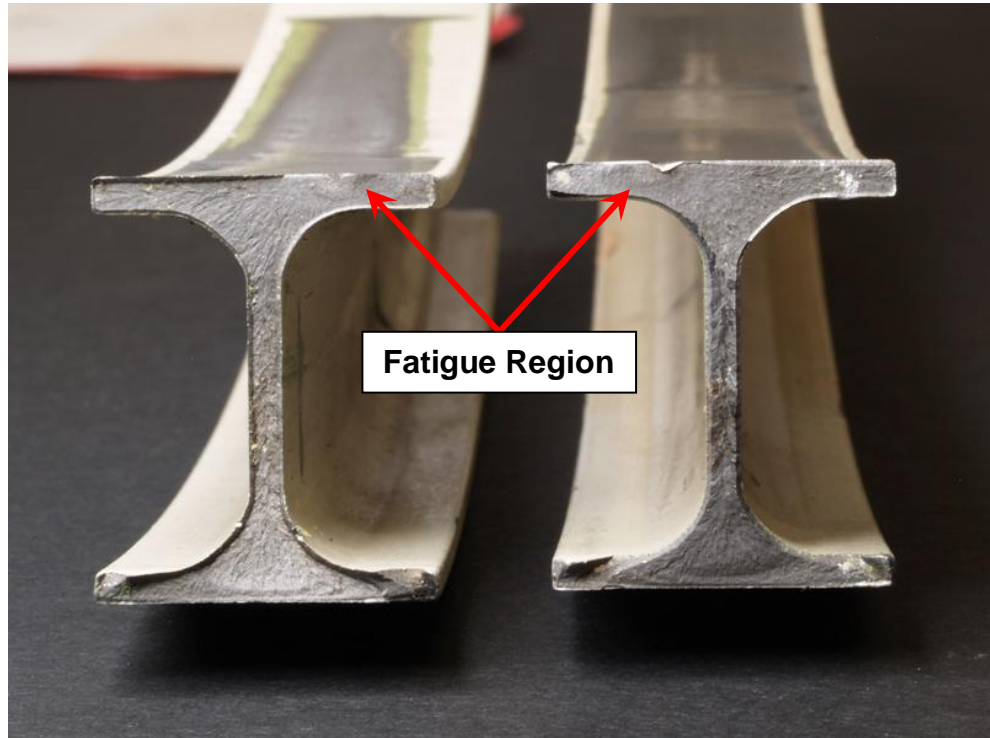
**Figure 5. Mating halves of Slat Track fracture**

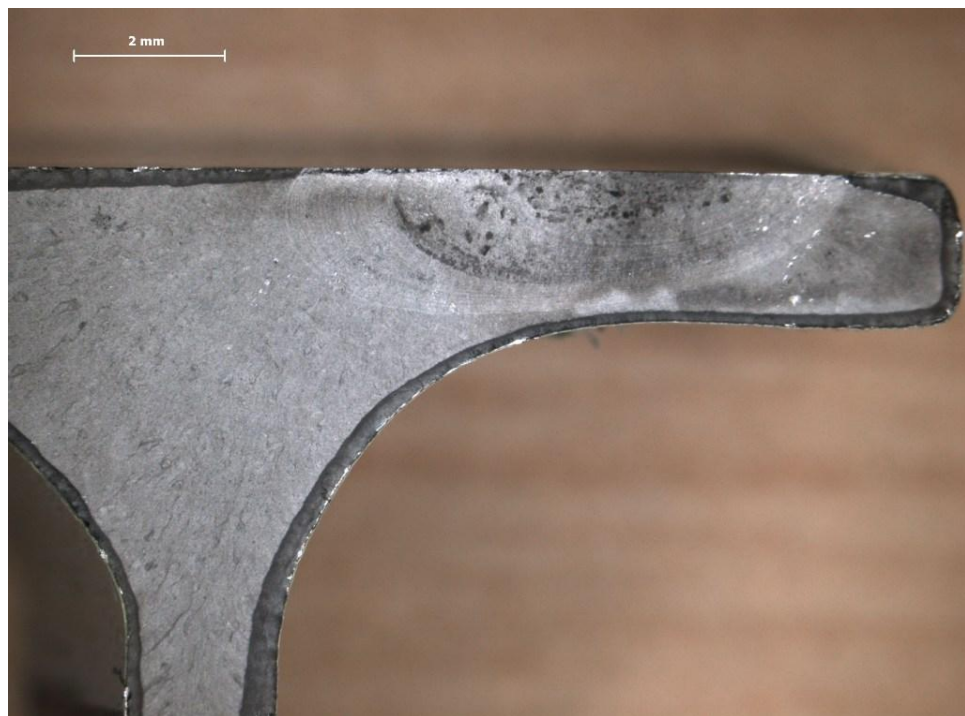
**Figure 6. Fatigue region on lower flange exhibiting beach marks**

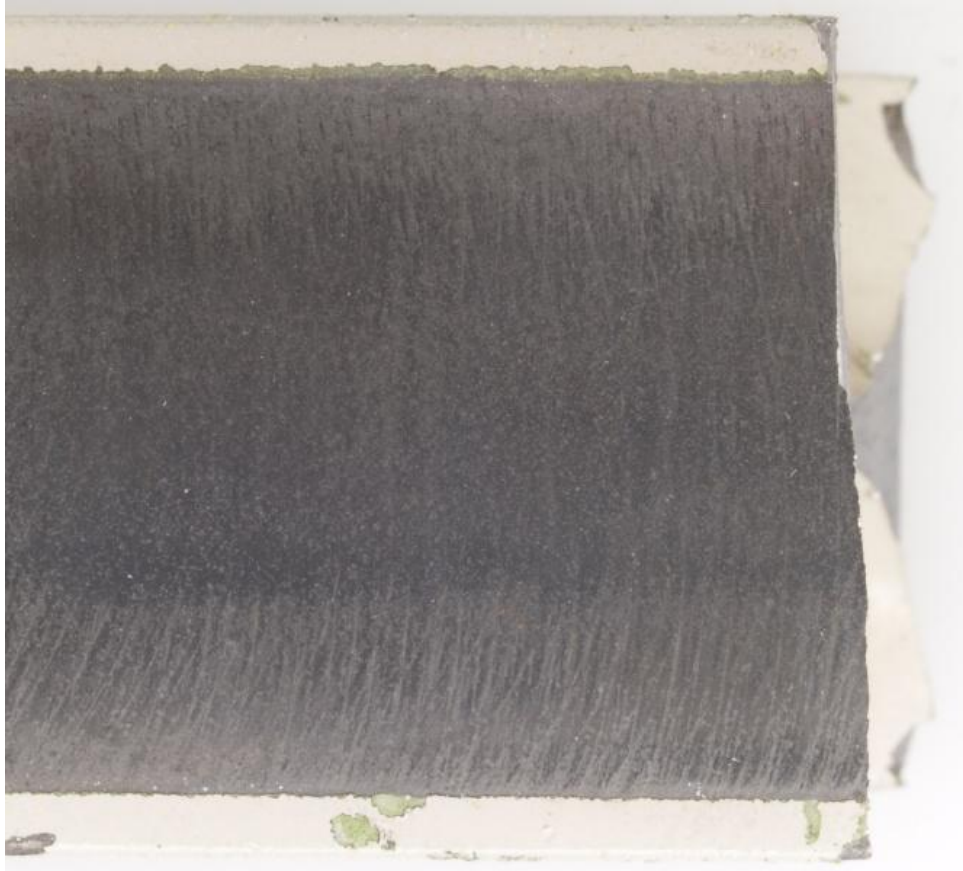
A series of machining marks was observed on the upper and lower track surface (Figure 7). The marks were predominantly visible at the edges of the track, indicating that they had probably been worn away in the centre by the track rollers. The marks were also visible under the paint which indicated that they were probably associated with the manufacture of the track.

**Figure 7. Machining marks on track rolling surface**

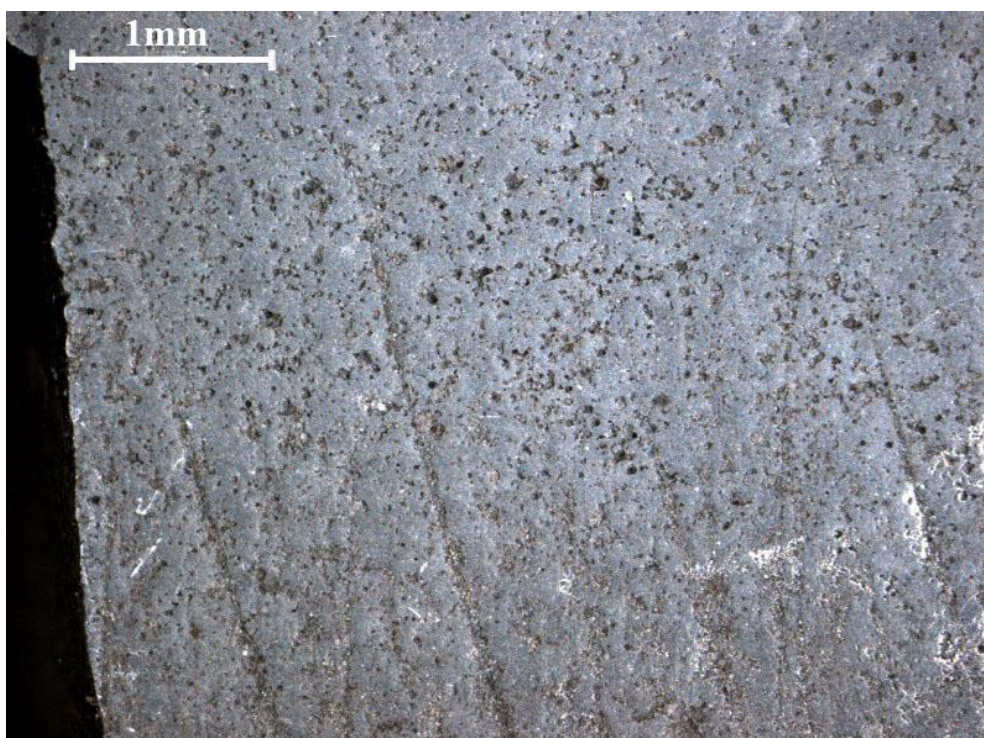
**Figure 8. Pitting on the lower flange adjacent to the fracture surface**

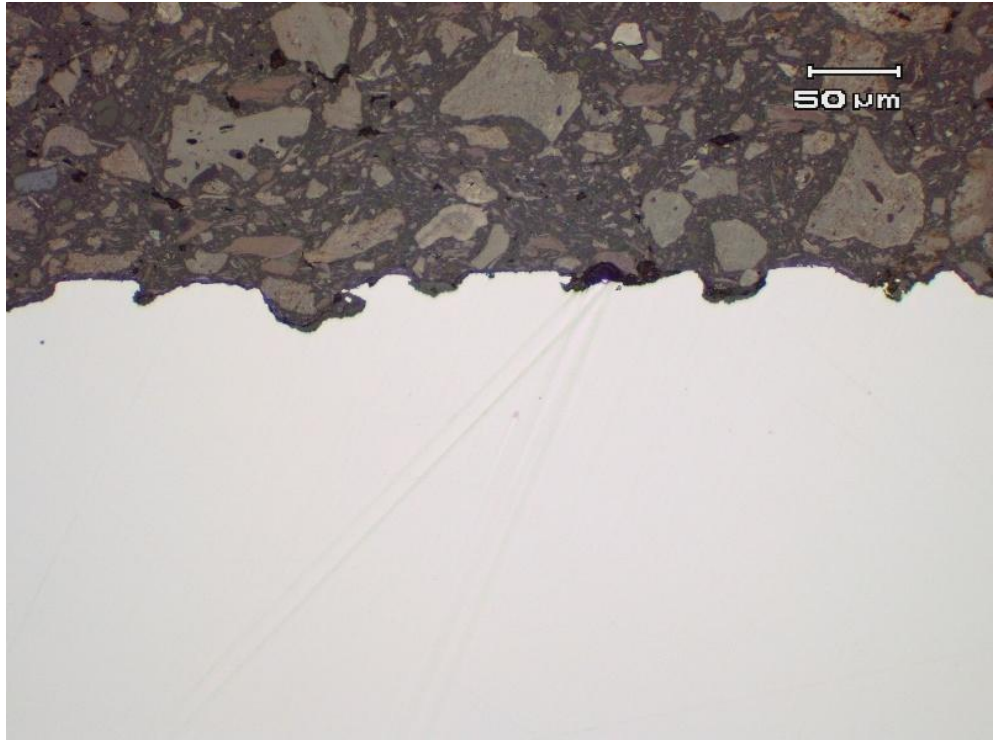
**Figure 9. Cross section showing pitting of rolling surface**

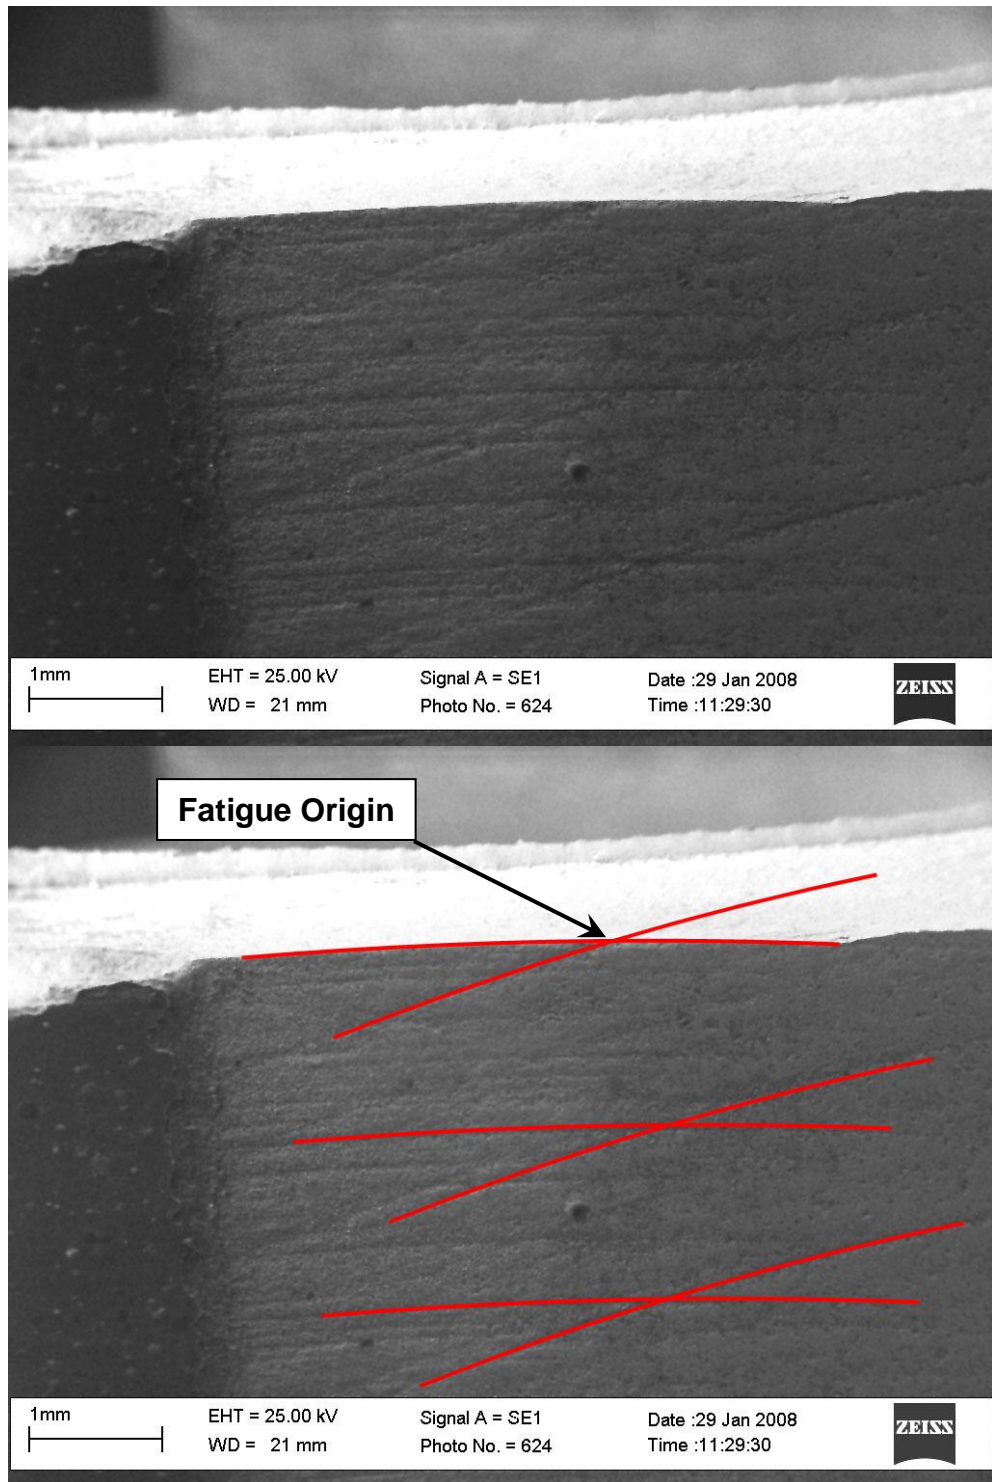
Figure 10. SEM image of machining marks adjacent to fatigue origin.

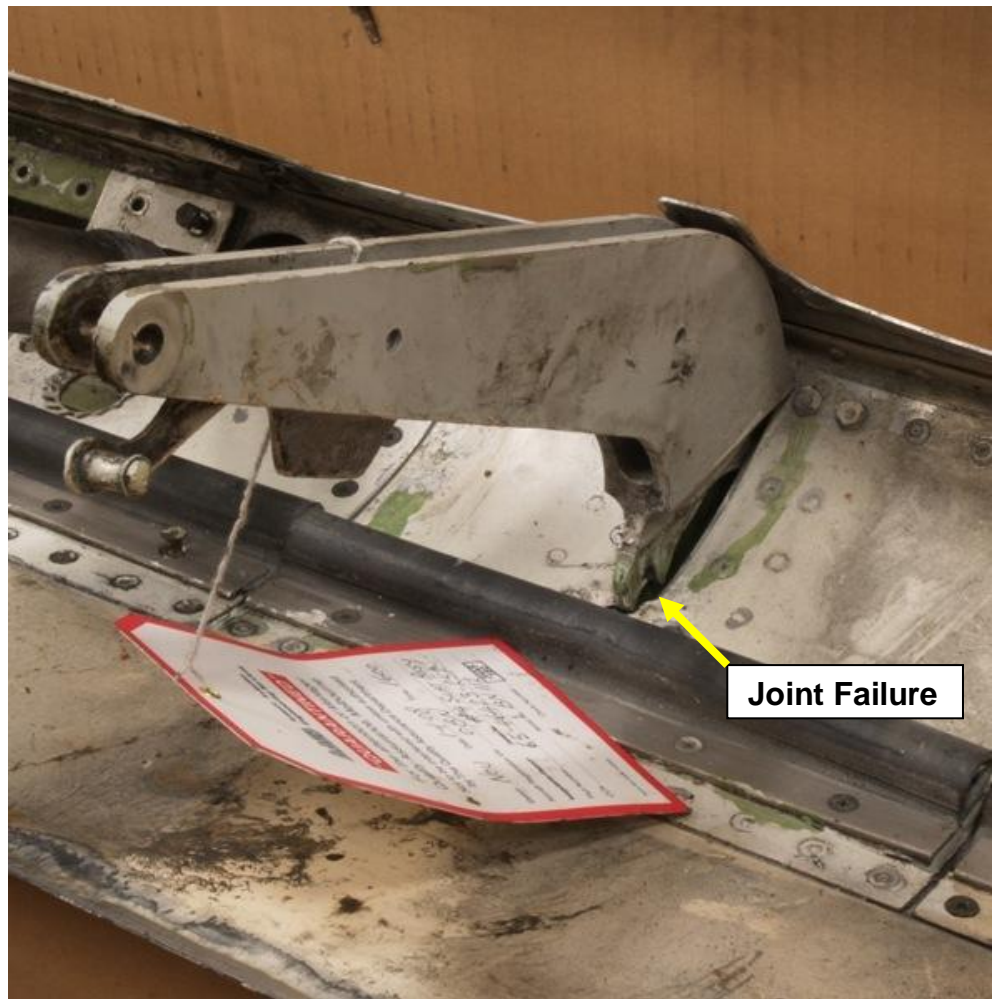
Figure 11. Inboard auxiliary track in situ

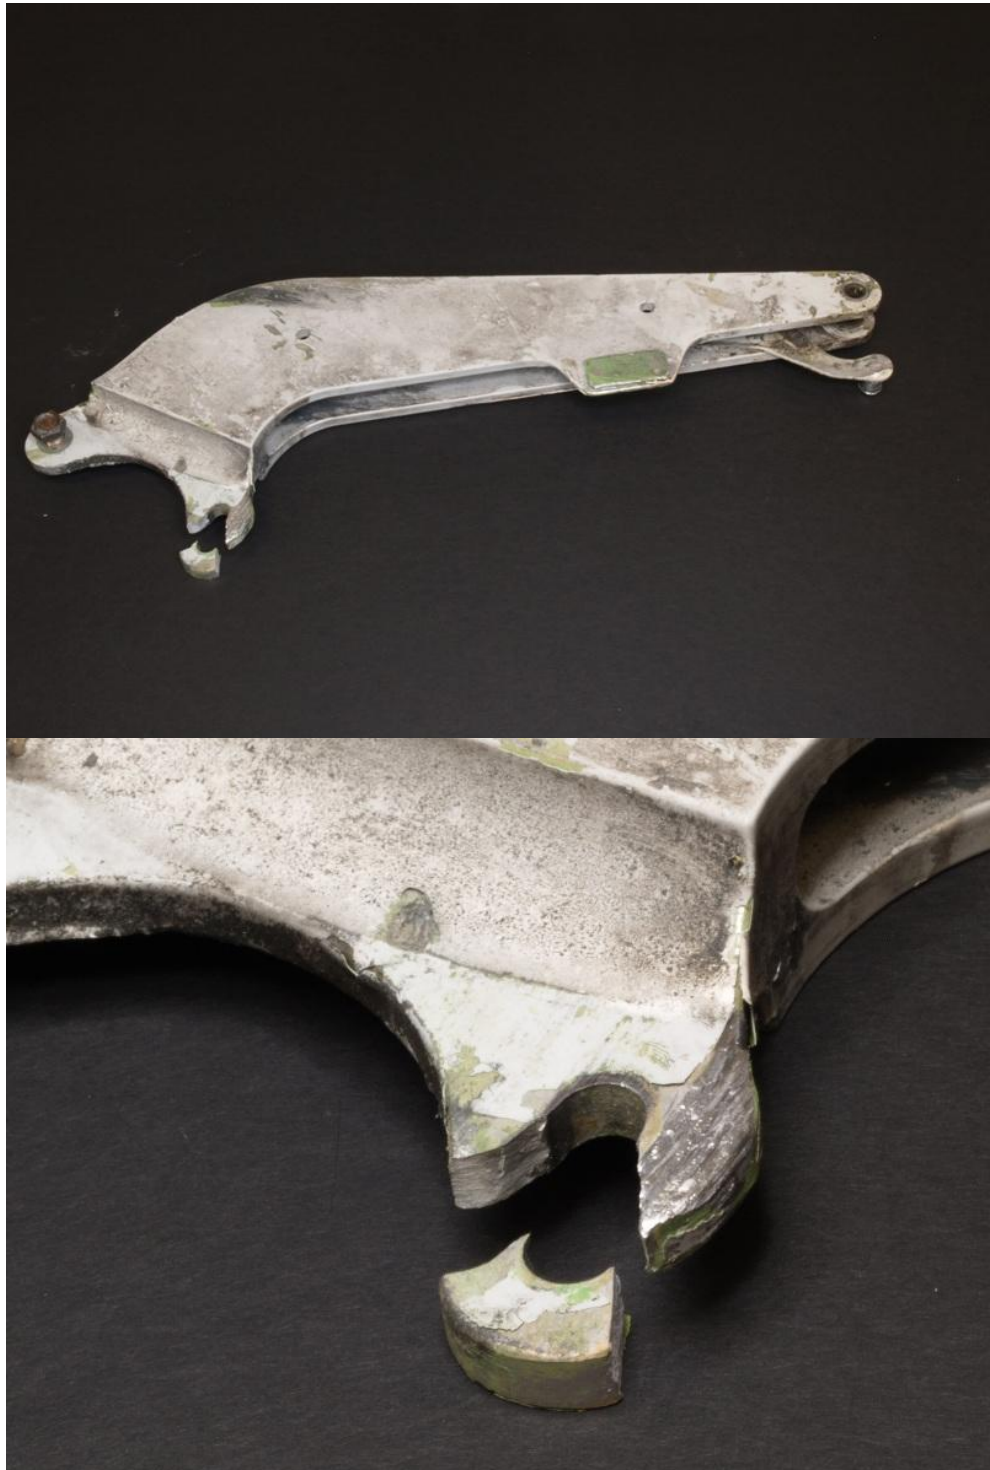
Figure 12. Inboard auxiliary track failure

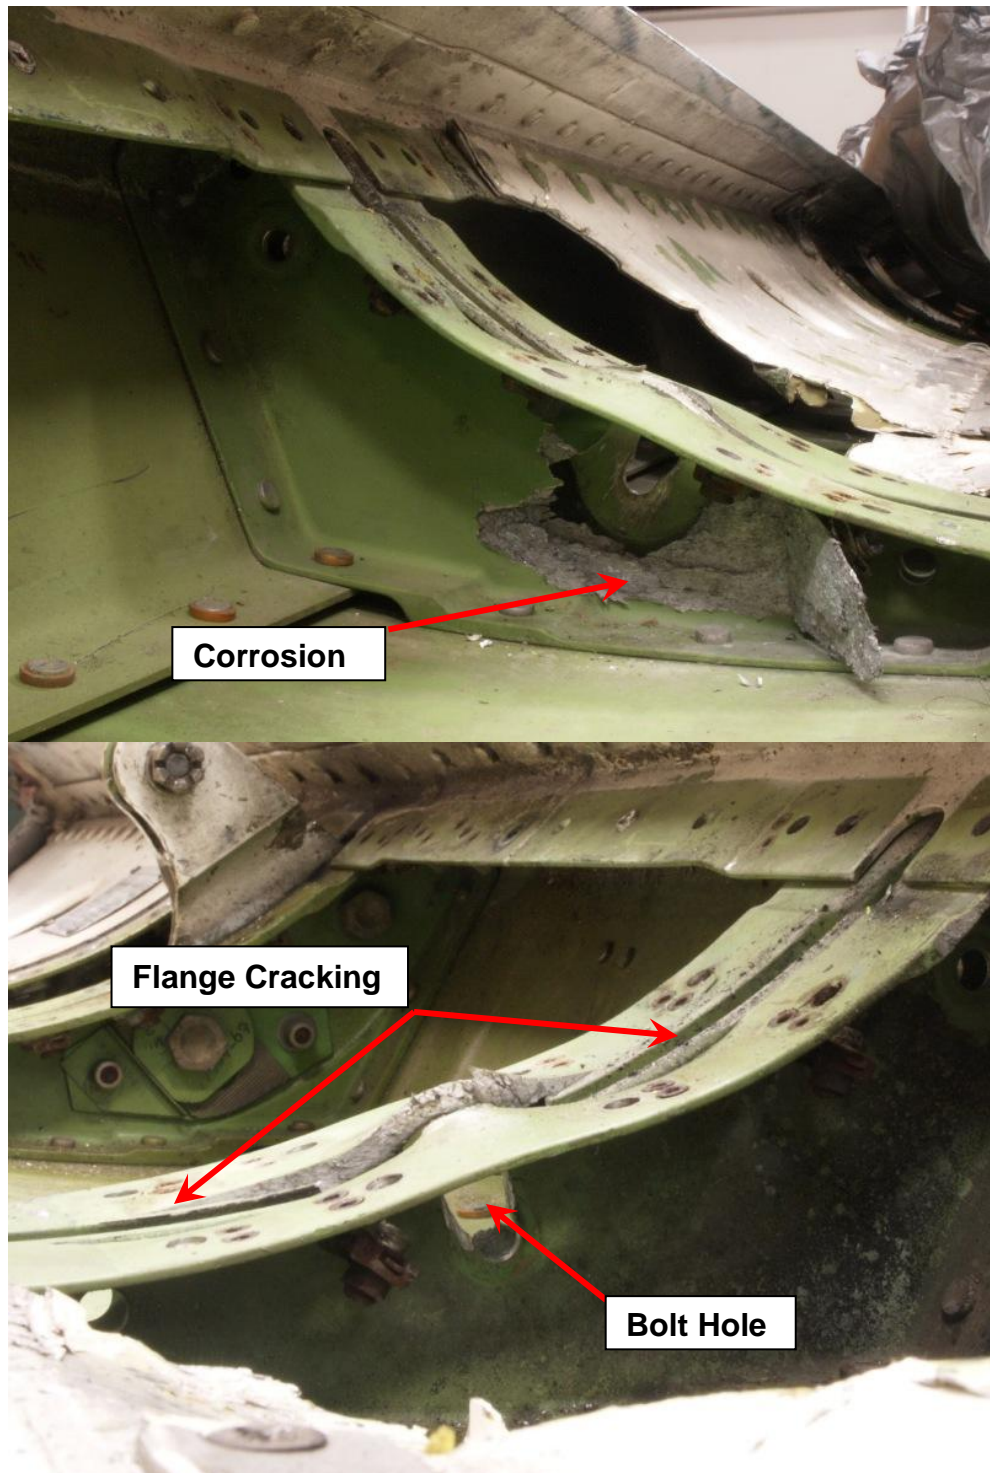
One of the aluminium support ribs for attachment of the outboard auxiliary track had failed as a result of extensive exfoliation corrosion (Figure 13). The corrosion was centred around the cadmium-plated steel bolt attaching the track to the ribs. The remaining rib failed through the bolt hole, which had fractured up to the rib flange. The flanges on both ribs had buckled outwards and were fractured along their length.

Figure 13. Outboard auxiliary track support ribs
