ATSB TRANSPORT SAFETY REPORT
Aviation Occurrence Investigation AO-2009-006
Final

Main landing gear wheel failure
Sydney Airport, NSW
6 February 2009
VH-KDQ
Saab 340B

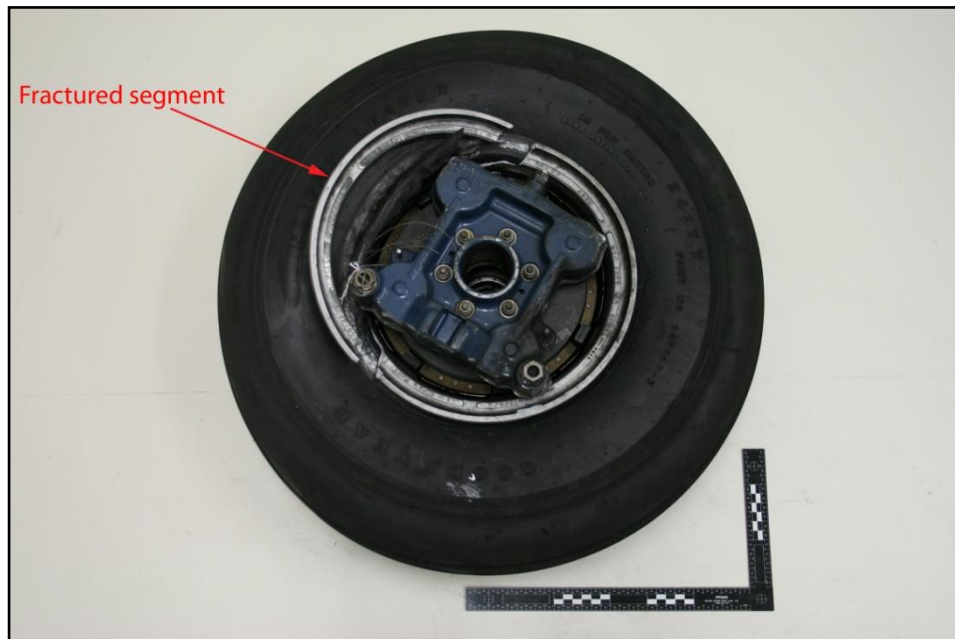
The failed wheel assembly was removed from the aircraft and sent to the ATSB's Canberra laboratories for further examination. Initial inspection revealed that a section of the rim had broken away, with the fracture path extending through the bead seat area (Figure 1). The broken section represented just less than one half of the entire circumference of the wheel rim. The tyre had been damaged in the area of the fracture, with evidence of exposed steel reinforcement. The tyre had moved over the fractured segment and was caught on the fractured edges of the rim.

Figure 1: Left outboard main wheel assembly as received

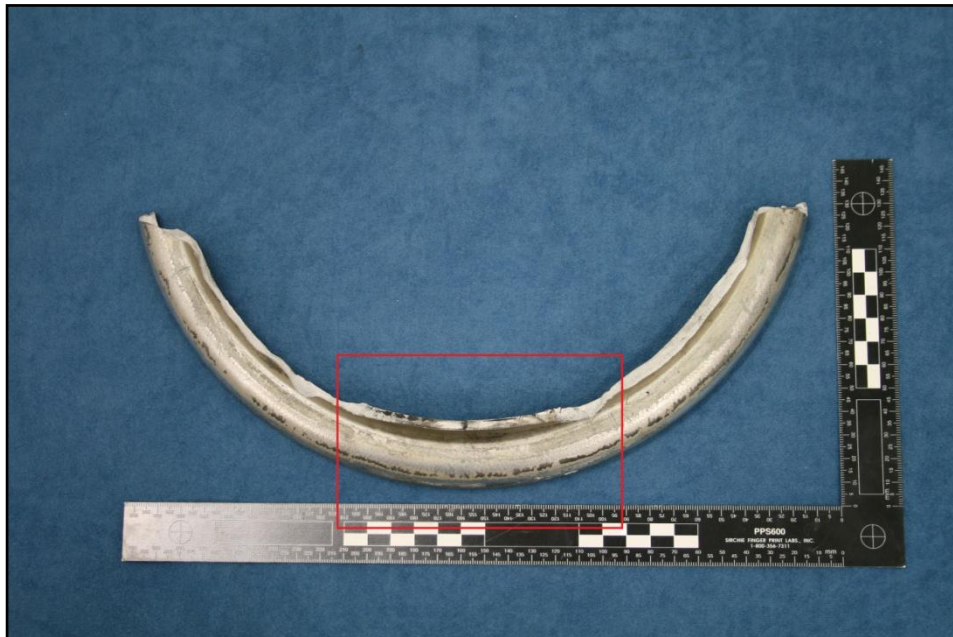
The fracture had followed a radial path through the wheel rim bead seat area. Features consistent with fatigue crack progression (beach-marks) were evident across the fracture surfaces. Those features extended radially from the internal bead seat radius surface, towards the centre of the exposed fracture face (Figures 2 and 3). The beach-marks extended circumferentially around the rim for approximately 100 mm, with several other crack initiation sites identified around the internal bead seat radius.

The outer sections of the fracture face were observed to be dull grey in colour, and were rough and fibrous in appearance, consistent with a ductile overstress failure in a heat treated aluminium alloy.

Evidence of a black discolouration, most likely rubber or grease, was observed on the fatigue area of the fracture face.

Figure 2: Inside surface of the fractured wheel rim section

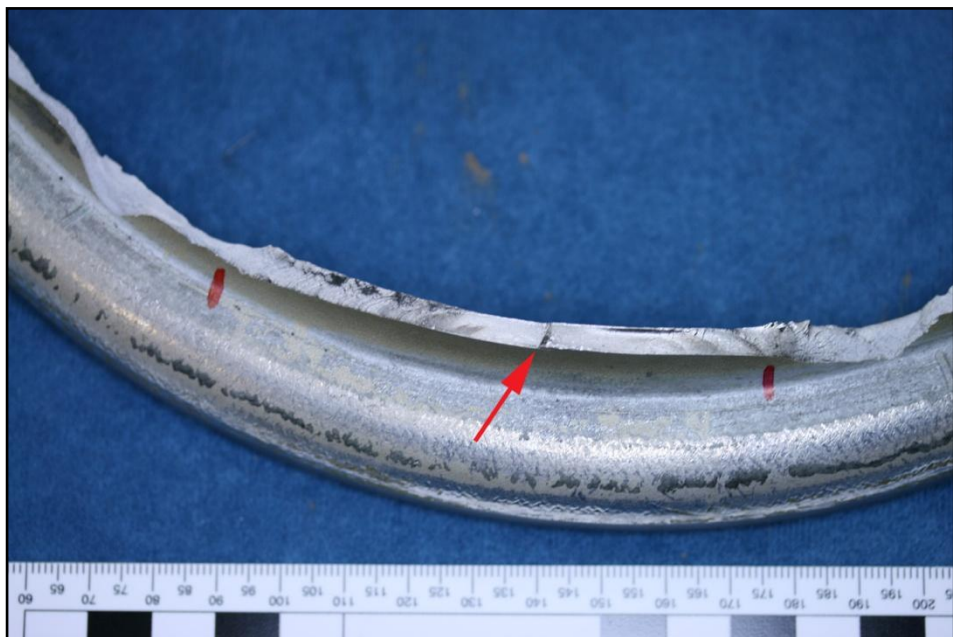
Figure 3: Magnified view of fracture face showing the crack progression (beach-marks) extending from the bead seat radius origin area (arrowed)

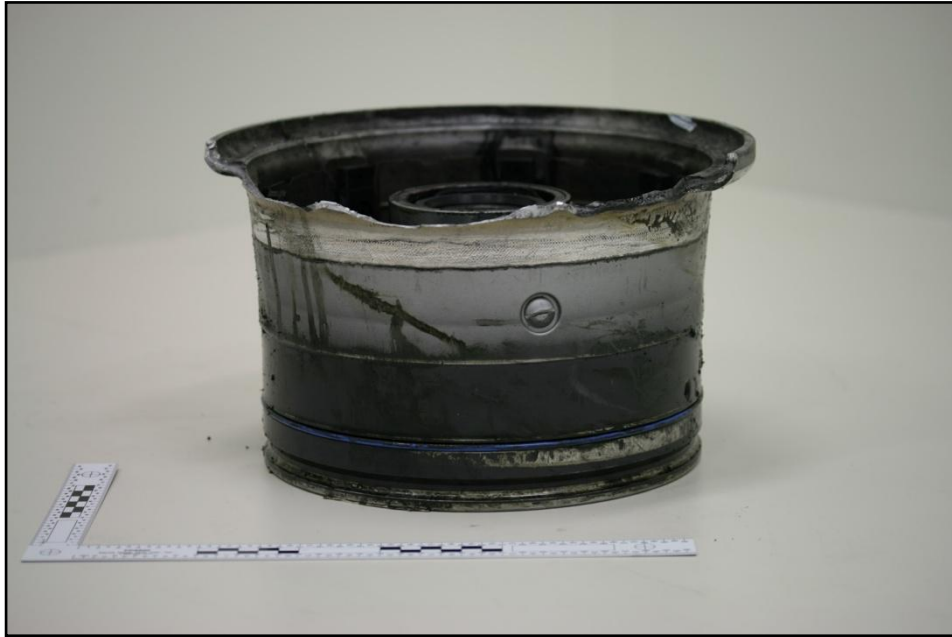
Disassembly of the wheel rim and removal of the tyre allowed inspection of the hub side of the fracture face (Figure 4). This surface exhibited similar features to those observed on the smaller section that had been excised from the wheel, and showed a clearer indication of the location of the fracture (as shown on the engineering drawing of the wheel, Figure 5). The primary crack origin was located at the transition radius between the bead seat and the rim area.

Figure 4: Overview of the wheel assembly following removal of the tyre

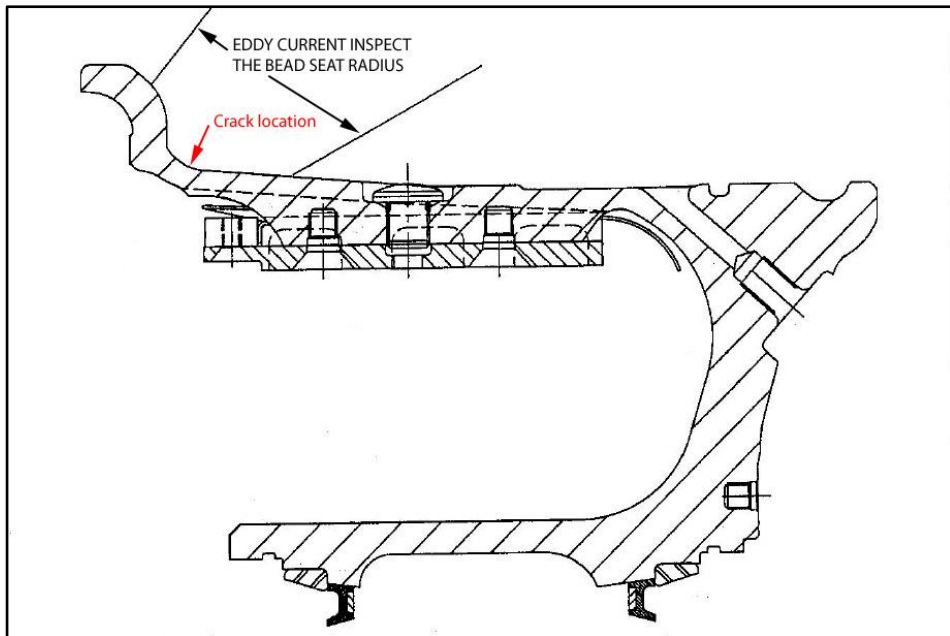
Figure 5: Cross section diagram of main wheel hub² showing the location of the fracture

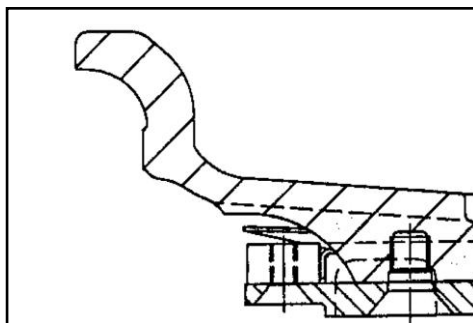
Figure 6: Diagrams showing the difference in the original and revised wheel designs

Bead seat of the subject original wheel design, part number 5010488, image from SF340-32-24 Rev 1

To reduce the probability of fatigue crack initiation, the revised design incorporated measures to reduce bulk stress levels in the rim region. This was achieved by an increase in the outer flange area and the use of additional reinforcement on the inside of the flange, opposite the tyre bead seat area (Figure 6).

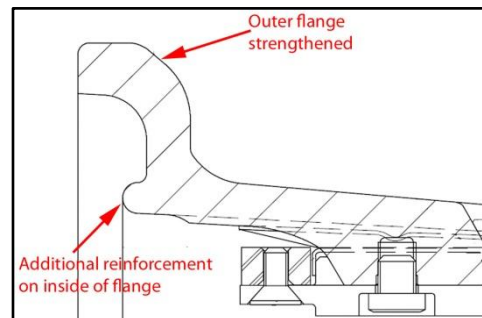
Bead seat of the revised design, part number 5010488-1, image from Saab 340-32-41
