**ATSB TRANSPORT SAFETY REPORT**  
Aviation Occurrence Investigation AO-2009-018  
Final

**Midair collision**  
**15 km SE Springvale Station, WA**  
**5 May 2009**  
**VH-PHT, Robinson Helicopter**  
**Company R22 Beta II**  
**VH-HCB, Robinson Helicopter**  
**Company R22 Beta II**

Report No.	Publication date	No. of pages	ISBN
AO-2009-018	17 February 2010	28	978-1-74251-034-7

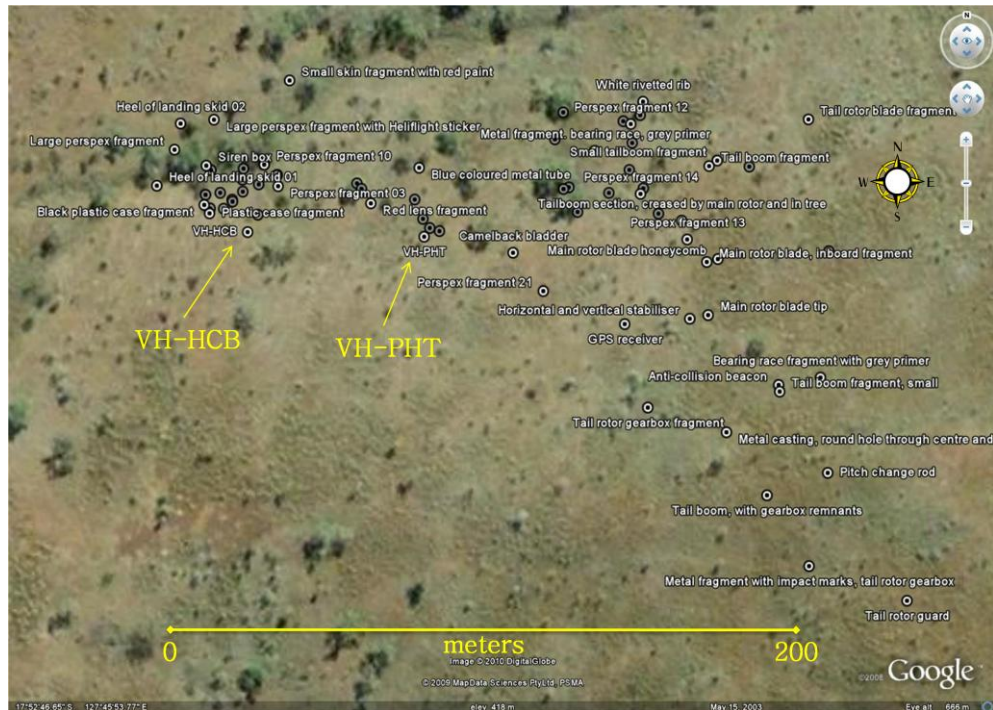
**Figure 3: Wreckage scatter**

Both helicopters were seriously damaged<sup>4</sup> as a result of impact forces associated with the midair collision, the impact with terrain and post-impact fires. The wreckage was scattered over an area of about 260 m by 100 m (Figure 3).

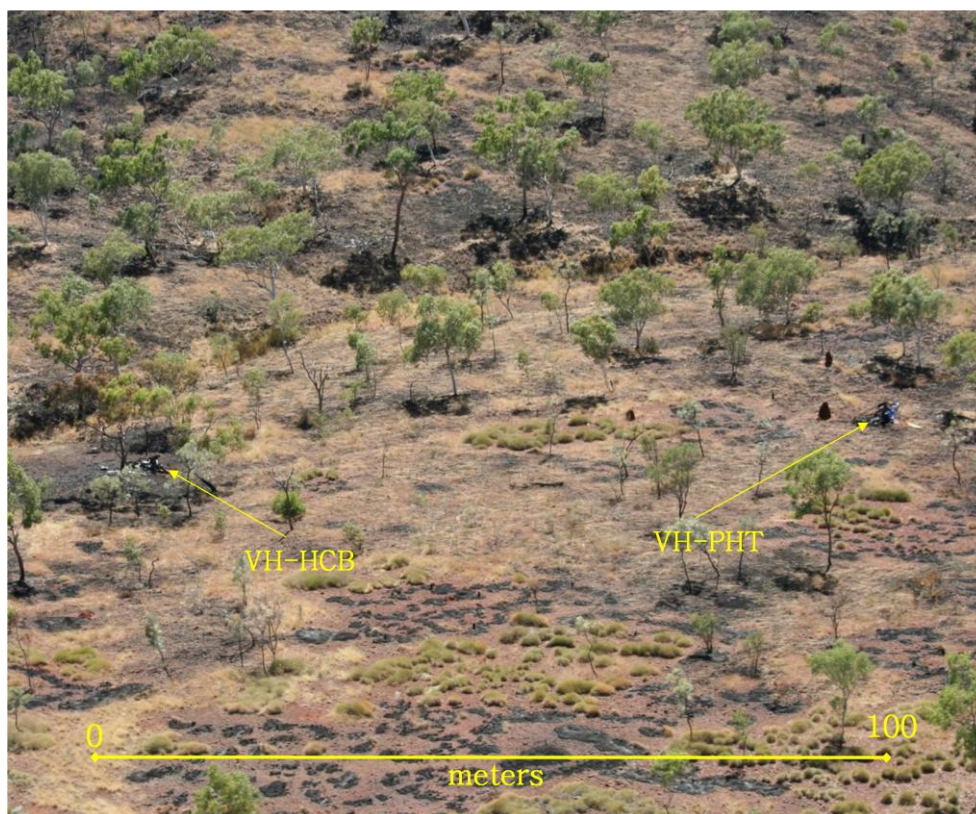
**Figure 4: Accident site**

The wreckage of the two helicopters was located on undulating terrain. The accident site consisted of a combination of dirt, rock, termite mounds, spinifex, and scattered small trees (Figure 4). All major sections and components of the helicopters were identified within the accident site except for the tail rotor hub and one tail rotor blade from HCB, which were not located.

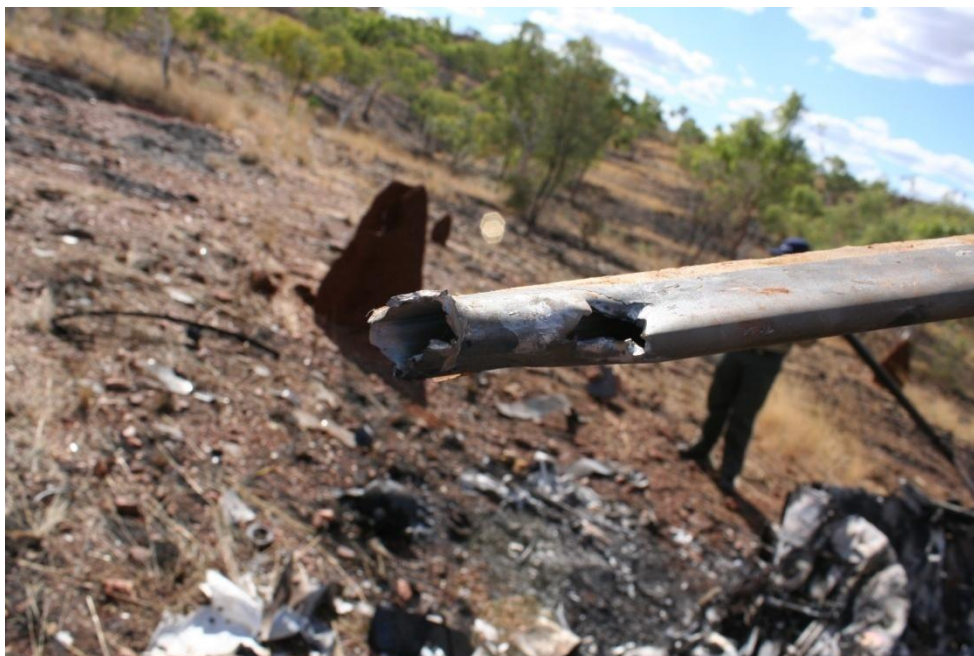
**Figure 5: Missing blade tip and notched leading edge**

Detailed inspection of the main rotor system identified signs of blade deformation including bending, which was consistent with the main rotor blades turning at low

RPM. About 700 mm of the outer portion of one blade had separated, and a notch, consistent with contacting a piece of HCB's tail rotor gearbox, was located about 70 mm inboard of the point of blade tip separation (Figure 5).

On the basis of the destruction to the tail boom of HCB and paint transfer markings, it was determined that the main rotor system of PHT came into contact with the tail boom of HCB in flight. Evidence available on site indicated that the engines of both helicopters were operating at the time of the accident. In each case, no mechanical defect was identified that would have precluded normal flight. The low rotational energy displayed on the tail rotor of PHT was consistent with a loss of main rotor RPM associated with the midair collision. The impact angle on the tail section of HCB was consistent with one or both pilots attempting to take avoiding action.

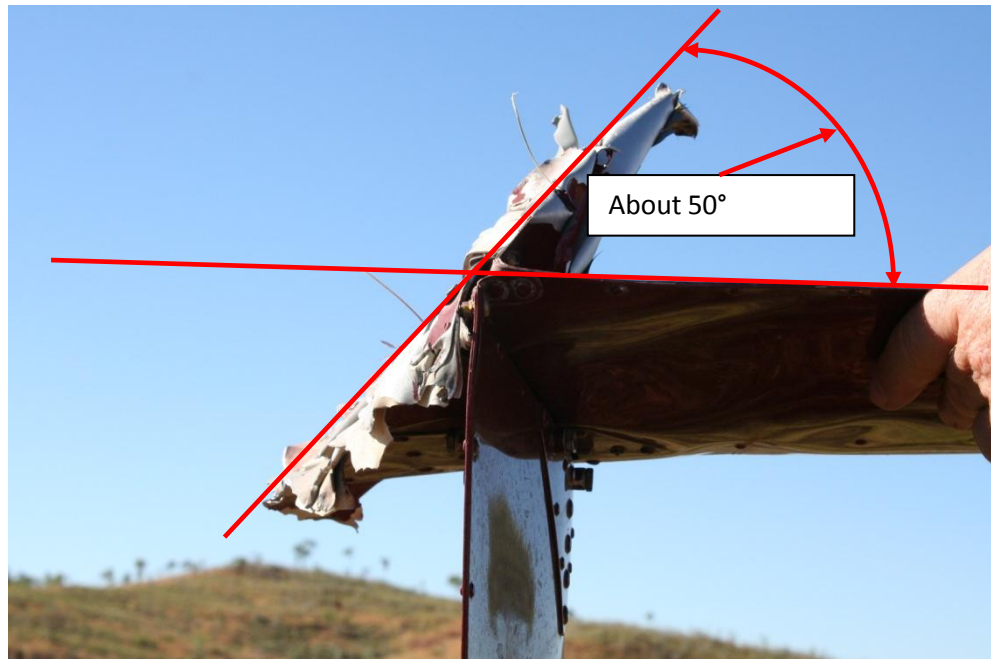
**Figure 6: Horizontal and vertical fins**

Inspection of the airframe revealed that the helicopter contacted the ground in a mostly upright attitude. A post-impact fire destroyed the majority of the helicopter. The tail boom was severely disrupted by the main rotor blades from PHT, which passed through the tail boom structure several times. The vertical and horizontal fins had been separated as an assembly by a main rotor blade strike (Figure 6). A yellow paint transfer was evident on sections of the tail boom, consistent with the colour used on an R22 main rotor blade tip. Rotational scuffing on the inner surfaces of a number of tail boom skin fragments that were found at the site, confirmed that the tail rotor driveshaft was rotating during the impacts with the tail

boom. Only the outer half of one of the tail rotor blades was located. The fracture surface on this blade displayed signs of gross overload.

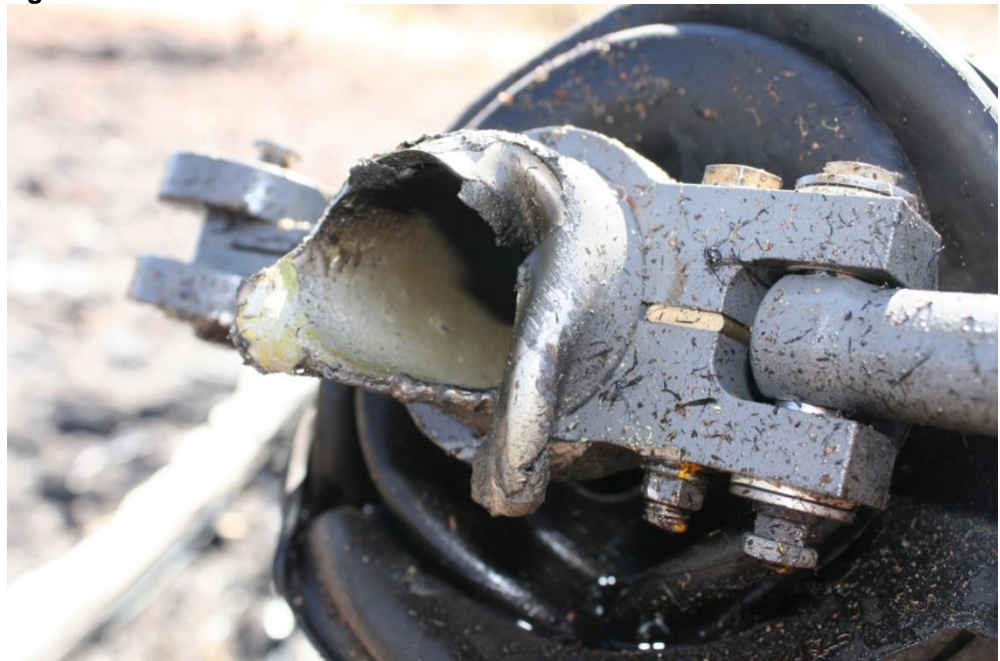
**Figure 7: Failed rotor mast**

A detailed inspection of the main rotor system showed that it was complete, but the mast had separated below the main rotor head. This failure displayed a degree of torsional twist, typical of an overstress fracture (Figure 7). The rotor system was further damaged by the post-impact fire.
