ATSB TRANSPORT SAFETY REPORT
Aviation External Investigation AE-2009-046
Final

**Aircraft instrument and fuel system detritus
examination
Bell 206L4, P2-HBC
Collision with Terrain in the
vicinity of Lake Murray PNG
25 September 2008**

On 25 September 2008, the pilot of a Bell 206L4 helicopter, registered P2-HBC, was conducting sling loading operations in the vicinity of Lake Murray, Papua New Guinea. While conducting a vertical lift, a witness reported hearing a 'different noise' from the helicopter's engine, before observing the pilot jettison the load. The witness then observed the helicopter oscillating from side to side, yawing to the left and then descending through the tree canopy to impact the ground. The pilot was fatally injured and the helicopter seriously damaged.

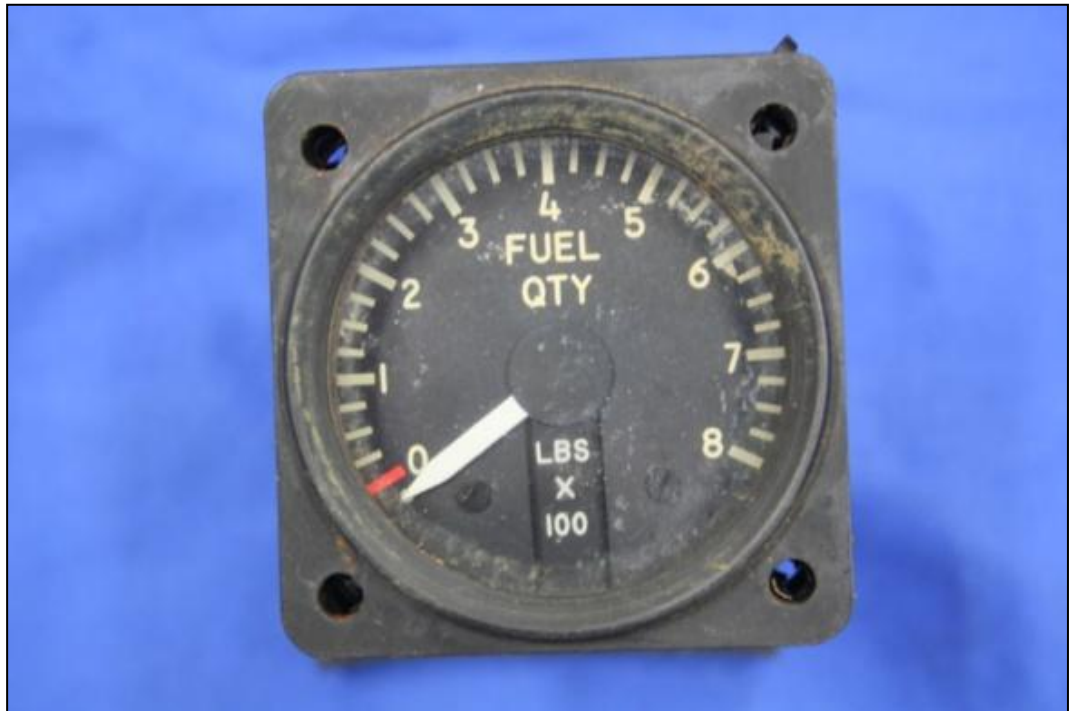
Figure 1: Fuel quantity gauge

- fuel quantity gauge, part No. 83-104-1 / serial No.9818-159 (Figure 1)
- turbine outlet temperature (TOT) gauge, part No.SEL-019DT / serial No.489A (Figure 2)
- warning annunciation panel: Serial No. 9818-157 (Figure 3)
- sample of detritus removed from the internal surfaces of the helicopter primary fuel filter check-valve assembly (Figure 4).

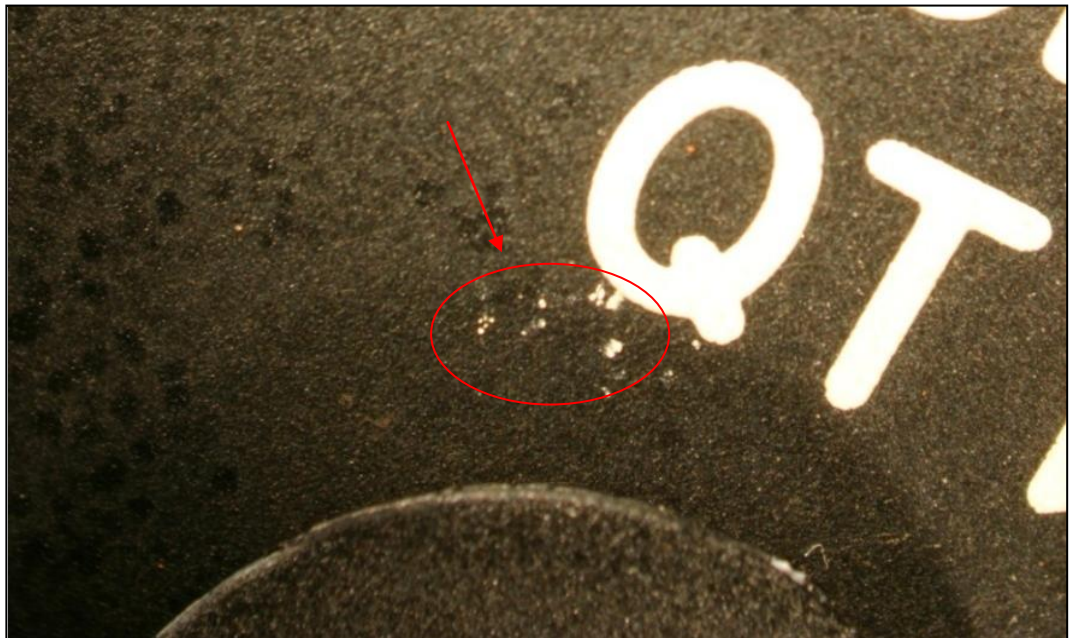
Various marks were found on the face of the fuel quantity gauge. Small paint deposits from the underside of the pointer were evident on the instrument face from an area of contact which correlated with a gauge reading of approximately 300 to 330 lb (Figure 5).

Figure 5: Paint marks on instrument face

Examination of the fuel quantity indicating gauge found evidence of witness marks on the face of the instrument in the form of paint transfer from a protrusion on the underside of the instrument pointer, possibly from a single contact event. The witness marks corresponded to an approximate indication of 300 to 330 lb of fuel.

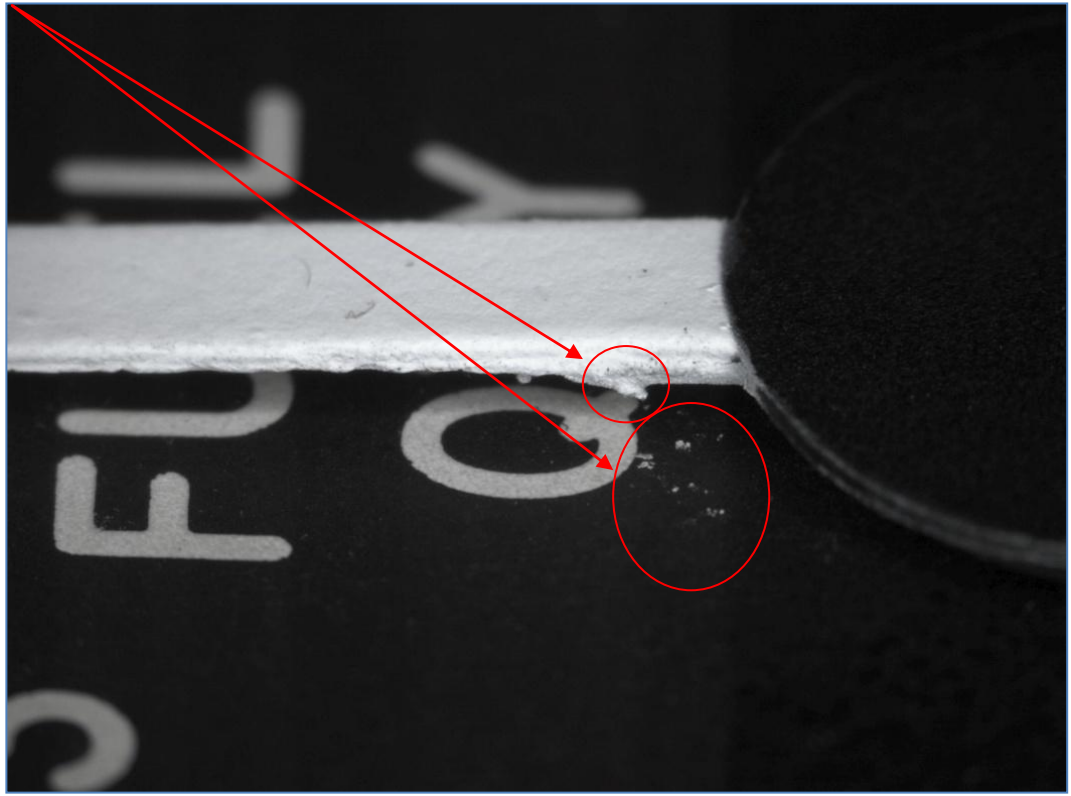
Examination of the gauge pointer identified a small paint protrusion on the underside surface, towards the pointer base (Figures 6 and 7). That protrusion was found to align with the location of the paint marks on the gauge face (Figure 6).

Figure 6: Comparison of the position of the dislodged paint on the protrusion on the underside of the pointer with paint marks found on the face of the instrument

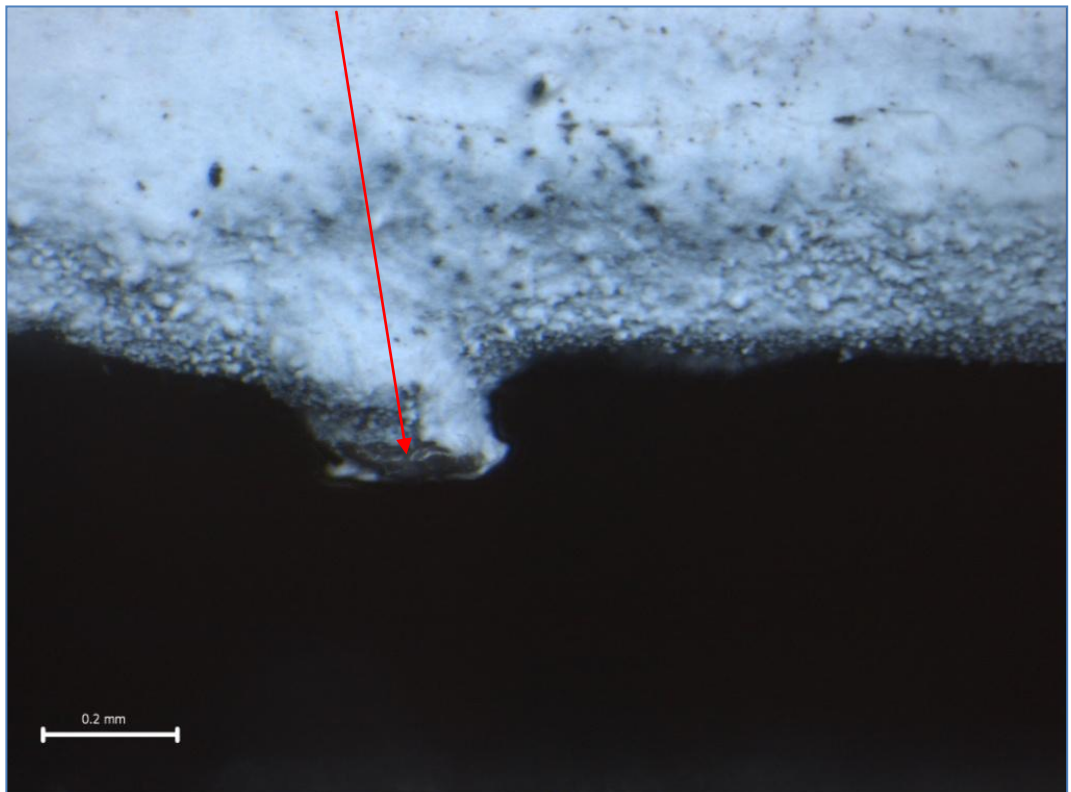
Figure 7: Paint missing from the protrusion

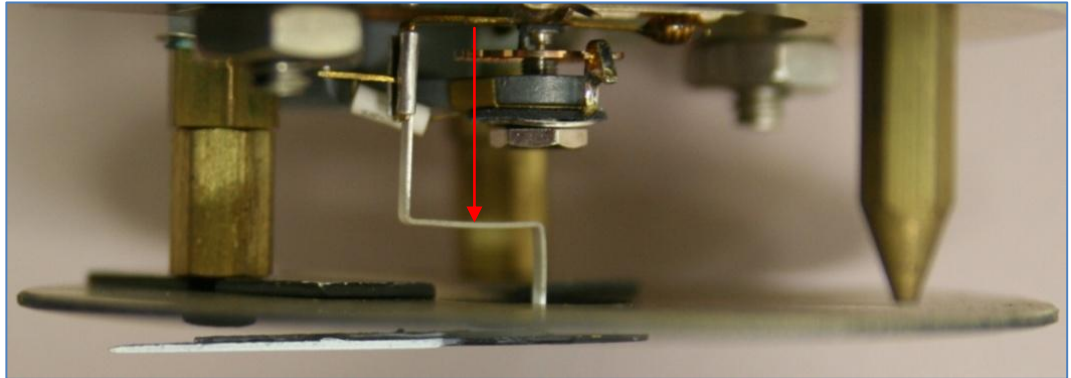
Figure 8: Instrument pointer mechanism

The instrument pointer mechanism, by virtue of its design, was very flexible in the axial direction (Figure 8), and an absence of other witness marks on the instrument face suggested that the marks found were the result of a single or ‘bouncing’ contact event.

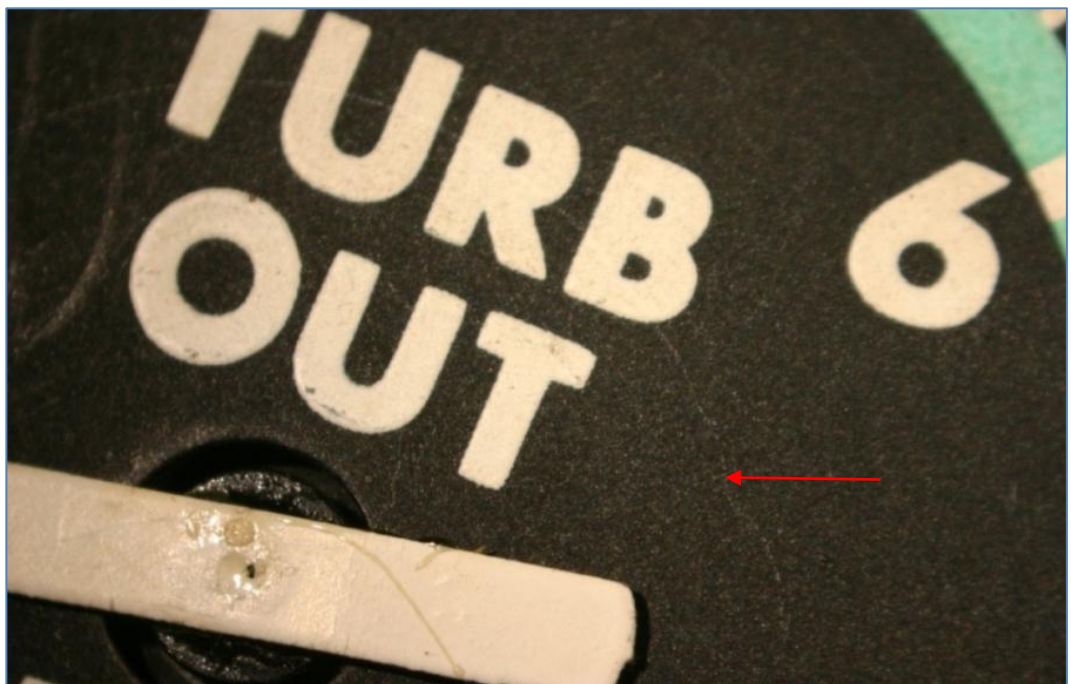
Under low-power magnification, scratch marks (abrasions) were observed (possibly formed on contact with the instrument pointer), starting with an irregular line at a gauge indication around 690 °C, a smooth arc downwards to approximately 250 °C and another smooth arc from approximately 450 °C down to 250 °C (Figures 9, 10 and 11).

Figure 9: Start of irregular line scratch mark

The irregular nature of the line formed on the instrument face was common to many other witness marks found during previous instrument examinations conducted by the ATSB.

The witness marks possibly indicate initial impact starting at the beginning of the irregular witness mark at 690 °C. It is likely that bending of the pointer in a forward direction towards the instrument face, resulted in contact between the pointer and the face of the instrument at the time of impact, leaving smooth circumferential marks down to 250 °C.

The irregular start to the witness mark is probably indicative of the type of impact to which the aircraft was subjected during the accident event. Prior experience in ATSB examinations of post-accident instruments has shown that these types of witness marks can be an indication of the position and travel of the gauge pointer during, and immediately following the accident event.

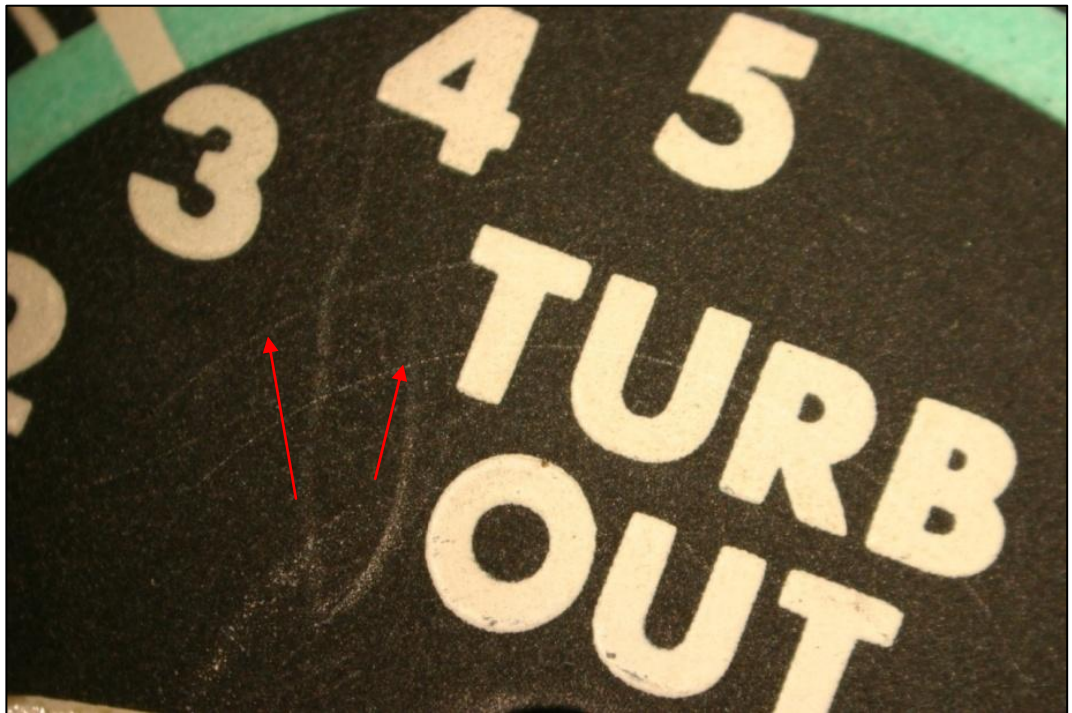
Figure 10: Smooth arc scratch marks

Examination of the turbine outlet temperature (TOT) gauge found circumferential witness marks on the face of the instrument indicating significant movement of the gauge needle while in contact with the gauge face.

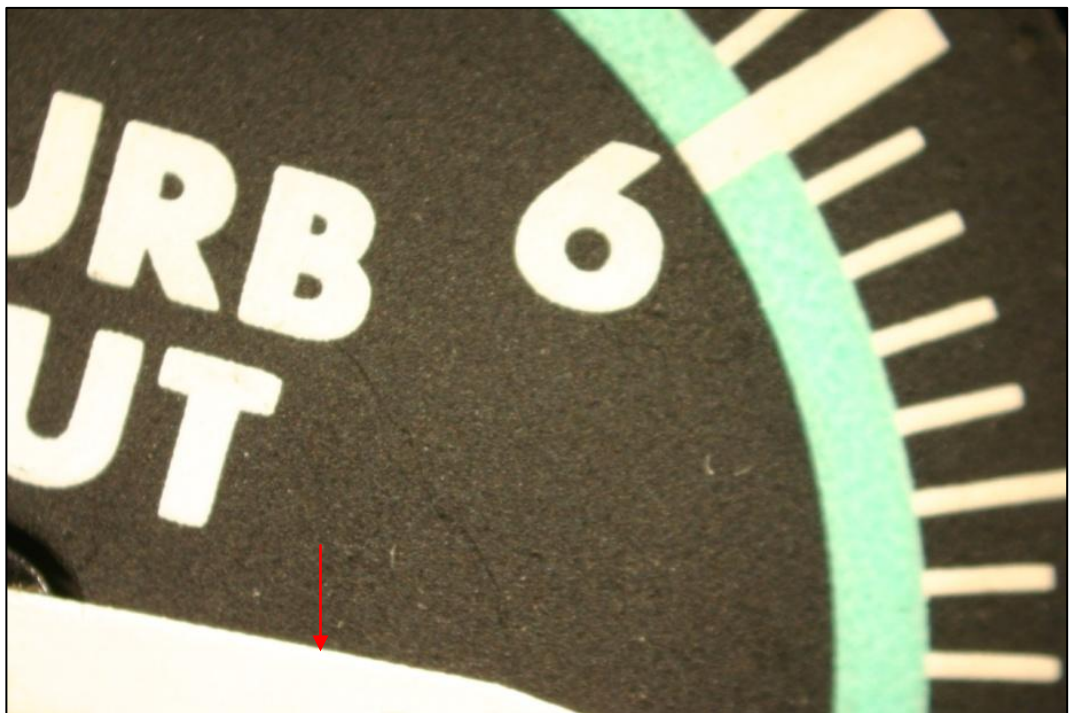
Figure 11: Pointer positioned at start of witness mark

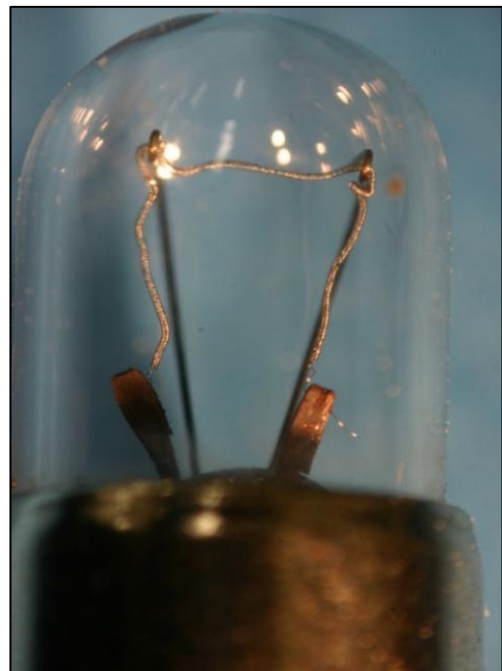
The examination found no confirmed evidence of filament stretch on any of the warning light globes from the annunciator panel.

Figure 15: Warning annunciator globe from P2-HBC no filament stretch.

Examination of the warning light globes in the annunciator panel found no evidence of filament stretch that might suggest illumination of any of the warning lights at impact.

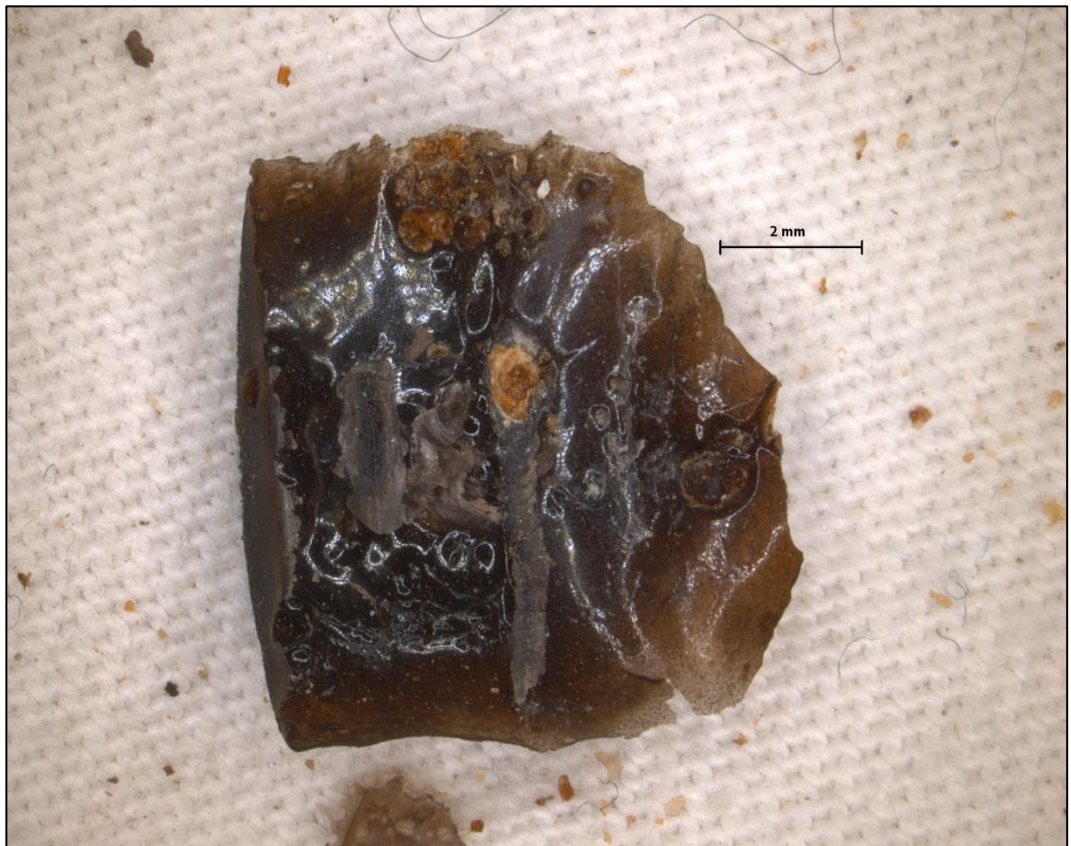
Unaided visual and low-power microscopic examination of the samples of material recovered from the helicopter's fuel system characterised the substance as a brown, semi-translucent material, with an amorphous, glassy lustre and brittle nature. The samples were of a shape that suggested they had formed around the inside surfaces of a pipe, tube or other cylindrical duct (Figure 16).

Figure 16: Typical appearance of the fuel system detritus at low-magnification

The small sample of material recovered from the helicopter's fuel system was entirely consistent with being a dried microbial biopolymer mass. Colour, appearance and solubility were all characteristic of this type of product, with the elemental composition suggesting possible presence of corrosion products entrained within the film.

Biopolymer films can form within aircraft fuel systems in the presence of water – either introduced with the fuel intake, or as condensate within the void-spaces in fuel tanks and reservoirs. Such films typically form at the water-fuel interface, and as they grow, they can slough-off biomass, which will accumulate in filters and orifices, contributing to premature plugging and restriction².

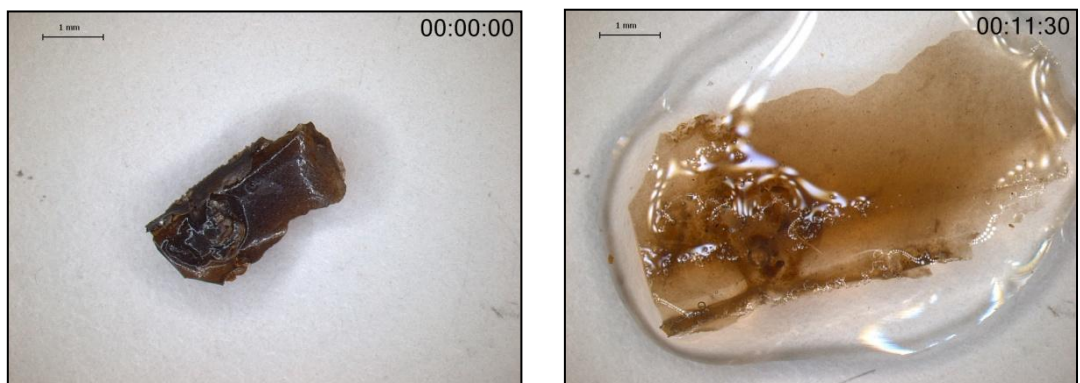
Water solubility tests found that the material hydrated and expanded rapidly when introduced to demineralised water (Figure 17) – eventually dissolving completely to form a light-brown solute.

Figure 17: Behaviour of a sample of the fuel system substance when introduced to water - time of exposure is in the right upper corner.

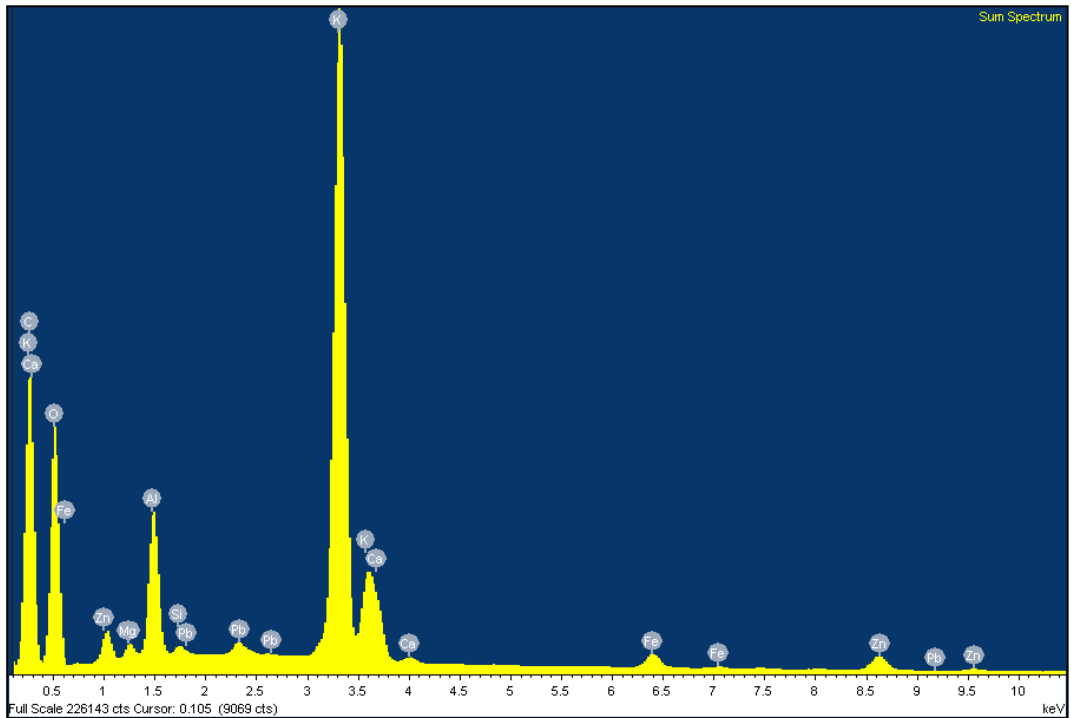
Figure 18: SEM-EDS spectrum of the fuel system material

Elemental microanalysis of a sub-sample of the material using scanning electron microscope-energy dispersive spectroscopy (SEM-EDS) techniques identified major compositional peaks for calcium (Ca), potassium (K), aluminium (Al), carbon (C) and oxygen (O). Minor peaks for zinc (Zn), magnesium (Mg), silicon (Si), iron (Fe) and lead (Pb) were also apparent.
