ATSB TRANSPORT SAFETY REPORT
Marine Occurrence Investigation No. 251
MO-2008-003
Final

Independent investigation into the disablement and subsequent grounding
of the Sierra Leone registered products tanker

Breakthrough

at the Cocos (Keeling) Islands

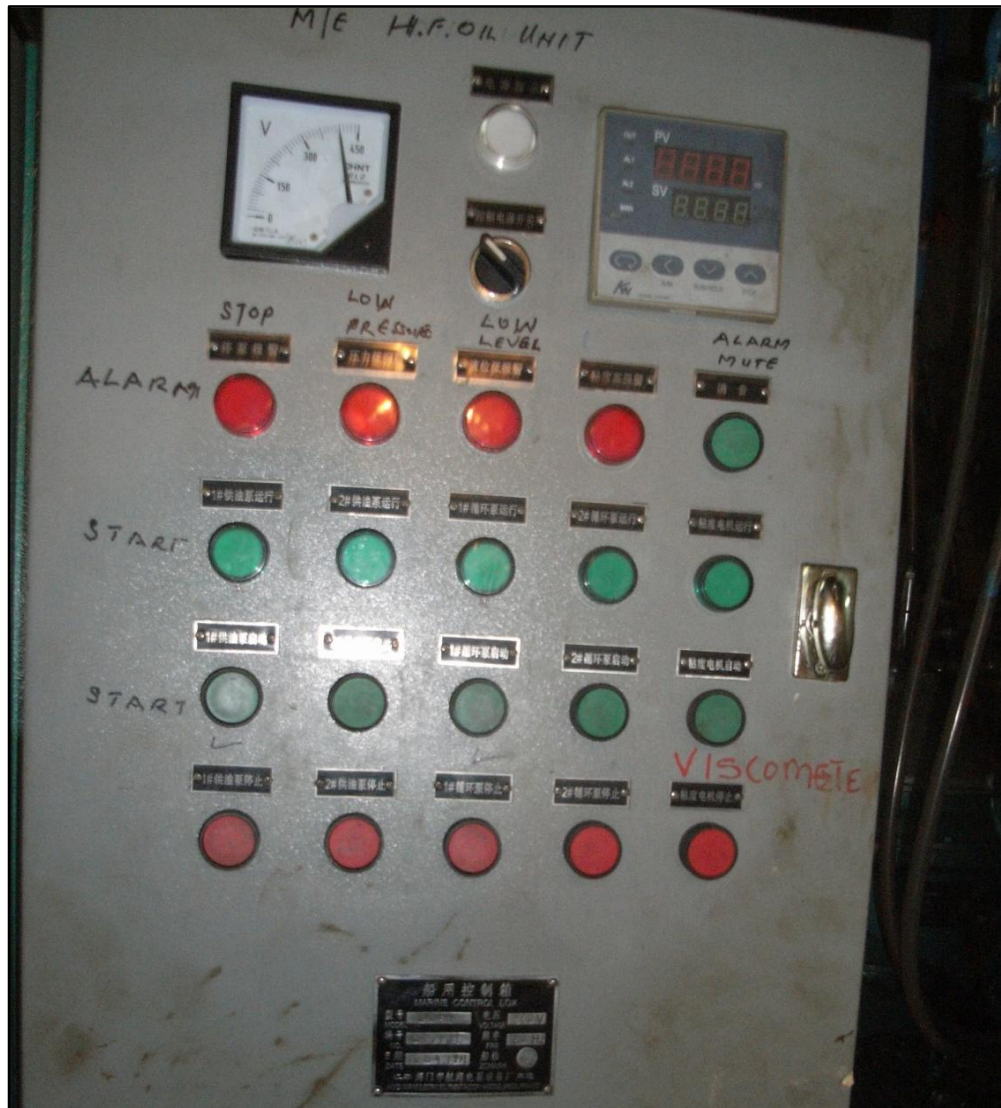
Figure 6: Fuel unit control panel

The Nigerian crew stayed in a hotel but attended the ship and noted defects which needed to be repaired before the ship's delivery. All of the ship's manuals, log books and the labels on most of the valves, switches and instruments were written in Chinese. A Chinese engineer translated many of these labels in the engine room into English for the delivery crew and the translations were written onto the equipment using a marker pen (Figure 6).

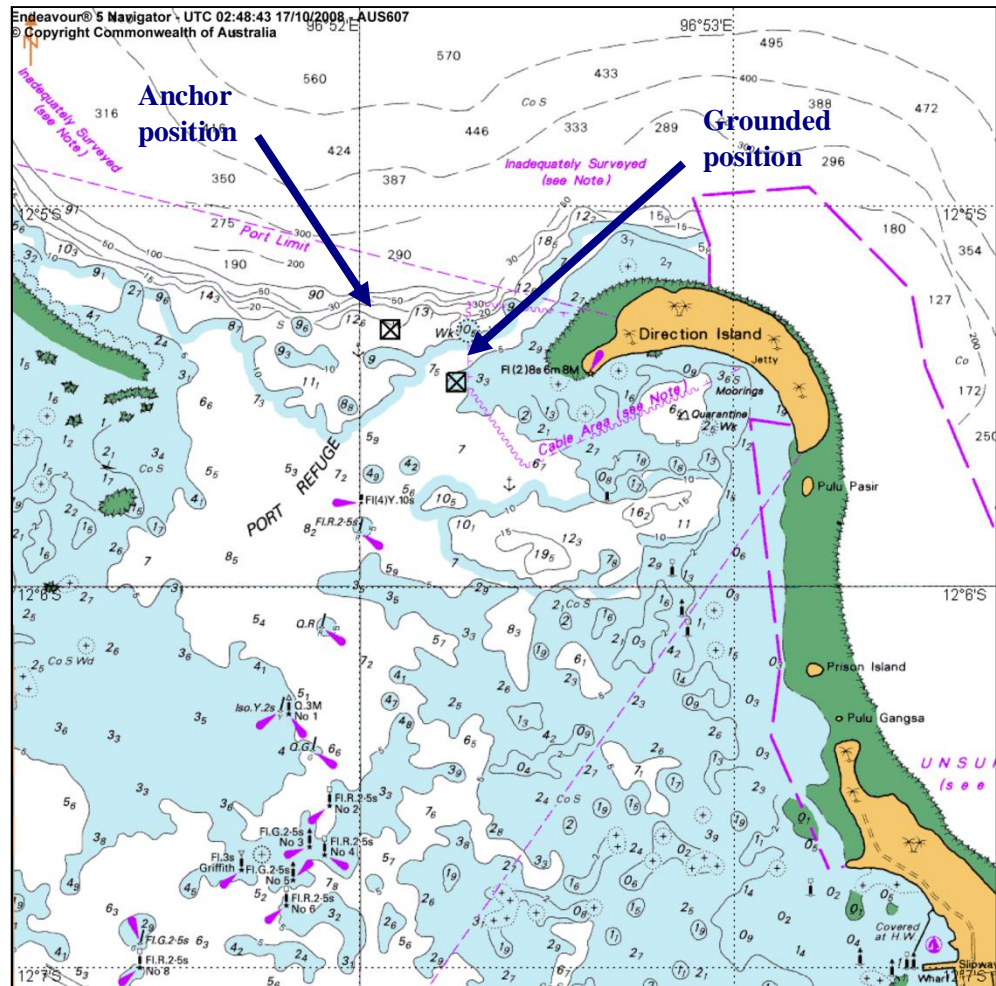
Figure 8: Section of navigation chart Aus 607 showing *Breakthrough's* anchor and grounding position

At about 1350, *Breakthrough*'s port anchor was dropped in position 12°08.42'S 96°52.17'E, off Direction Island (Figure 8). While the ship was at anchor, the master, chief and second mates maintained anchor watches.

At 1545, the ship's stern grounded on shoal water off the western tip of Direction Island (Figure 8). The steering gear was damaged when the stern pounded onto the reef (Figures 9 and 10) and the main engine was stopped because the propeller blades were striking the reef.

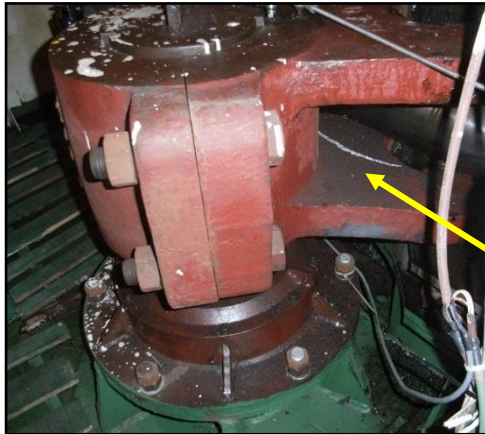
Figure 9: Damaged steering gear

An inspection of the ship revealed that the hull had not been breached but a small amount of water was entering the ship through the damaged rudder stock gland as the waves battered the aft section of the ship.

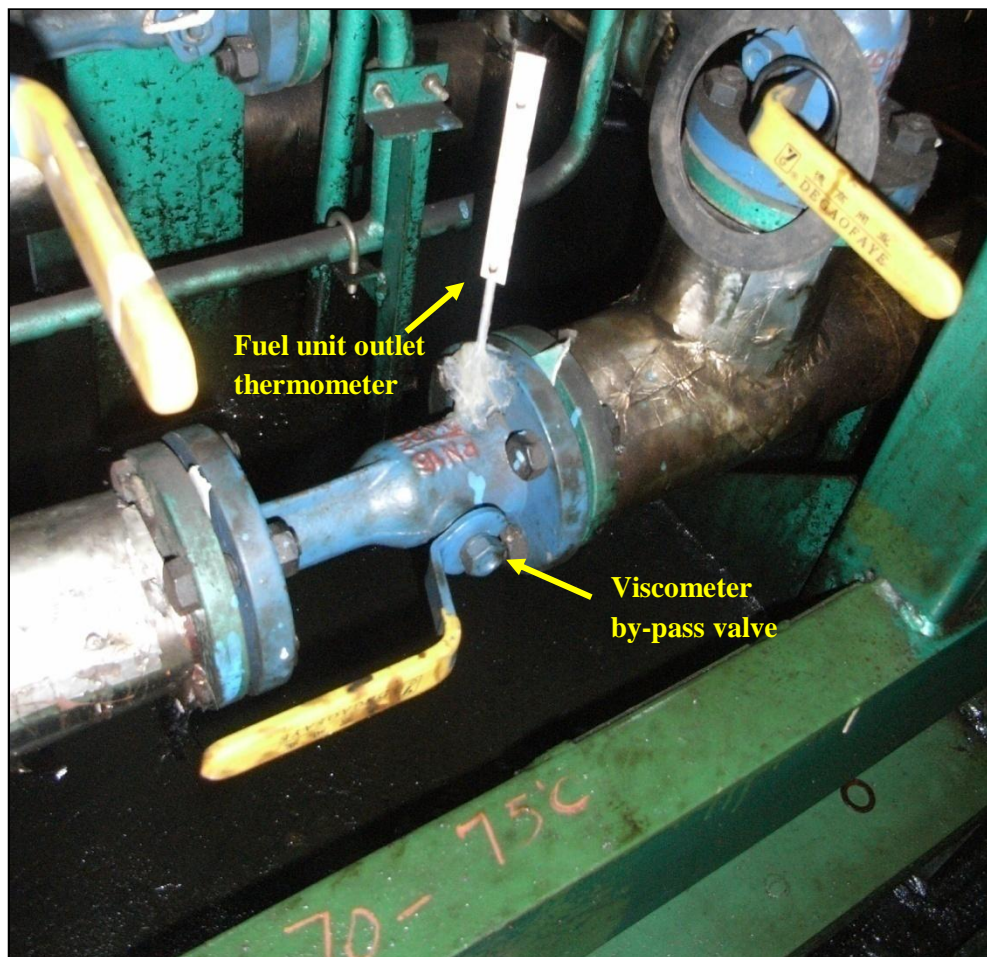
Figure 11: Fuel unit viscometer bypass valve and outlet thermometer

On 14 January, when the purifier was commissioned and on 20 January, after the main engine was changed over to IFO, the steam pressure was logged as 2.5 bar (a saturated steam temperature of 139°C). Allowing for some heat loss in the pipes and heaters, this steam temperature would probably not have been sufficient to heat the fuel to 120°C, as required.

After the engineers reduced the main engine speed because of the fuel filter problems, the steam pressure dropped to about 1.0 bar (a saturated steam
