Derailment of train 2PM6 – near Loongana, Western Australia

11 November 2008

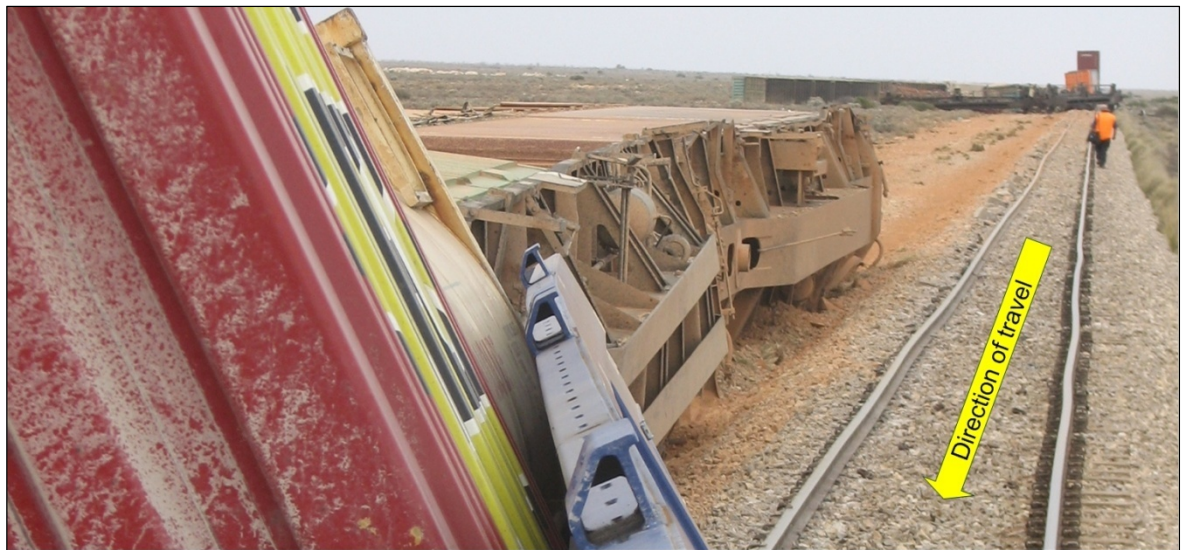
Figure 1: Derailment site showing separated front and rear portions of train 2PM6.

The hand-held radio was then set to 'repeater mode' to enable the drivers to communicate with train control while off the locomotive. Both drivers then alighted from the locomotive and walked back to inspect the train. They subsequently reported that the train had derailed at the 34th freight wagon and separated between wagons 36 and 37. It was reported that there was a gap of approximately 400 m between the 36th wagon and the remaining group of derailed wagons (Figure 1).

The 36th freight wagon (RQWW 22029K), positioned behind RQPW 60065Q, had overturned on its right side and remained coupled (Figure 1). All four double stacked containers remained locked to wagon RQWW 22029K.

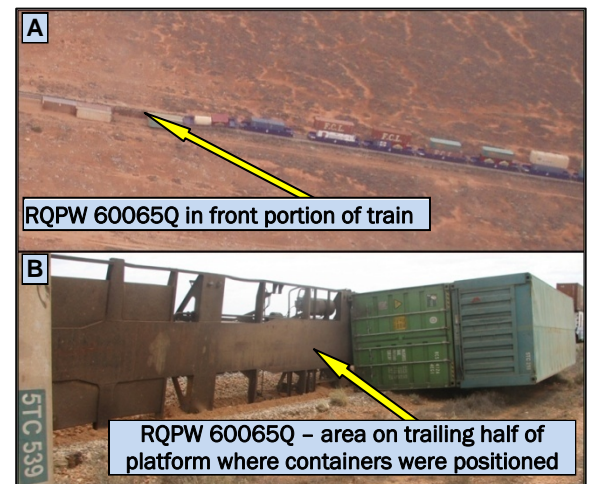
The two-unit wagon ahead of RQPW 60065Q (CQWY 5008J-2) was considered to have derailed as a consequence of being pulled to the right of the track after wagon RQPW 60065Q had overturned onto its side. The trailing unit of CQWY 5008J had derailed but remained upright and attached to the front portion of the train.

Figure 2: RQPW 60065Q showing location of displaced containers.

During the derailment, two 12.2 m (40 foot) containers that were positioned on the trailing end of wagon RQPW 60065Q became detached and were ejected about 25 m to the south side of the track, coming to rest as a pair on their sides. One twist lock was torn from the centre left corner on the wagon platform (high side after overturning) and remained located in the lower container. Closer inspection revealed that this twist lock casting was a replacement that had not been fully welded and correctly reinforced in accordance with the original design and construction. Welds securing the twist lock casting were superficial and structurally unsound. While the failed twist lock casting may have been subjected to loads outside of normal operational parameters as a result of the derailment sequence, it was considered likely that the inferior weld and lack of reinforcement could have resulted in a future failure even under normal operational loads. It was also considered possible that maintenance work on other twist lock castings could be of a similar inferior quality.

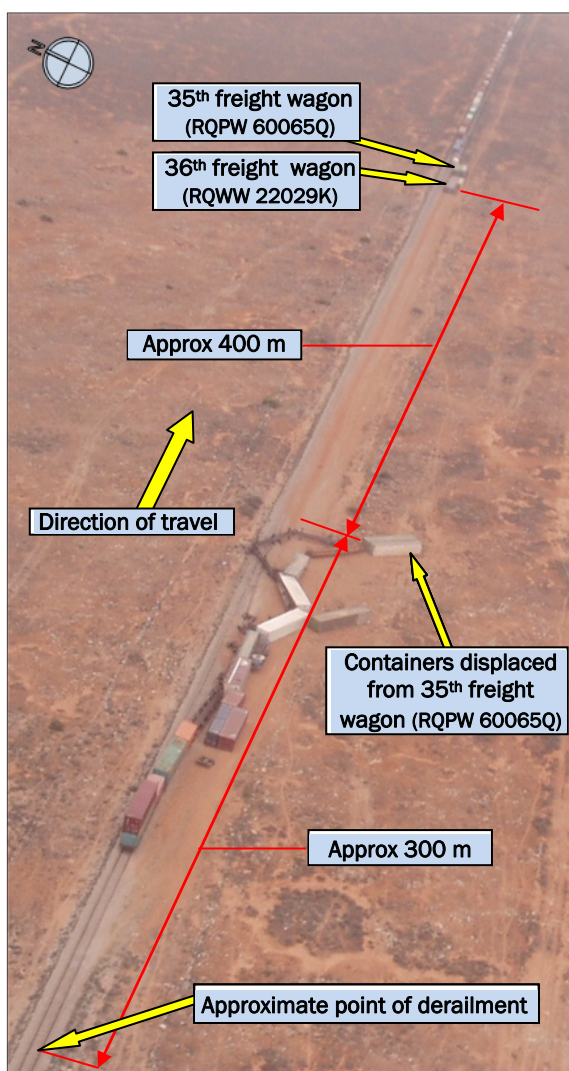
wagon had been displaced about 400 m before the train came to stop (Figure 3).

Figure 3: Aerial view of derailment site showing derailed front & rear portions of train

- The containers displaced from RQPW 60065Q were located at the front of the derailed rear portion of the train and were about 25 m from the track. (Figure 3).
- Both double stacked containers that had been displaced from the trailing end of wagon RQPW 60065Q remained attached to each other and came to rest on their side (Figure 3).
- The derailed 5-unit wagon (RRQY 07304F, positioned 37th), had bunched up and rolled onto its side in an arc formation immediately behind the two containers that had been displaced from RQPW 60065Q. RRQY 07304F had also displaced most of its load and shed its bogies.

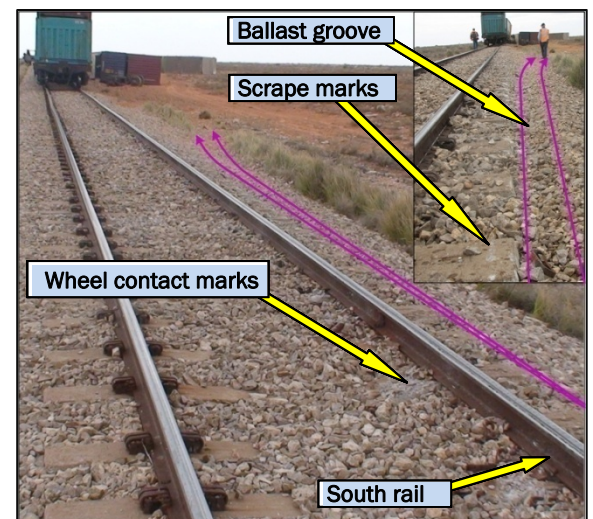
Damage to resilient clips, steel resilient clip anchor housings and sleepers on the inside of the south rail increased significantly (implying high vertical wheel loading) while damage to the same components on the north rail opposite were light and no longer evident after four wheel strikes (implying low or negligible vertical wheel loading). Wheel contact damage on the surface of the sleepers within 300 mm of the south rail extended for about 15 m before scrape marks (probably from a bogie side frame) started to appear on the concrete sleeper surface outside the south rail (Figure 4).

Figure 4: Displaced ballast and sleeper damage

These scrape marks were evident on the top of about nine sleepers before they were no longer visible and damage started to increase on the southern side sleeper ends.

The severity of the marks on sleepers and fasteners indicate heavier impacts and contact force on the south side. When compared to the south side, the north side damage was minimal, evident by light markings and resilient clip displacement over a short distance.

The combination of the wheel unloading and light damage to sleeper fittings on the north rail indicated that a wagon (most likely to be wagon RQPW 60065Q) and its load of containers progressively began to lean towards the south side of the track before overturning onto its side (Figure 4).

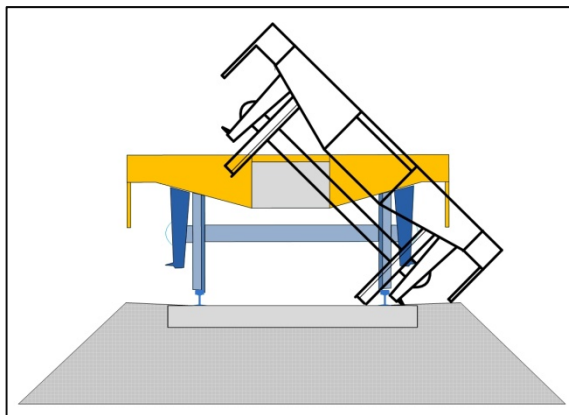
When considering a roll-over scenario, it is likely that the profile of the disturbed ballast was caused by the side frame and steps of wagon RQPW 60065Q (considered to have been the first derailed wagon) as it tilted sideways. In addition, as the wheels on the south side had dropped to the inside of the rail, the gap was reduced between both the wagon side frame and steps and the track components immediately before contact was made with each of these items (Figure 5).

Figure 5: Overlay of rolled RQPW wagon

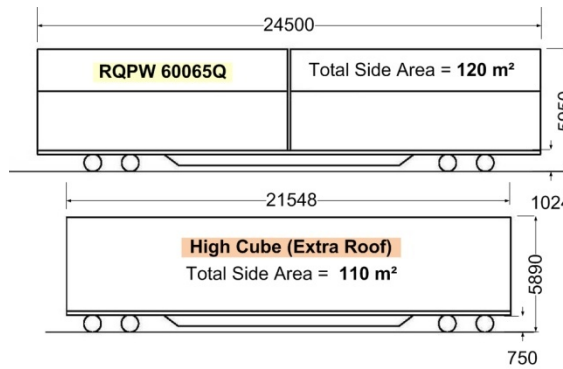
On train 2PM6, wagon RQPW 60065Q was loaded with four 12.2 m long (40 foot) containers that were positioned with two 2.89 m high containers on the bottom layer and two 2.03 m high containers mounted above. This configuration created a total side area of 120 m² (Figure 6).

Figure 6: Wagon profile and area comparison

When considering the profile that loaded wagon RQPW 60065Q would have presented to winds and comparing these figures with the wagon models subjected to wind tunnel testing, the SCT high cube wagon with extra roof is found to be the closest match. Therefore, the wind tunnel results for the SCT high cube wagon with extra roof were used as the closest reference for calculating the percentage of wheel unloading on wagon RQPW 60065Q for different wind speed and vehicle speed combinations.

For train 2PM6, the load configuration of wagon RQPW 60065Q exhibited a poor profile with respect to wind load by having a large side surface area, light weight and high centre of side area. In calculating the percentage of wheel unloading, a simplified method assumes that the wagon's centre of mass acts continuously at the centre point between the two rails (that is, the wagon suspension is rigid and does not permit body roll). When the train is travelling at a speed of 90 km/h, 100% wheel unloading on wagon RQPW 60065Q is calculated to occur when atmospheric wind speed is about 80 km/h and at an angle of between 60 degrees and 80 degrees relative to the direction of travel.
