ATSB TRANSPORT SAFETY REPORT
Marine Occurrence Investigation No. 256
MO-2008-008
Final

Independent investigation into the grounding of the
Isle of Man registered bulk carrier

Iron King

at Port Hedland, Western Australia

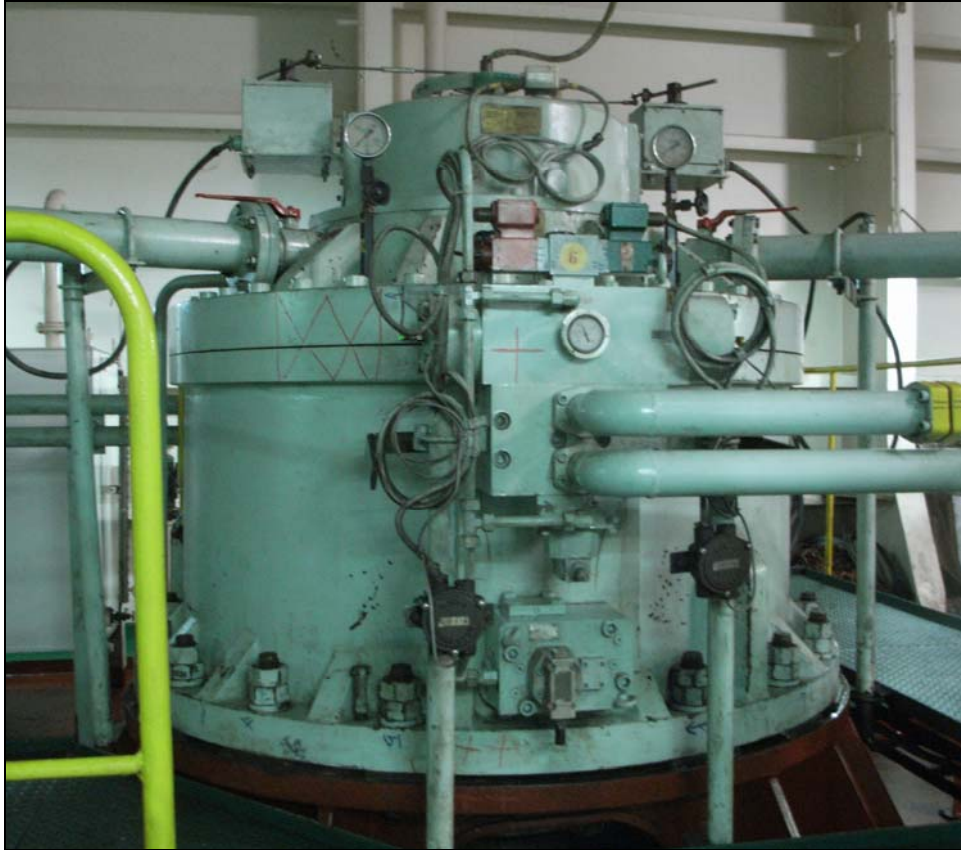
Figure 2: Rotary vane steering gear assembly

Iron King is fitted with a Porsgrunn hydraulically operated rotary vane steering gear (Figure 2). The rotary vane unit (actuator) consists of a rotor, mounted directly on the upper section of the rudder stock, which is enclosed in a circular housing (stator) that is secured to the ship's structure (Figure 3). A set of nitrile rubber seals provide an oil seal between the rotor and stator.

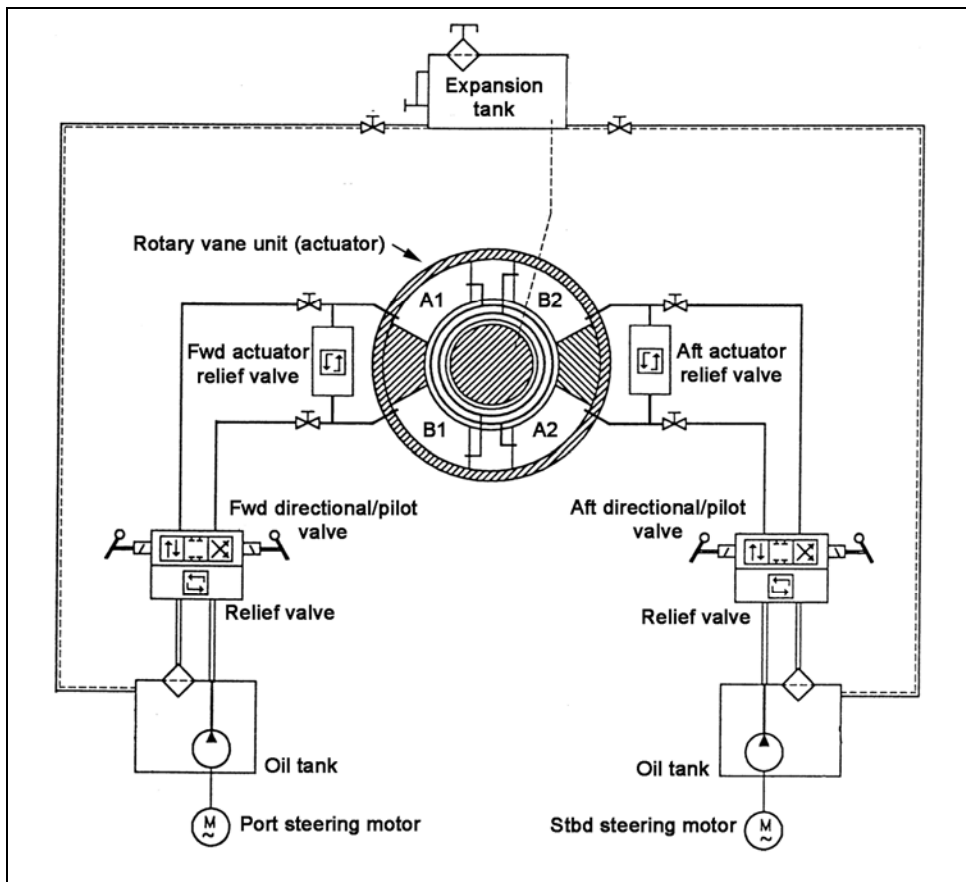
Figure 4: Schematic diagram of the hydraulic control system

For redundancy purposes, the steering gear has two identical and independent hydraulic and control systems (Figure 4). The various hydraulic control and pressure relief valves are mounted on the outside of the steering gear housing, one set on the forward end and the other set on the aft end. The two hydraulic units, each incorporating an electric motor, pump and hydraulic oil tank, are mounted separately.

The technician tested the two hydraulic pump units and found that they were both providing the design pressure of 75 bar⁸. He then checked the rotary vane unit (actuator) pressure and discovered that the actuator pressure was 75 bar when the rudder was turning to starboard, but only 20 bar when it was turning to port. He determined that the aft actuator relief valve (one of two valves controlling oil pressure within the actuator) was draining oil from the actuator whenever the rudder was turning to port. As a result, the actuator pressure was being limited to 20 bar, a pressure that was insufficient to provide the torque required to turn the rudder to port when it was under load.

- On two occasions during *Iron King*'s outbound transit of the Port Hedland channel on 31 July 2008, the ship's rudder failed to respond to the pilot's port helm orders because, whenever the rudder moved to port, the steering system hydraulic pressure was limited by a leaking actuator relief valve.

The aft actuator relief valve was removed and the technician found that it was sticking. He overhauled the valve, re-set it and then refitted it to the steering gear housing. On 12 August, the ship was again taken to sea for a steering gear trial. On this occasion the steering gear operated correctly.

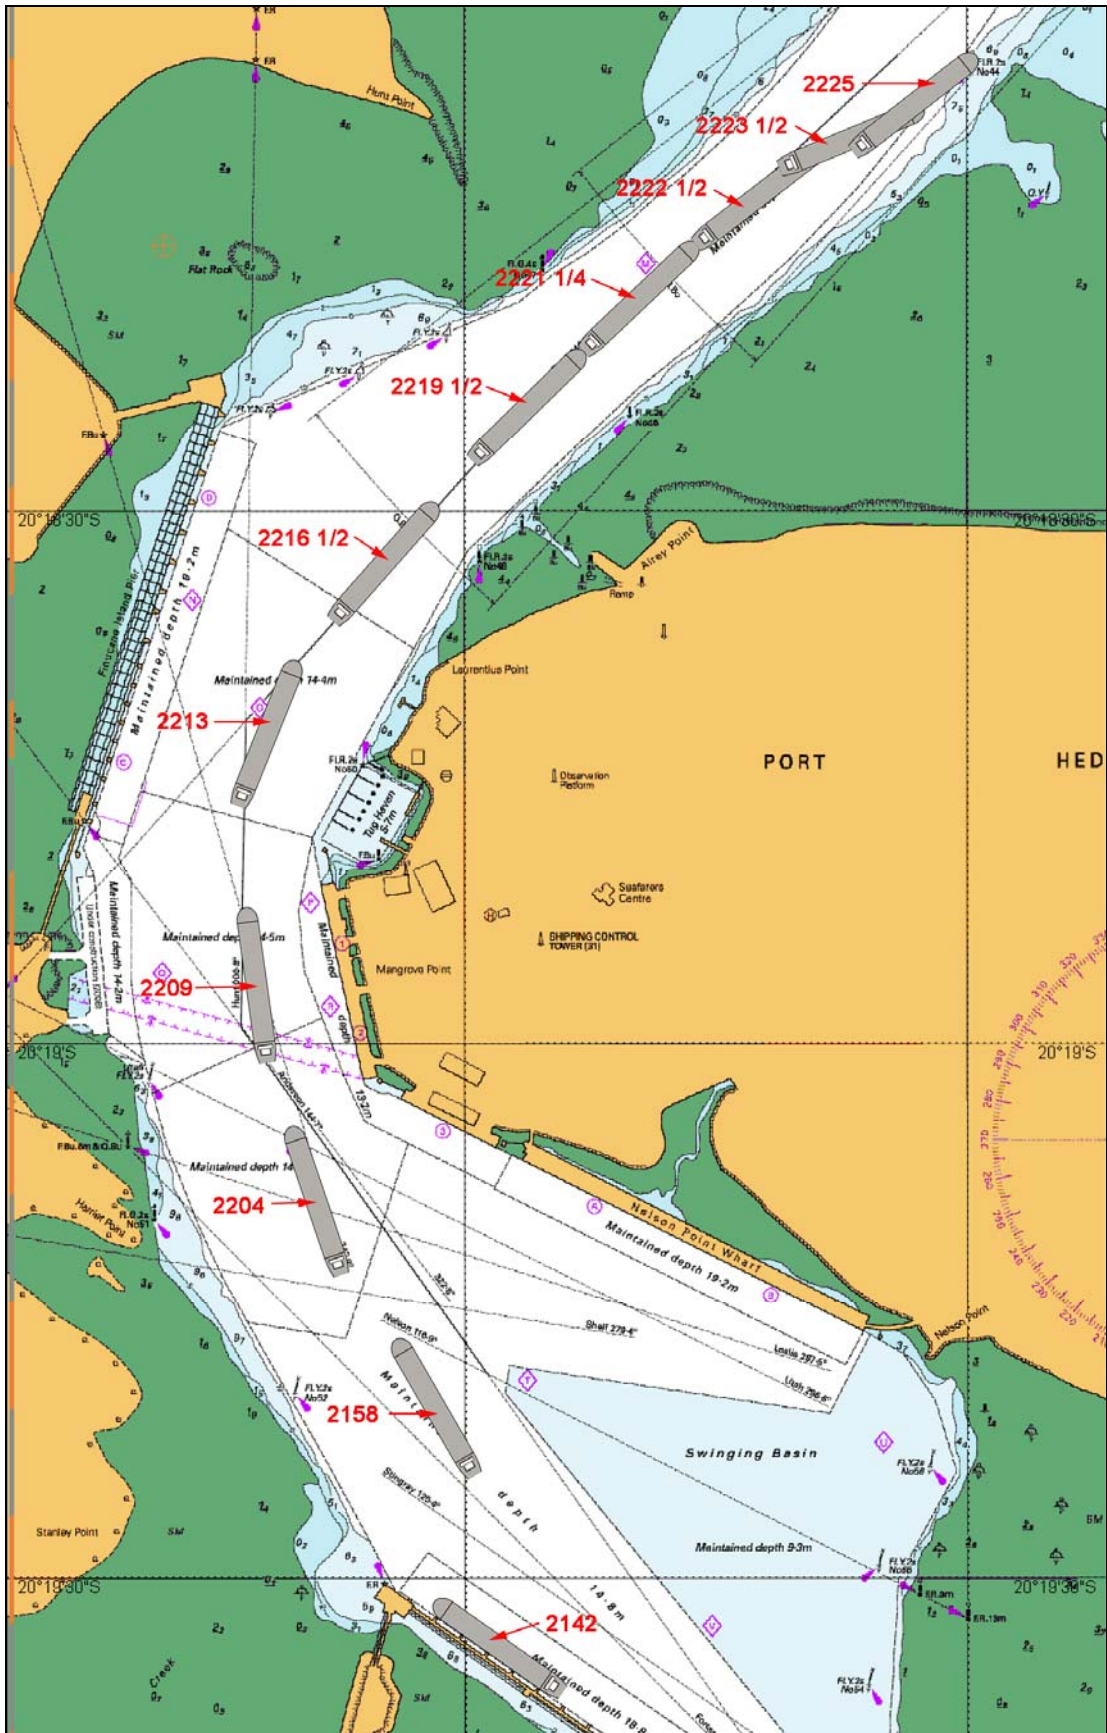
Figure 7: Section of navigational chart Aus 54 showing *Iron King's* track displayed by a series of scale images of the ship

At 2221¼, the pilot ordered midships. However, when the helmsman moved the helm to the midships position, the rudder again failed to respond. The rudder then began slowly moving to starboard. The helmsman moved the helm to port, hoping that doing so would make the rudder respond and the master switched the steering stand selector switch between the two follow-up steering systems, in an attempt to get the steering to respond.

The pilot noticed that the rudder had not responded and, at 2221½, he said, in a quiet voice, 'stuck again'. The master then suggested to the pilot that he should stop the engine. In response, the pilot ordered dead slow ahead before directing the tugs to make fast. The ship was now on a heading of 045° and turning to starboard.

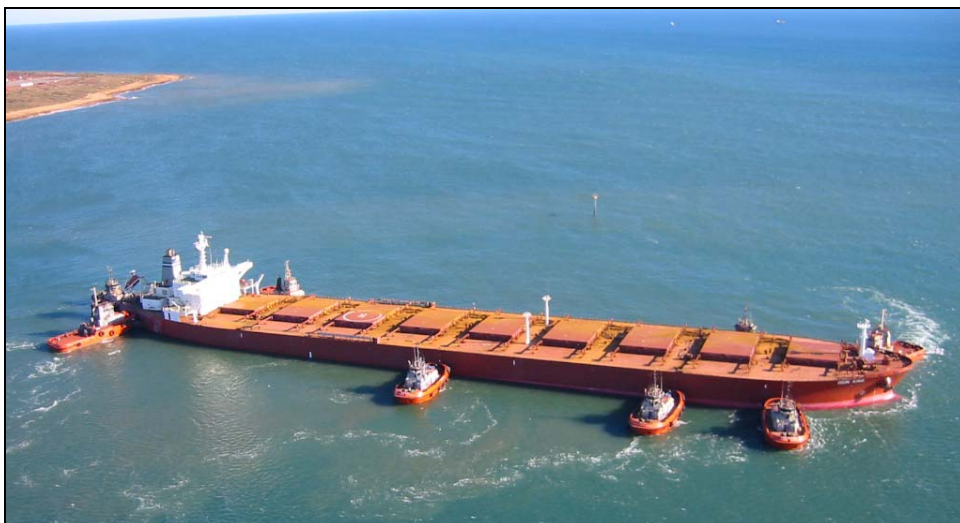
Figure 9: Tugs assisting *Iron King* from its grounded position

At about 1007, and then again at about 1010, the rudder stuck at starboard 20° and then drifted to starboard as port helm was applied. On both occasions, the pilot stopped the main engine and used the tugs to correct the ship's heading. He then decided to continue the transit without the use of starboard rudder. He used the rudder to turn the ship to port and the tugs to turn the ship to starboard.

The divers' inspection confirmed that the grounding damage was confined to the bow area and consisted of major indentation of the shell plating to a maximum depth of about 300 mm forward of the collision bulkhead. Aft of the collision bulkhead, there was an indentation of about 100 mm in depth, over a 10 m length. The divers found no damage to either the propeller or the rudder.
