Independent Inquiry Report

Coal Train Collision

Beresfield NSW

23 October 1997

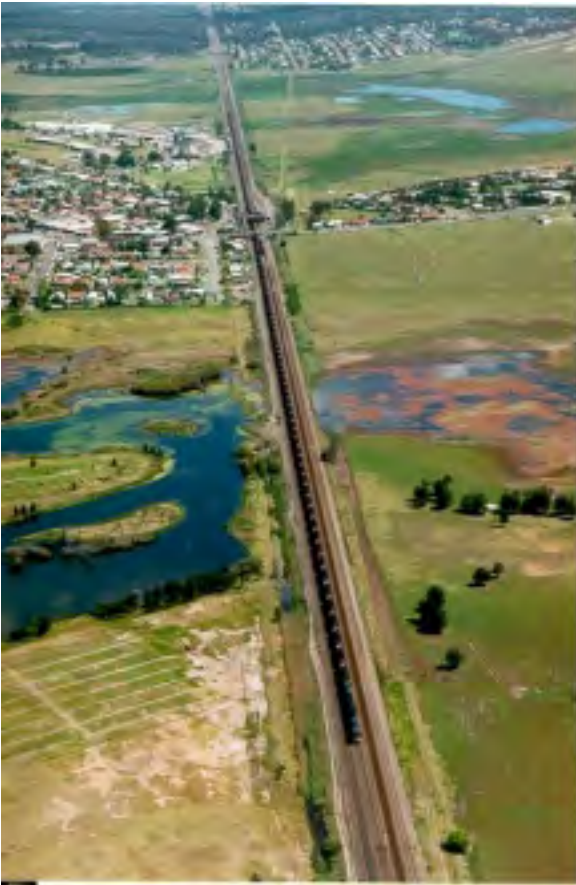
Figure 2
View of Beresfield Station looking
in direction of travel. DR396 in foreground.

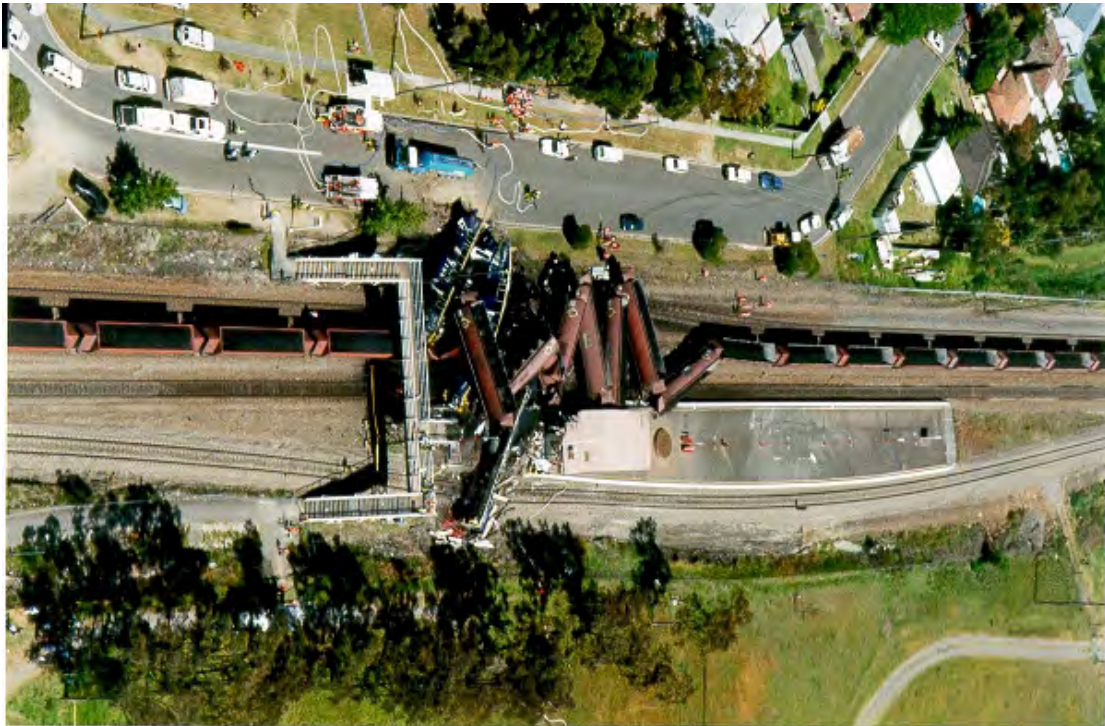
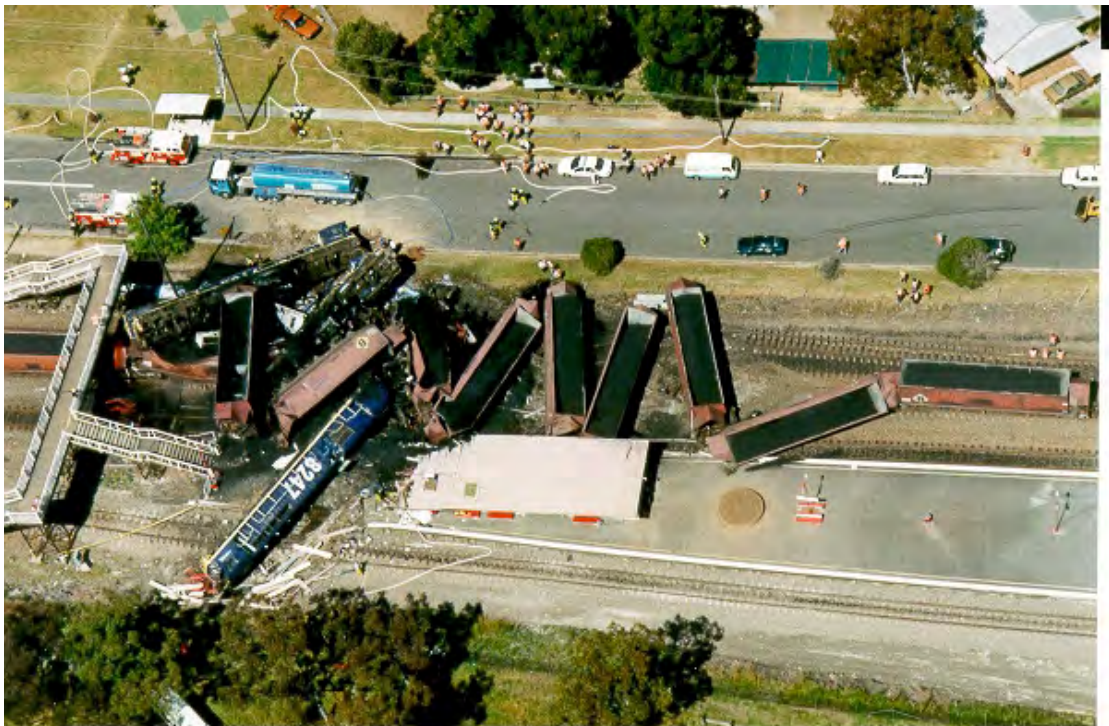
Following the initial impact the lead locomotive of DR396 derailed and came to rest on top of the 64th wagon of MT304, laying across both coal roads and extending to the edge of the adjacent street (see figures 4 and 5). Locomotive 8219 derailed and came to rest inverted, across both coal roads, and the main down line. The third locomotive, No. 8247, also derailed, crossing the main down line and station platform before coming to rest across both main lines and the platform. The first 10 wagons of DR396 concertinaed into the locomotives and derailed, blocking both coal roads and the down main line.

Figures 4 and 5 showing wreckage distribution. Overhead bridge is located at eastern end of platform.

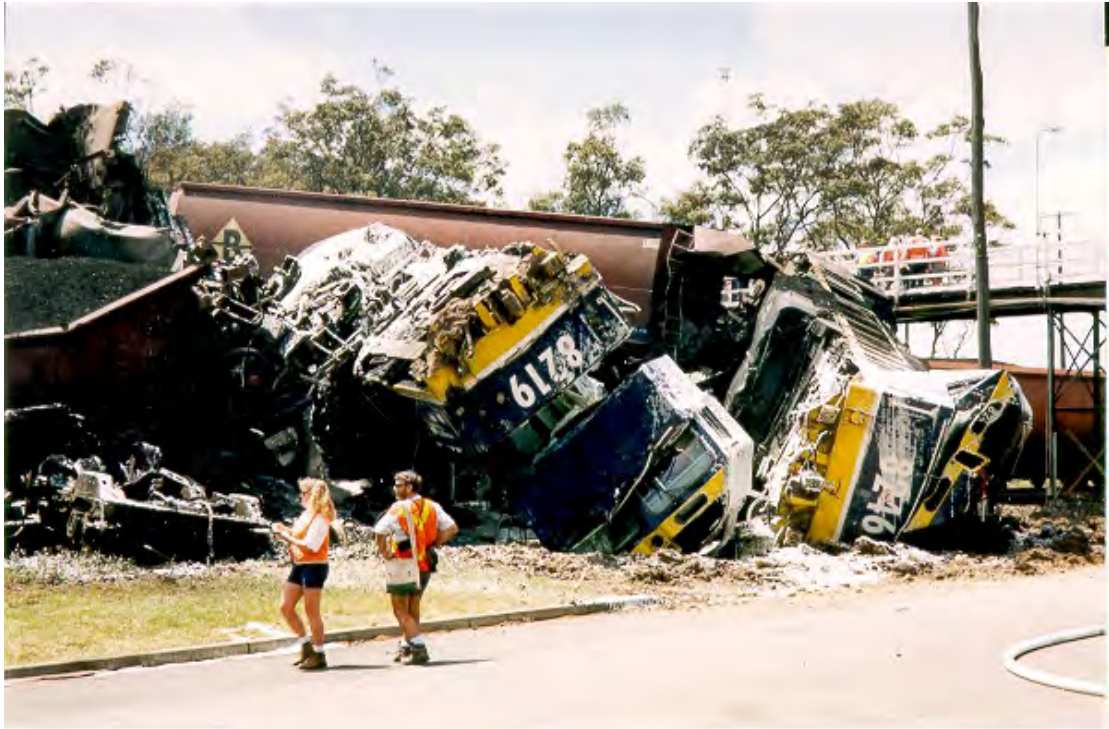
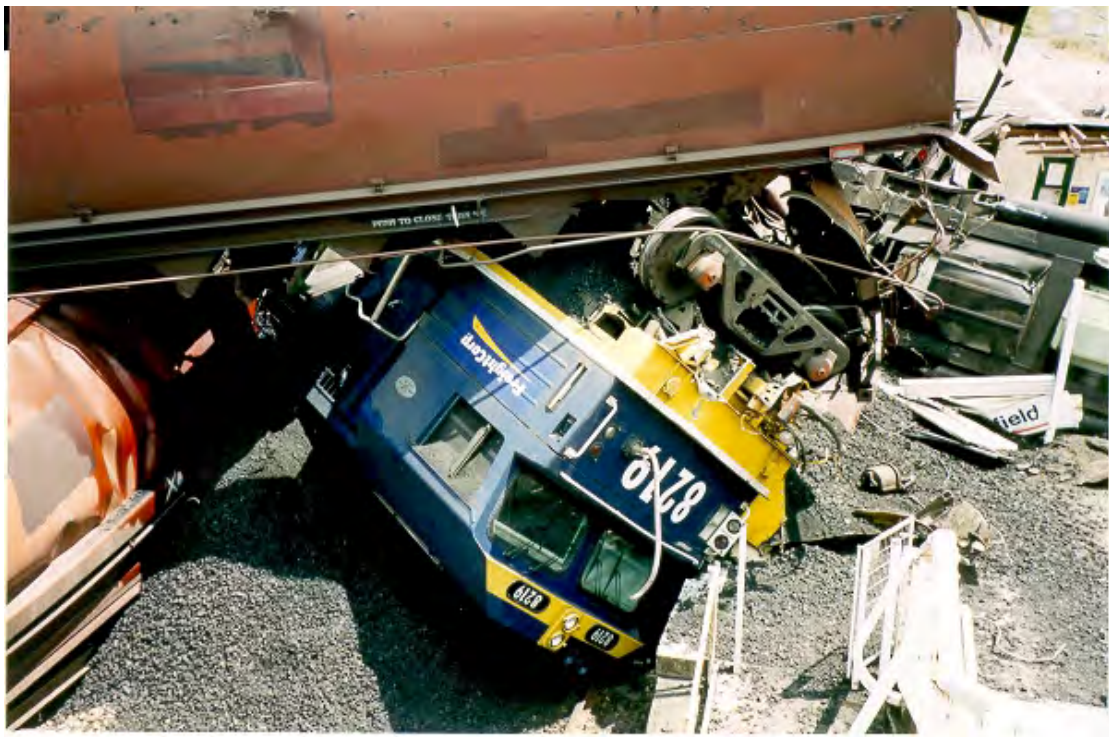
The three rear coal wagons of MT304 were also derailed. Damage to locomotives and rolling stock was extensive, and typical of this type of collision (see figures 6 and 7). Both trains were operated by FreightCorp.

Figures 6 and 7 showing massive disruption to locomotives and rolling stock.

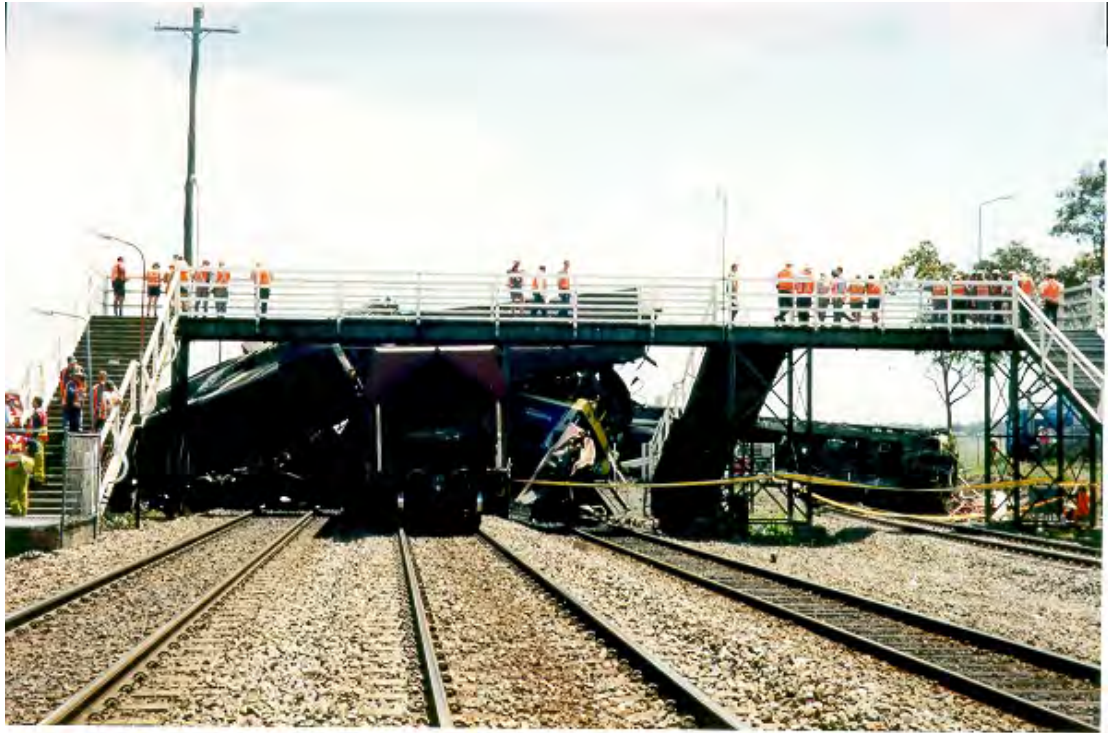
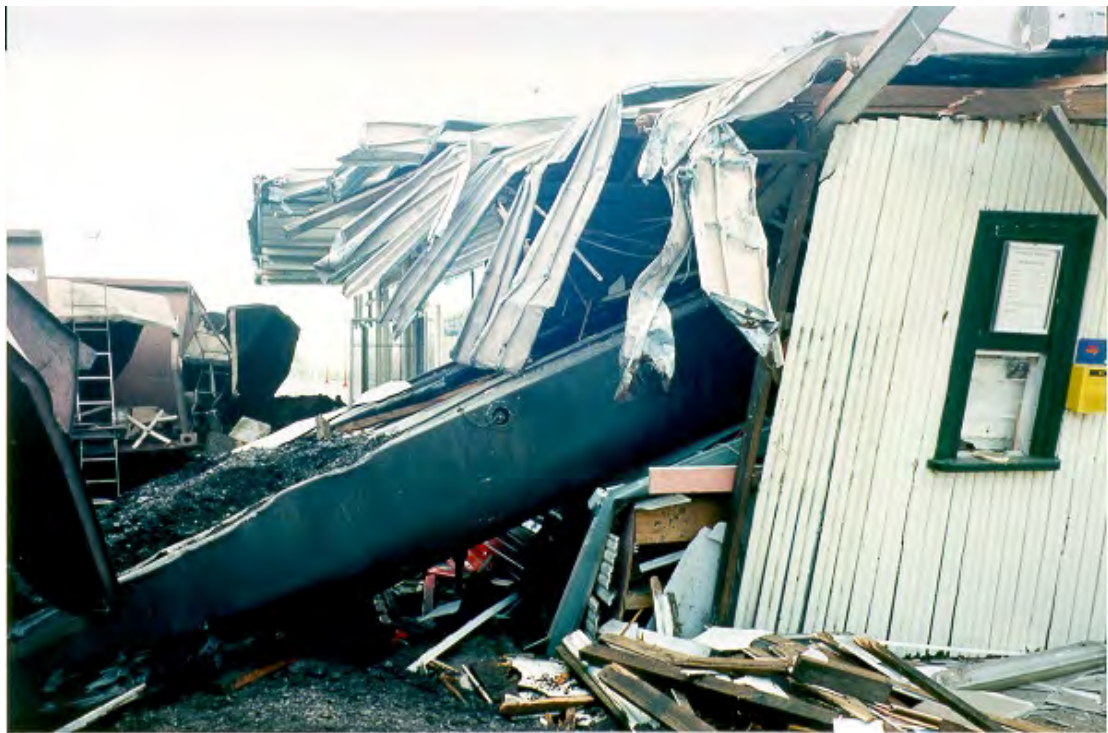
The wreckage of both trains, and associated coal spillage, lay spread over both coal roads, both main lines, and Beresfield Station for a distance of about 130 m. The permanent way, the station platform and associated structures, together with surrounding areas were all extensively damaged (see figures 8 and 9). The Stationmaster at Beresfield suffered minor injuries, while a passenger waiting on the platform suffered more serious injuries. They were subsequently transported to hospital by ambulance, together with both injured drivers.

Figures 8 and 9. Both coal roads and main northern lines were completely blocked. Extensive damage to the Beresfield station booking office and platform is evident

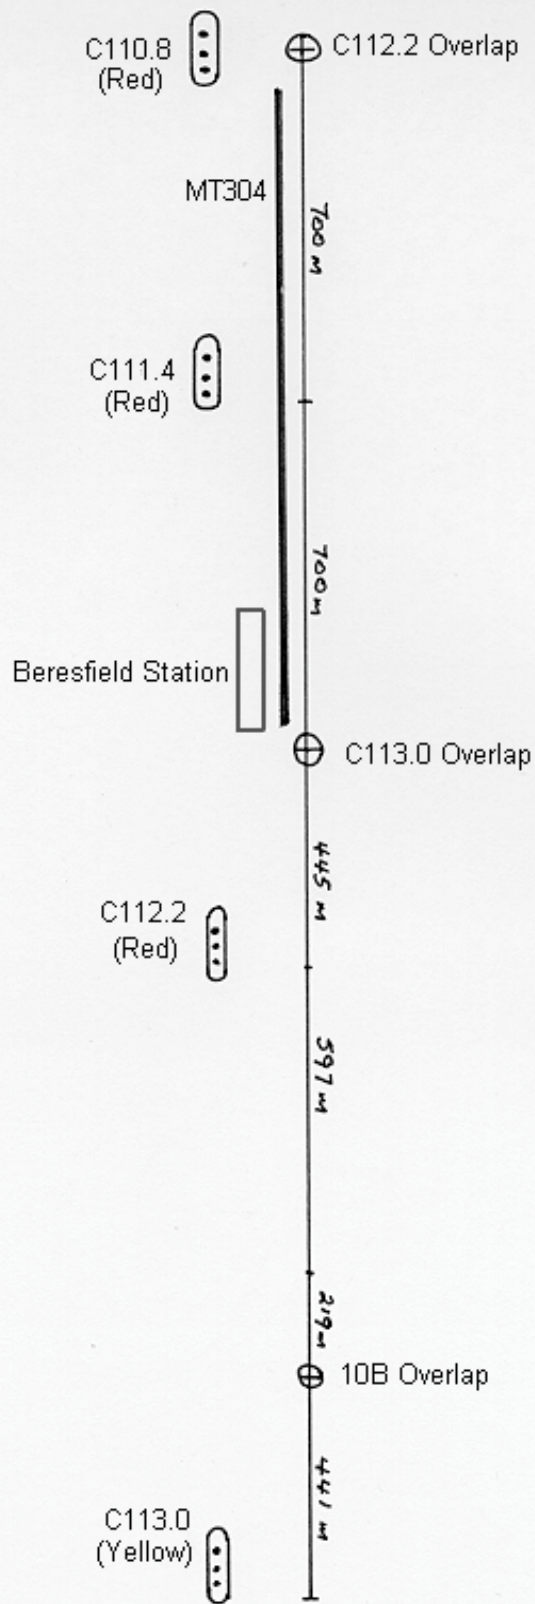
Figure 10.

Schematic of signal indications immediately prior to the collision.

8. At the time of the collision signal C113.0 was showing a caution indication, and signal C112.2 was showing stop. There was no evidence found to indicate any signal malfunction that could have contributed to the accident.

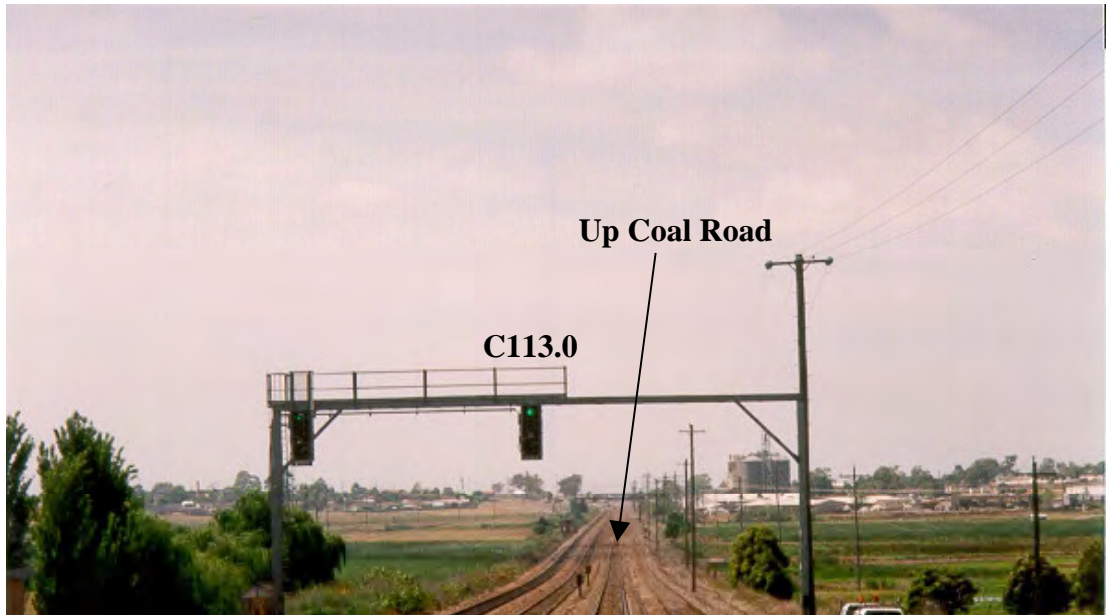
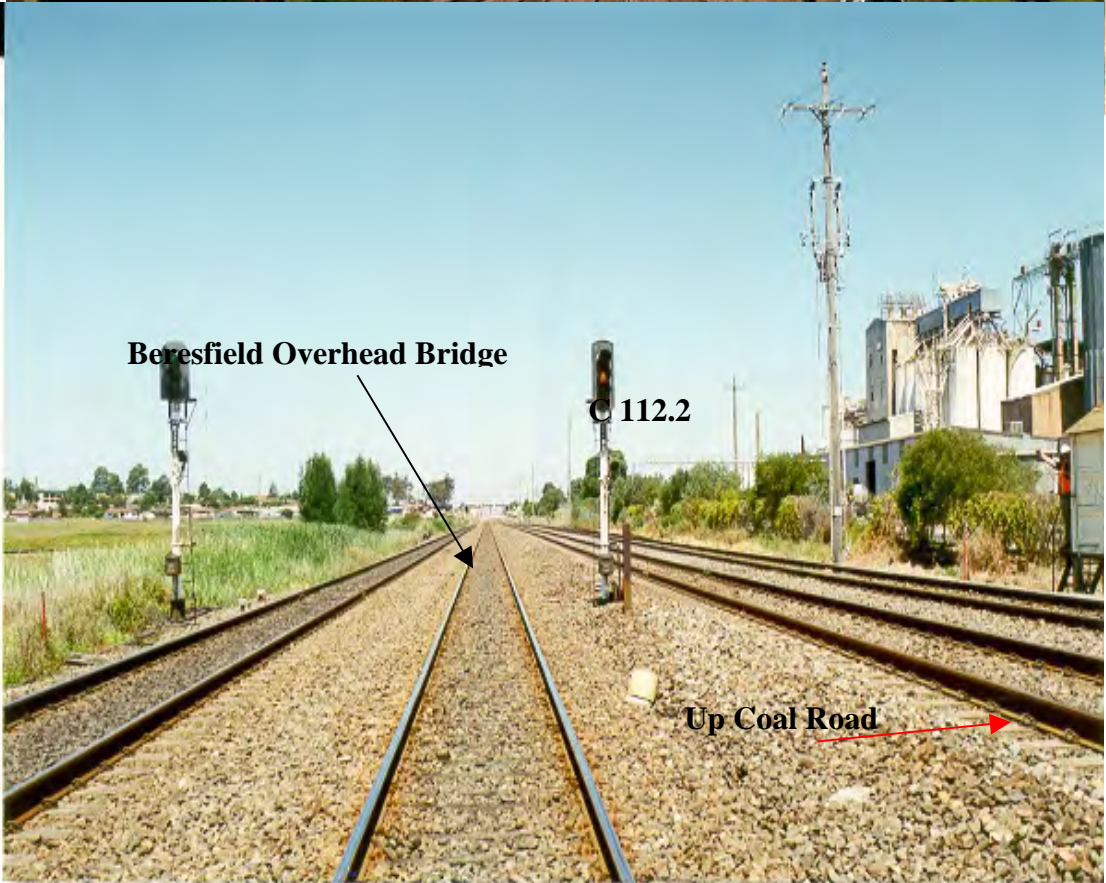
Comprehensive testing was carried out by technical experts, utilising established industry standards, on the track circuitry associated with the operation of the signals between C113.0 and C110.8. Those examinations failed to reveal any defect prior to the collision that could have resulted in incorrect signal indications.

Figures 11 and 12 showing signals C113.0 and C112.2.
