**ATSB TRANSPORT SAFETY BULLETIN**  
Aviation Level 5 Investigations AB-2010-020  
Final

# **Level 5 Factual Investigations:** **1 December 2009 to 30 March 2010**

AB-2010-020

**Level 5 Factual Investigations:  
1 December 2009 to 30 March 2010**

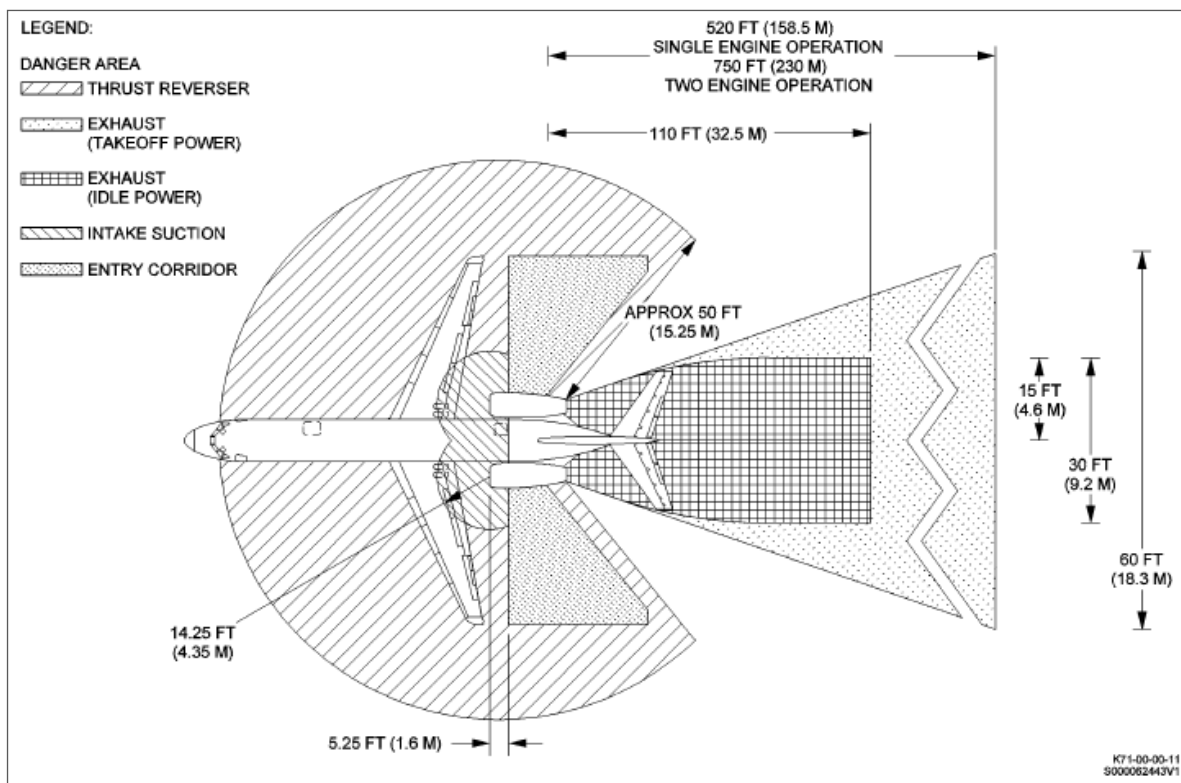
**Figure 2: Boeing 717 engine hazard area and entry corridor, for normal and thrust reverser engine operation**

A turbine engine's inlet and exhaust areas provide a significant hazard to ground personnel. During operation, a turbine engine creates a low-pressure area around the inlet, which leads to large quantities of air surrounding the inlet being sucked into the engine. Therefore, it is necessary for ground personnel to remain a safe distance from the front of the engine. For the 717 this is a radius of 4.35 m from the centre of each engine, within the span of the wing (Figure 2).

Correspondingly, air exits the engine exhaust at a very high speed. For the 717 (two engine operations), air can be travelling at 240 km/h up to 16 m directly behind the engine when the engines are operating with ground idle thrust. The jet exhaust hazard area was localised to 9 m either side of the aircraft centreline.

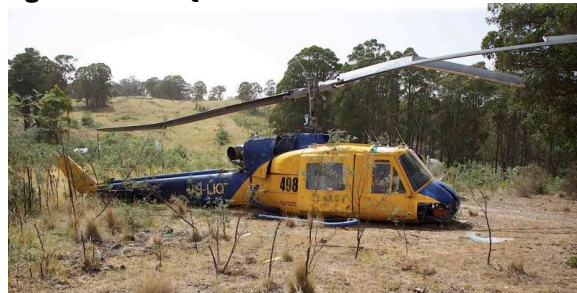
Figure 1: VH-LIQ at the accident site

On 8 December 2009, at about 1645 Eastern Daylight-saving Time<sup>1</sup>, a Bell Helicopter Company TH-1F, registered VH-LIQ, was conducting aerial fire-fighting operations south-east of Tamworth, New South Wales (NSW). On approach to a water source, the pilot in command (PIC) noted a loss of engine power. The PIC reported that he lowered the collective<sup>2</sup> and rolled the throttle on; however, the engine continued to spool down. The PIC manoeuvred the helicopter to a cleared area and carried out an emergency landing. The helicopter landed heavily and sustained serious damage. The PIC sustained a fractured nose, while the other occupant (second pilot) was uninjured.

At the time of writing this report, the reason for the total power loss was unknown.

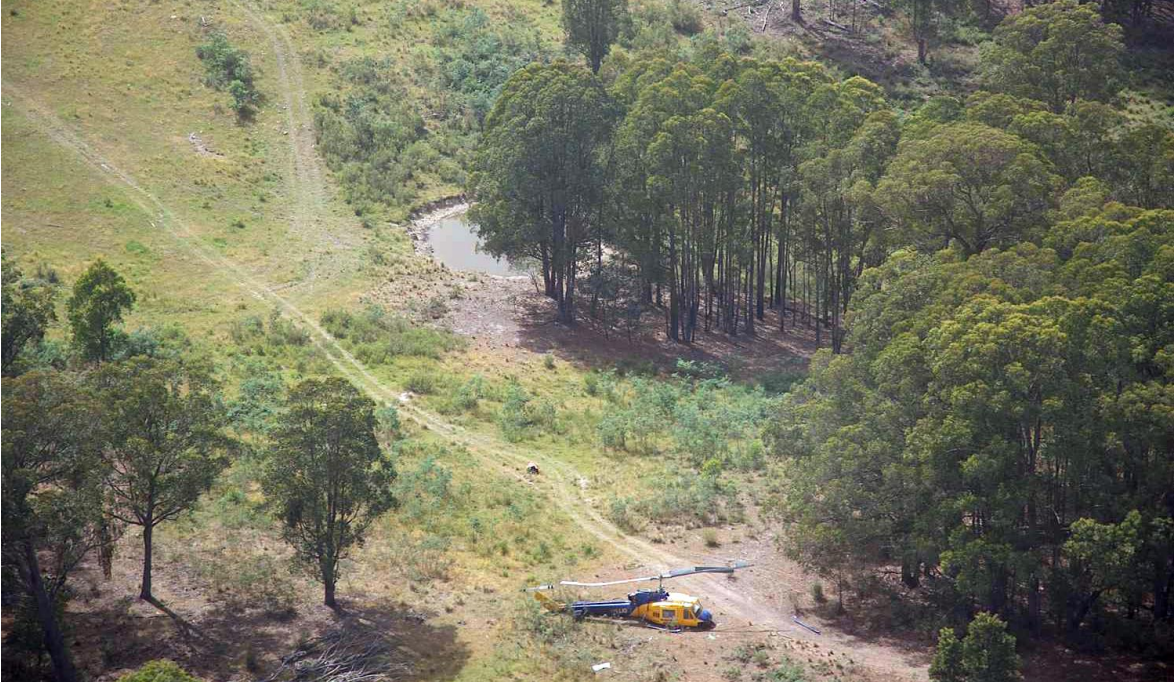
Figure 2: Overview of the accident site showing the small dam south-east of VH-LIQ

The PIC found a suitable clearing and conducted an emergency landing. He flared the aircraft and cushioned the impact using the collective. The helicopter landed heavily, reportedly yawing left and rolling slightly right. The helicopter sustained serious damage (Figure 2).

The engine control system was examined by an aviation consultant on behalf of the NSW Rural Fire Service and was reported to have been rigged correctly, with only impact damage observed.

A Licensed Aircraft Maintenance Engineer (LAME) employed by the operator conducted tests on the engine. These indicated that there was unlikely to be a failure within the fuel control unit and that fuel flow between the fuel feed and the flow divider was normal.

The operator removed the engine from the wreckage and sent it to Canada for a full engine tear down and inspection. At the time of publication of this report, the results of this inspection were not known. If further information becomes available relating to the engine failure, the ATSB will update this report.

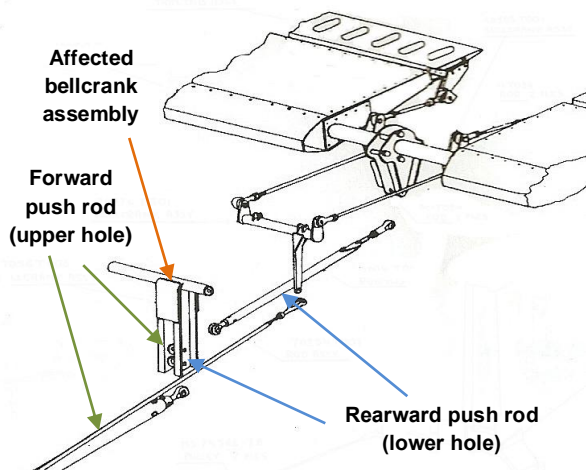
**Figure 2: Elevator bellcrank assembly**

A subsequent engineering investigation by the aircraft's maintenance provider determined that the elevator push rods had been fitted in the reverse order during recent maintenance, thus

When the push rods were refitted into the bellcrank assembly, they were placed in reverse order; the forward push rod placed in the lower hole and the rearward push rod placed in the upper hole. While the elevator system still functioned correctly, the incorrect positioning of the push rods limited the nose down travel of the elevator. Ground simulations conducted by the maintenance organisation determined that the last 6° of elevator down was not available due to the incorrect fitment of the push rods.

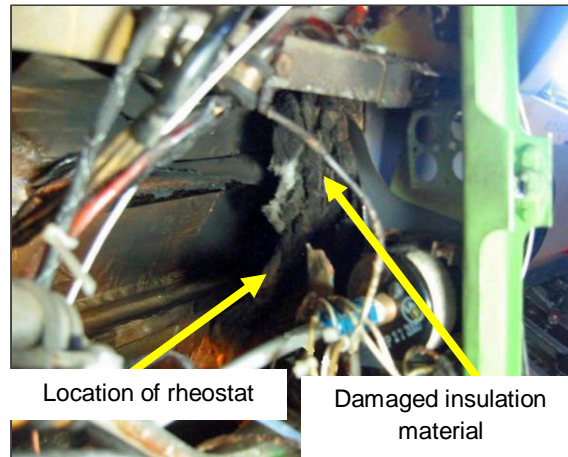
**Figure 2: Back of right instrument panel**

An engineering investigation conducted by the operator determined that the right red instrument panel light rheostat had developed a 'hot spot'. A small amount of insulation material located adjacent to, and above the rheostat had become detached and fallen onto the rheostat and wires within close proximity (Figure 2). The insulation material absorbed the heat from the 'hot spot' and transferred it to the wires, which produced smoke and flames.

Further examination identified that the rheostat had a broken moveable contact and a burnt contact surface; eight wires surrounding the rheostat were also damaged. The rheostat and affected wires were replaced.

The operator advised the ATSB that the following actions have been taken in relation to the inspection and replacement of rheostats:

- all of the operator's aircraft have been examined to ensure that there is sufficient clearance between the rheostats, insulation material, and surrounding wires. The operator will continue this examination as part of the aircraft's 375 hourly inspection.
- any insulation material located in close proximity to a rheostat has been removed.
- a search has been conducted to locate replacement rheostats that produce minimal heat. The operator is now in the process of selecting the most suitable rheostat and will seek the appropriate approval from the Civil Aviation Safety Authority for fitment.

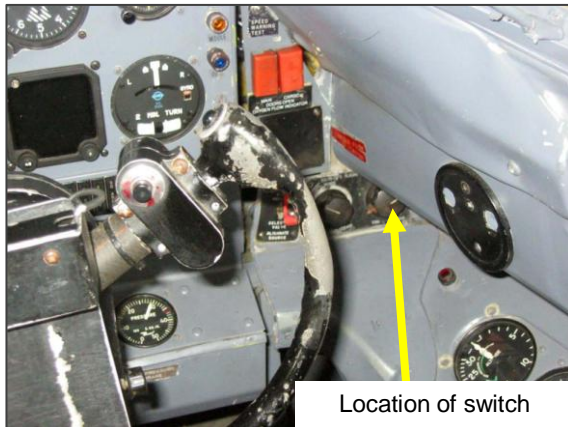
**Figure 3: Location of right red instrument panel light switch**

About 2 months prior to the incident, the aircraft was being operated on a night cargo flight. The pilot in command of this flight advised a Licensed Aircraft Maintenance Engineer (LAME) with aircraft electrical qualifications that the right red instrument panel light rheostat was not operating as expected. The defect was not recorded in the aircraft maintenance log.

The aircraft operator has issued a notice to crews to emphasise the importance of recording defects in the aircraft maintenance log.
