ATSB TRANSPORT SAFETY REPORT
Aviation Occurrence Investigation AO-2007-047
Final

Aircraft loss of control
255 km SW of Warburton, Western Australia
17 October 2007
VH-WXC
Cessna Aircraft Company 210M

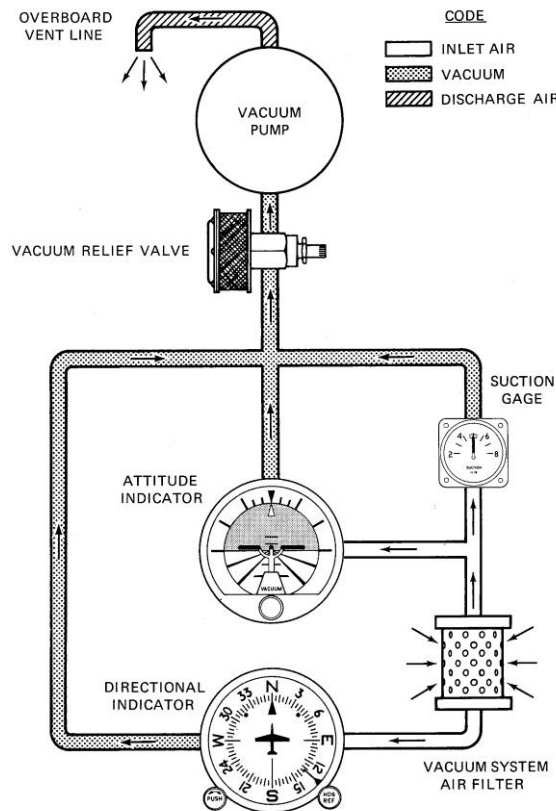
Figure 1: Schematic of aircraft instrument vacuum system (Cessna Aircraft Company)

The aircraft manufacturer's Aircraft Flight Manual (AFM) indicated that a suction of 4.6 to 5.4 inches of mercury (inHg) was required to operate the suction-powered gyroscopic flight instruments. The AFM indicated that a suction reading outside of that range may indicate a system malfunction or improper adjustment, and that in such a case, the attitude and directional indicators should not be considered reliable.

A suction gauge was mounted on the right side of the cockpit instrument panel and could be used by the pilot to monitor the suction being supplied to operate the attitude and directional indicator gyroscopes.

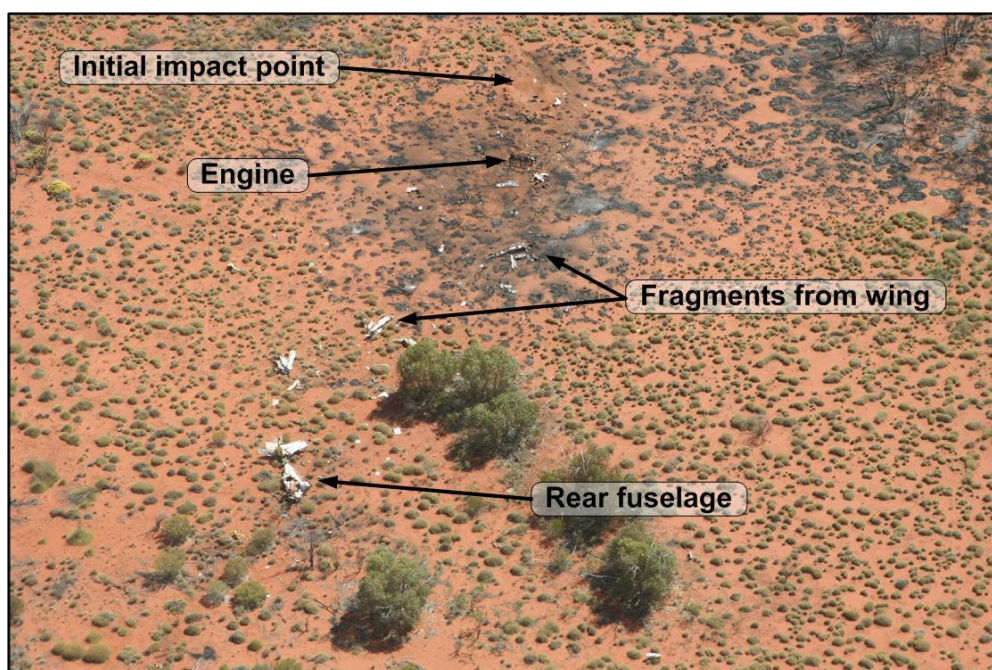
Figure 2: Photograph overhead the accident site

The aircraft impacted sandy, desert-type terrain at high speed (Figure 2). Ground markings in the vicinity of the initial impact were consistent with the aircraft's nose, engine and forward fuselage; the leading edge of the aircraft's wing; and the aircraft's vertical stabiliser striking the ground at that point.

Fragments of red and green coloured lens material from each of the aircraft's wingtip-mounted navigation lights, and of the red lens, tail-mounted anti-collision beacon were found in the immediate vicinity of the initial impact point. The location of those fragments relative to the impact point indicated that the aircraft was in an inverted attitude when it collided with terrain. The orientation of the ground marks that were made by the leading edge of the wing and the vertical

stabiliser was consistent with the aircraft being in a banked, left wing-low attitude of about 30° from the horizontal, and a nose-down attitude of about 20°.

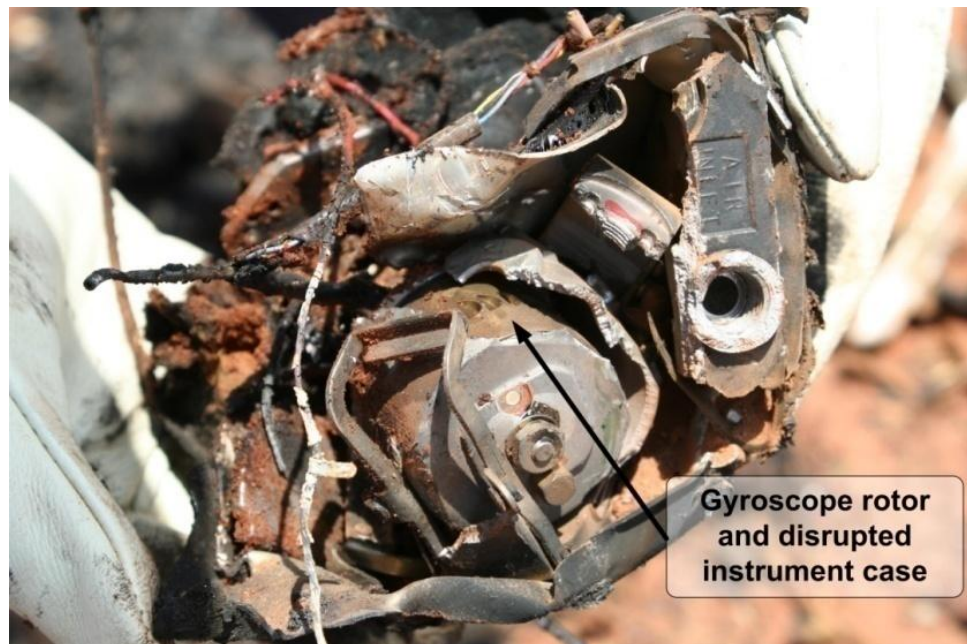
Figure 3: Directional indicator with gyroscope rotor and disrupted instrument case

Although the cases of the attitude and directional indicators had been disrupted, each instrument's brass gyroscope rotor had remained within its respective case assembly (directional gyroscope shown at Figure 3). An examination of those rotors revealed damage that was consistent with their being in a low energy state at the time of the impact with terrain.

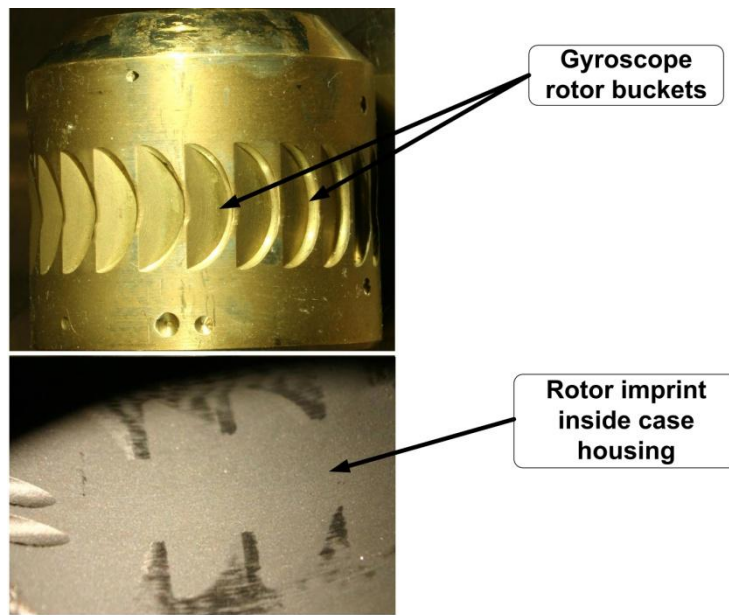
Figure 4: Disassembled attitude indicator and case imprint

The gyroscope rotor from the attitude indicator had contacted the inside of its case housing. There was minor scuffing to the case assembly and an imprint of the gyroscope rotor buckets on the housing (Figure 4). That damage was consistent with the rotor impacting the case housing and stopping suddenly while in a relatively low energy state.

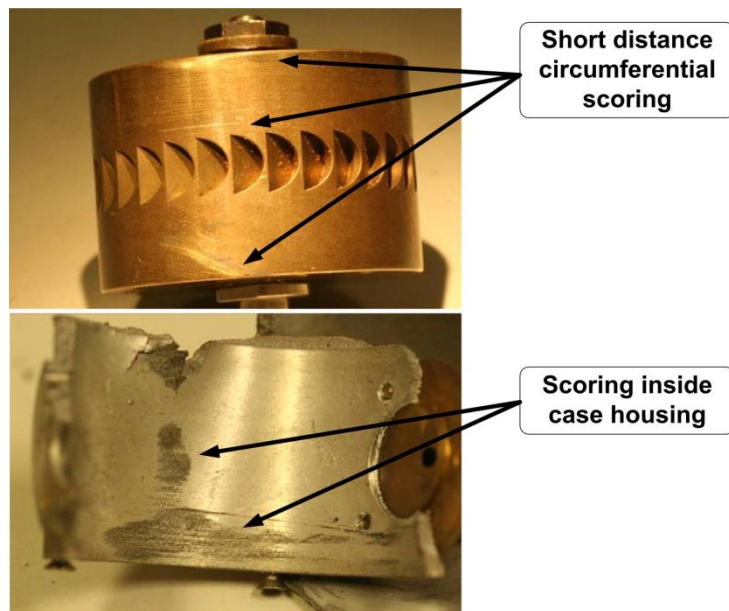
Figure 5: Disassembled directional indicator and case scoring

The gyroscope rotor from the directional indicator had also contacted the inside of its case during the impact sequence, and exhibited short-distance rotational scoring (Figure 5). That was consistent with the rotor being in a relatively low energy state at that time, rotating only a short distance while in contact with the housing before being brought to a stop.

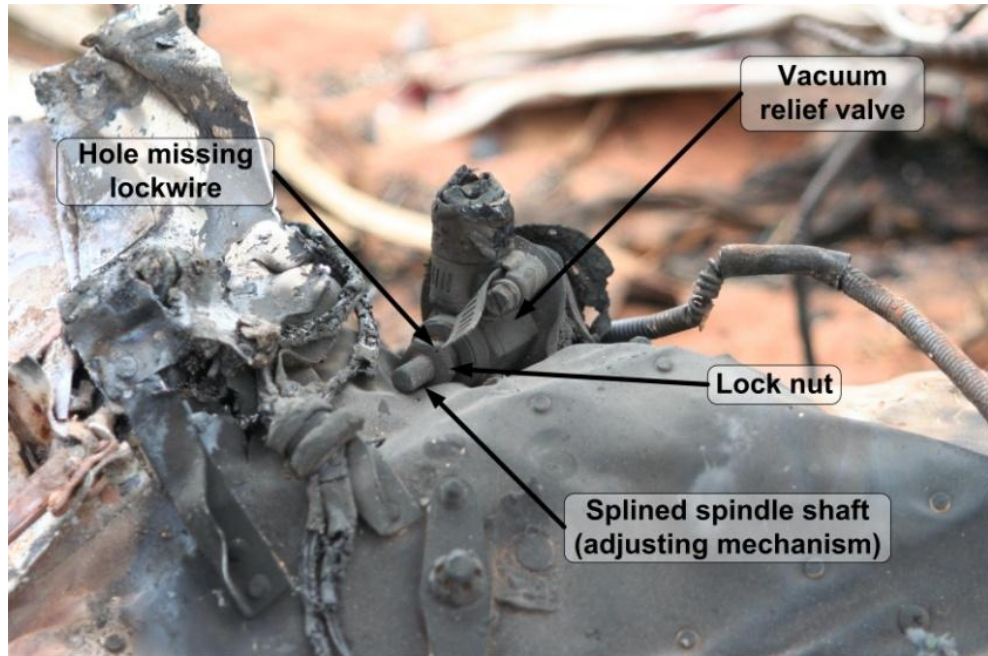
Figure 6: Vacuum relief valve mounted on the engine firewall

The end cover plate of the vacuum relief valve was dislodged during the impact and the diaphragm was heavily charred and embrittled as a consequence of the

post-impact fire. The polyurethane foam garter filter within the valve had also been consumed by the fire. There was no lockwire attached to the valve's splined spindle shaft lock nut (Figure 6).

The missing lockwire that was necessary to secure the lock nut to the vacuum relief valve's spindle shaft adjusting mechanism, increased the risk of a reduction in the clamping pressure against that shaft. Any loss of lock nut security could allow the spring tension on the diaphragm to move the lock nut, and therefore the adjustment spindle, towards a setting where progressively lower suction was provided to the aircraft's suction-powered flight instruments. Any in-flight vibration increased the likelihood for that to have occurred.

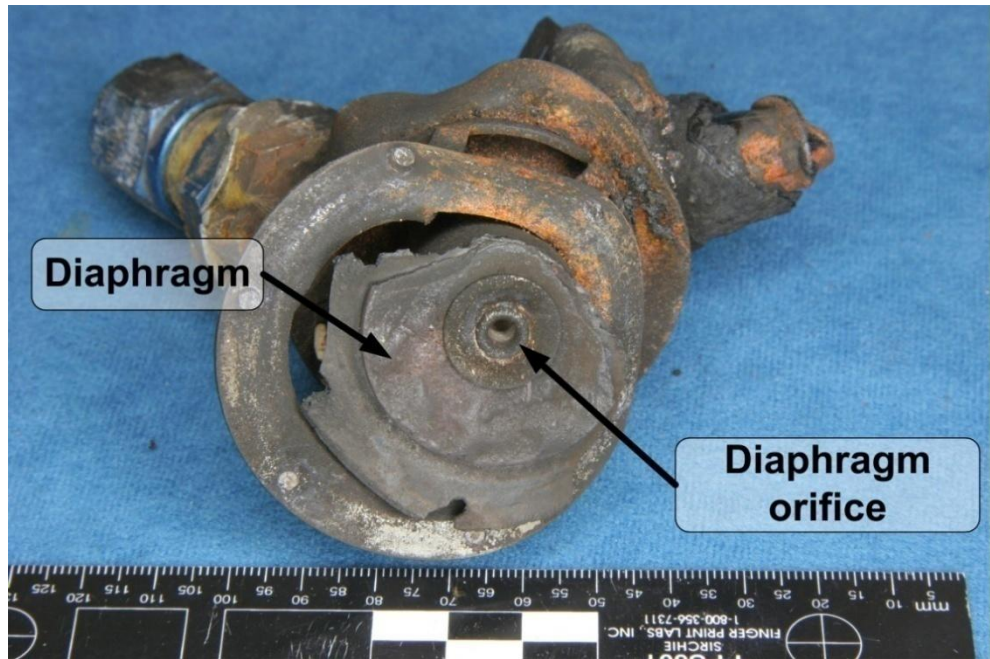
Figure 7: Fire damage to regulator diaphragm

At the base of the regulator diaphragm (Figure 7), the bleed orifice was found partially covered with congealed, oily sand, which was also found around, and on both sides of the orifice plate (Figure 8). The regulating spring was free to move on the threaded portion of the spindle shaft and was securely attached to the orifice plate.

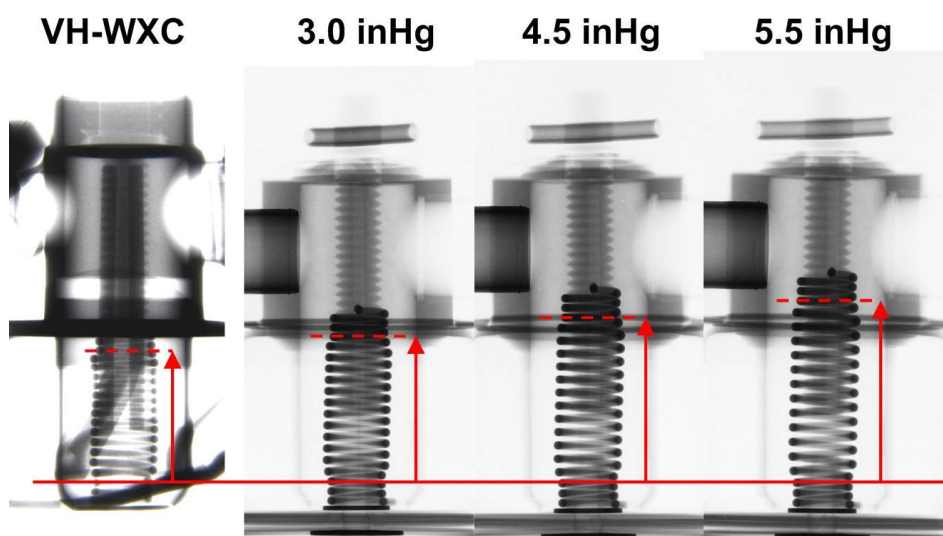
Figure 9: Comparative diaphragm spring positions vs vacuum set points in comparison with the as-found regulator from WXC

The diaphragm spring tension (and hence the valve set-point) was indicated by the position of the spring end that engaged with the threaded spindle, and by the relative separation of the individual coils of the diaphragm spring. A comparison of the various set-points for the exemplar vacuum relief valve found that the lower vacuum settings corresponded with a lower diaphragm spring tension.

A comparison of the aircraft's vacuum relief valve with the exemplar unit showed that the diaphragm spring position corresponded most closely with the lowest set-point examined; 3.0 inHg (Figure 9).
