ATSB TRANSPORT SAFETY REPORT  
Marine Occurrence Investigation No. 260  
MO-2008-012  
Final

Independent investigation into the rupture of a  
submarine gas pipeline by the Hong Kong registered container ship

# APL Sydney

13 December 2008

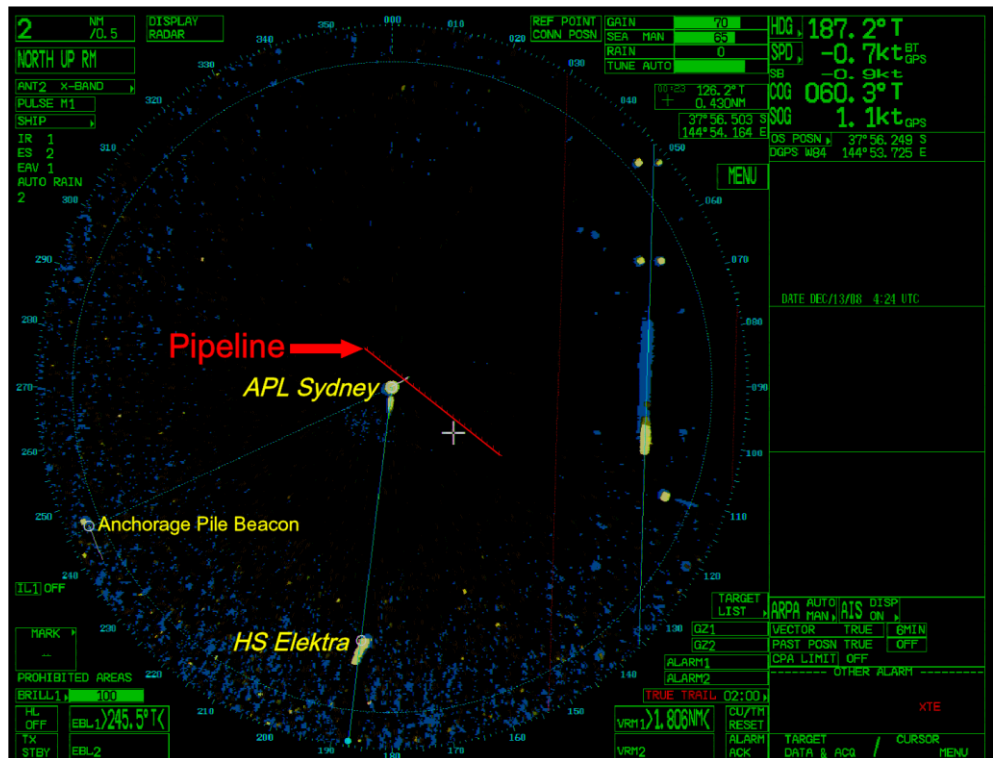
Figure 7: APL Sydney's radar screen at 1524 with pipeline astern of ship

APL Sydney's yawing became more rapid and at 1524, the ship's radar indicated that it was moving towards the pipeline at a speed of 1.1 knots. At 1525, alarmed that the anchor was dragging rapidly, the master called the pilot boat to check its ETA at the ship. He was given an ETA of 1600. Moments later, the control officer informed the master that it appeared the ship may be dragging its anchor and that the engine should be used to keep the ship clear of the pipeline. The master asked if he could move the ship half a mile ahead and this time the control officer replied 'you have permission to shift your vessel'. Almost immediately, at 1527, the master put the engine dead slow ahead and ordered the chief mate to start weighing anchor.

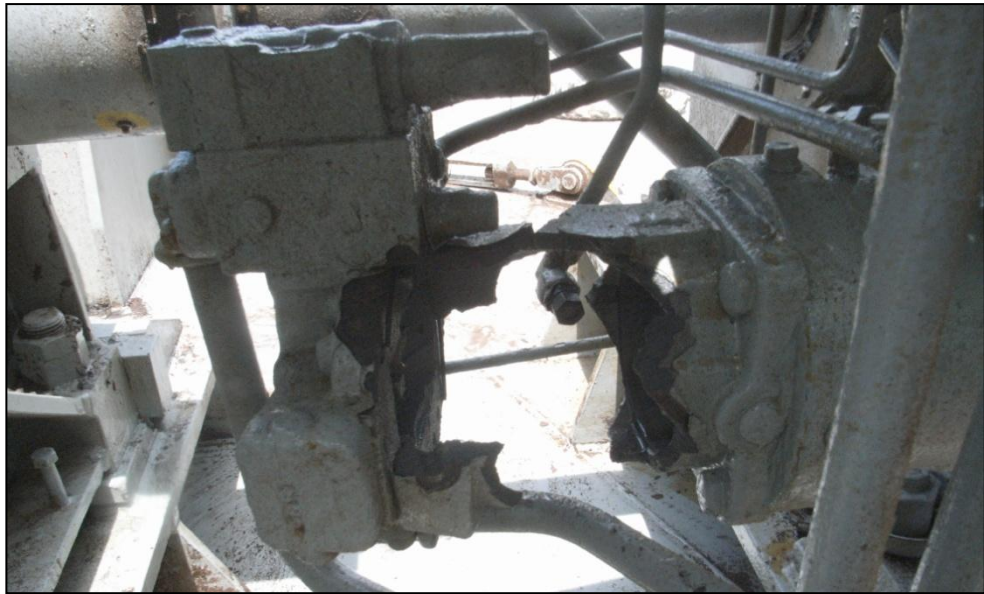
**Figure 8: Shattered casing of windlass hydraulic motor**

At 1548, the master advised the pilot that he was waiting for him to board and there was 1 shackle of anchor cable in the water. The pilot asked for the anchor to be heaved all the way home. There was already weight on the cable and as soon as it was heaved on, it suddenly began to run out. The boatswain quickly applied the windlass's manual friction brake and when the cable stopped running out, there were 2 shackles in the water. The cast iron casing of the windlass's hydraulic motor had shattered (Figure 8). Many of the motor's internal parts had been ejected from the casing. No one was injured by the ejected parts of the motor, fragments of the casing or debris from the cable as it ran out.

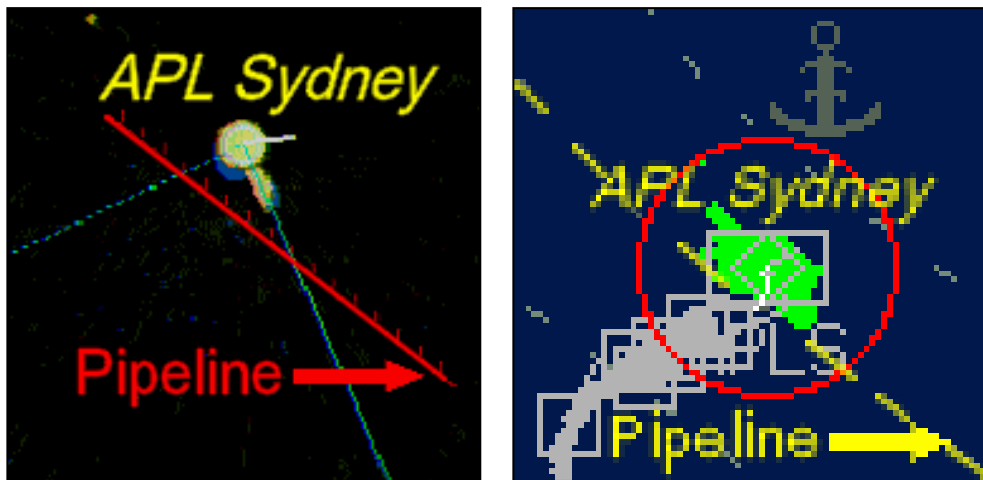
**Figure 9: Sections of the ship's and harbour control's radar displays at 1547**

At 1549, the master informed harbour control that he was unable to weigh anchor and there were 2 shackles of cable in the water. The control officer asked that the engine be used to maintain a safe distance from the pipeline. The master told him that the engine could not be used because *APL Sydney* might be 'above' the pipeline and indicated that he did not know exactly where the pipeline was. The radar displays on board the ship and at harbour control indicated that the pipeline was slightly south of the ship (Figure 9).

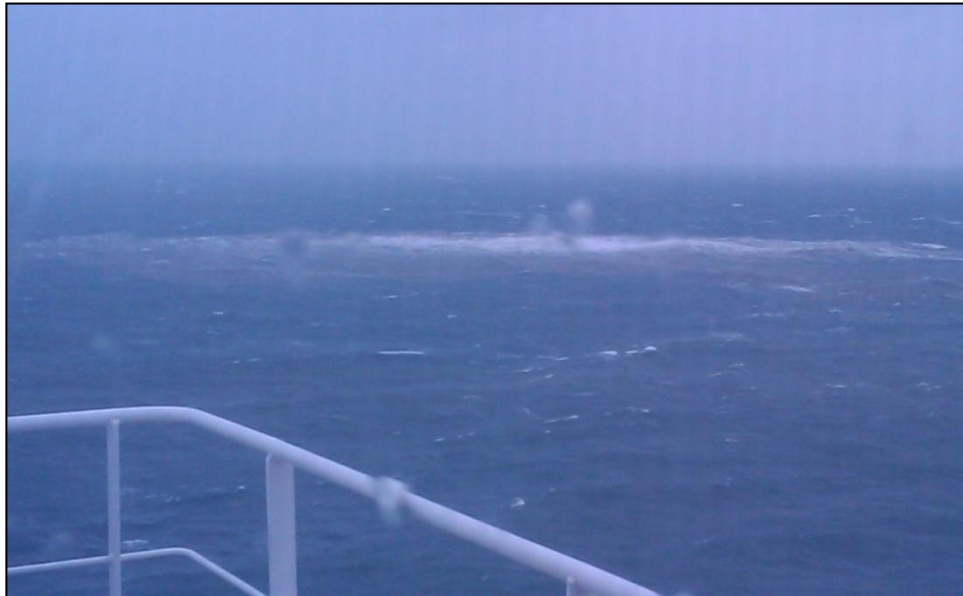
**Figure 10: Gas eruption as seen from the ship's bridge**

At 1621, less than 1 minute after the engine started to run ahead, there was an eruption of gas in the water about 50 m from the ship's starboard bow. The chief mate reported the bubbling wave-like turbulence and the master told the pilot that the pipeline had 'broken'. The sea surface appeared to the pilot as though it was boiling (Figure 10). The engine was stopped and the master asked the pilot to notify harbour control. The GPS unit indicated that the ship was in position 37°56.10'S 144°54.02'E.

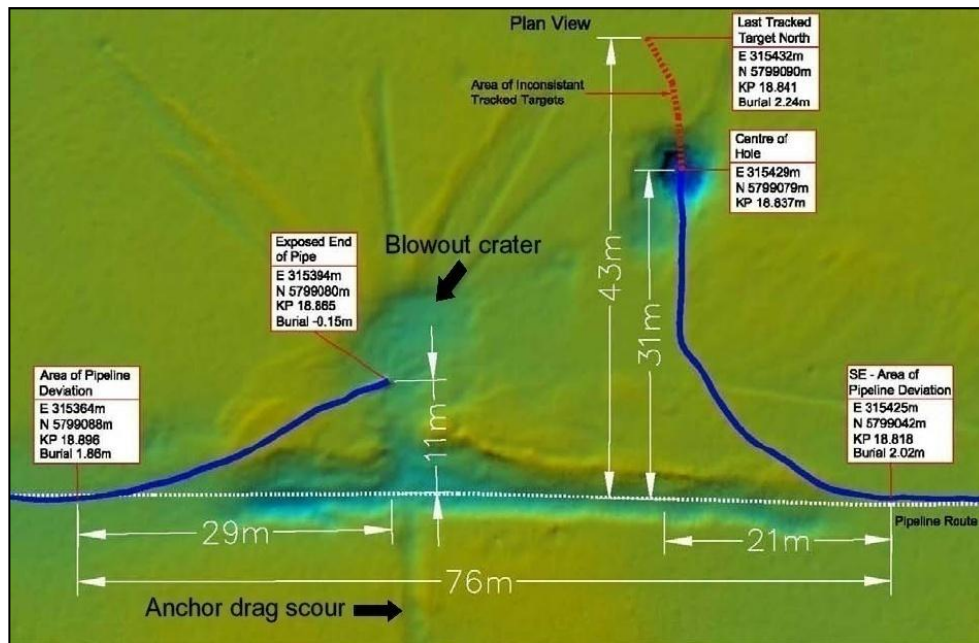
Figure 11: Plan view image from preliminary survey of the ruptured pipeline

The preliminary survey of the ruptured pipeline revealed the anchor dragging scour mark, sections of the displaced pipeline and the blowout craters (Figure 11). This evidence is consistent with what is likely to have happened. The anchor's flukes are 2.5 m long and, when tripped, extend more than 1 m from the shank. The anchor, at more than 8 tonnes, would have sunk into the mud on the sea-bed and as it dragged, the flukes probably went under the pipeline and pulled it from its trench. The anchor then held the ship with its flukes hooked under the pipeline and the shank above it. When the ship's engine was run ahead, the pipeline was pulled with sufficient force to rupture it.

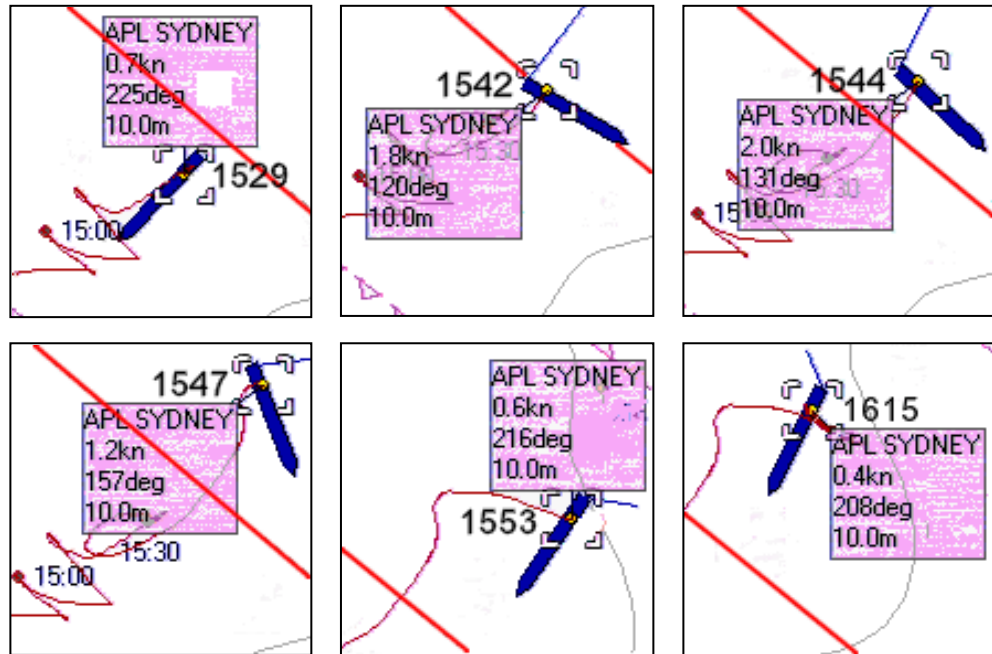
**Figure 13: Sections of harbour control's AIS display at 1529, 1542, 1544, 1547, 1553 and 1615 (the pipeline is indicated in red)**

By 1553, *APL Sydney* lay head to wind and its position in relation to the pipeline became constant. It was evident from the AIS display as the ship began yawing, that its anchor had probably snagged the pipeline and was holding the ship but the control officer appears not to have noticed this. At 1615, he advised the harbour master that the pilot thought the anchor 'could be' south of the pipeline although accurate information was readily available by interpreting the AIS display.

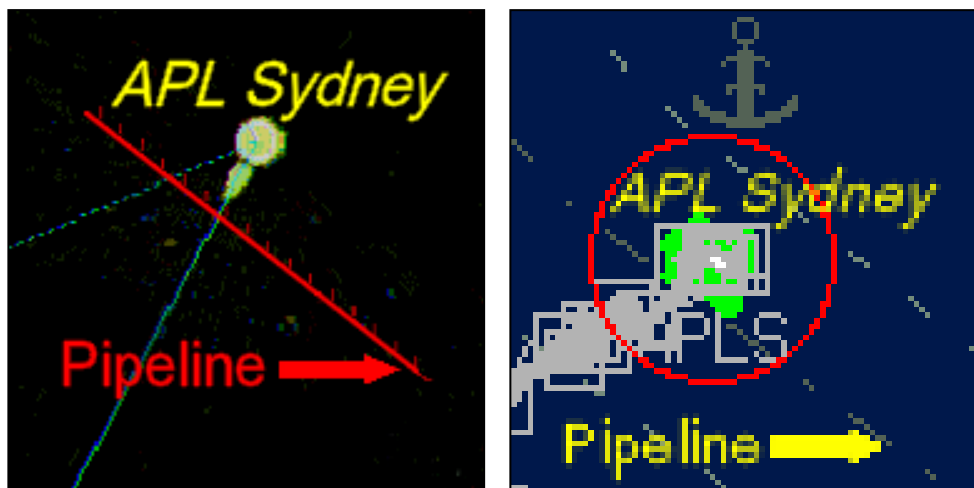
**Figure 14: Sections of the ship's and harbour control's radar displays at 1615**

*APL Sydney*'s charted position at 1547 and 1615 indicated that the ship's bridge had remained in nearly the same position. The ship's and harbour control's radars also indicated the ship's position in relation to the pipeline (Figure 14). This meant that the ship had brought up to the anchor with 2 shackles of cable out and lay head to wind. However, the pilot concluded that the bow was located above the pipeline and the anchor lay just south of it. He was assuming that the accuracy of the ship's 1615 position that he had plotted on the chart (Aus 155, Scale 1:37,500) and that of the charted pipeline, was within metres and could be relied upon.
