# Operational event

## Brisbane Airport, Queensland

### 25 November 2007

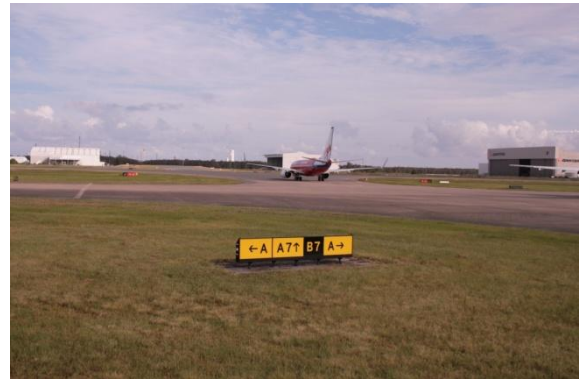
**Figure 2: Taxiway intersection (in daylight)**

The PIC, as the pilot flying, continued the turn and entered taxiway Alpha (Figures 2 and 3) and commenced the take-off run. The airport safety officer saw the Gulfstream accelerating on taxiway Alpha and, at 2225:28, transmitted on the ADC frequency to alert the ADC to the situation.

Airport movement area lighting was operating normally including taxiway, runway and runway movement areas guidance signs (MAGS) at taxiway intersections (Figure 2) and at the runway holding points.

very wide, and may have appeared to the PIC to be as large as a runway.

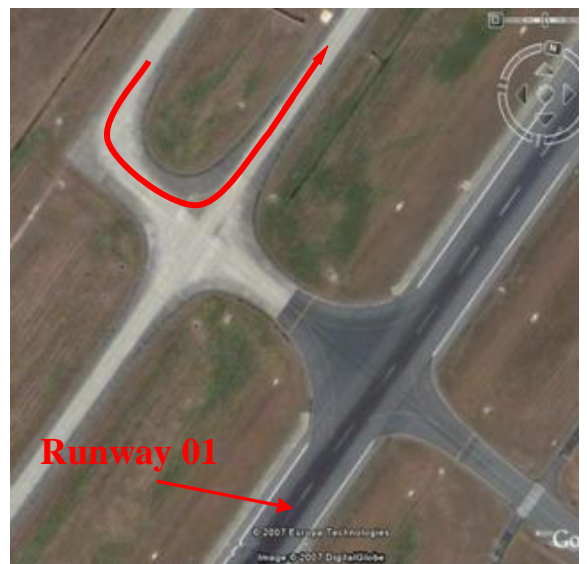
**Figure 3: Overhead view of intersection<sup>4</sup> with aircraft track highlighted**

- The pilot in command did not use the available means to assist in guiding the aircraft during taxi after his electronic flight bag display became unserviceable.
- The communication between the flight crew was adversely affected by a steep trans-cockpit authority gradient.
- The pilot in command commenced the takeoff on taxiway Alpha at the Alpha 7 intersection.
