Australian Government
Australian Transport Safety Bureau

AVIATION SAFETY INVESTIGATION REPORT
200204328

Hamilton Island Aerodrome

Piper PA-32-300, VH-MAR
26 September 2002

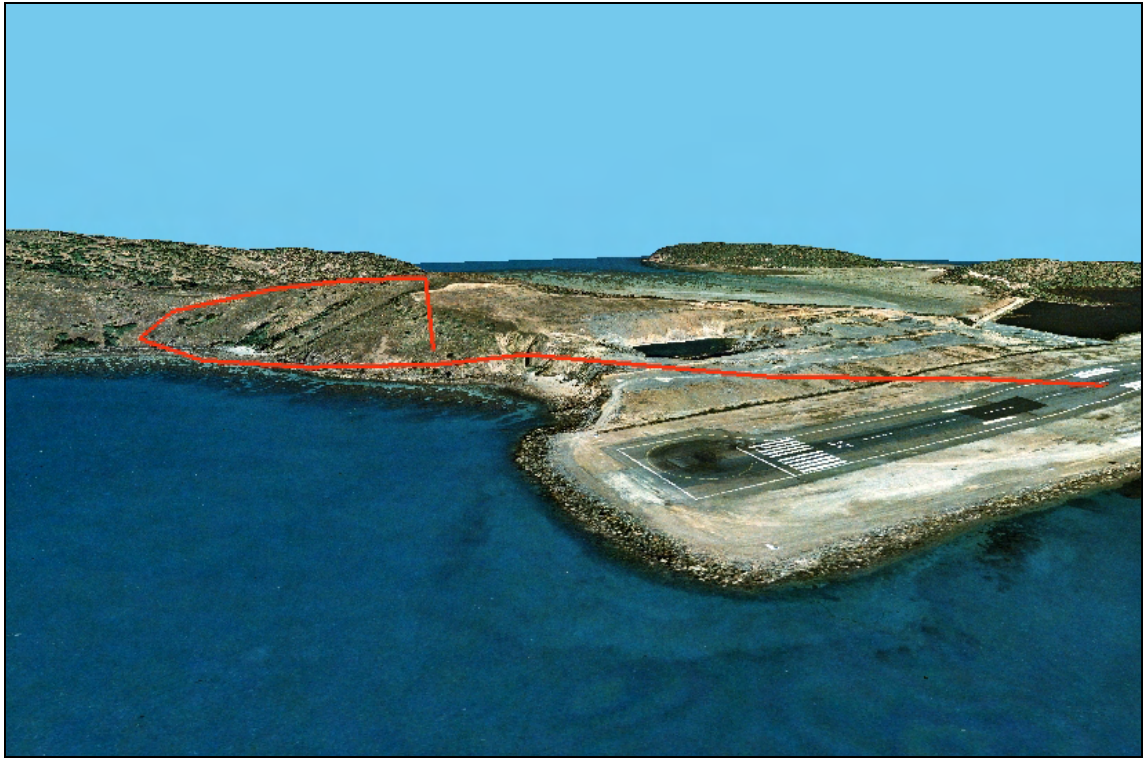
Figure 2: Probable aircraft flight path

A number of witnesses reported that, when part way around the turn, the engine again ‘cut out’, and the aircraft descended ‘...like a dart’ before impacting the sloping ground of the hillside. There was no report of any object falling from the aircraft, or of any vapour or smoke emanating from the aircraft. The maximum height achieved by the

aircraft was reported as approximating the 98 m (322ft) elevated ground to the southwest of the runway end and in the background of the witnesses field of vision. An indication of the probable aircraft flight path is at Figure 2.

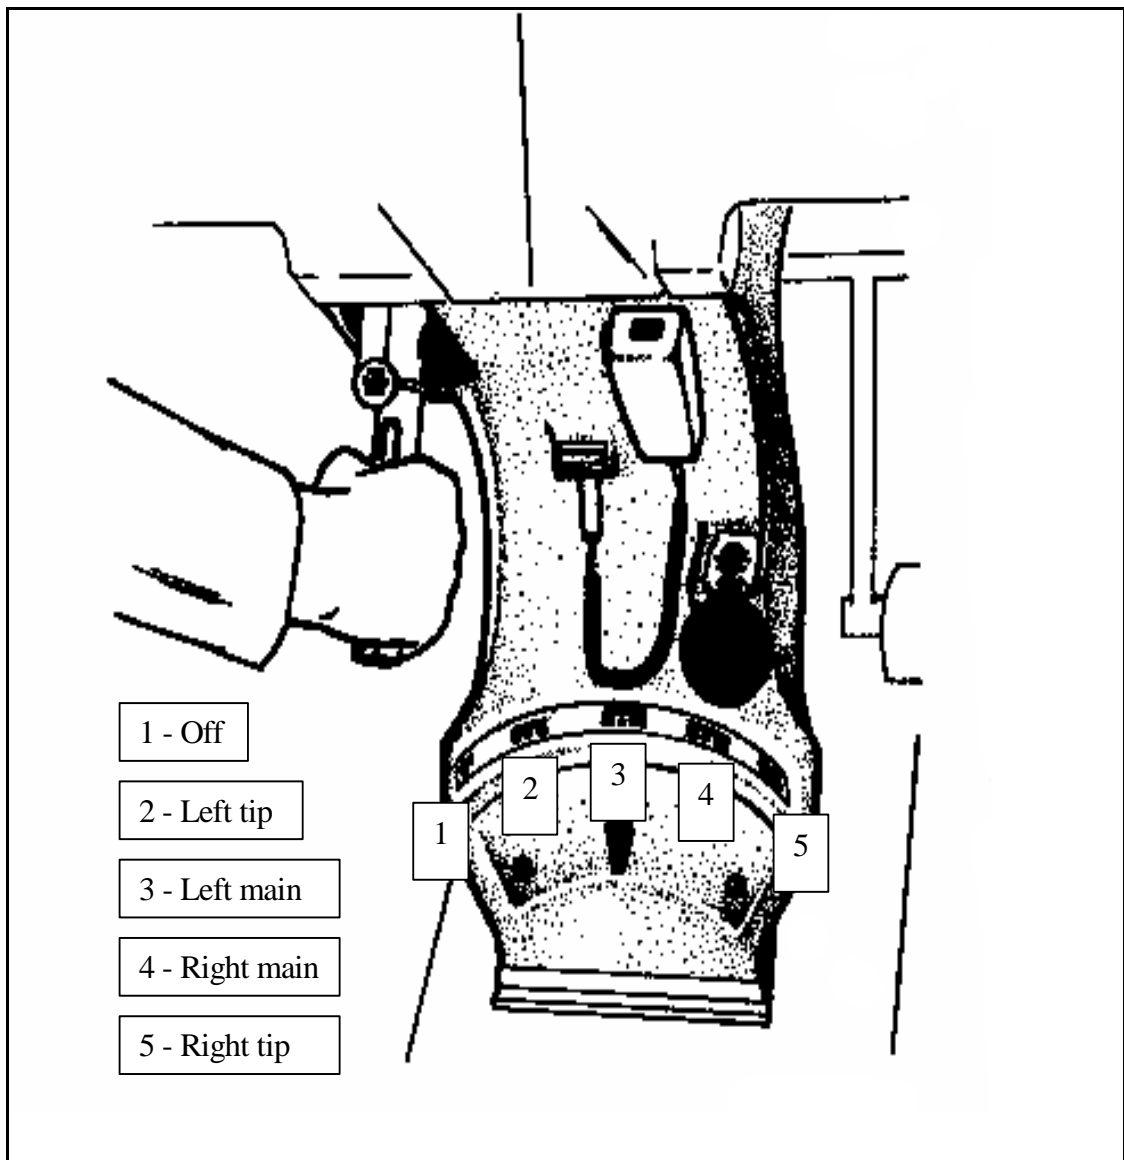
Figure 3: Fuel selector control positions

The fuel selector valve was in a beyond the OFF position consistent with being driven beyond the off detent by impact forces. The absence of witness marks on the fuel selector housing and plate prevented determination of the position of the fuel selector mechanism prior to impact. There was no evidence of any pre-existing defects. Although the fuel selector valve detent mechanism was intact and showed minimal wear, it was not possible to determine its pre-impact effectiveness.

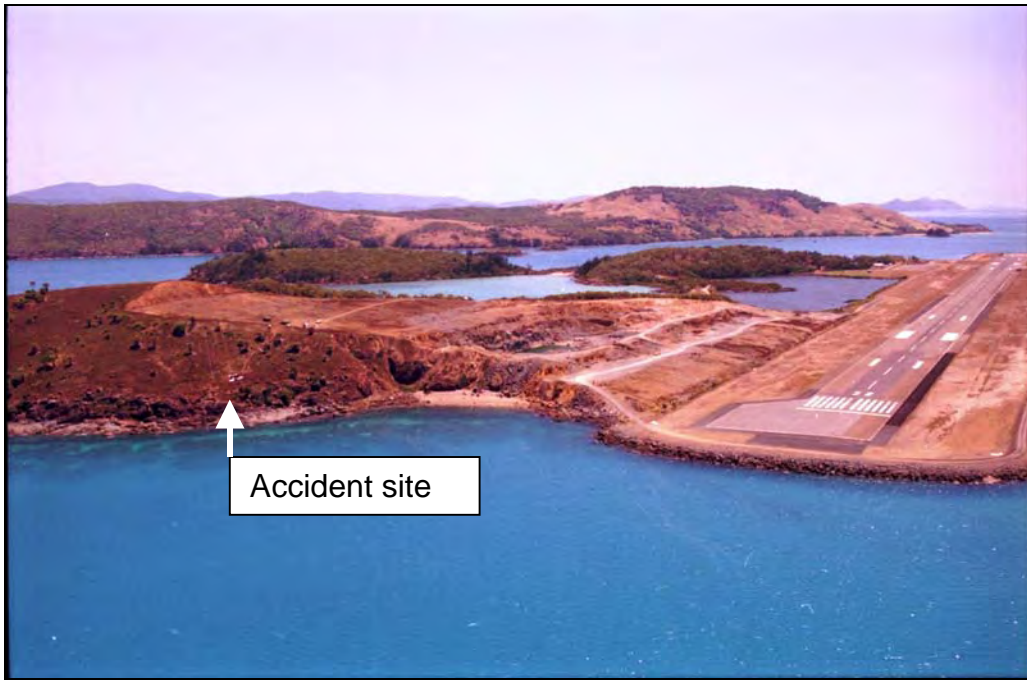
Figure 6: Accident site location

The accident site was located approximately 300 m to the west of the take-off runway centreline and approximately 100 m south of the departure end of that runway. The terrain at the accident site was inclined at an average of 19 degrees down to the horizon, with light scrub and numerous small groups of palm trees. Numerous large rocks were found in the vicinity of the impact point. A photograph of the location of the accident site is at Figure 6.
