Australian Government

Australian Transport Safety Bureau

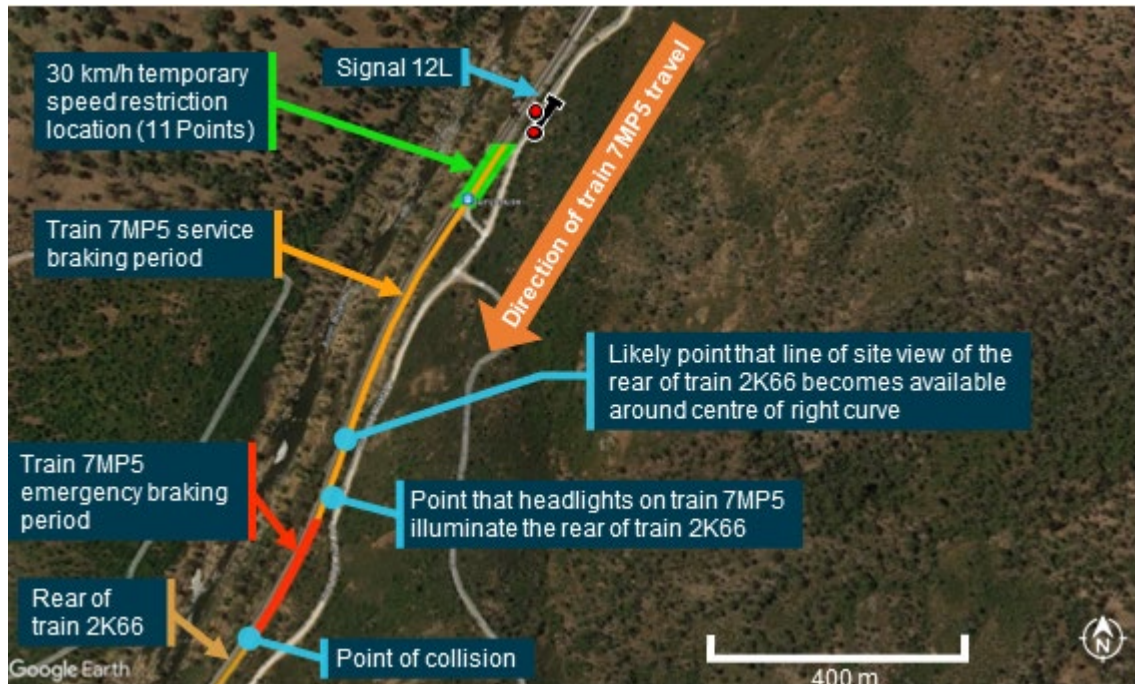
The image shows the track curvature and geography of the Jumperkine accident site. This includes graphics showing about where 7MP5 service and emergency brake applications were made as well as the location of signal 12L and train 2K66.
Source: Google Earth and Pacific National, annotated by the ATSB

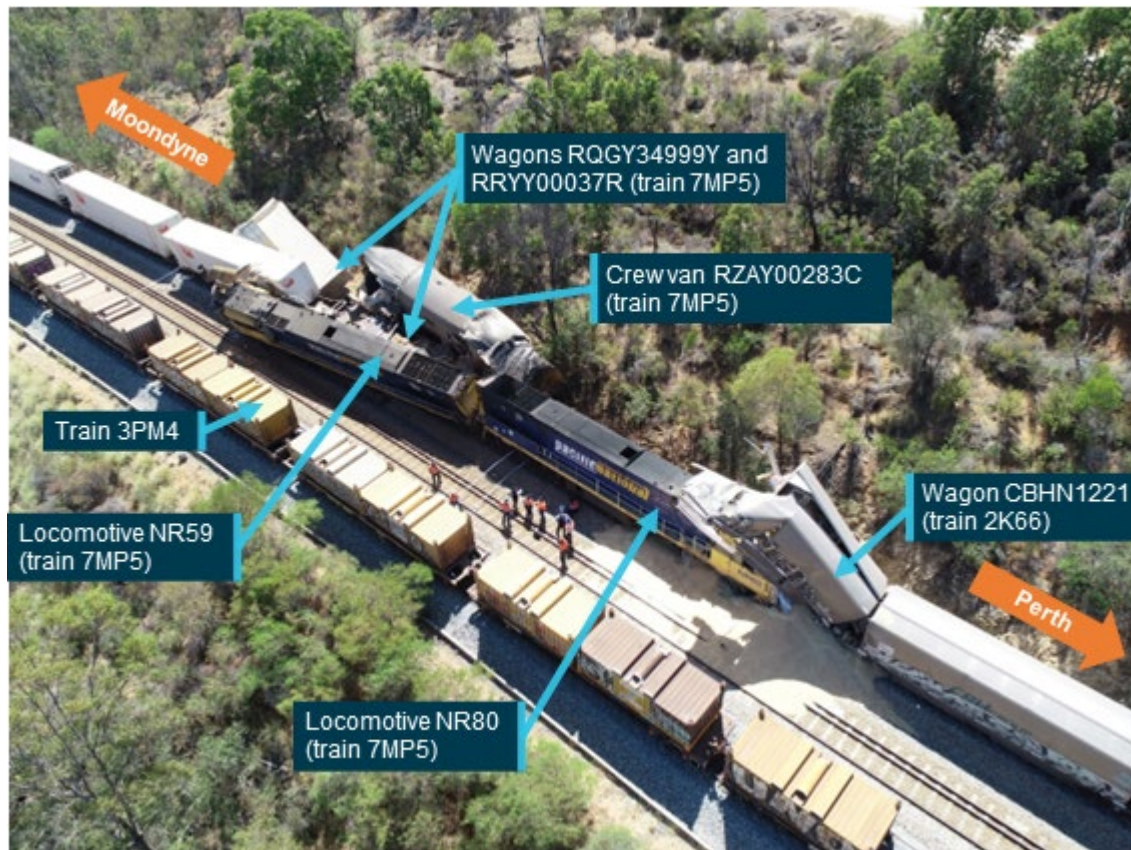
The image shows damage to rolling stock from train 7MP5 and last wagon on train 2K66 post collision.
Source: Western Australia Police, annotated by the ATSB

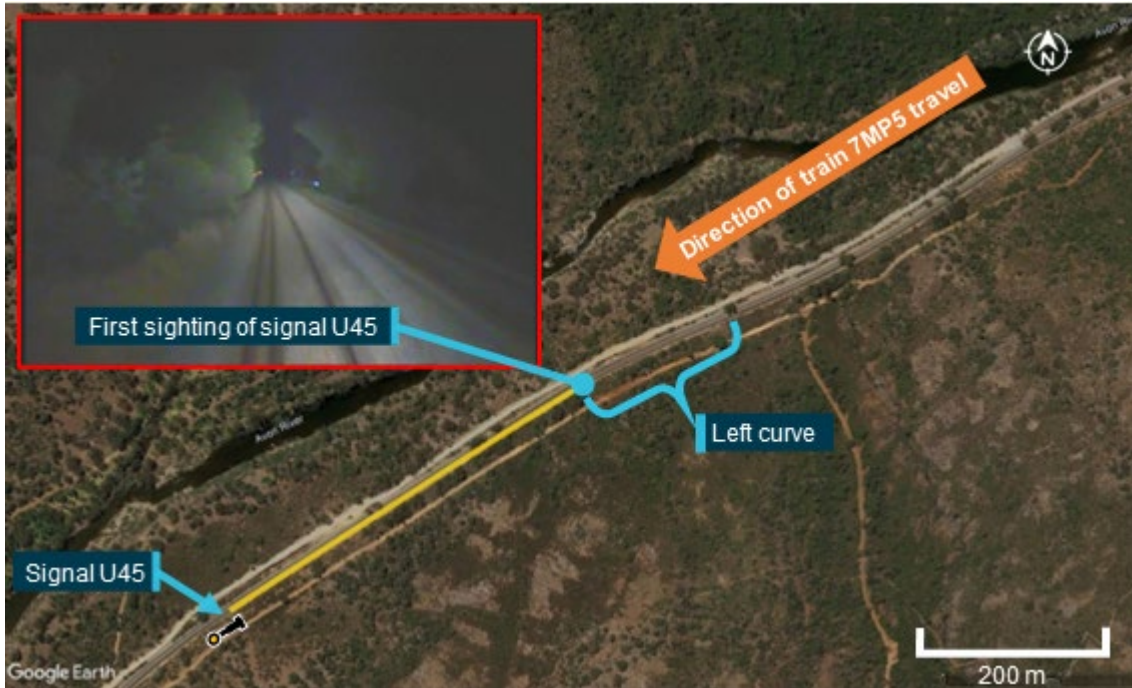
The image shows the track curvature towards signal U45 between Moondyne and Jumperkine, and an image of the first available sighting of signal U45 from 7MP5 (top left).

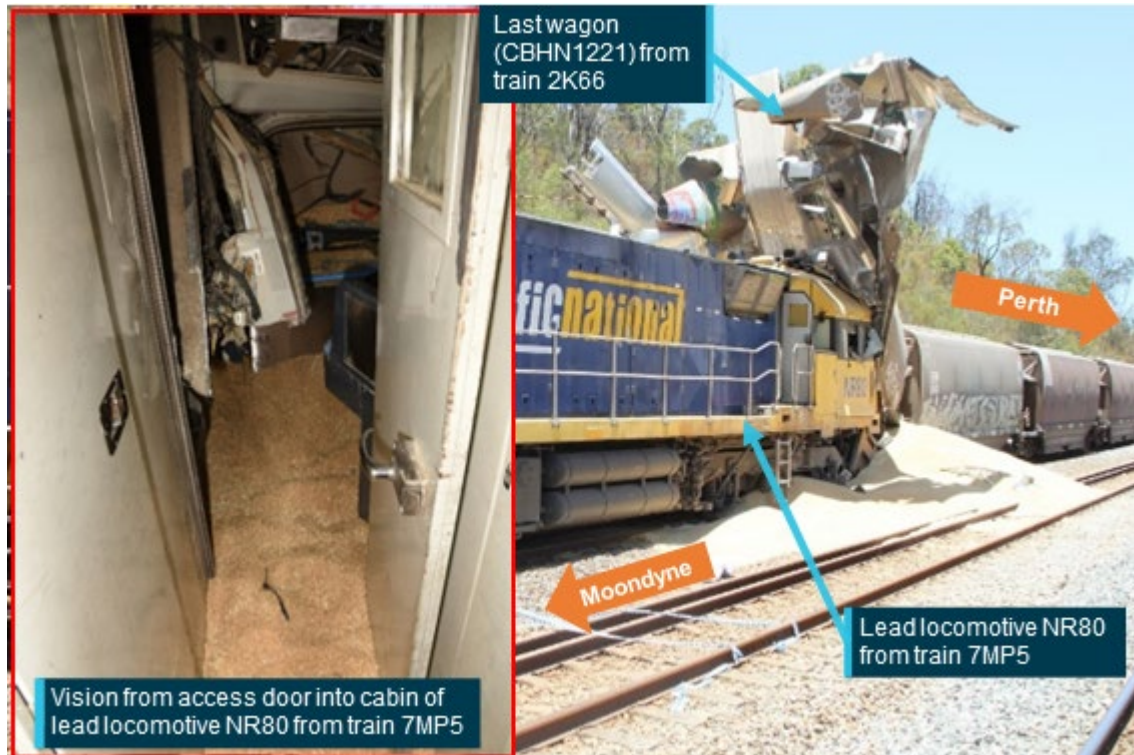
The image shows accident site wreckage of train 7MP5 and train 2K66, including ingress of grain to the lead locomotive (NR80) of 7MP5. Source: ATSB

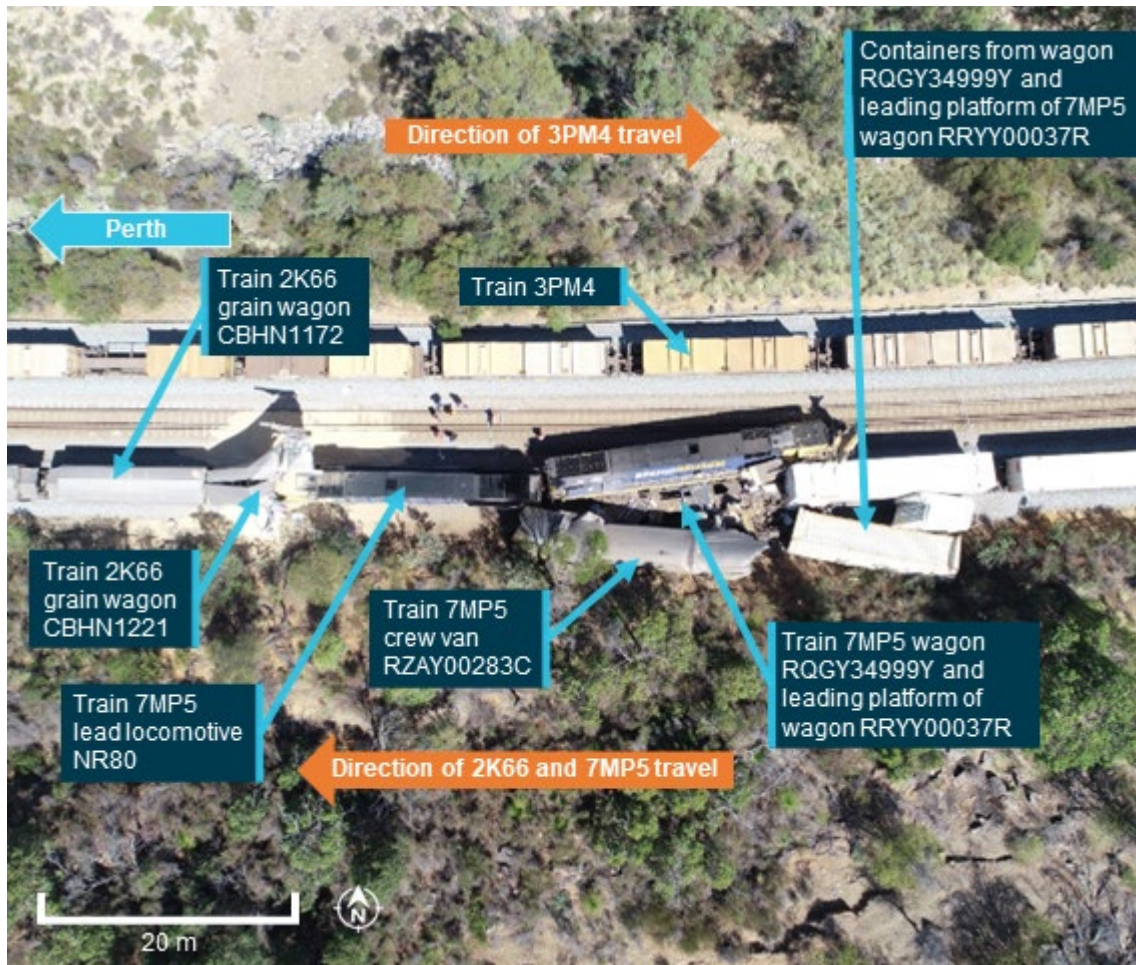
The image shows the site and wreckage layout at Jumperkine. Source: Western Australia Police, annotated by the ATSB

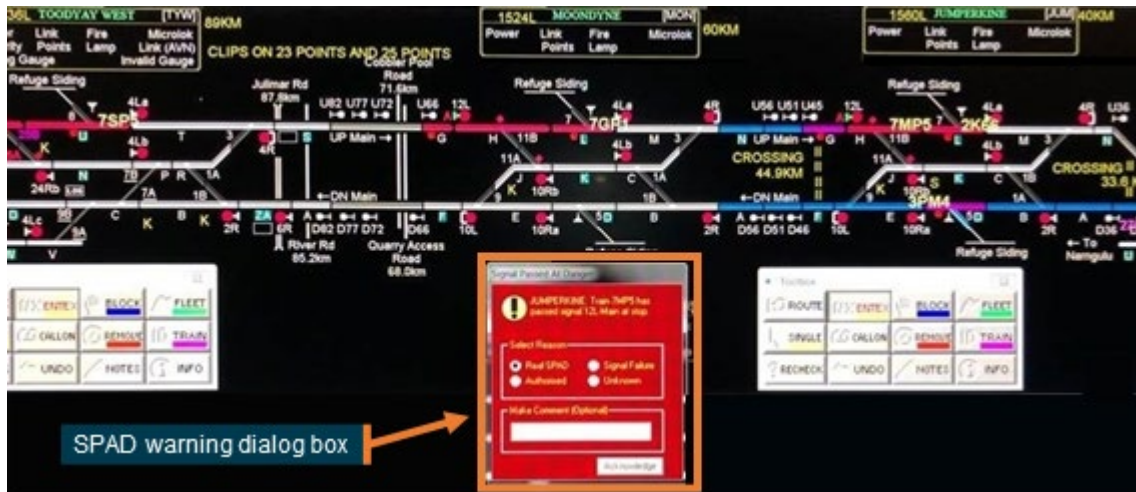
The image shows a portion of the track layout including Jumperkine, and an inset image of the SPAD warning dialog box like that provided by the Phoenix TCS system.
Source: Arc Infrastructure, annotated by the ATSB

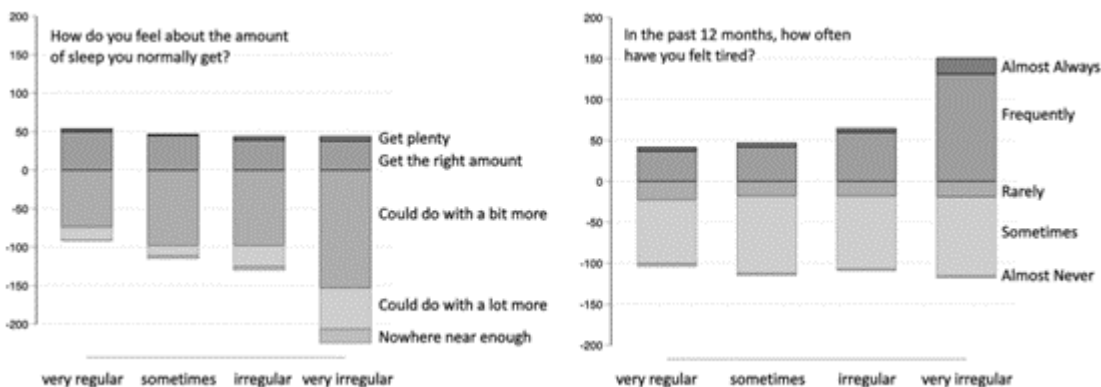
Note: From Dorrian and others (2022). Vertical axes show perceptions of sleep amounts (left) and tiredness (right), split by schedule regularity (horizontal axis).
