Australian Transport Safety Bureau

Aviation Safety Investigator

Investigation briefs

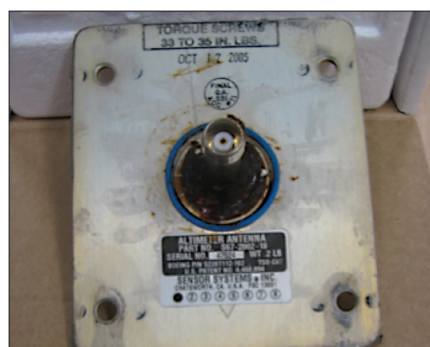
The investigation determined that spurious data from the left radio altimeter (RA) provided an indicated altitude of minus 7 ft, resulting in the autopilot disconnecting and the thrust lever movement. An examination found that the left RA receive antenna displayed rubbing wear adjacent to the attachment screw inserts. A bonding check of the antenna indicated that its resistance was outside the aircraft manufacturer's limits.

The maintenance history for the aircraft operator's fleet of 38 Boeing 737-800's revealed that, over the previous 12 months, the operator had removed and replaced 24 RA antennas. The replacements (including for this event) were as a result of 11 antennas having failed bonding checks, and 12 antennas exhibiting RA system faults or alerts.

The antenna was replaced and the aircraft was returned to service.
