Australian Government  
Australian Transport Safety Bureau

ATSB TRANSPORT SAFETY INVESTIGATION REPORT  
Aviation Research and Analysis Report – B20070191  
Final

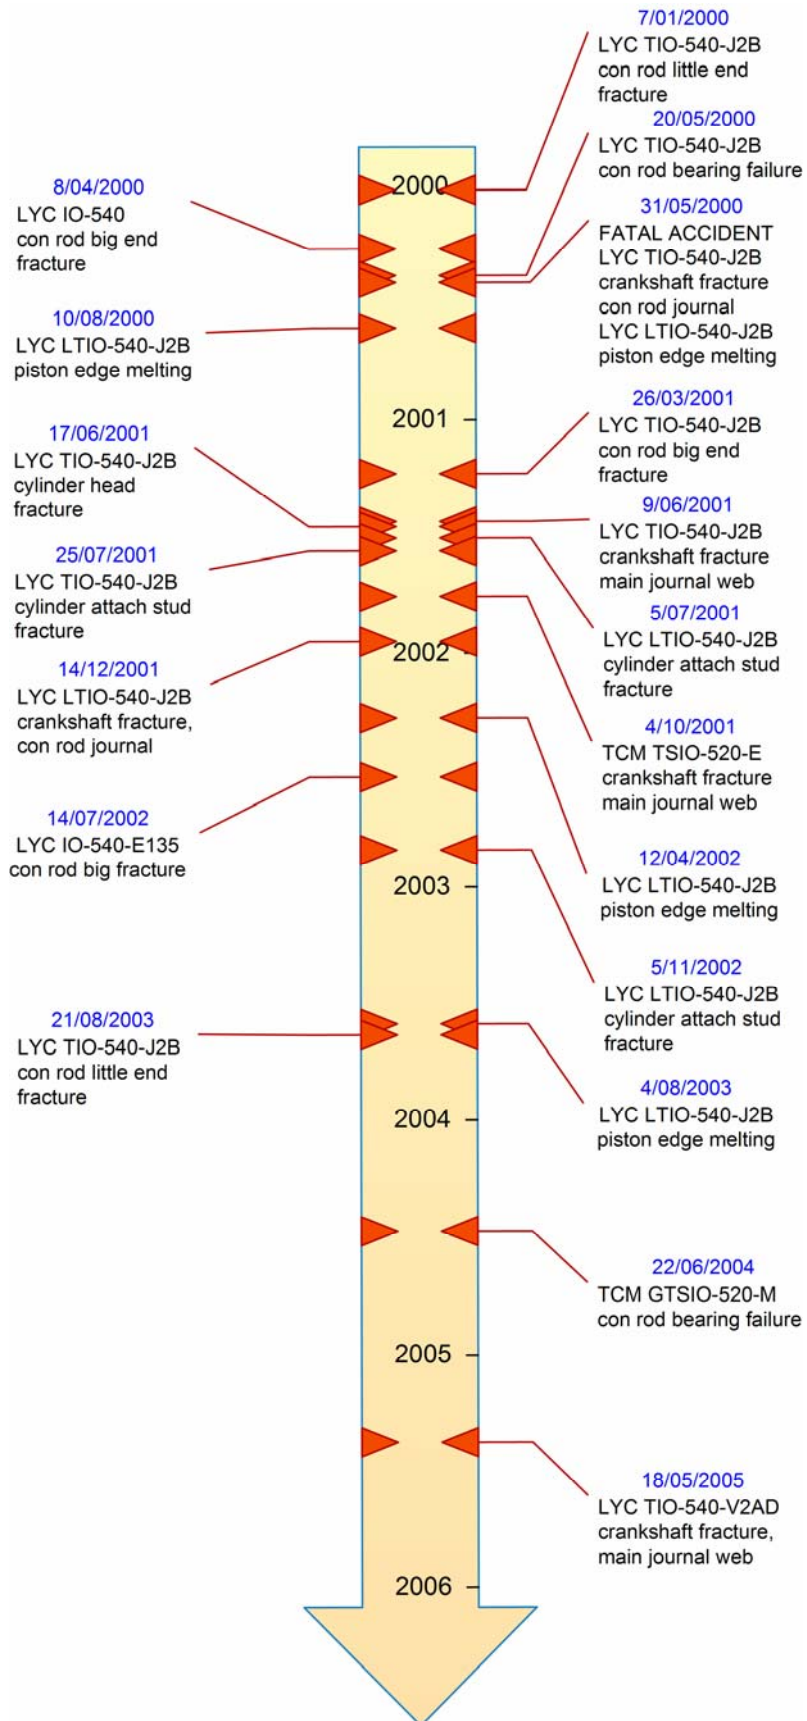
In addition to these reported air safety occurrences, several other structural issues with this class of engine have been reported to the regulatory authority as major defects<sup>1</sup>. In particular, there were a large number of reports of crankshaft bearing failure (Sprigg, 2003).

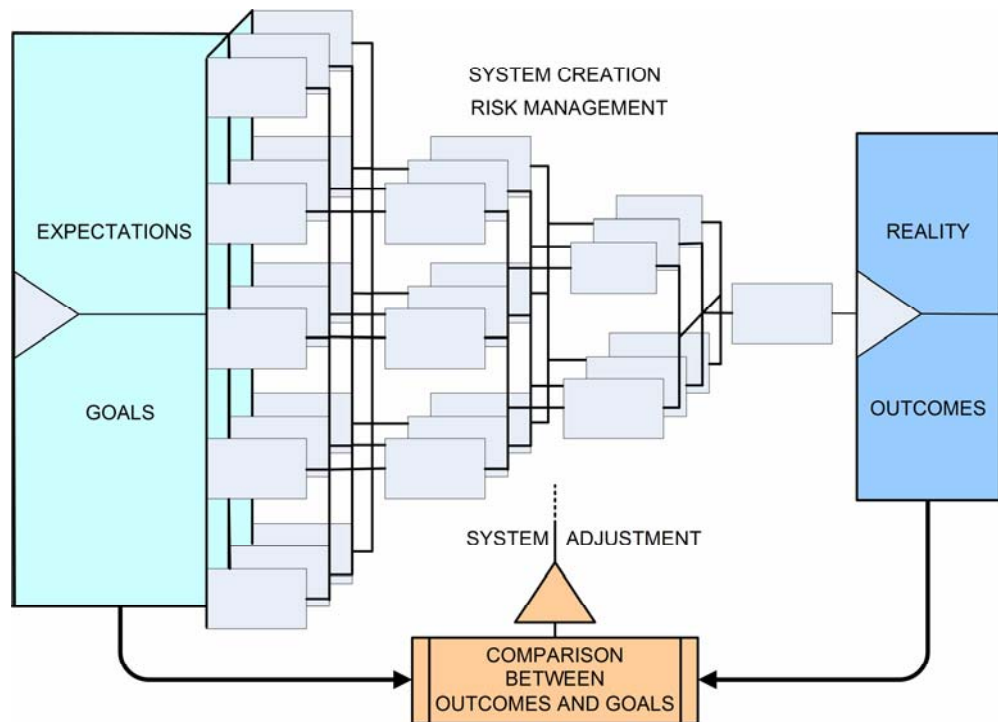
Feedback control loops operate at all levels within a system, the overall system, subsystems and system elements. The linkages between the system goal comparison function and the system adjustment function are information linkages. Feedback is a necessary, widely called for, process in transport systems to ensure continued safe operation.

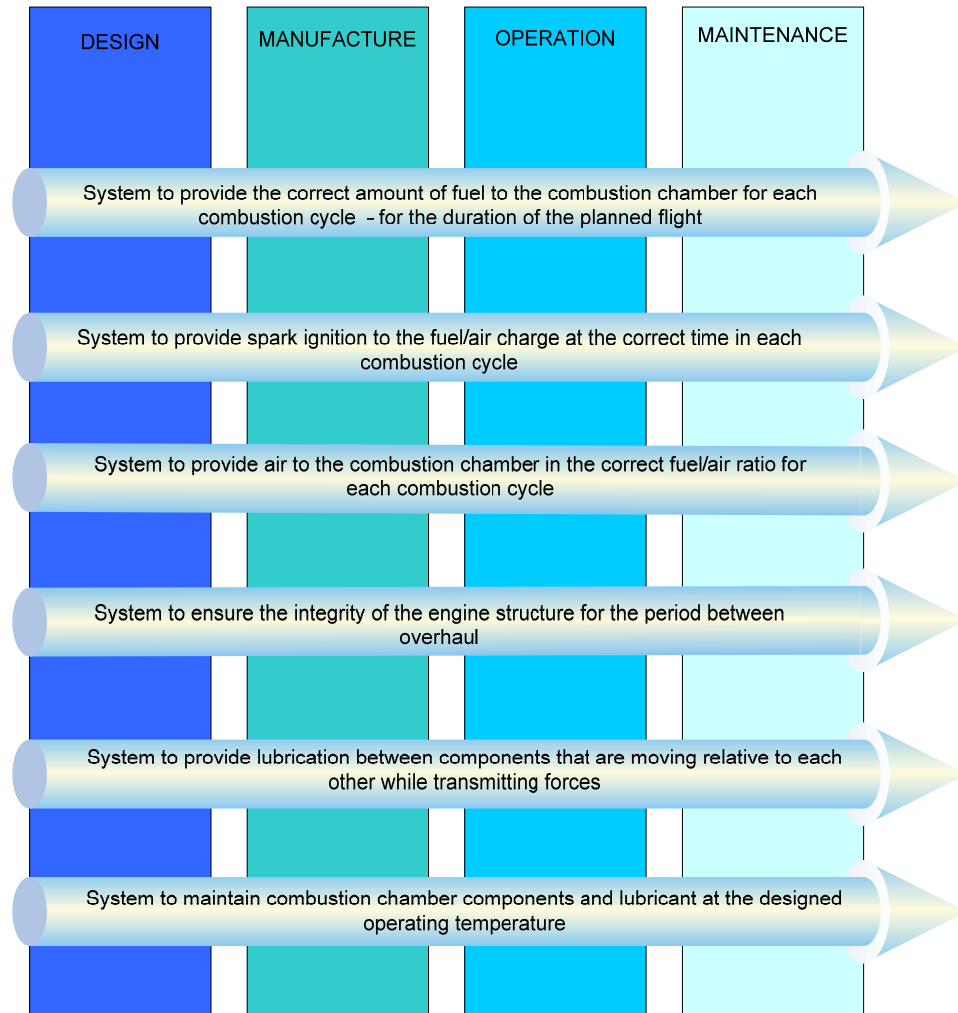
The confidence that an aircraft engine will perform reliably and that risks are managed is established by a certification process. The engine design, along with approved instructions for operating limits, lubrication, inspection, component replacement, and testing and adjustment, must pass an extensive testing program.

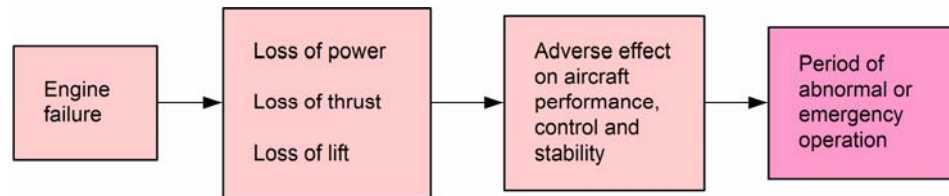
There are two possible defences for the hazard created by engine failure:

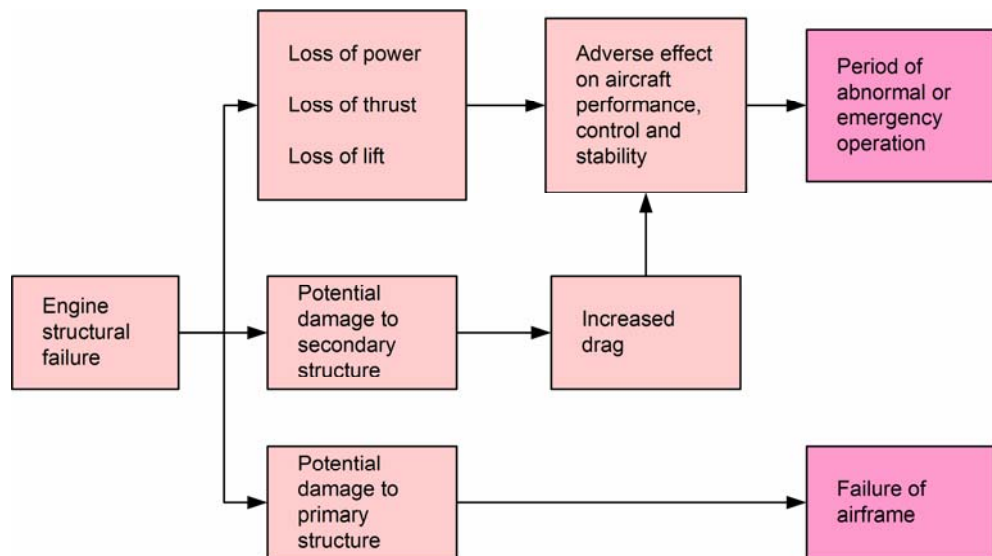
The creation of drag through engine failure is the most critical factor influencing the performance of 8 to 10 seat twin reciprocating-engine air transport aircraft.

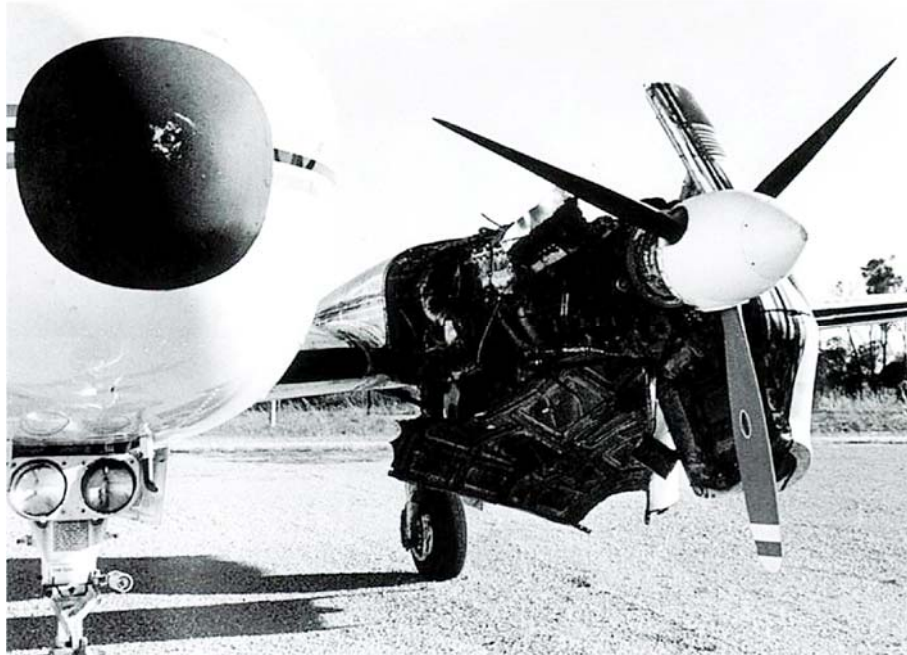
Examples of accidents and forced landings resulting from the disruption of engine cowlings are present in the literature.

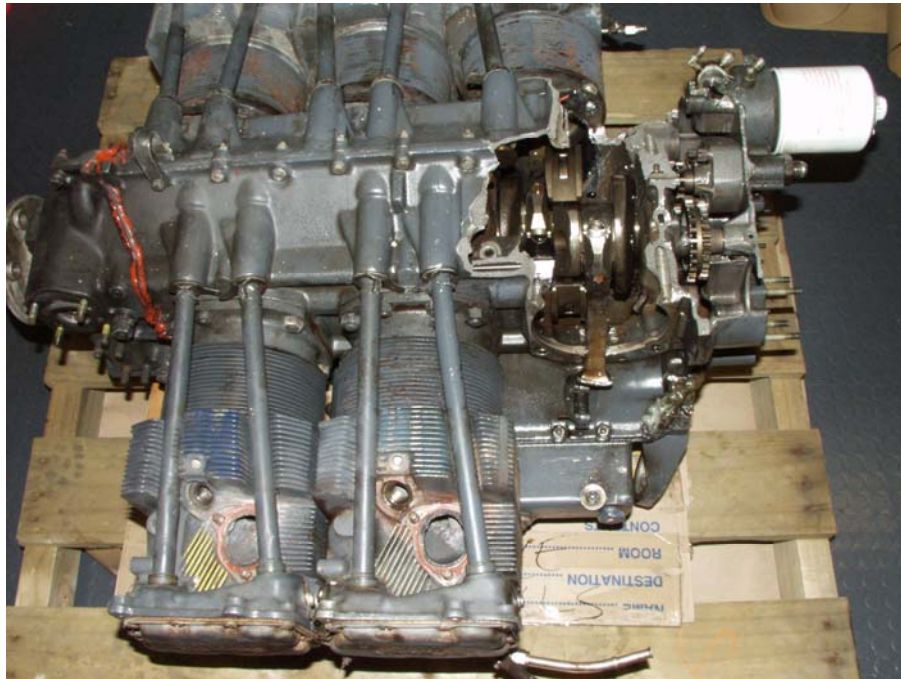
### 3.5 Reliability measurement

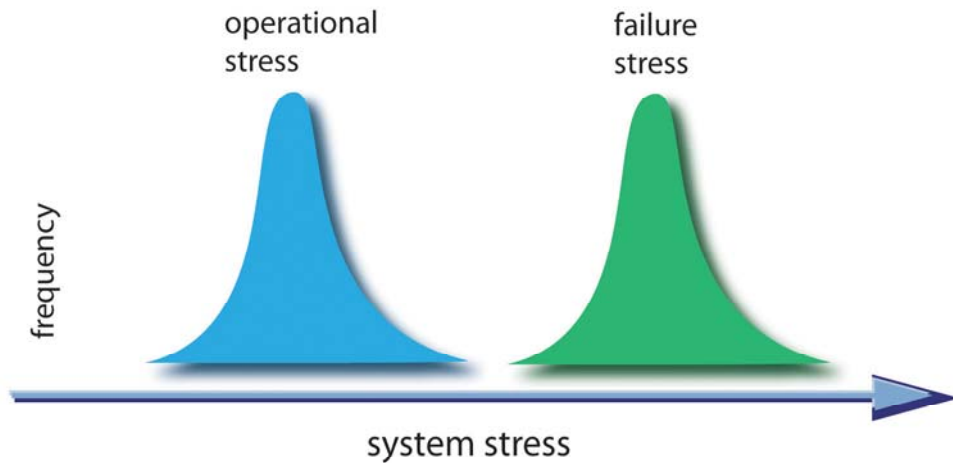
If the distributions of operational stress and failure stress do not overlap, the probability of failure is zero.

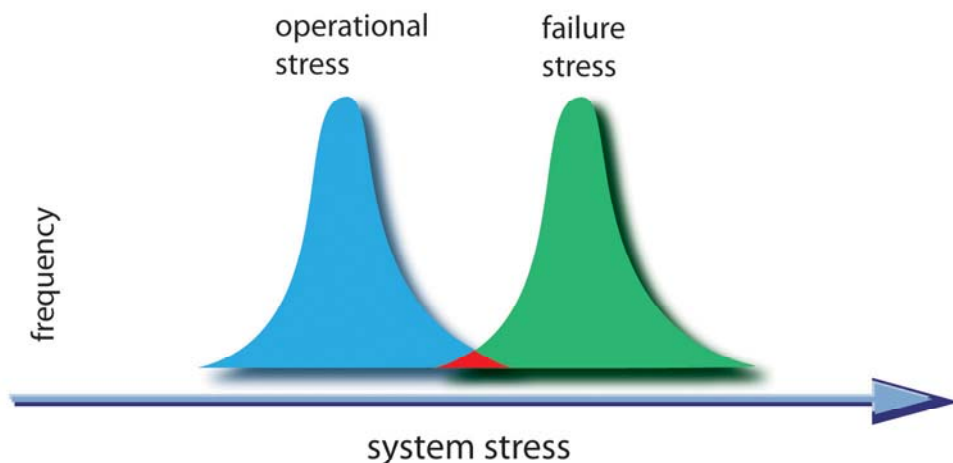
The area of overlap (coloured red) represents the probability of system failure.

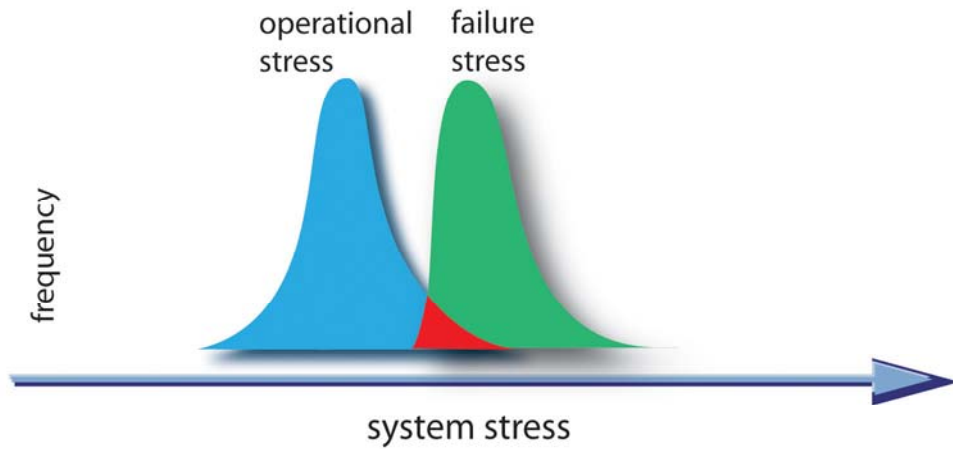
Changes in the nature of distributions, for example, skewing the distribution toward the lower end of the failure stress distribution, will increase the probability of failure – everything else being equal. Similarly, skewing the operational stress distribution toward the higher end of the distribution will also increase the probability of failure.

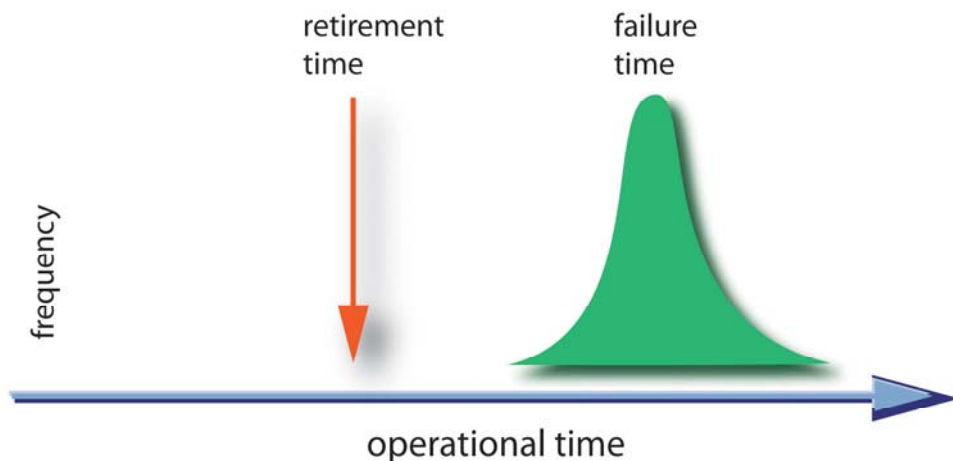
**Figure 4.5: The relationship between retirement time and failure time that results in a number of component failures**

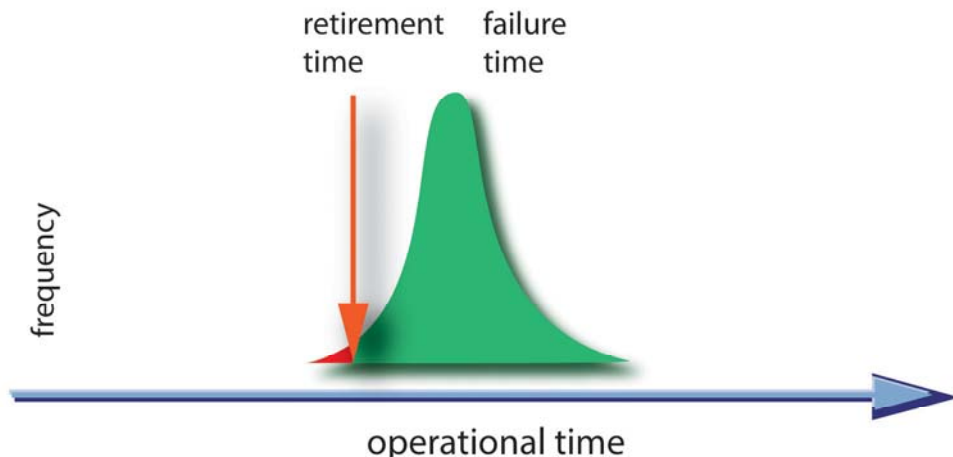
## 4.4 Powertrain component failure control plans<sup>1</sup>

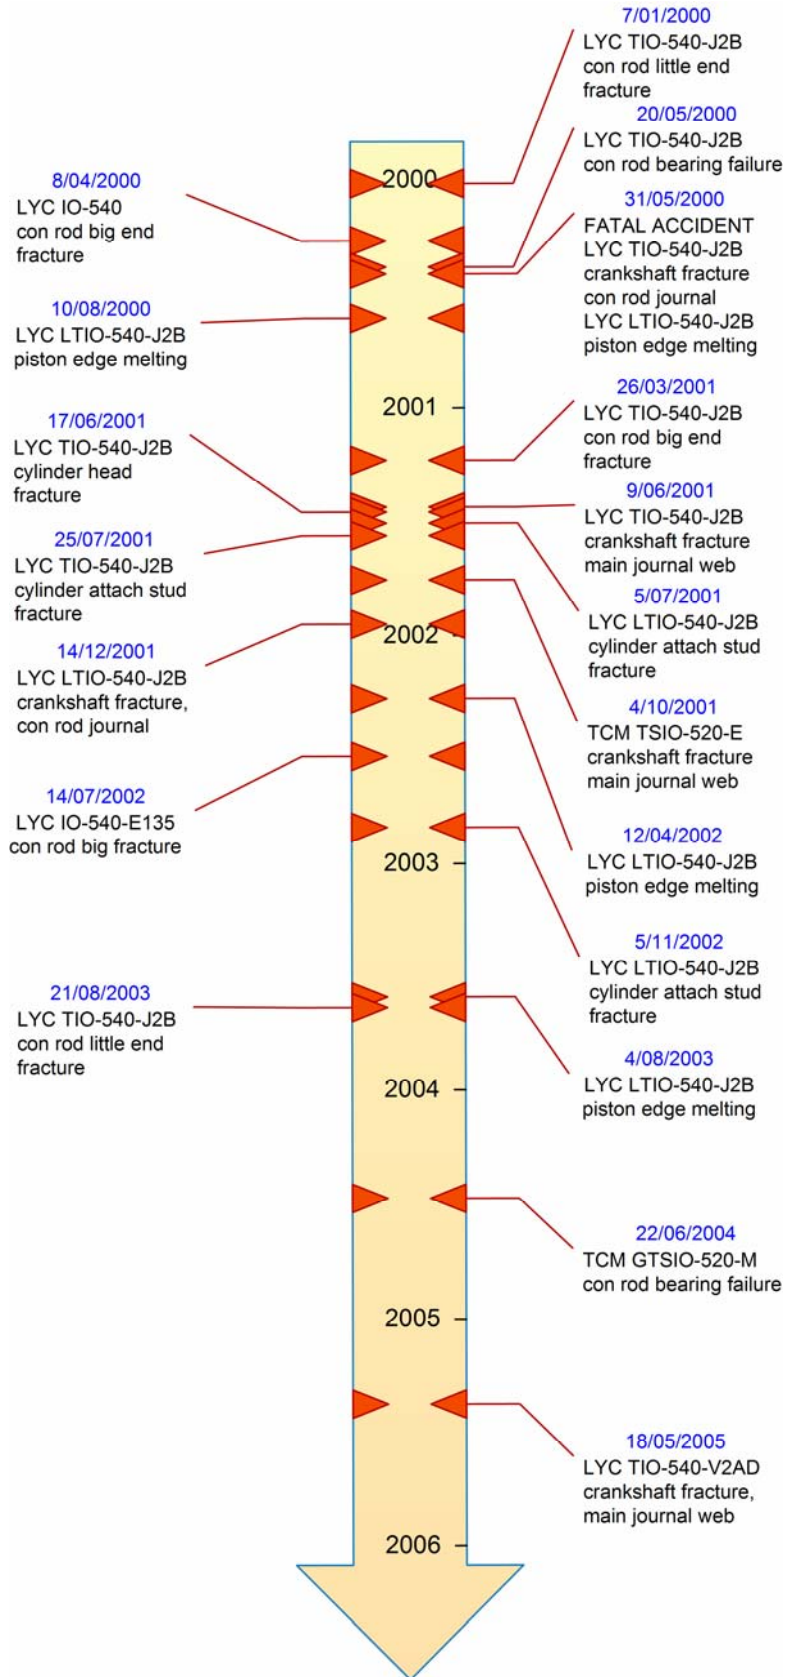
## 6.2 Combustion chamber assembly failures

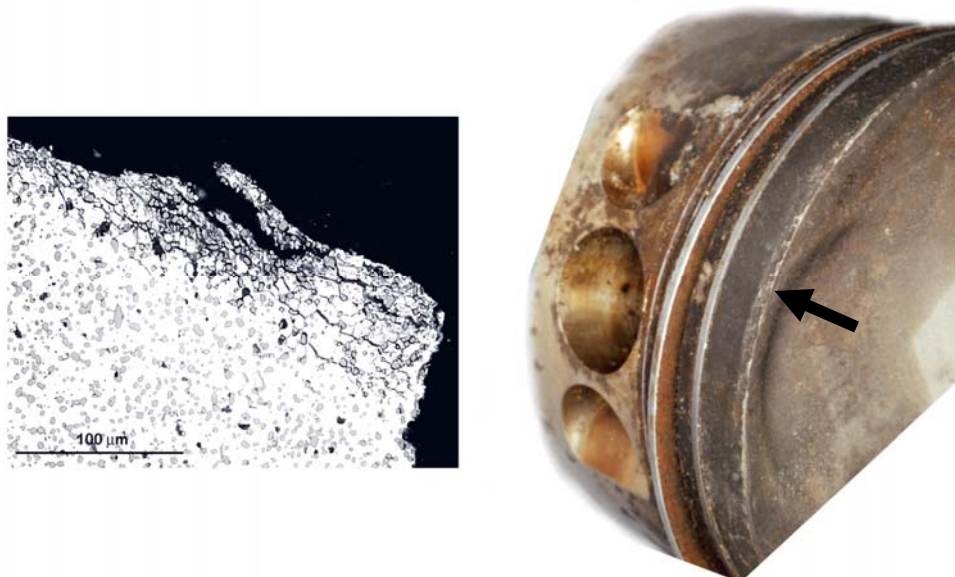
The metallographic section is oriented with the piston crown to the right and the piston side to the top. The microstructural features indicate that material is breaking away from the piston edge as a result of extensive softening of the edge and the forces developed during engine operation.

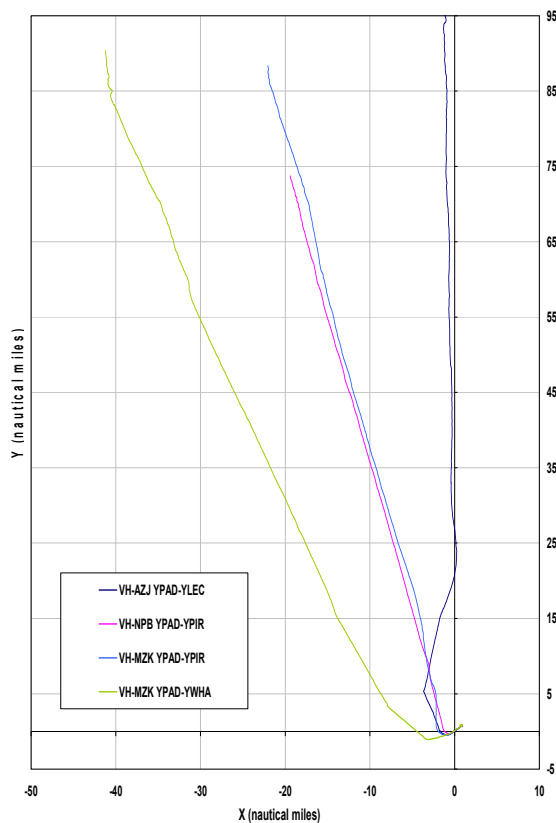
A detailed examination of the parameters of altitude, ground speed and heading for the accident flight (MZK) indicated that the initial section of the cruise phase of flight was normal. However, it is evident that, 17 minutes after top-of-climb, there was a short-term deviation in heading (approximately two minutes) accompanied by a sustained drop in ground speed. The event responsible for the deviation in heading and reduction in ground speed may have been the sudden failure of one engine. It is important to note that the deviation in heading does not represent the direction of aircraft yaw that would be expected to accompany a sudden engine failure in a twin-engine aircraft. The deviation in heading may be a consequence of a control response to an engine failure, and may be an under or over correction.

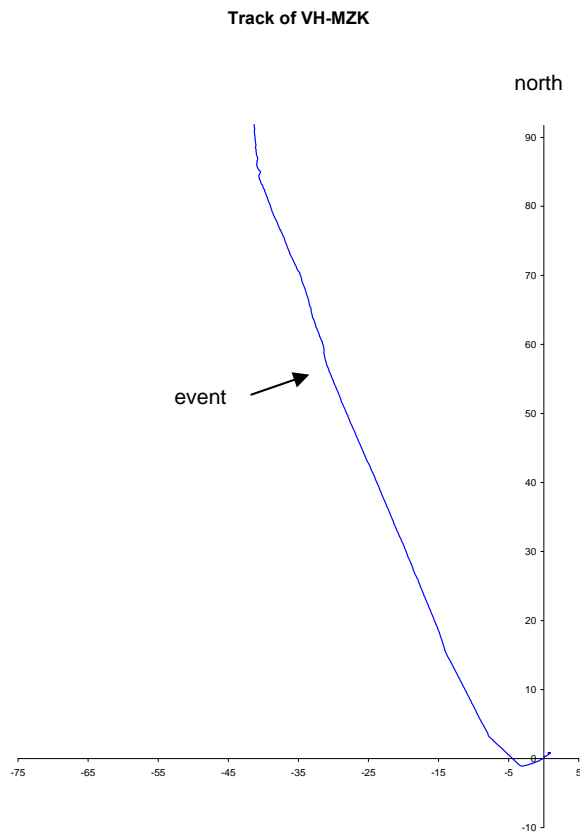
Fourteen minutes after the event that resulted in a deviation in heading and a reduction in groundspeed, the pilot made a Mayday transmission – ‘both engines failed’.

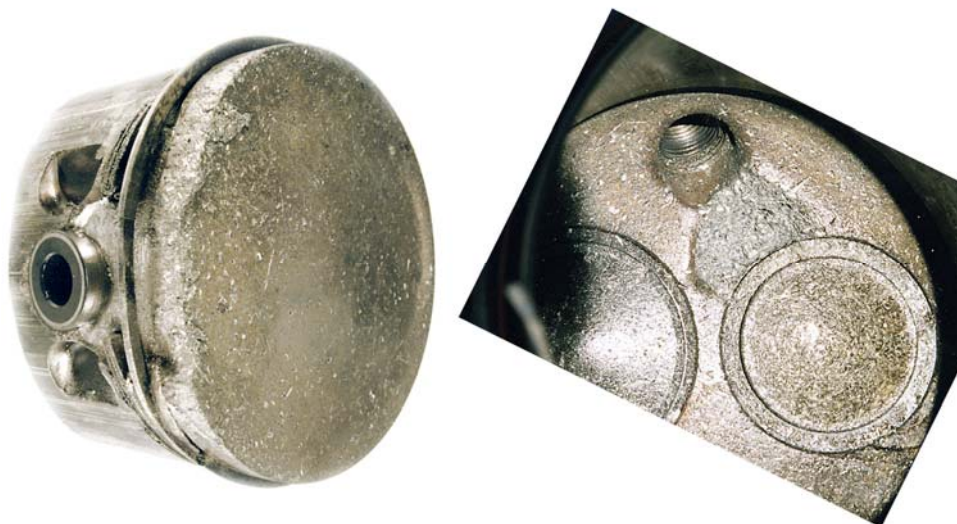
During an inspection of the remaining components of the engine, the presence of cracking in the No.4 main bearing journal fillet radius of the crankshaft was discovered. The cracking comprised of a series of short cracks, oriented parallel with the journal axis, in the fillet between the journal and the No.4 main/No.5 connecting rod web, see figure 6.10. Cracking of this nature occurs as a result of sliding contact between the main bearing inserts and the journal fillet radius, following the displacement of the inserts from their normal position in the main bearing housing during engine operation.

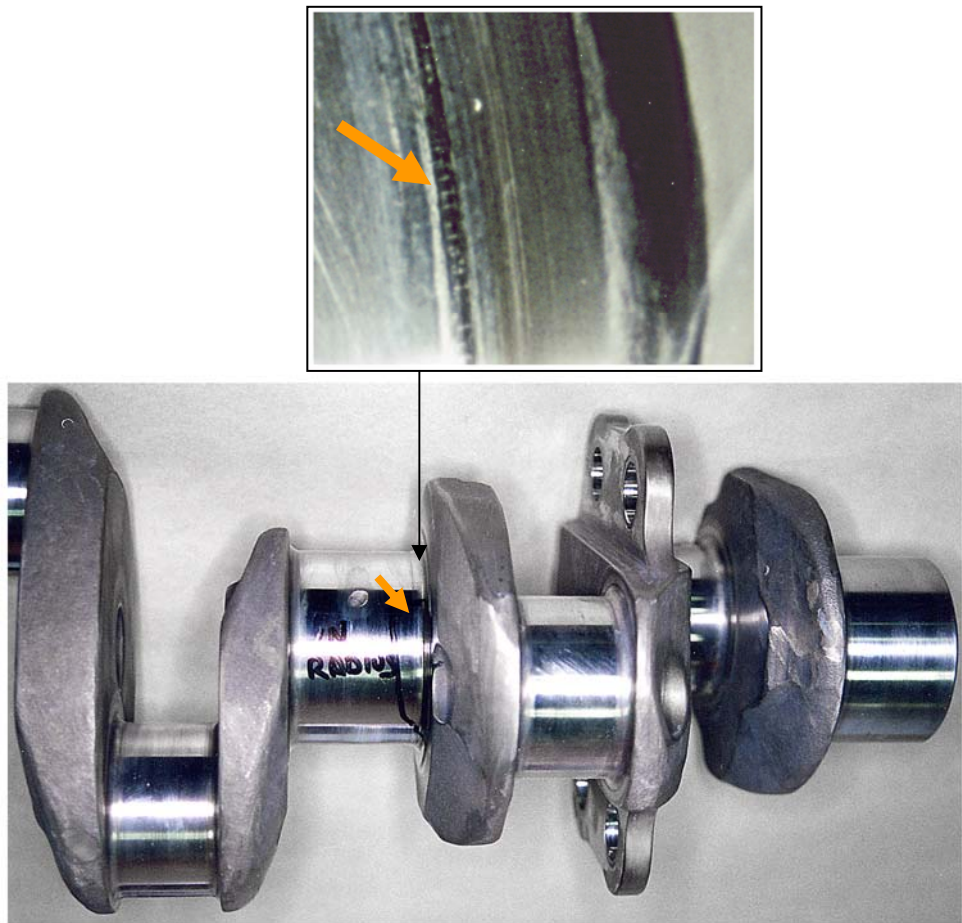
The location of cracking is arrowed. The nature of cracking is shown in the inset.

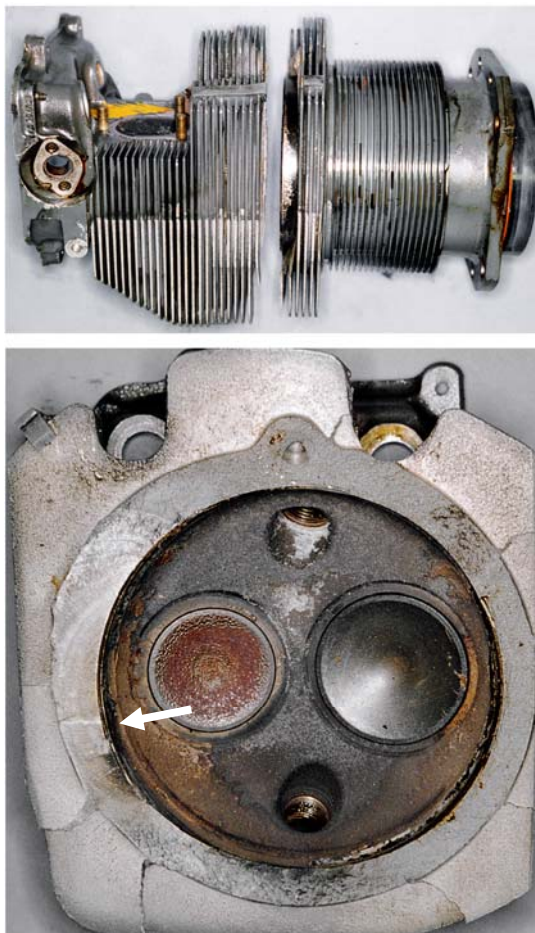
## 6.2.4 Occurrence 2001/3357 VH-RNG

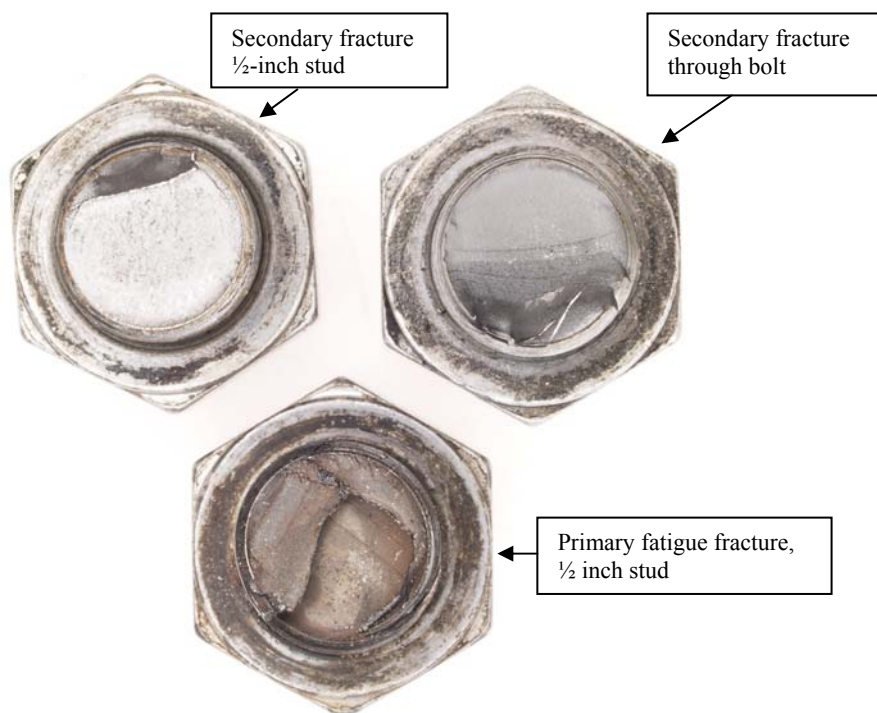
The remaining ½-inch stud and, one of the two ½-inch through bolts, fractured as a result of fatigue crack growth and fastener load redistribution following the initial ½-inch stud fracture. The smaller, ⅜-inch, studs fractured as a result of fastener load redistribution, figure 6.13. The second through-bolt remained intact.

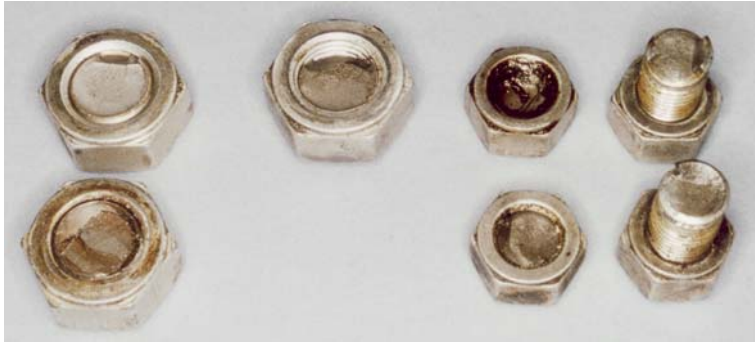
## 6.2.5 Occurrence 2001/3251 VH-FIA

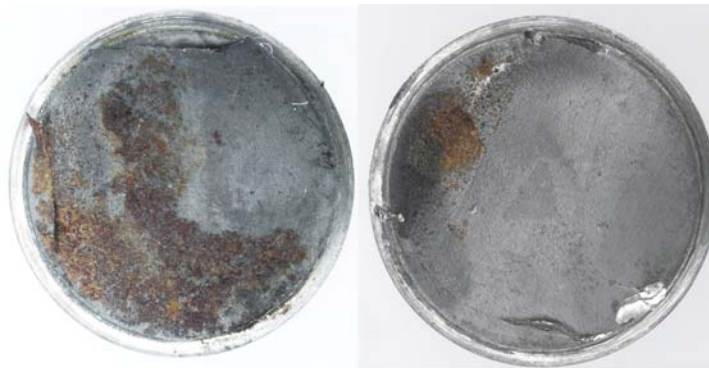
**Figure 6.15:** The four fractured  $\frac{3}{8}$  inch studs

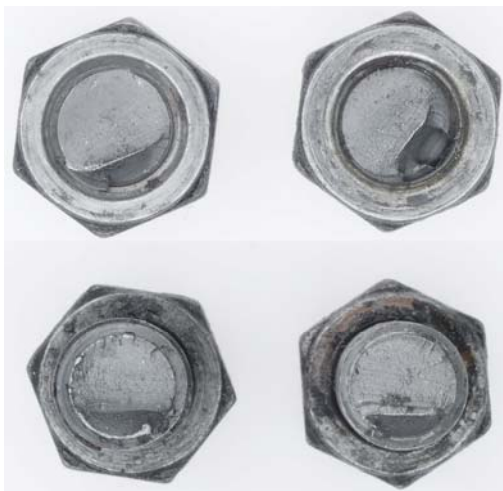
## 6.2.6 Occurrence 2002/2059 VH-LTW

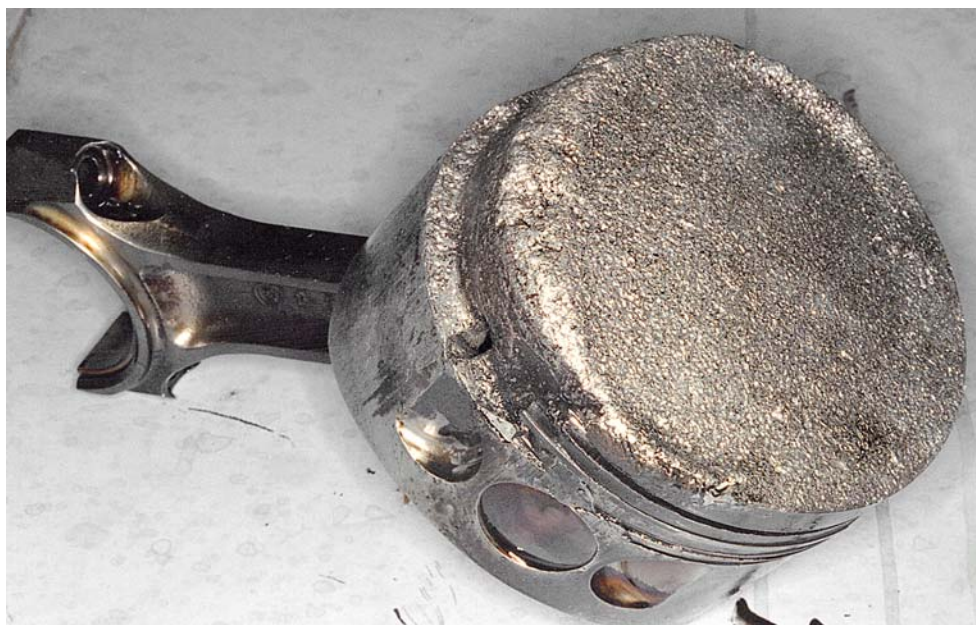
**Figure 6.17:** The No.3 piston and cylinder head showing the extent of damage created by the fragmented piston rings

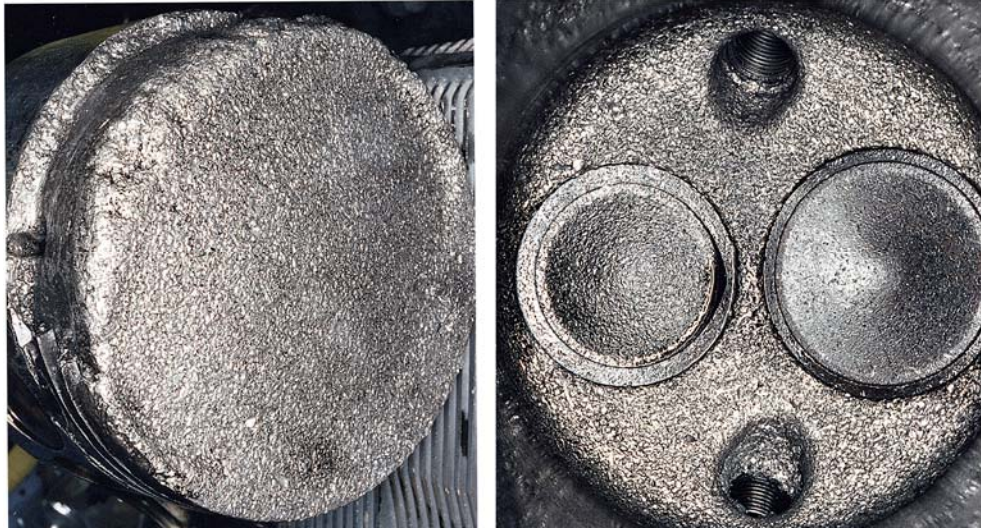
## 6.2.7 Occurrence 2002/5129 VH-TZY

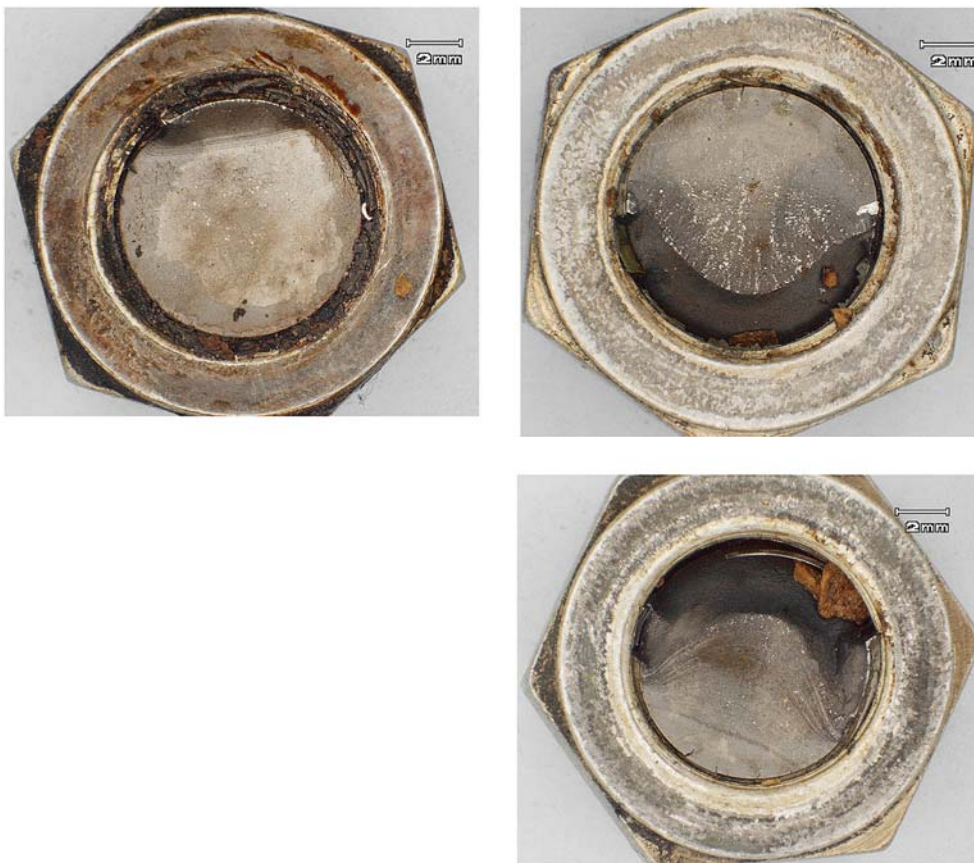
## 6.2.8 Occurrence 2003/3532 VH-HJS

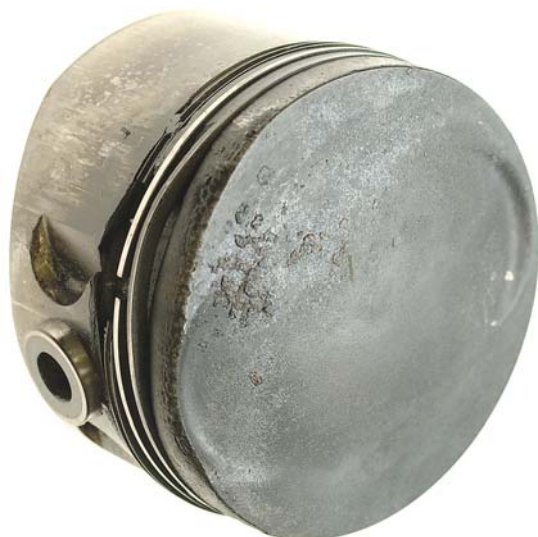
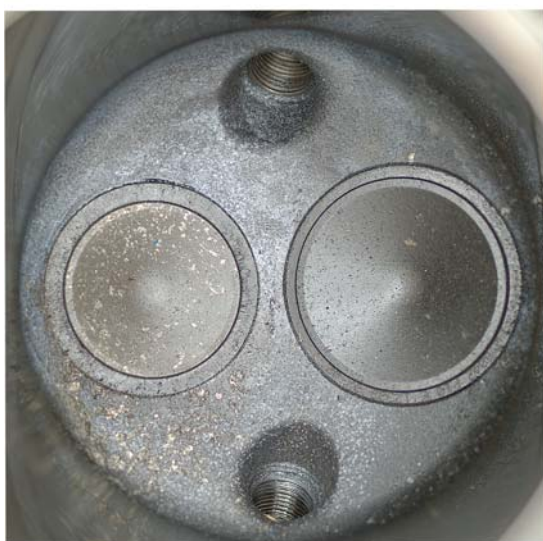
## 6.3 Connecting rod assembly failures

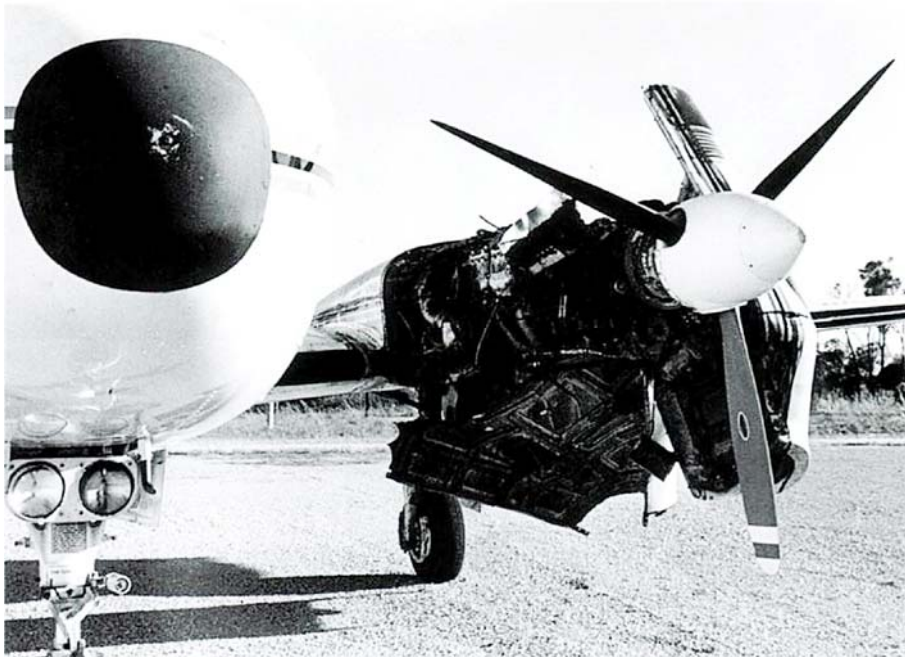
#### *Physical evidence*

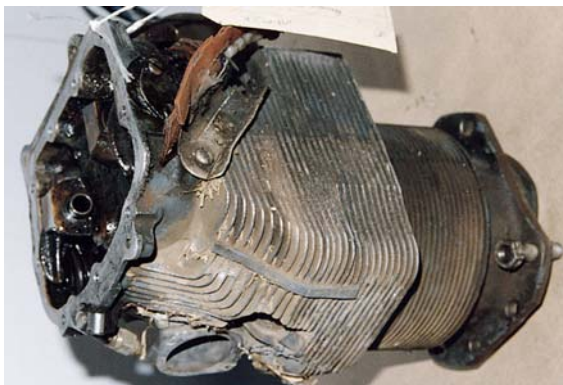
**Figure 6.22: The No.1 connecting rod showing the fractured little-end housing**

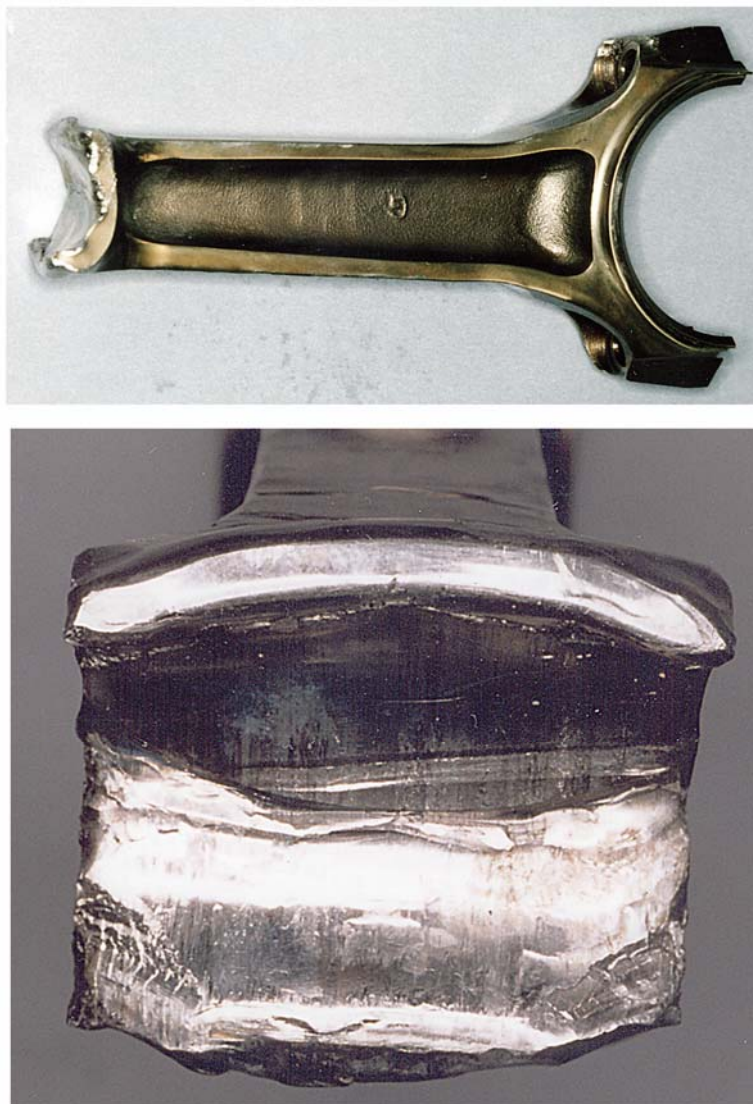
While the remnant of the little-end housing had been damaged extensively and the rest of the housing was lost during the engine failure, it is evident that the nature of the failure is consistent with the development of fatigue in the housing.

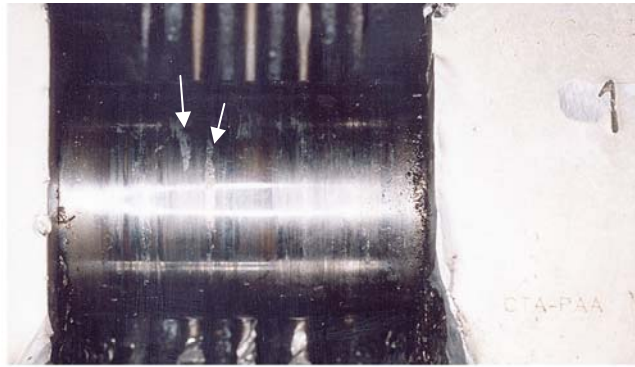
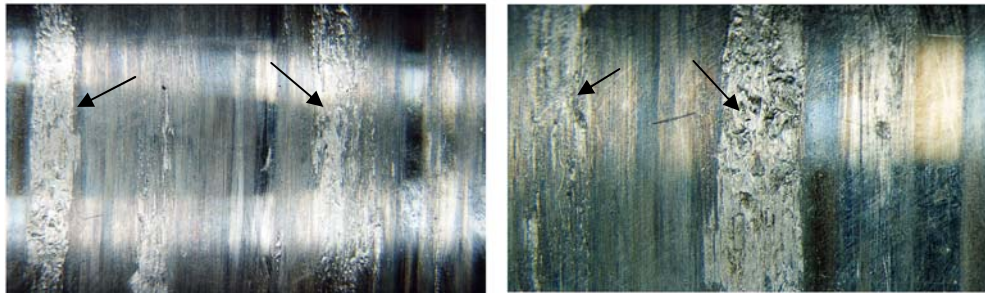
An overview of piston pin wear, with the piston in situ in the No.1 piston, is shown at the top of the figure. Detailed views of two regions of galling are shown at the bottom of the figure.

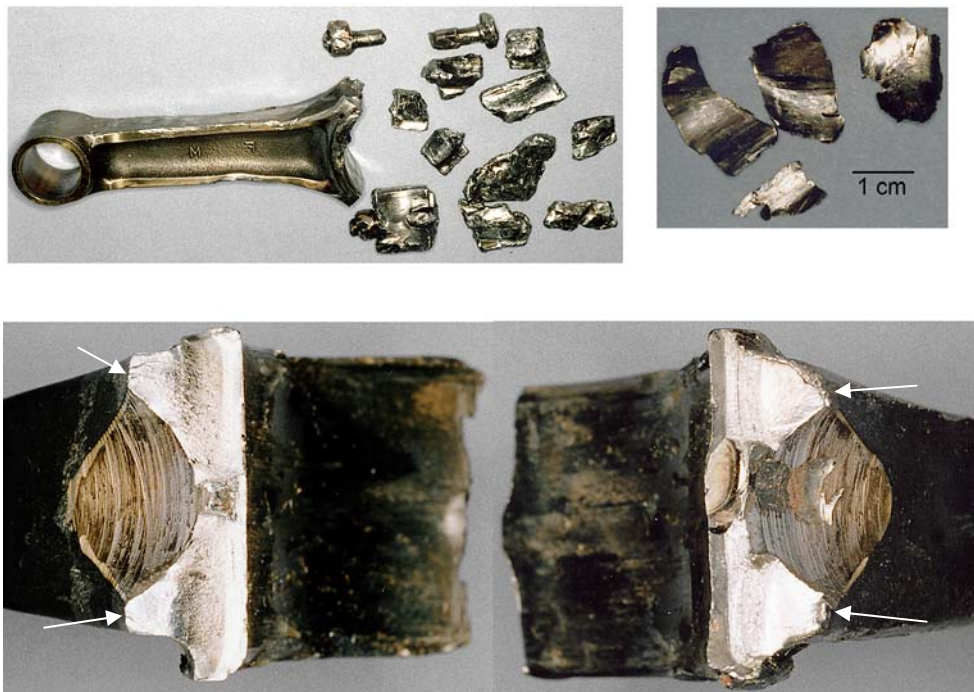
The recovered fragments of the big housing (top left), some of the larger fragments of the bearing inserts (top right), detailed view of both housing fractures at the transition to the rod 'I' beam (bottom). The sites of fatigue initiation are arrowed.

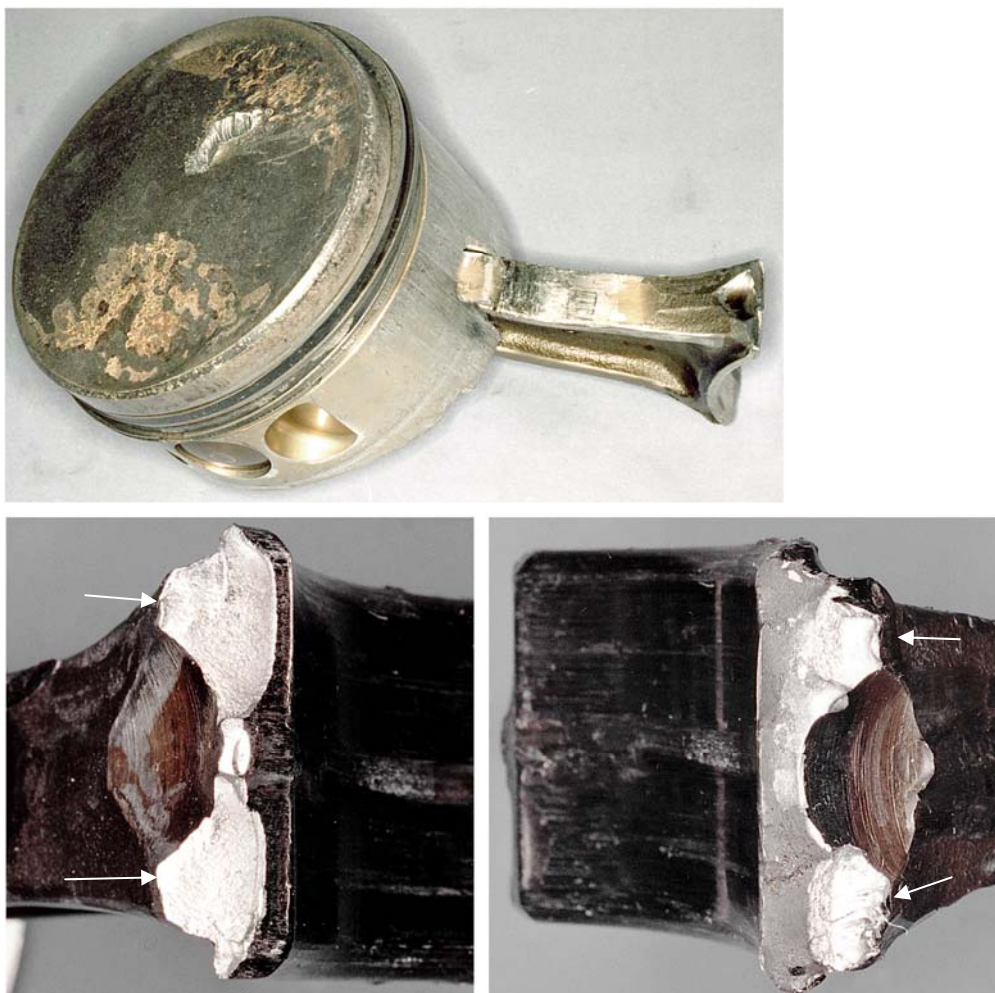
Detailed views of both fractures in the big-end housing, at the transition between the housing and rod 'I' section (bottom). The sites of fatigue crack initiation are arrowed.

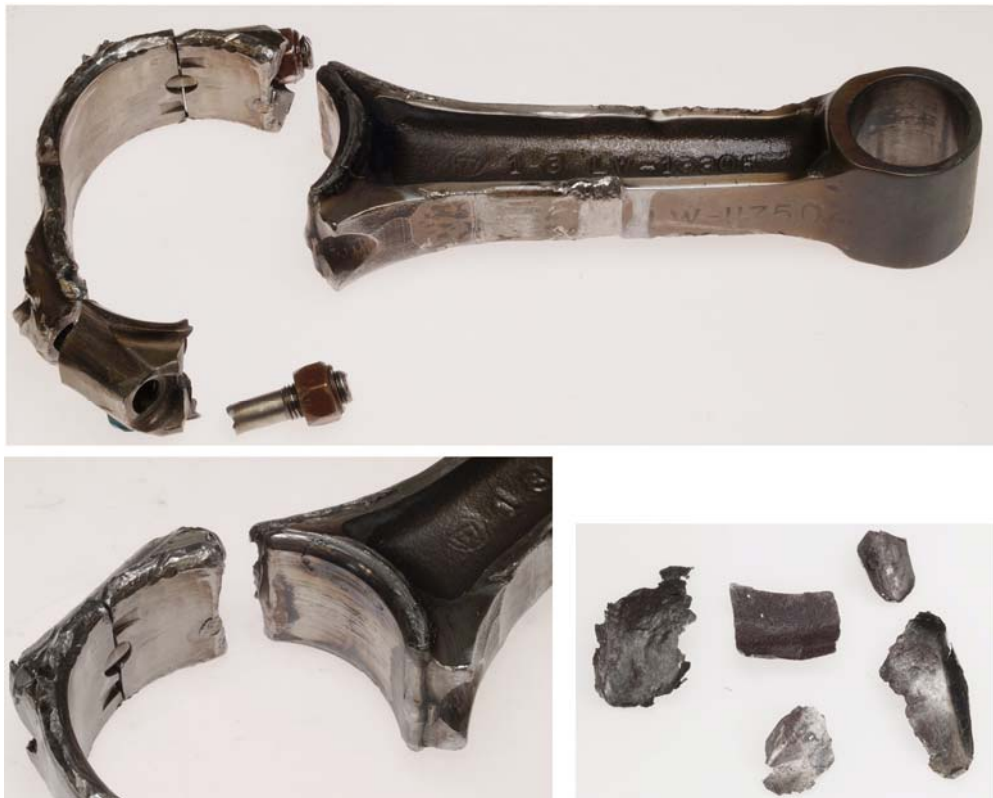
Some of the larger fragments of bearing inserts recovered from the debris in the engine sump are shown (bottom right).

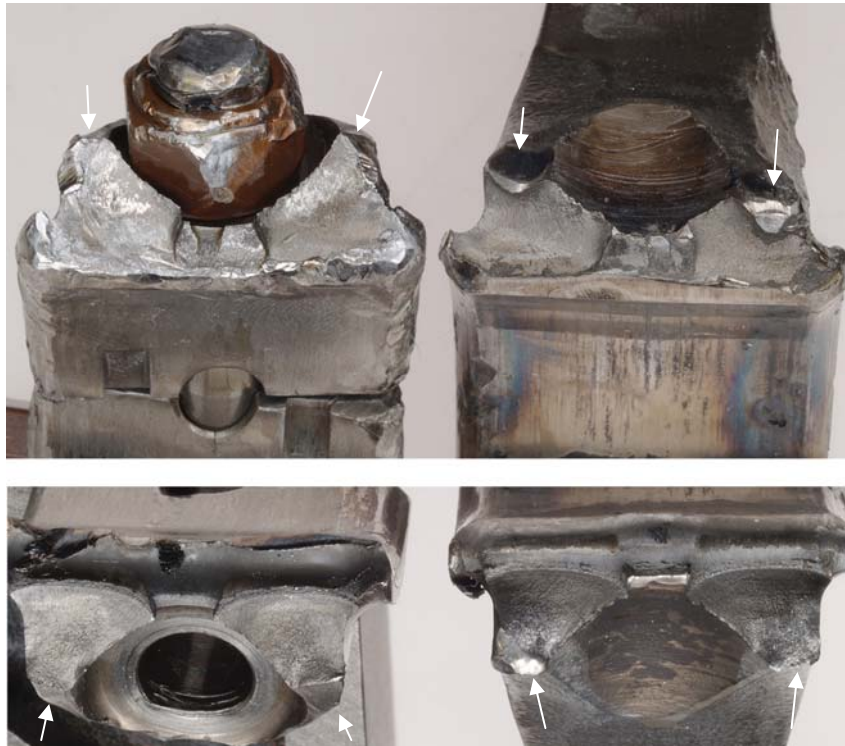
It is evident that the initial fracture of the big-end housing occurred as a result of fatigue crack growth from the outer surface to the inner surface of the housing. The sites of fatigue crack initiation are associated with the regions of reduced cross-section created by the counterbore at the transition between the housing and the connecting rod 'I' beam.

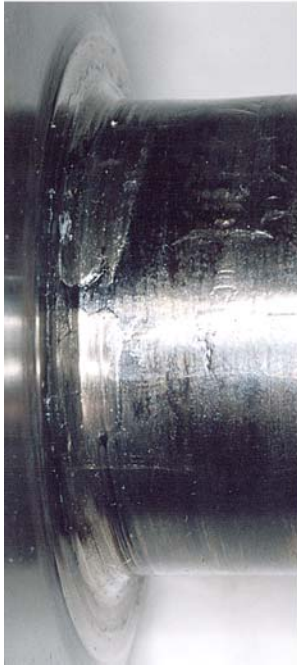
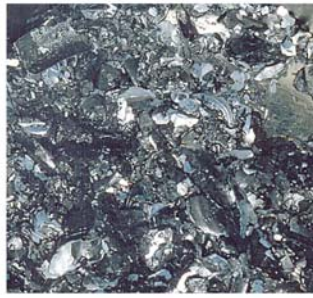
### 6.3.6 Occurrence 200303701 VH-OCF
