Australian Government  
Australian Transport Safety Bureau

ATSB TRANSPORT SAFETY INVESTIGATION REPORT  
Aviation Research and Analysis Report – B20070191  
Final

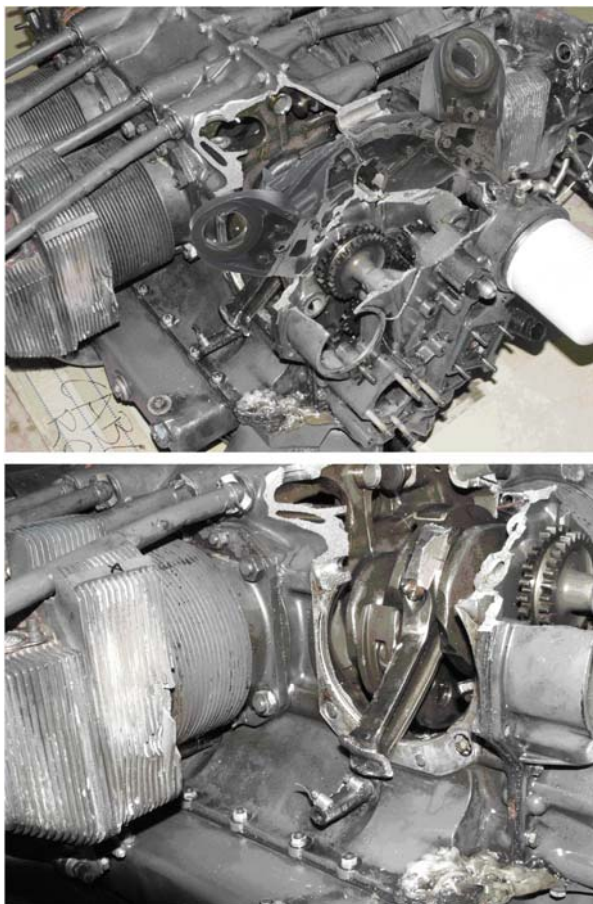
**Figure 6.30: The fractured little-end housing of the No.6 connecting rod**

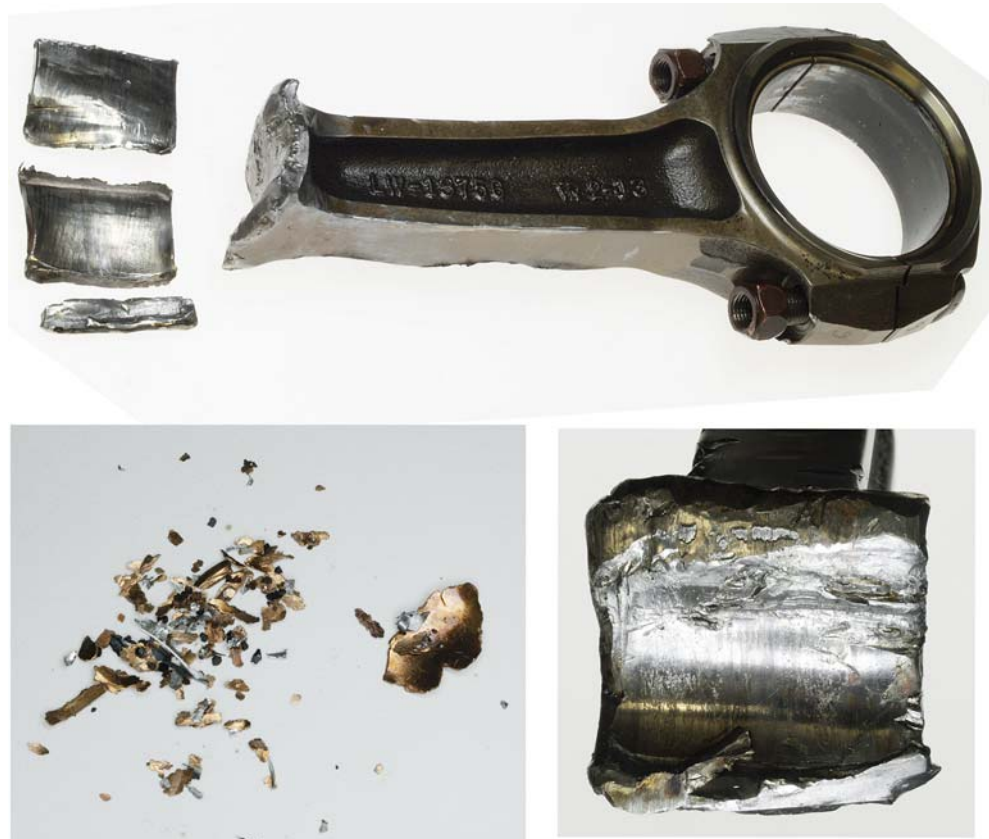
A sample of debris from the little-end bearing, recovered from the sump and filters is shown bottom left.

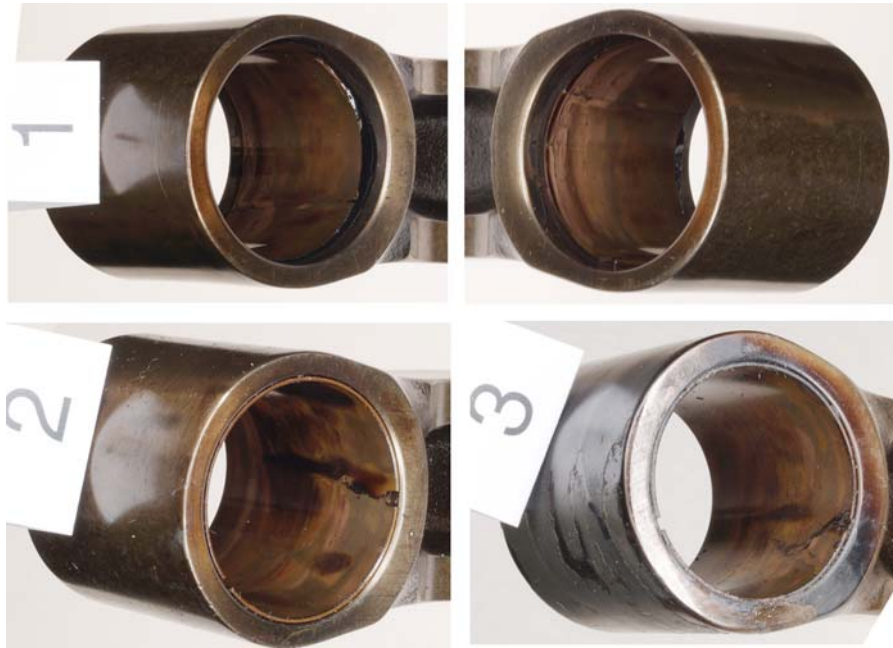
Cracking and edge breakaway is evident at both ends of the No.1 rod little end bearing (top), cracking is evident in the bearings from the No.2 and No.3 connecting rods.

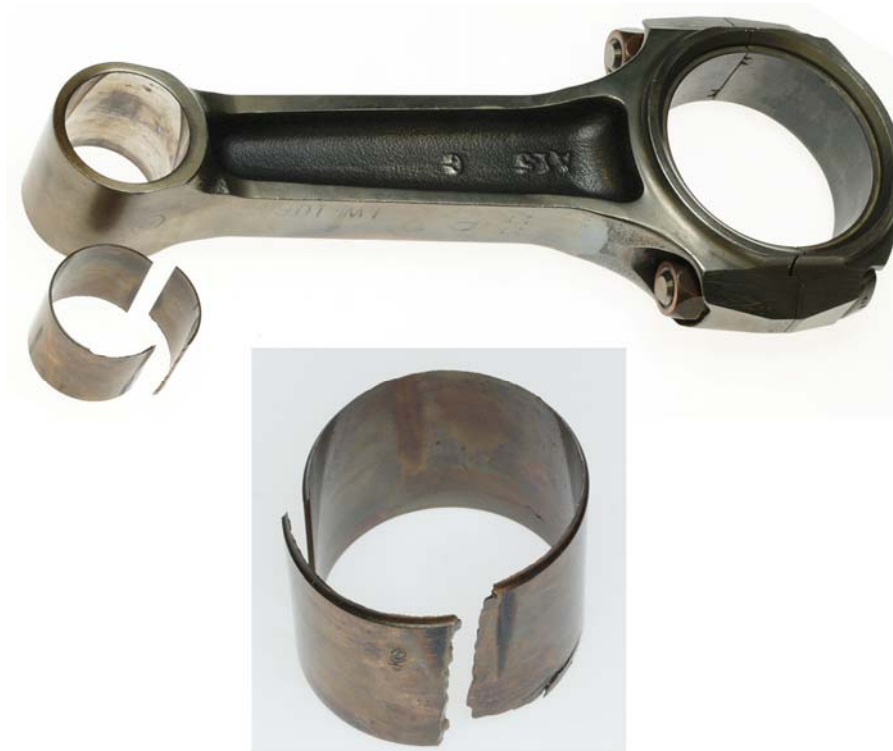
## 6.4 Crankshaft failures

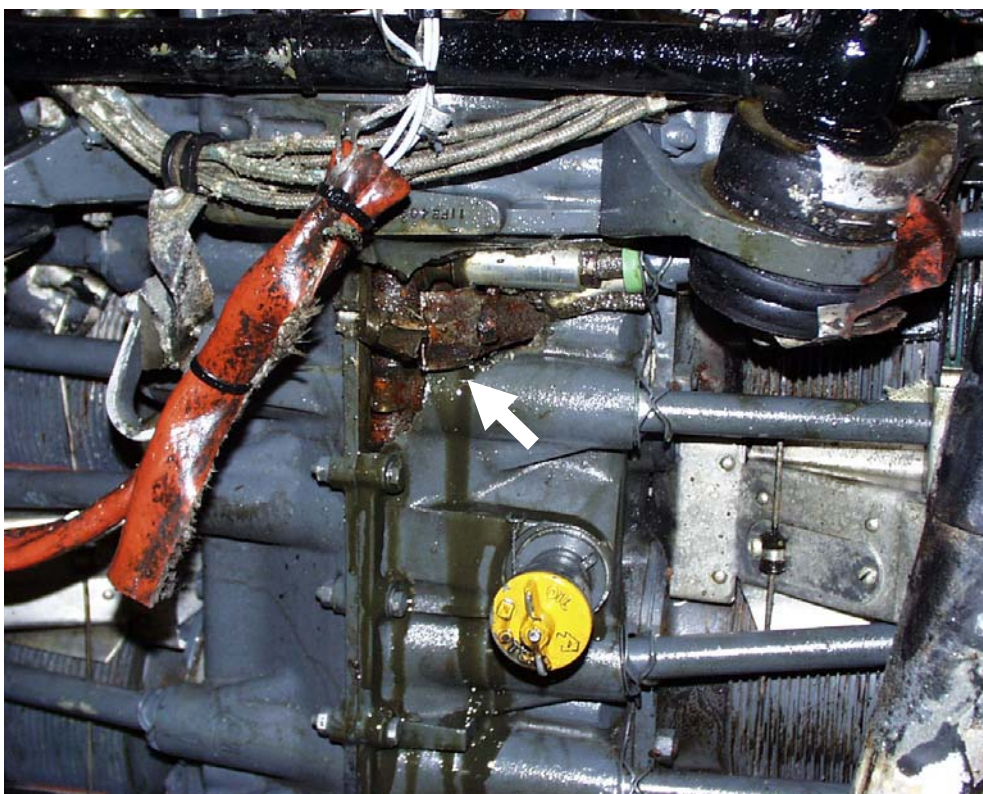
The site of crankcase rupture is arrowed.

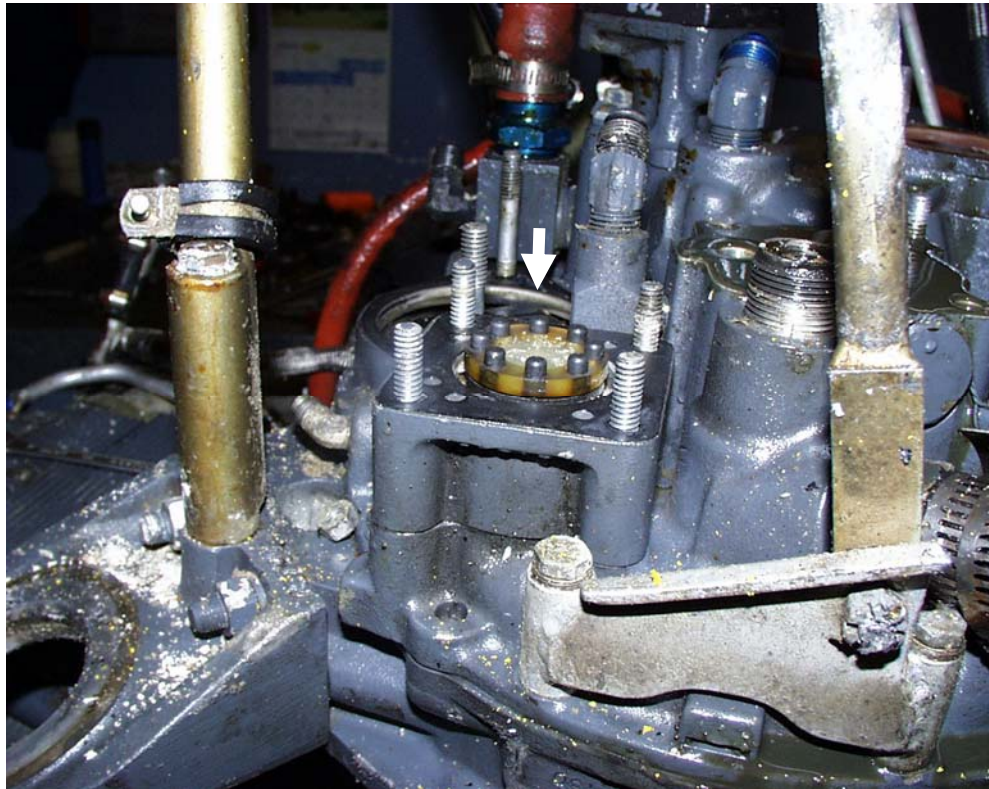
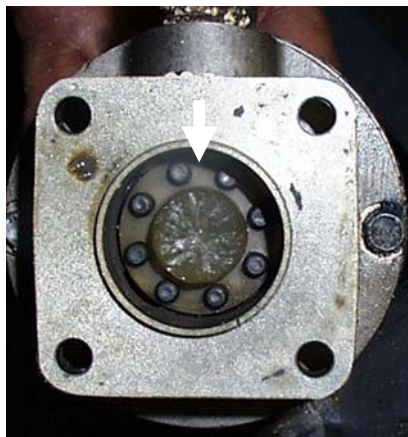
The fractured pneumatic pump drive coupling is arrowed.

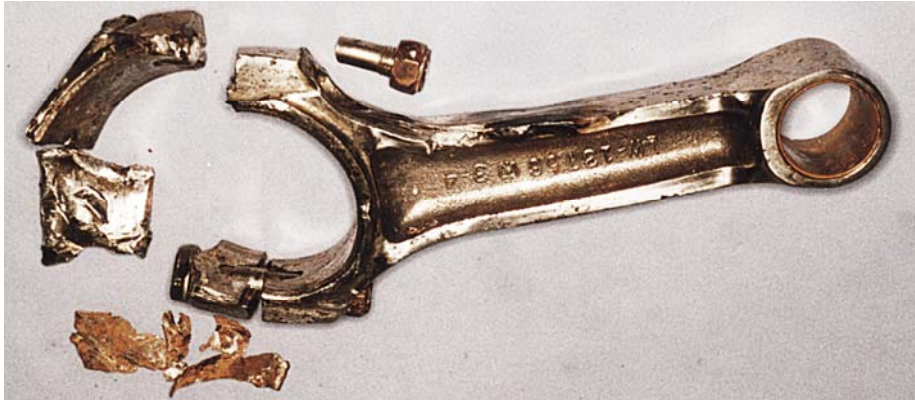
Several fragments of the big end bearing inserts are shown at the bottom of the figure.

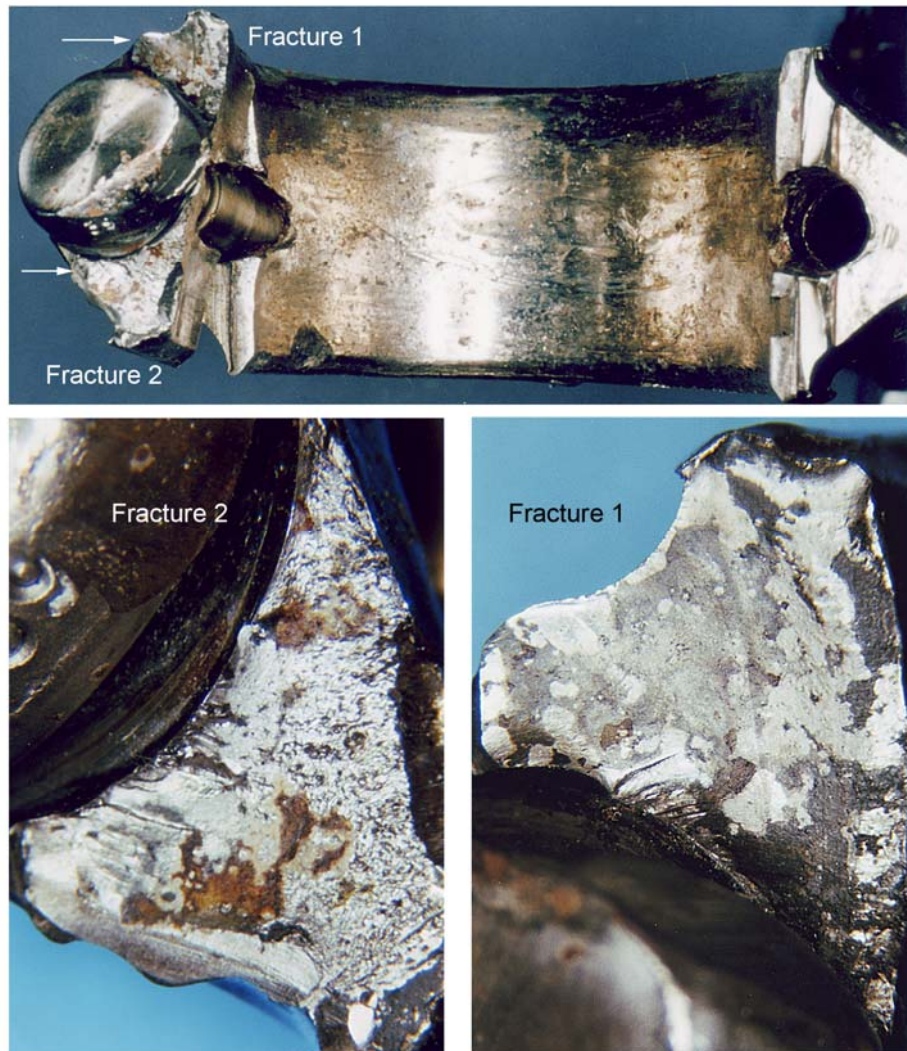
The sites of fatigue crack initiation are arrowed. Fatigue crack growth, in the region identified as 'fracture 1', extended over the full extent of the cross-section.

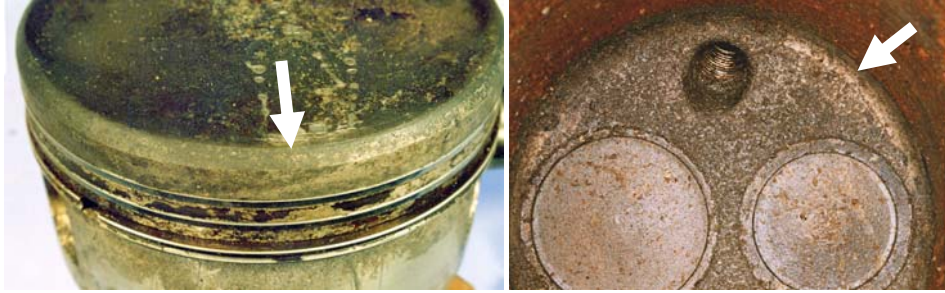
The deformation of the edge of the piston and the region of contact between the piston and cylinder head are arrowed.

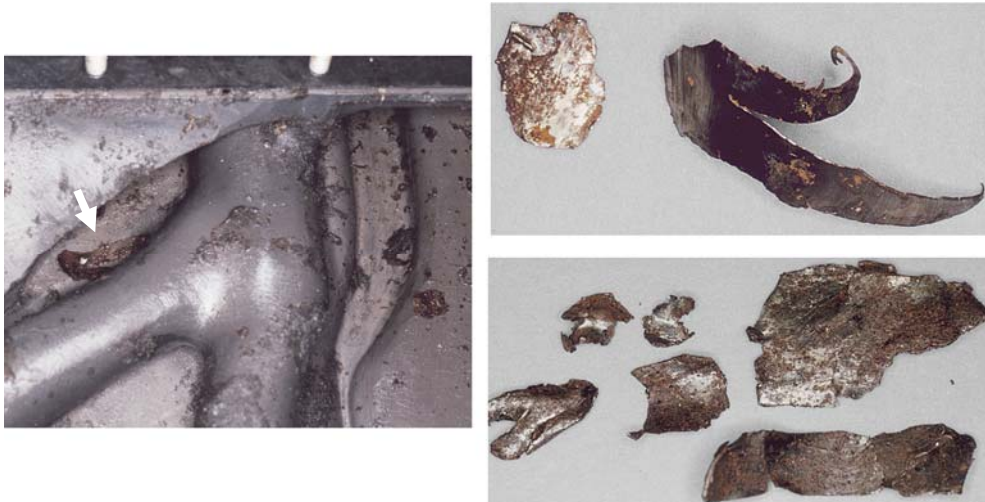
A fragment of the steel backing from the No.6 connecting rod bearing insert remained in the sump, arrowed left.

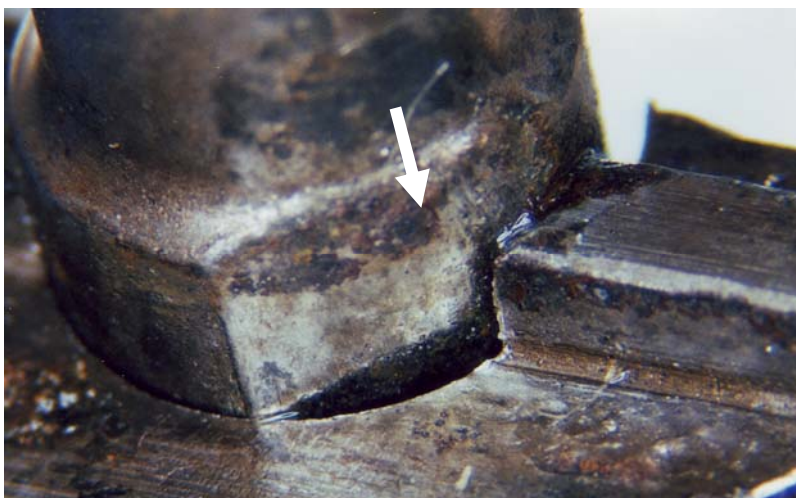
The design of the connecting rods fitted to Lycoming TIO-540-J2B engines is such that the guide section, (the increased diameter at the centre of the bolt), protrudes beyond the housing inner surface into a recess machined in the rear surface of the bearing inserts.

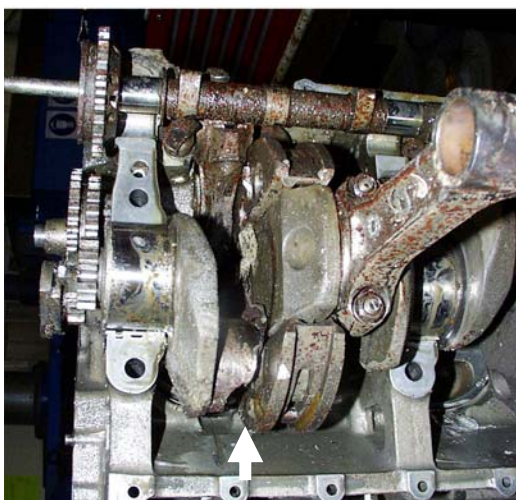
Fracture was caused by fatigue crack initiation and growth. Fatigue cracking initiated at the transition between the journal and the crankweb fillet, figure 6.41. Distinctive fatigue 'progression' marks were present on the fatigue fracture surface. These marks are created by major changes in the alternating loading spectrum. Typically, for engine crankshafts, they are associated with engine start/stop cycles. It was estimated that fatigue crack growth had occurred over a period of at least fifty engine start/stop cycles.

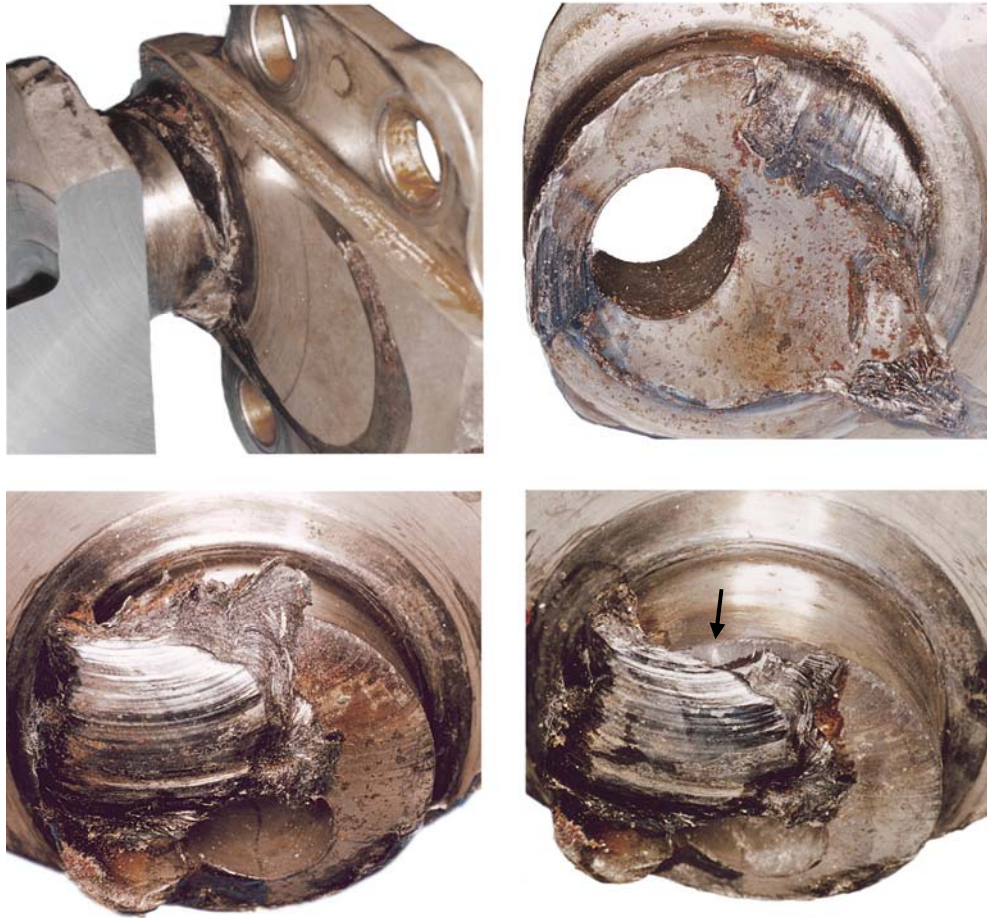
The lower two photographs show the fracture surface of the rear crankshaft section in the 'as received' condition (left) and after some of the deformed material had been broken away to reveal the initiation site of fatigue cracking.

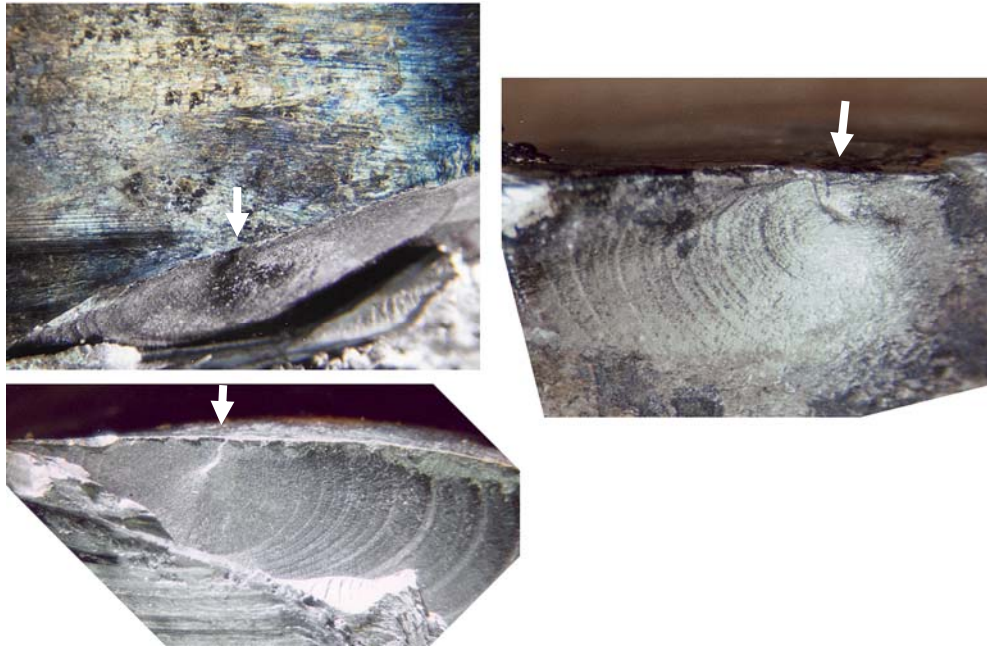
Further evidence, that the engine had continued to operate and the crankshaft had continued to rotate, is provided by the presence of fatigue cracking in the fillet of the No.5 connecting rod journal and the fillet of the No.4 main journal.

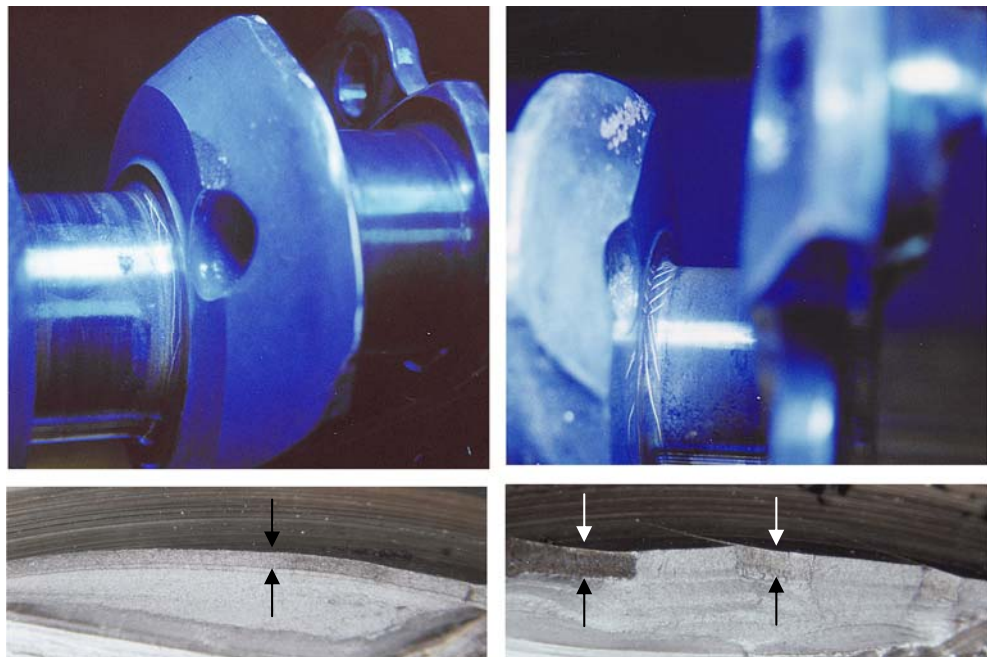
No.4 main journal is shown on the left, No.5 connecting rod journal is shown on the right. Examples of fatigue crack growth extending from the surface of the journals, associated with magnetic particle indications are shown below the photographs of the journals. The extent of fatigue cracking from the journal surface is arrowed.

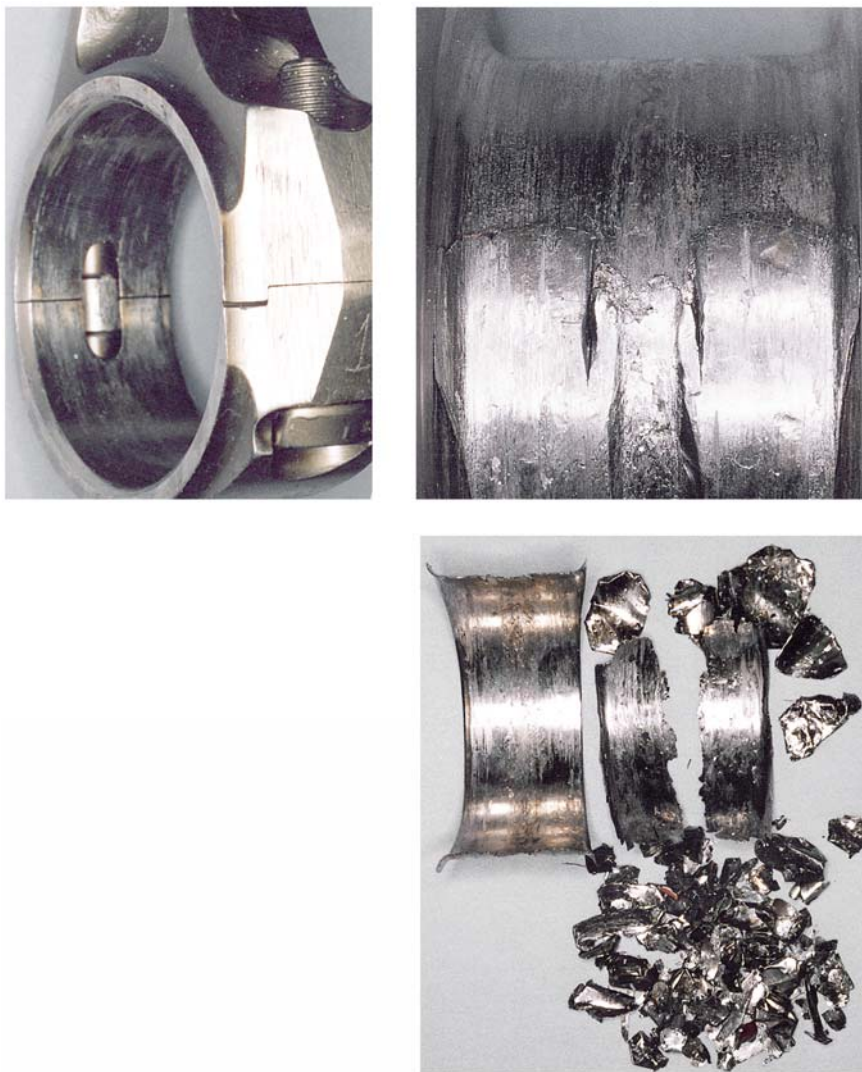
Bearing breakdown was characterised by the separation of the aluminium-tin and lead-tin bearing alloy layers. The steel backing was in various states of destruction:

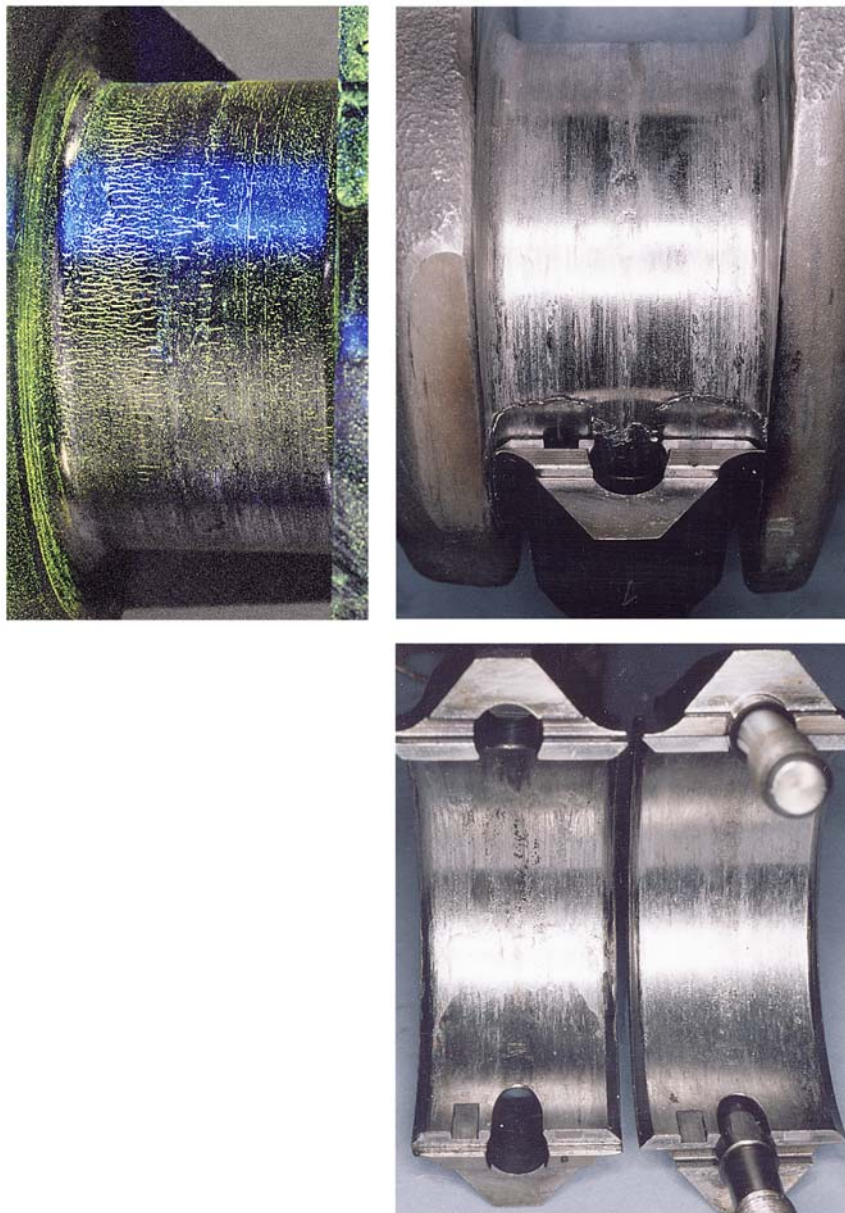
Extensive 'thermal' surface cracking of the journal is evident in the magnetic particle inspection indications (top left).

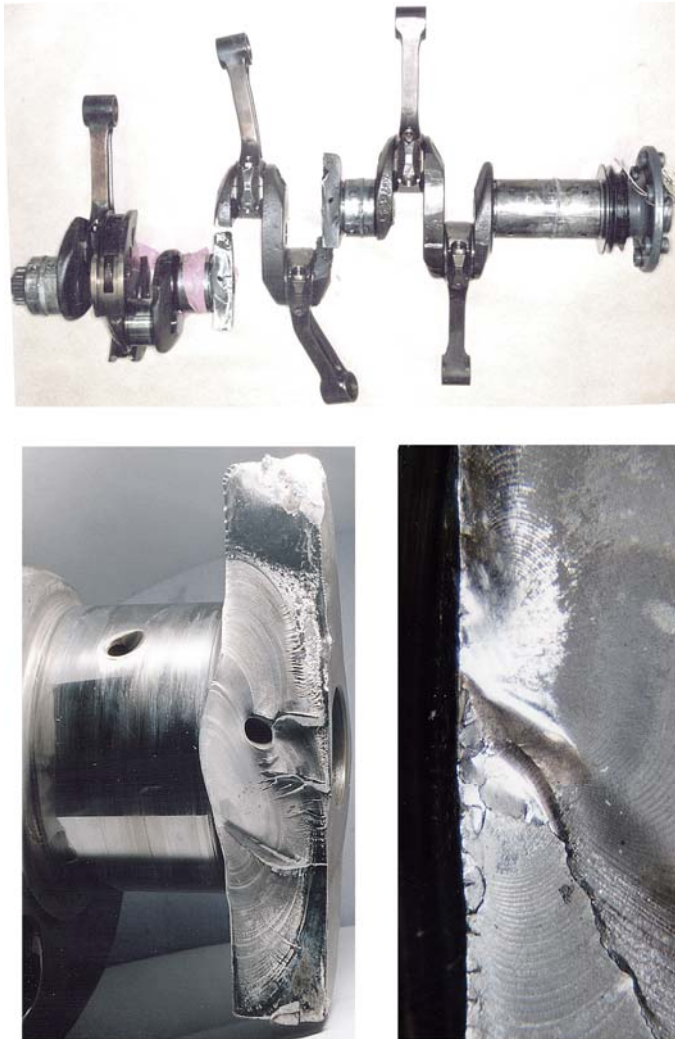
It is evident that fatigue cracking initiated in the crankweb between the No.4 main-bearing journal and the No.4 connecting-rod journal as a result of damage created

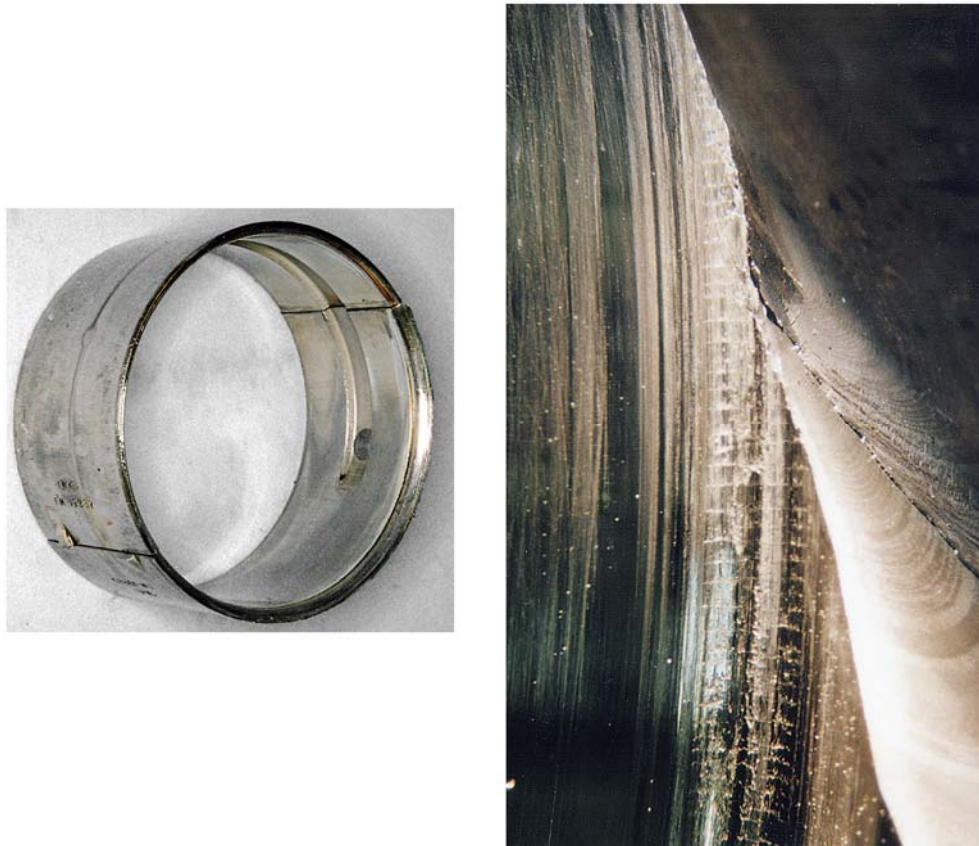
Contact between the rotating crankshaft and bearing inserts created two types of journal damage: circumferential scoring; and a series of short cracks created by localised thermal expansion of the journal surface. The circumferential scoring changes the geometry of the fillet radius and increases the level of local stress concentration. The series of 'thermal' cracks, oriented parallel to the journal axis, create discontinuities in the surface hardened zone of the journal and also act to increase local stress concentration levels.

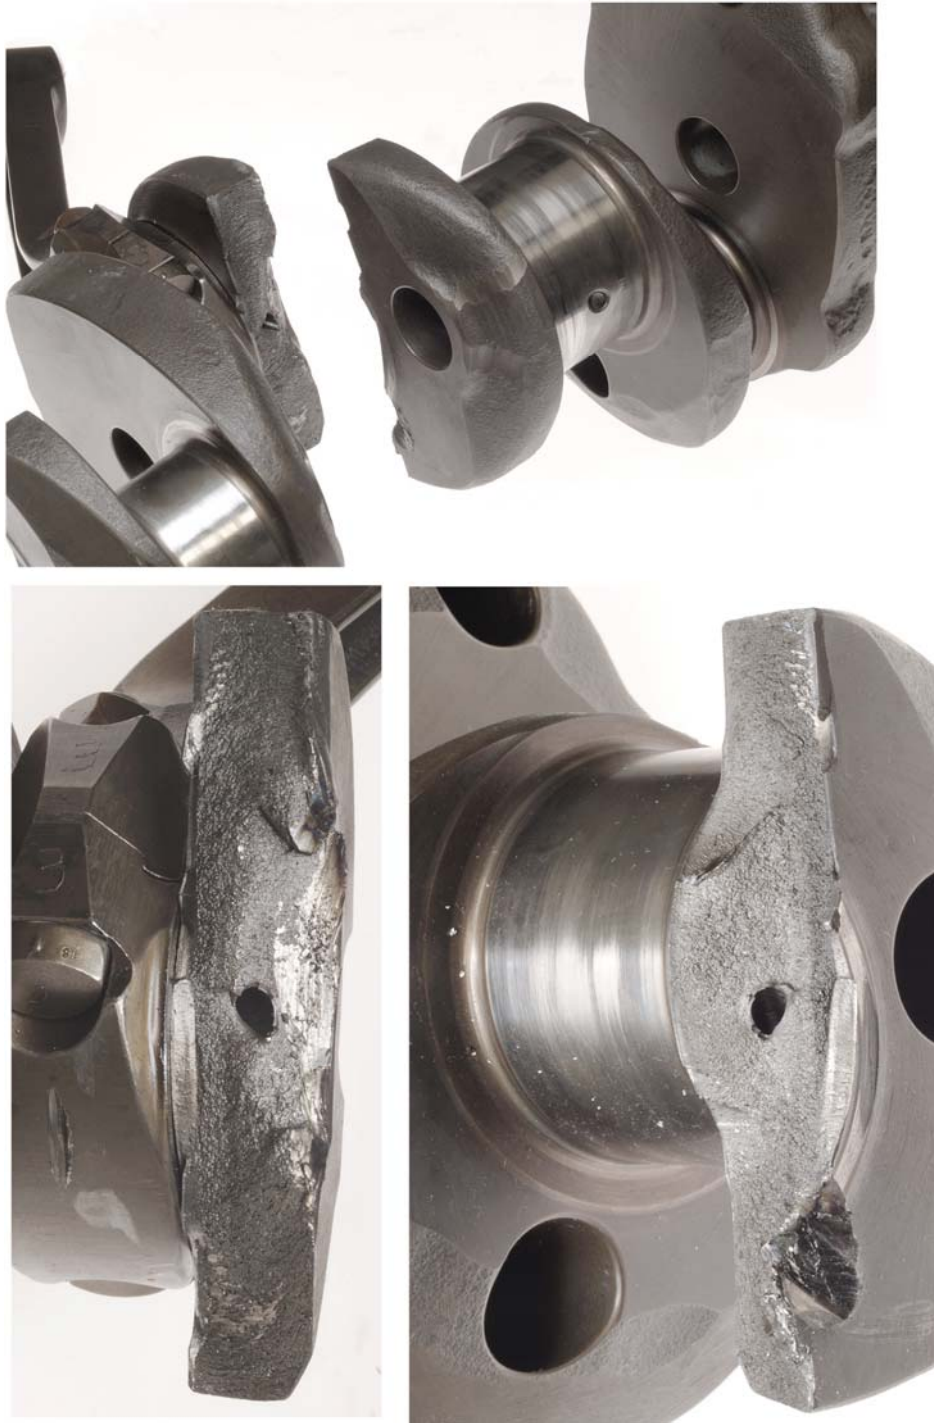
The crankshaft was marked with the following identifiers, part number LW 10346, serial number 87928.

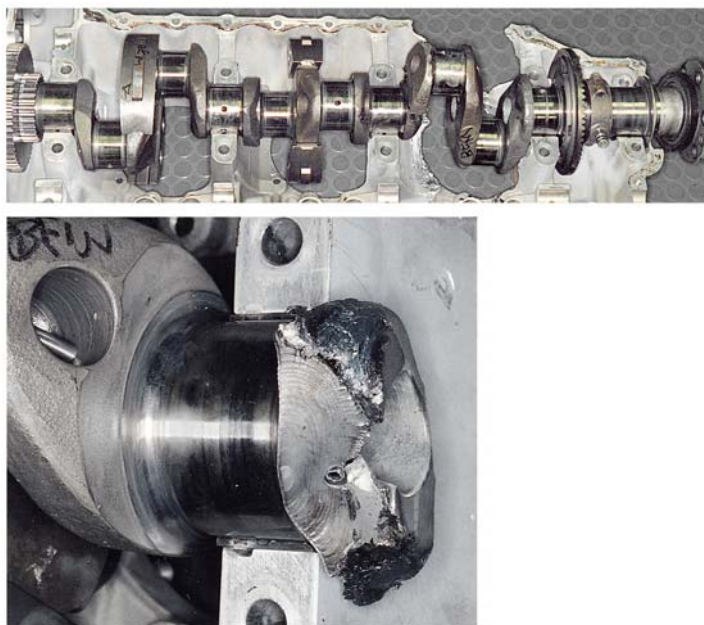
**Figure 6.50: Detailed views of the site of fatigue crack initiation, scanning electron micrographs**

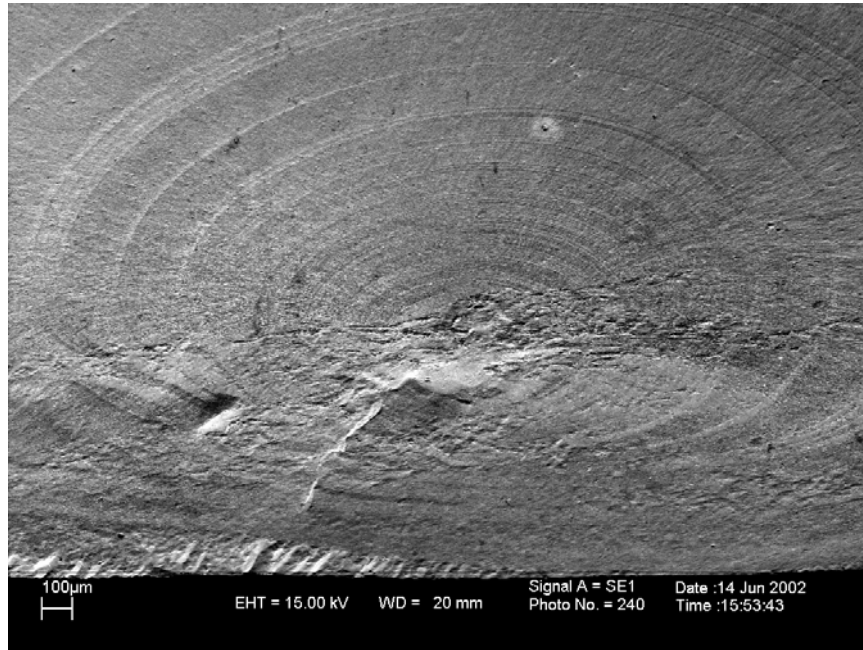
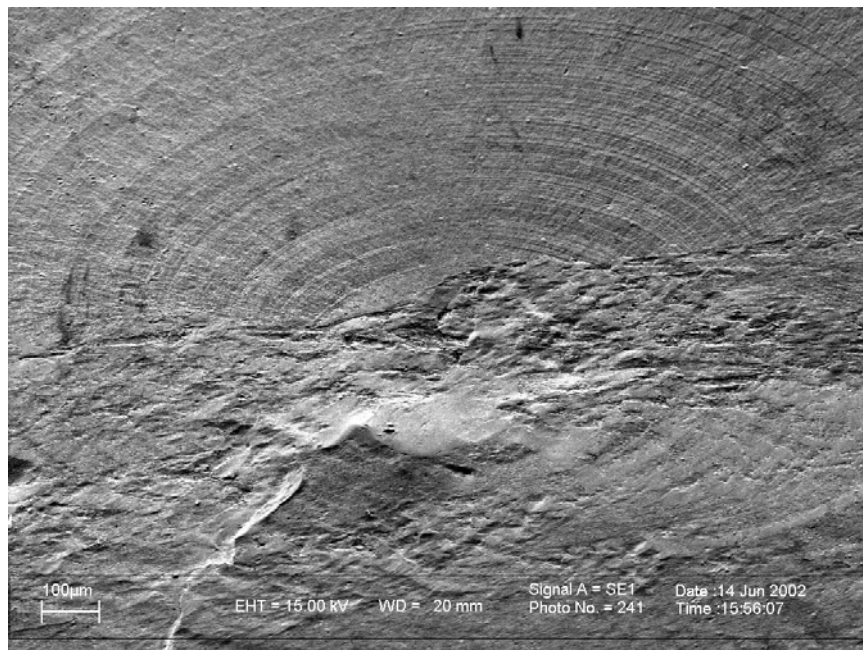
## 6.4.6 Occurrence 2001/5866 VH-JCH

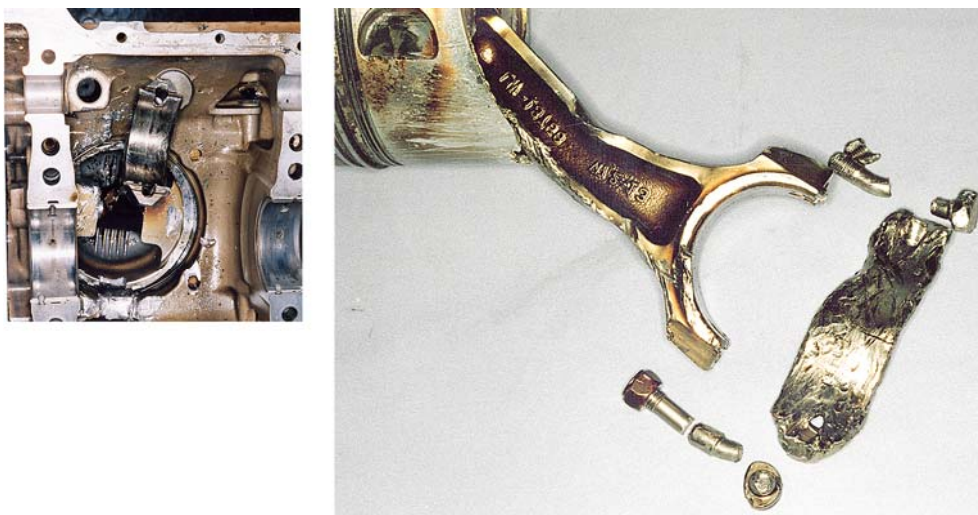
**Figure 6.52: Pneumatic pump coupling fracture, right engine JCH**

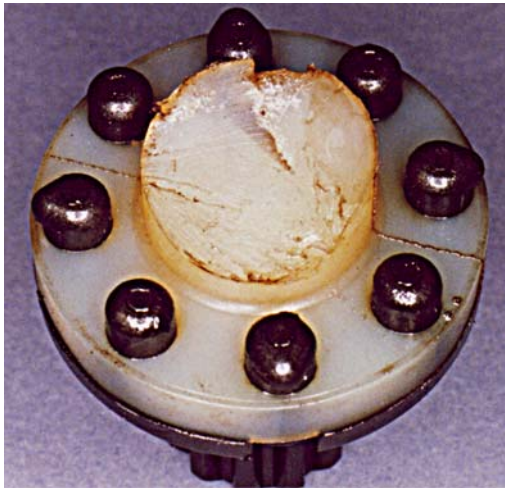
Separation of the No.6 big-end housing allowed the piston to strike the domed surface of the combustion chamber with sufficient force to deform the edge of the piston crown, see figure 6.53.

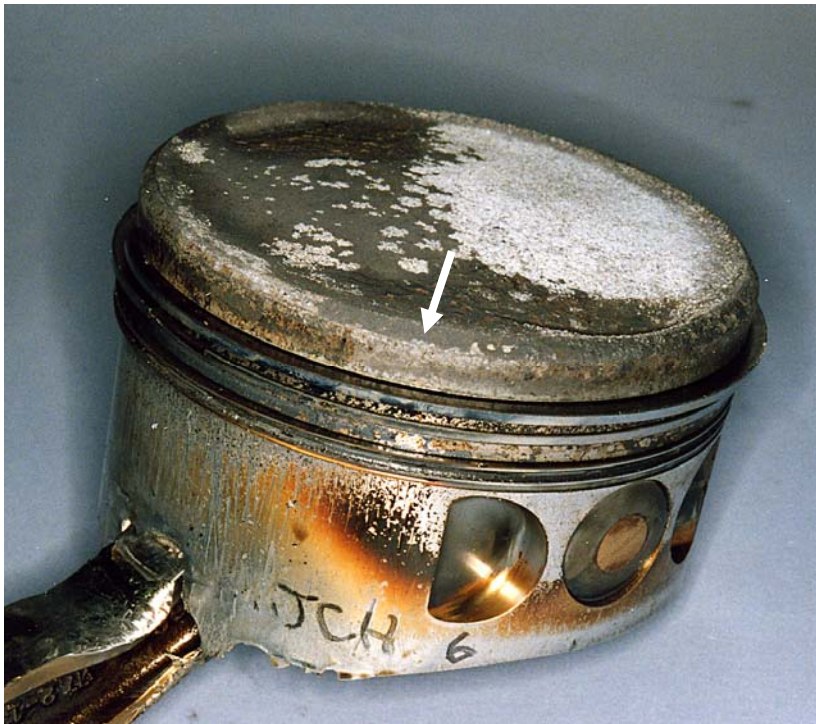
The separation of the No.6 big-end housing involved the loosening of nuts installed on the big-end housing bolts and the eventual loss of one nut. Evidence of nut loosening is provided by the fretting wear damage on the bolt threads and those regions of the boltholes that contact the bolt thread or guide surface, see figure 6.54.

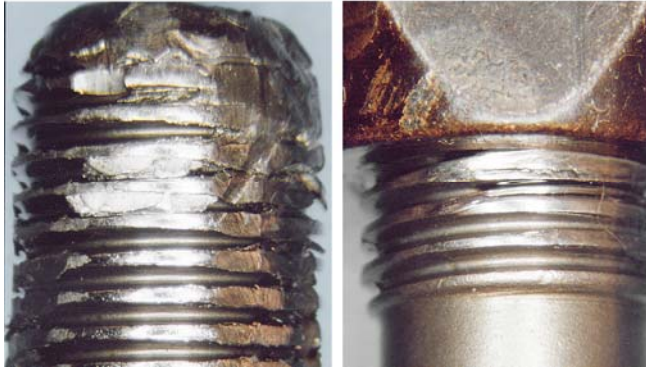
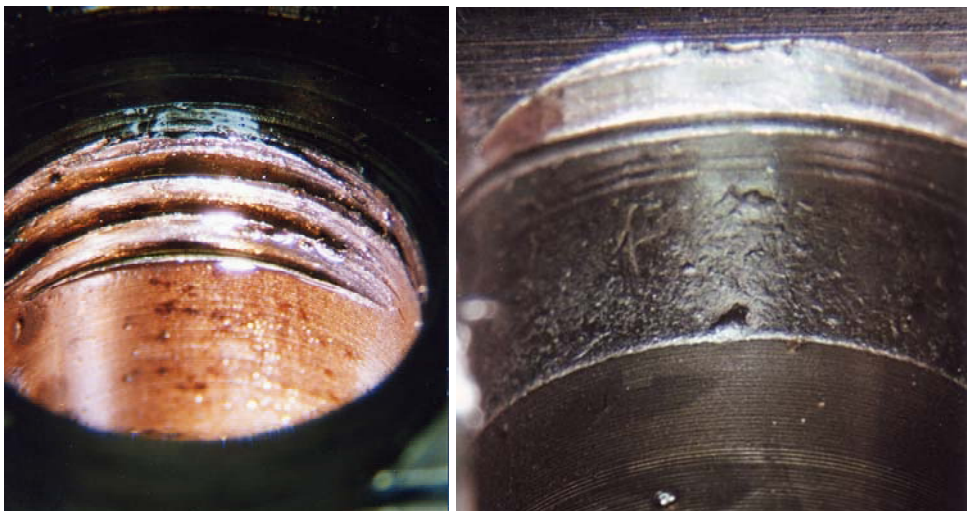
While it is clear that both parts of the connecting rod big-end housing (rod and cap) had remained intact (figure 6.55), it is evident that the inner surface of the housing had been damaged by rotational contact with the crankshaft journal in the absence of the big-end bearing inserts. The damage was sufficient to initiate fatigue cracking in the centre of the cap, figure 6.56.

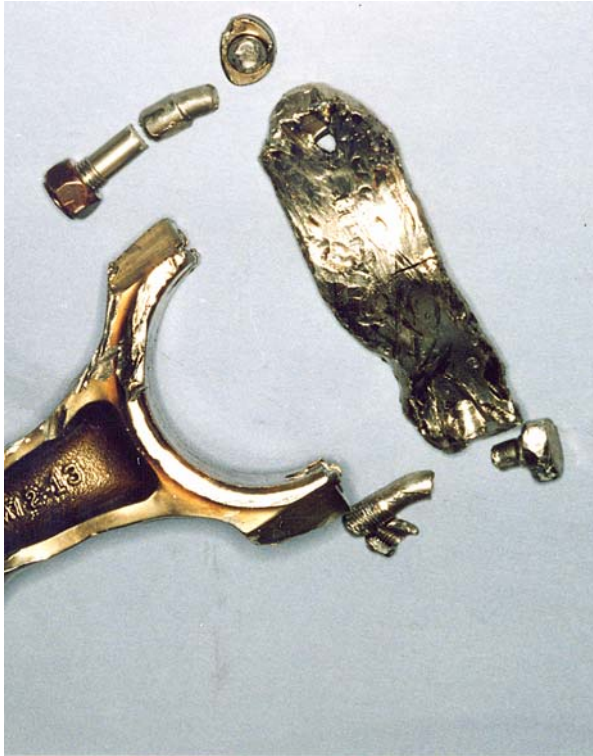
**Figure 6.56: The location of fatigue cracking, extending from the inner surface of the No.6 connecting rod big-end cap**

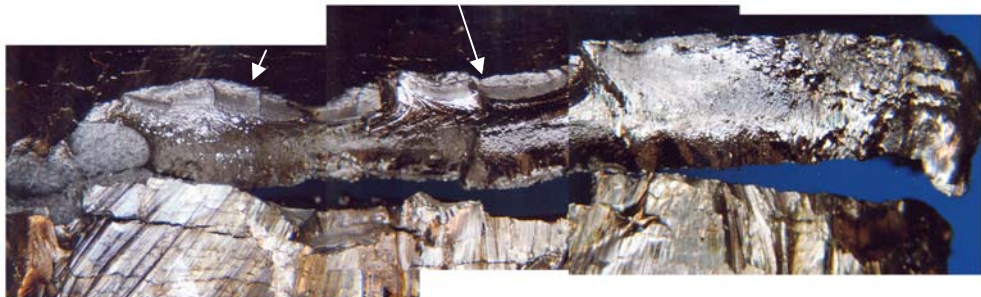
**Figure 6.57: Fragments of the No.6 big-end bearing inserts recovered from the engine sump**

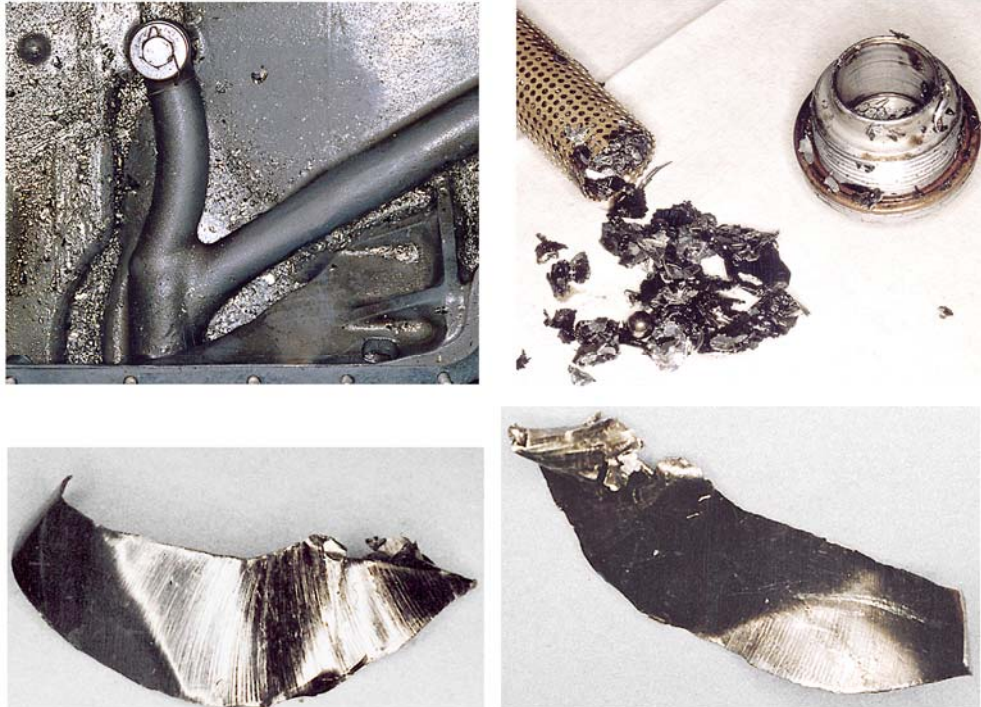
Upon disassembly of the engine, it was clear that the crankshaft had fractured at the No.6 connecting-rod journal, see figure 6.58. The two halves remained supported by the main bearings. The orientation of the plane of fracture allowed rotational forces to be transmitted between the two halves.

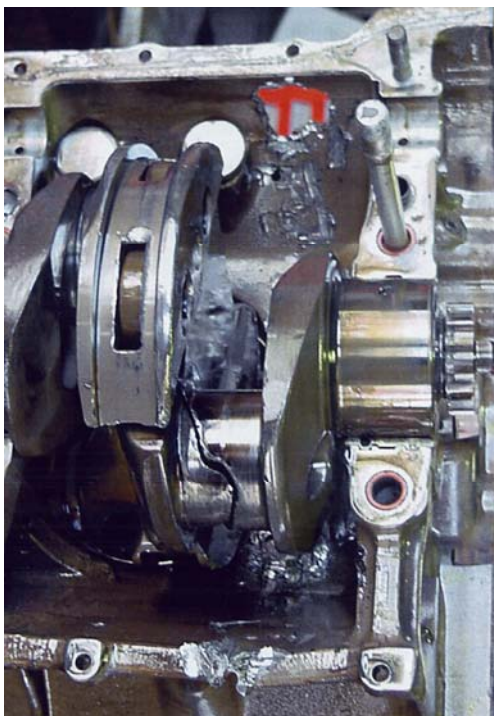
It is evident that with continued engine operation and crankshaft rotation the interlocking parts of the crankshaft halves were being progressively deformed, see figure 6.59. Continued operation with progressive deformation of the fracture surfaces will have an effect on engine timing and as such, engine performance. It is a design feature of the horizontally-opposed engine that ignition and valve timing for all cylinders is indexed to the position of the crankshaft through a gear train driven from the rear of the crankshaft. Correct timing for all cylinders relies on the fixed location of all connecting-rod journals with the timing-gear train.

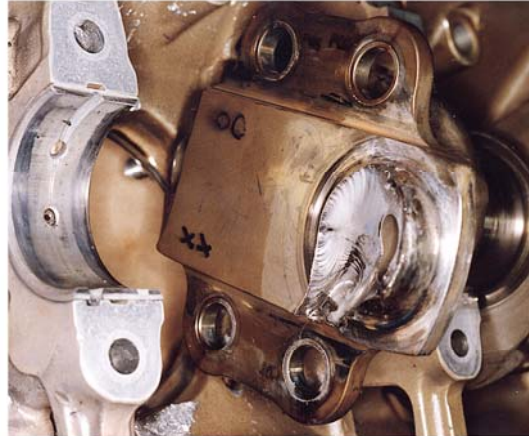
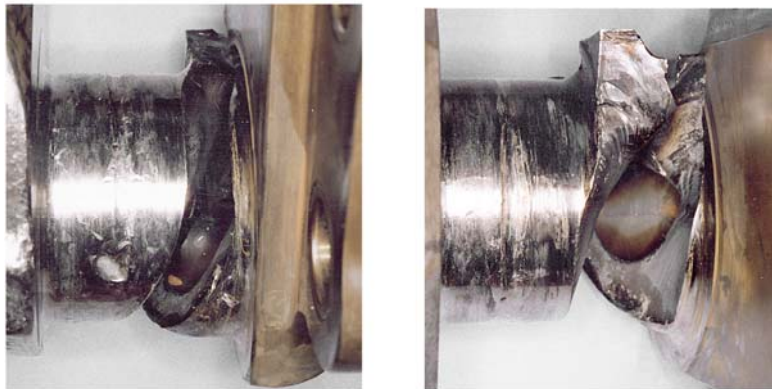
Fracture was caused by fatigue crack initiation and growth. Fatigue cracking initiated at the transition between the journal and the crankweb fillet. Distinctive fatigue ‘progression’ marks were present on the fatigue fracture surface, figure 6.60. These marks are created by major changes in the alternating loading spectrum. Typically, for engine crankshafts, they are associated with engine start/stop cycles. It was estimated that fatigue crack growth had occurred over a period of at least 76 engine start/stop cycles.

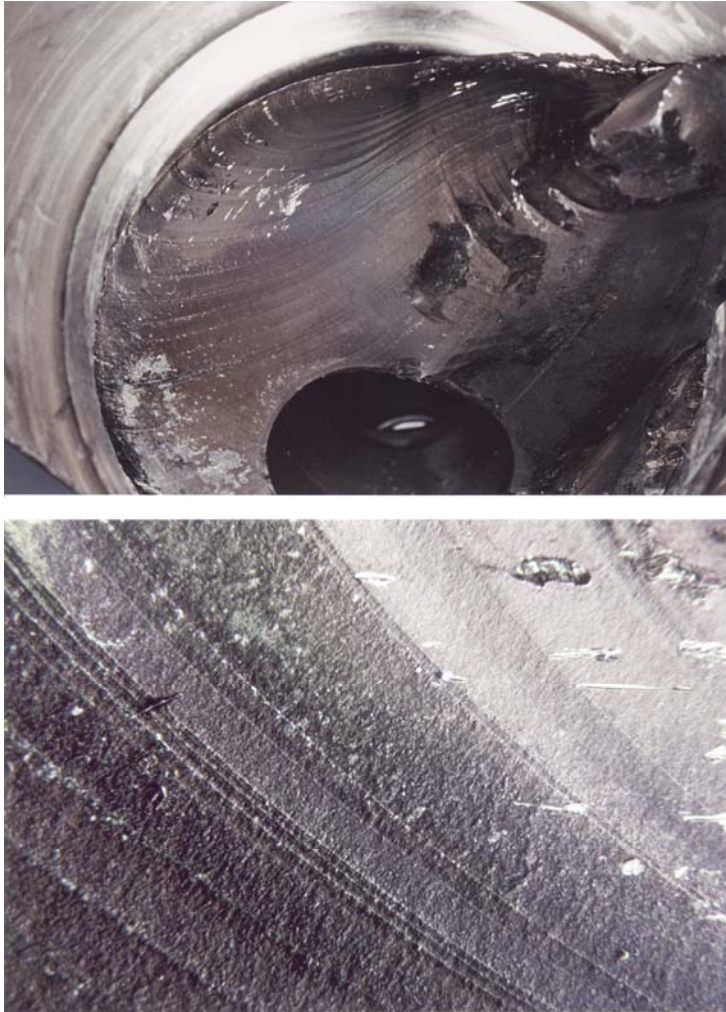
Fatigue cracking initiated at the transition between the No.6 journal surface and the fillet of the crankarm between the No.6/No.5 connecting rod journals at a site below the journal surface, figure 6.61. This region of the fatigue fracture surface had been affected by heating and localised deformation. It is noticeable that a ‘steplike’ feature extended from the site of initiation to the surface, figure 6.62.
