Australian Government  
Australian Transport Safety Bureau

ATSB TRANSPORT SAFETY INVESTIGATION REPORT  
Aviation Research and Analysis Report – B20070191  
Final

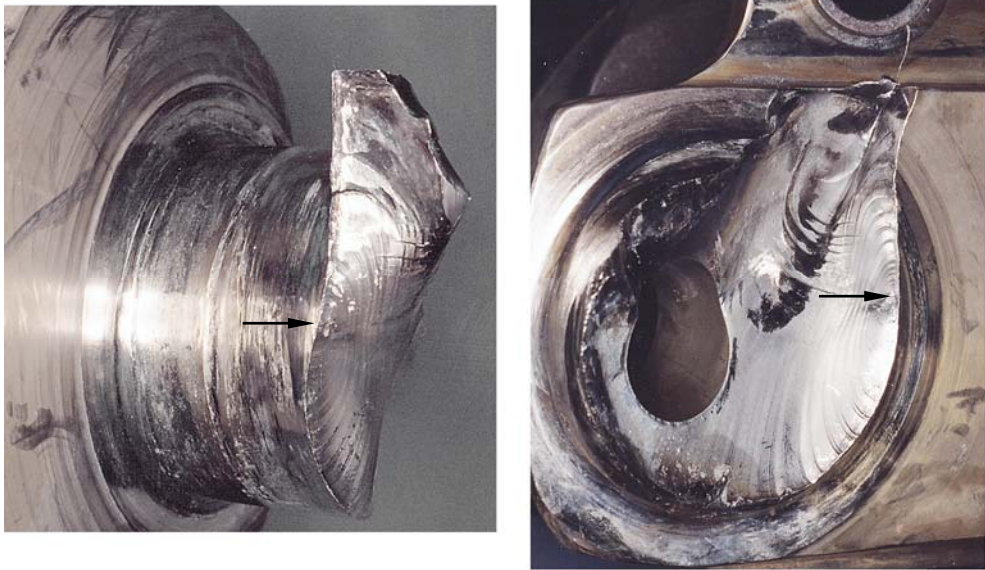
**Figure 6.62: Detailed views of the site of fatigue crack initiation**

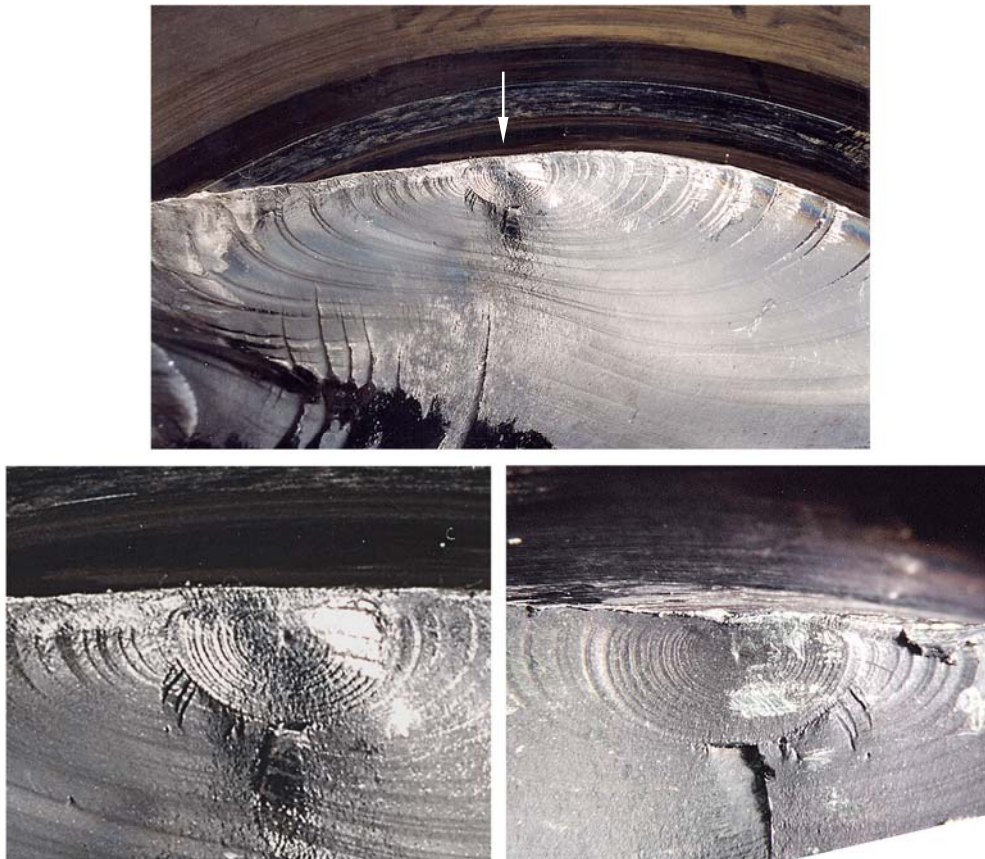
Crankweb side of the fracture.

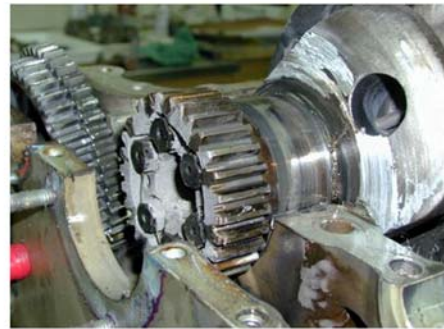
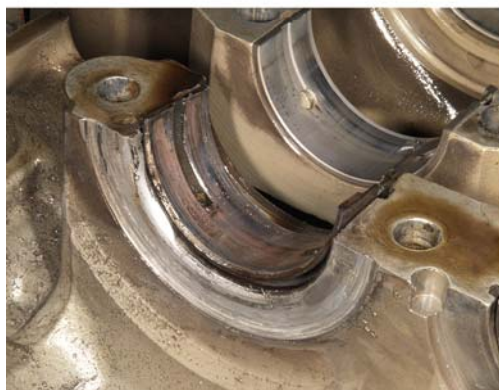
**Figure 6.63: The regions of crankcase 'machining' wear caused by crankshaft expansion**

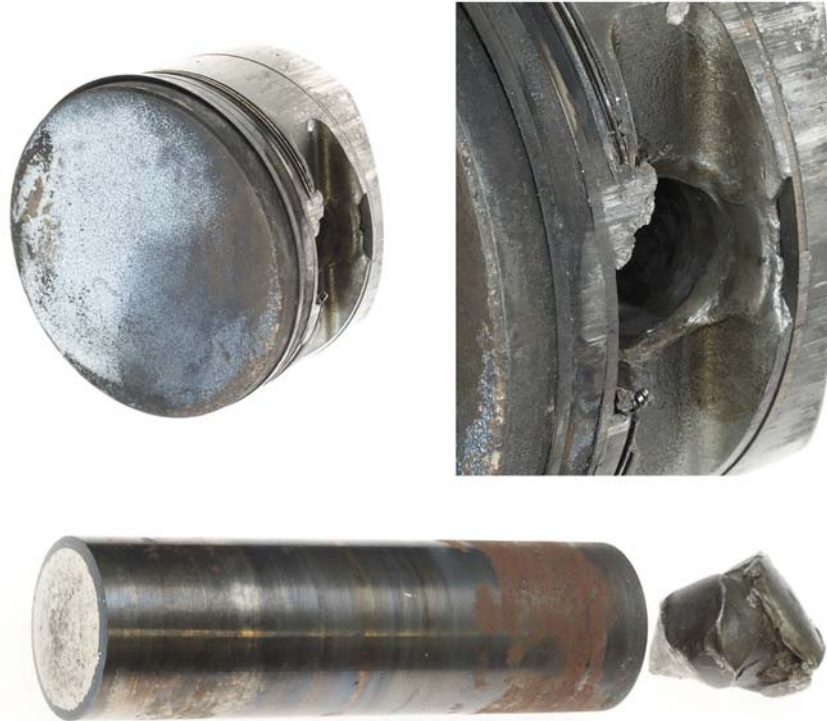
No.3 piston-pin plug damage.

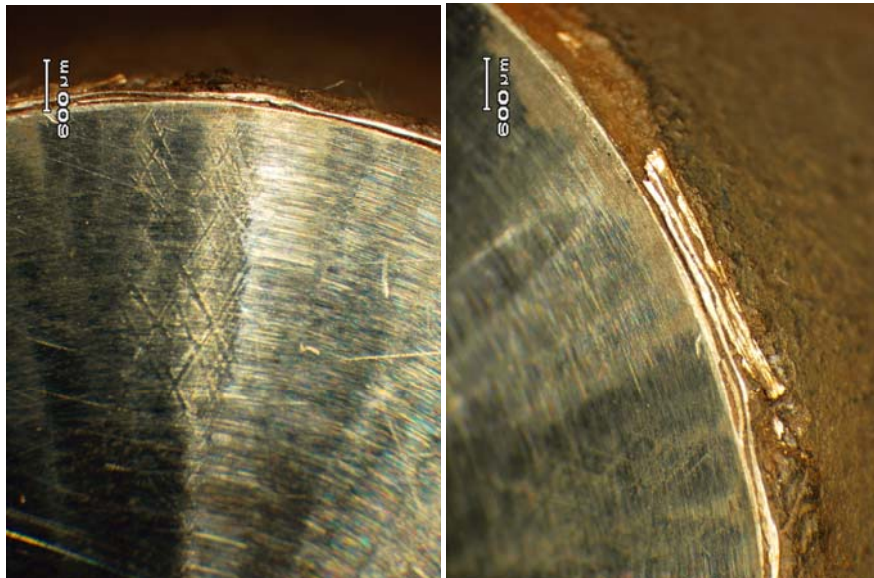
Detailed view of piston-pin plug wear (piston pin from another cylinder in the engine).

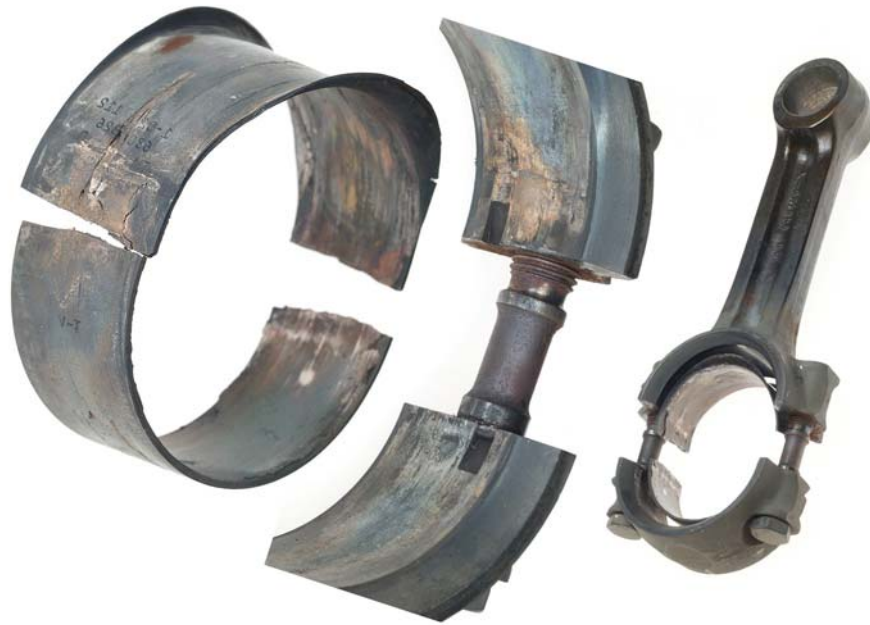
**Figure 6.66: Evidence of copper diffusion through the steel backing of the bearing insert and into the No.3 connecting rod housing**

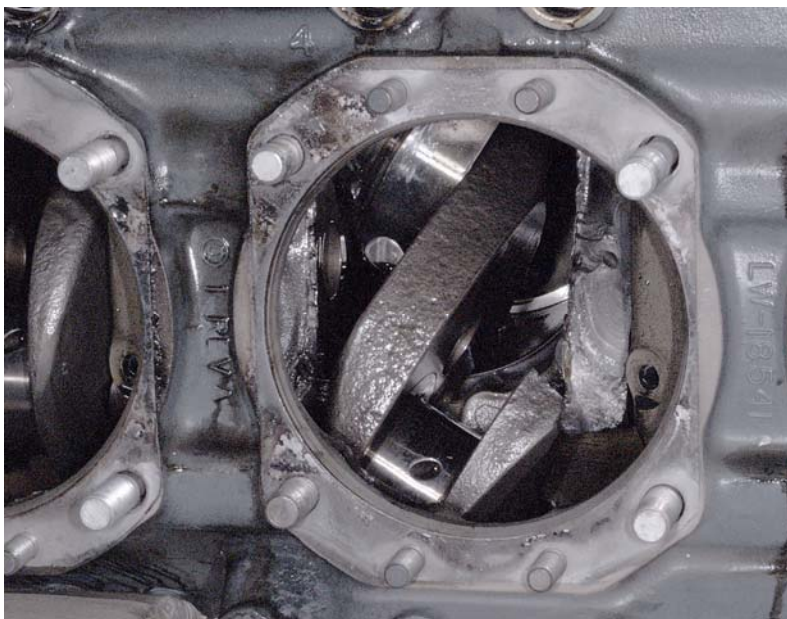
Further examination of the engine revealed that the crankshaft had fractured in two locations: through the crankweb between the No.4 main-bearing journal and the No.4 connecting-rod journal; and through the crankweb between the No.3 main-bearing journal and No.3 connecting-rod journal, see figure 6.69.

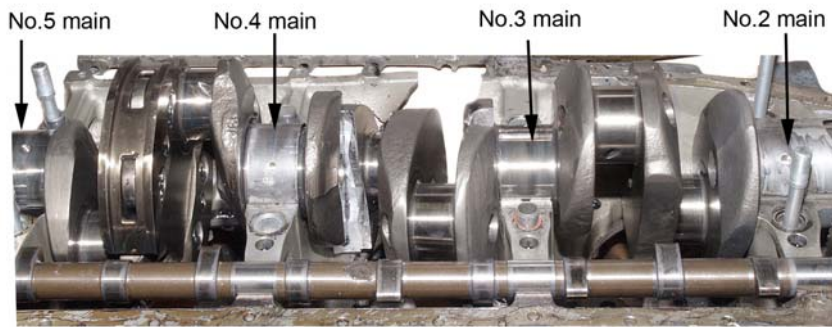
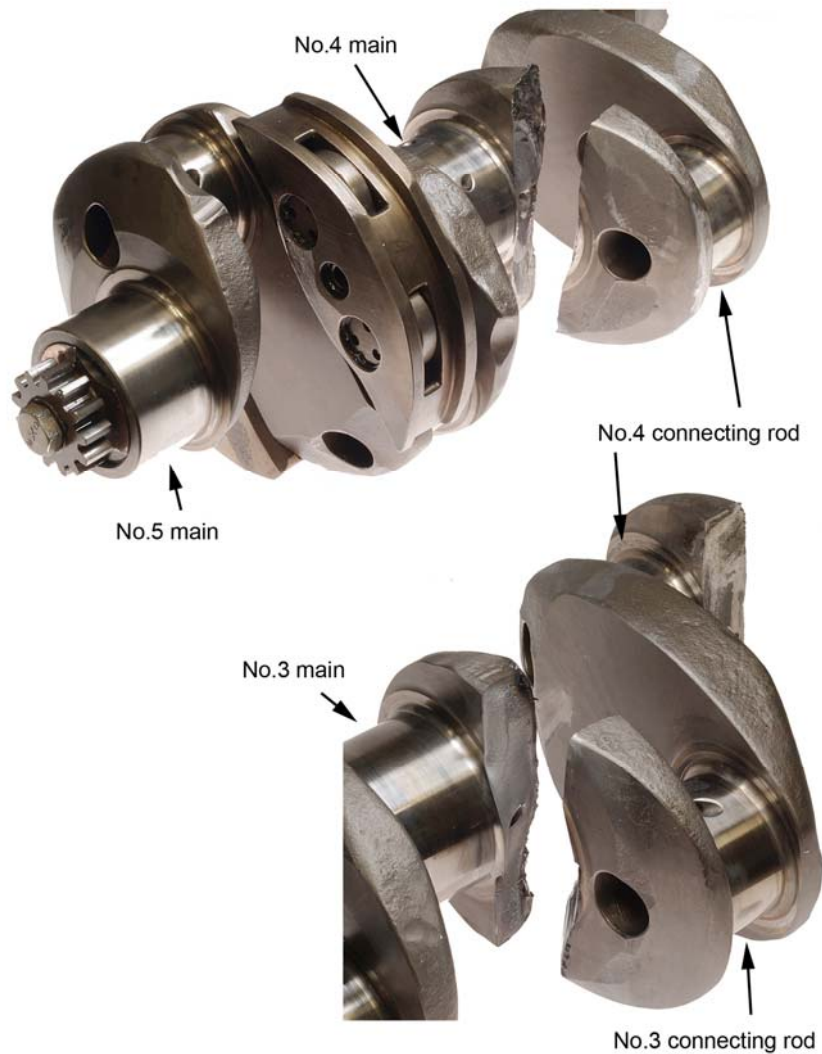
The fracture of the web between the No.4 main and No.4 connecting rod journals occurred as a result of fatigue crack initiation and growth, figure 6.70. The fatigue fracture progression marks present on the fracture surface indicated that crack growth had occurred over a period of approximately 50 engine start/stop cycles.

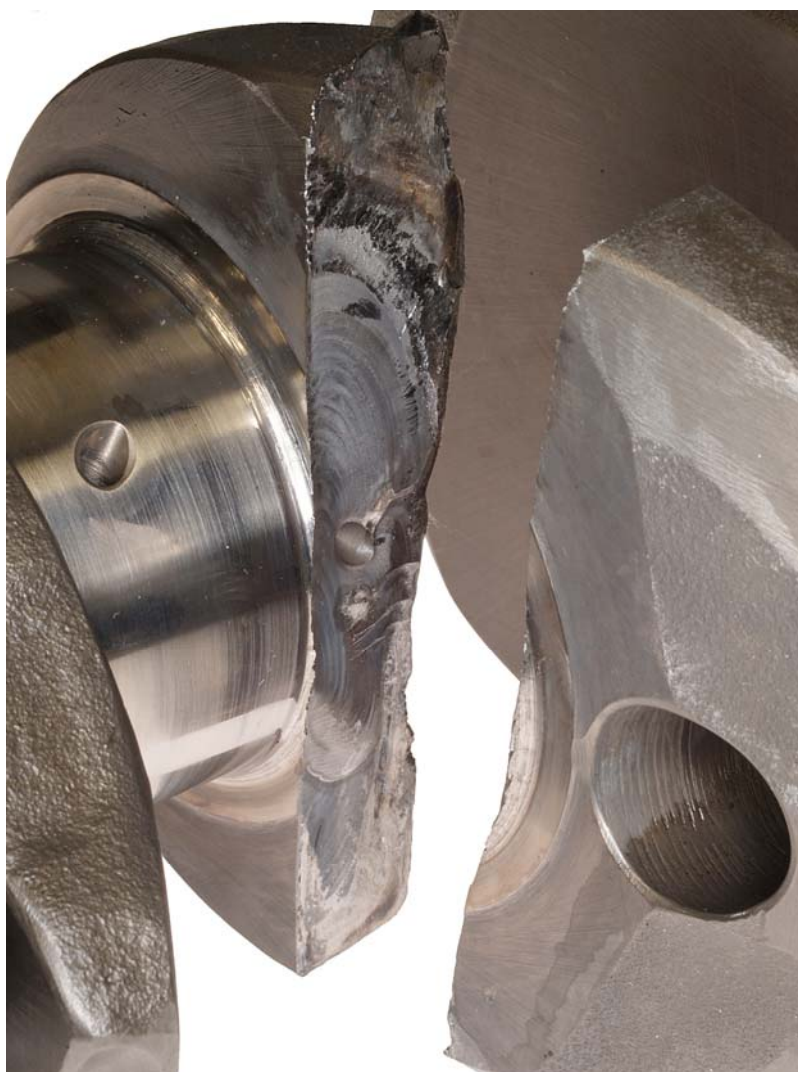
### ***Maintenance history***

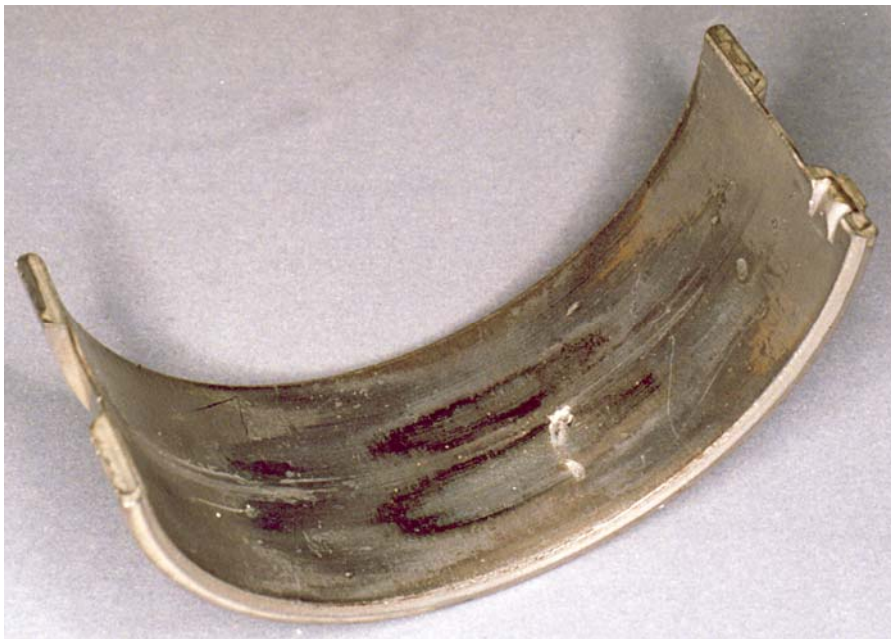
Time since overhaul 835 hours, bearing part number 74309 – M03, date of manufacture 1-98

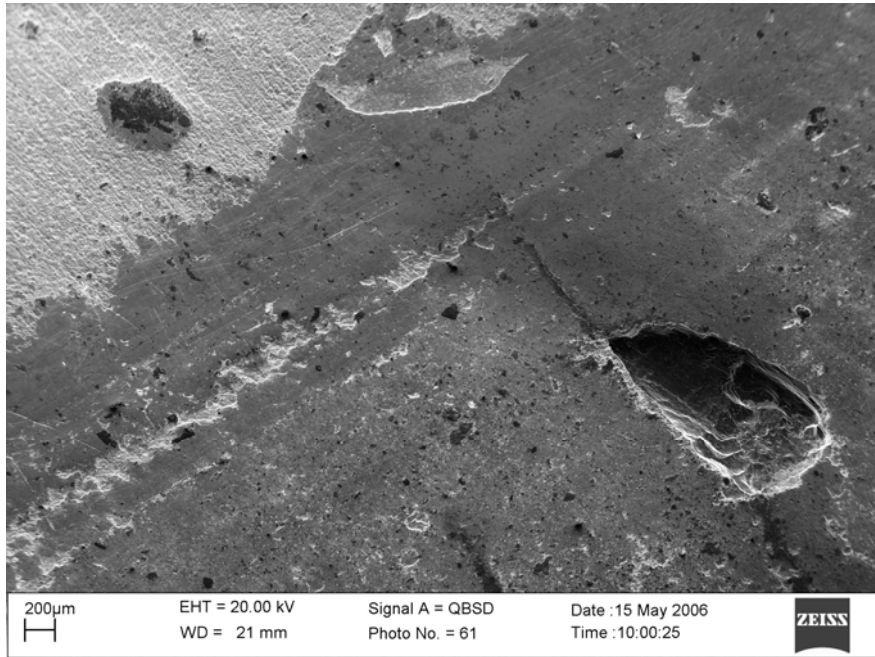
Time since overhaul 157 hours, bearing part number SL 13521-M03, date of manufacture 1-00.

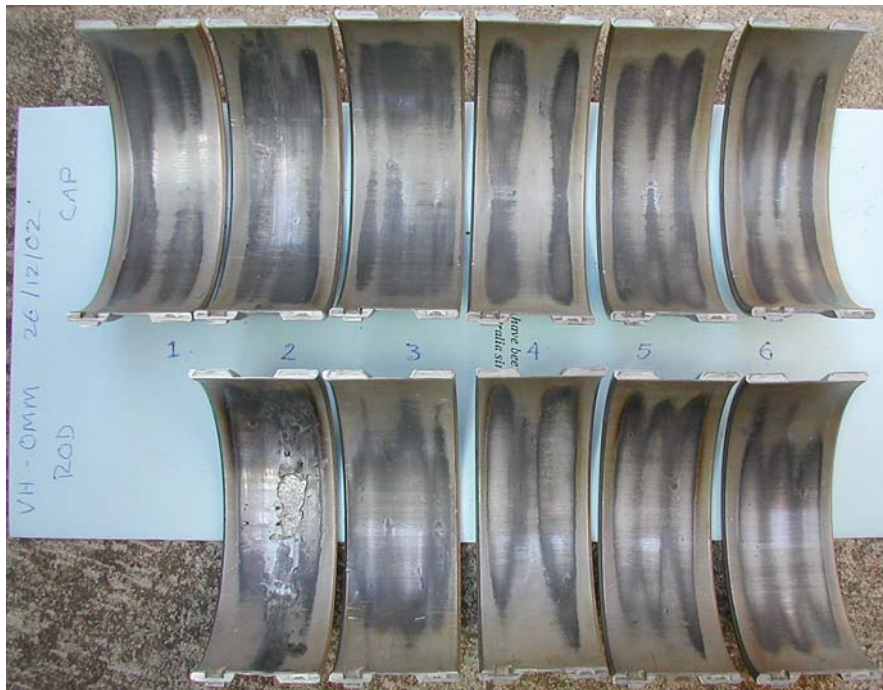
Time since overhaul 719 hours, bearing part number 74309 – M03, date of manufacture 1-01.

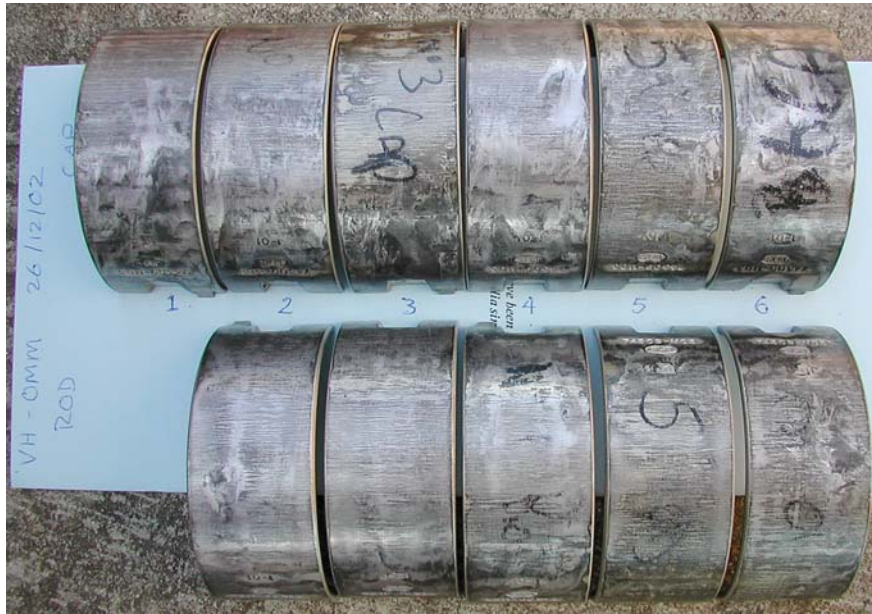
**Figure 6.75: Main bearing surface wear, VH-OMM (photo, Sprigg, 2003)**

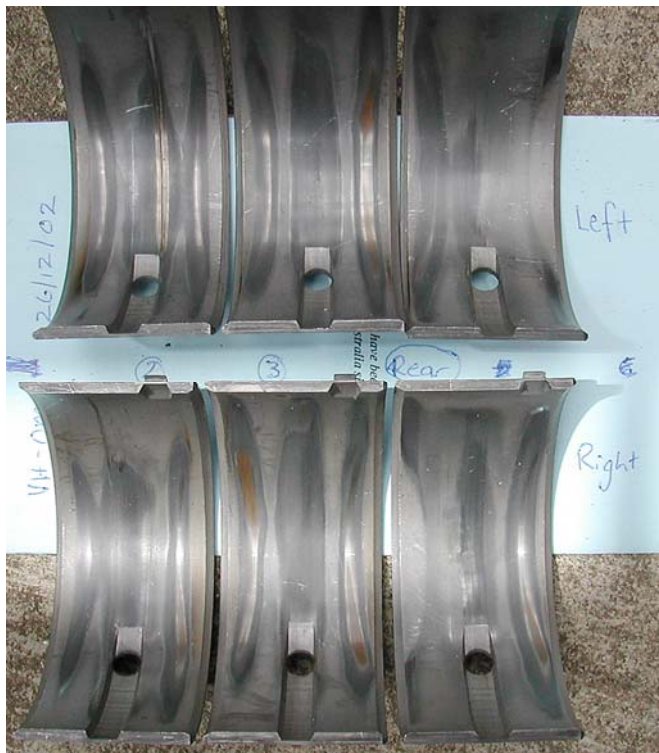
The main bearing inserts fitted to OMM were manufactured with a copper-lead bearing alloy intermediate layer.

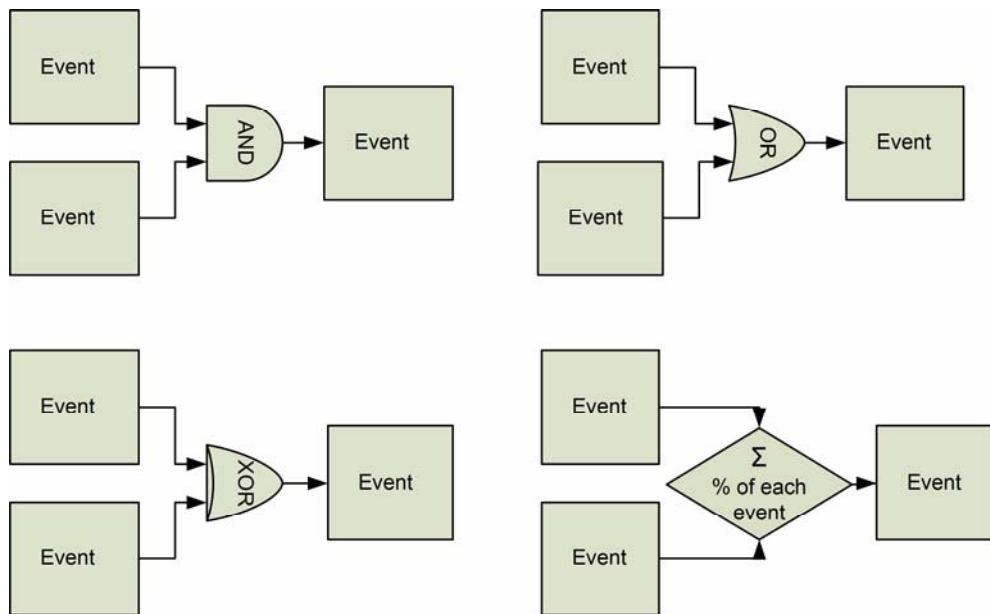
## 7.2 Cylinder head fatigue fracture

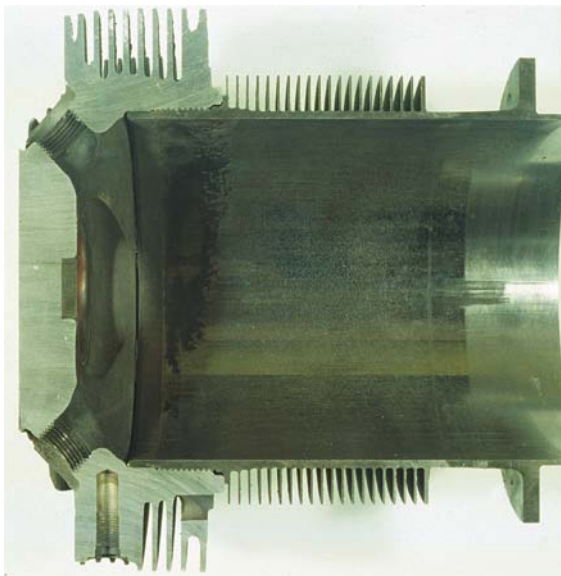
Whenever the thermal expansion or contraction (thermal strain) of a body is prevented, thermal stresses develop. It is common to distinguish between thermal stresses caused by external constraint and those that develop without external constraint because of temperature differences within the body. Stress can be created in a uniformly heated or cooled body if it is constrained. For the case of bodies that are not constrained, stresses in the body can be created between regions of varying temperature. For example, cooling the surface of a hot body creates tensile stresses in the surface as the contraction of the cooled material in the surface is restrained by the expanded hot core.

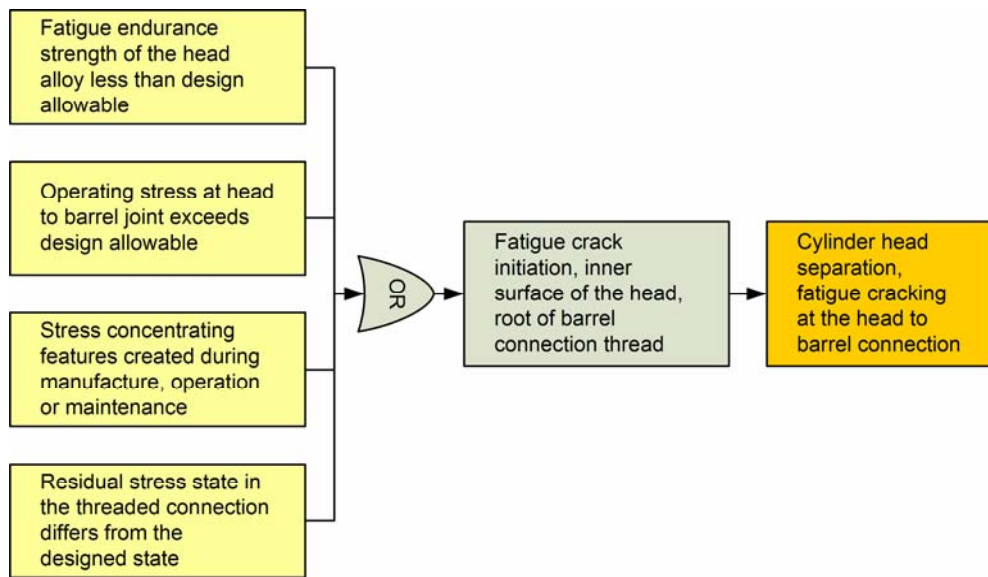
Differential thermal expansion/contraction cycles may result in fatigue cracking in other areas of the cylinder head. However, this form of fatigue cracking may provide an indicator of its presence through a loss of compression prior to final fracture and may be controlled by an ‘on-condition’<sup>1</sup> approach.

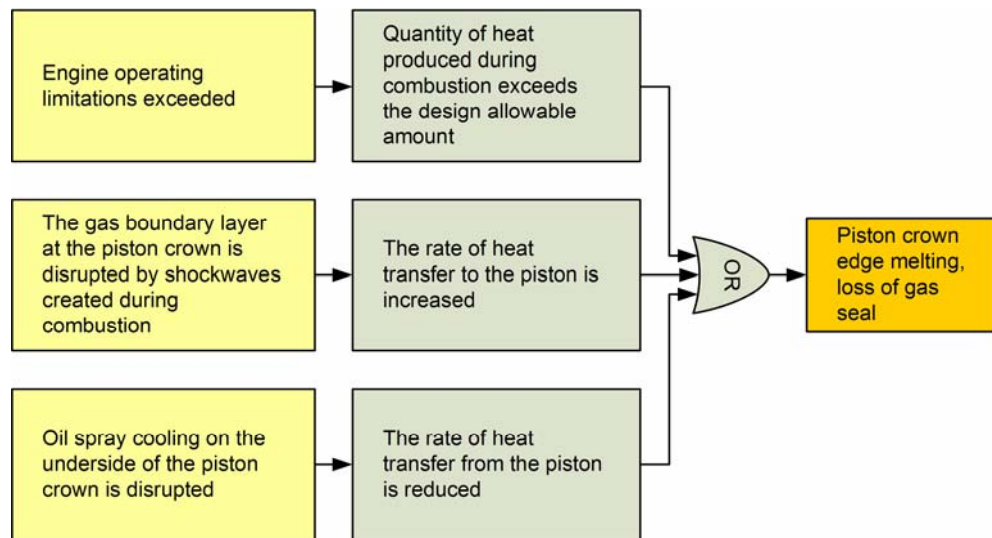
Localised melting in an aluminium alloy cylinder head, sometimes associated with piston crown edge melting, is affected by the same parameters. The only difference is the manner in which heat is removed. Heat is transferred from cylinder heads by the provision of cooling air over the external surface of the head. Investigations of occurrences where localised melting of a piston and cylinder head have occurred, need to consider the different mechanisms of heat transfer from each component to the external environment.

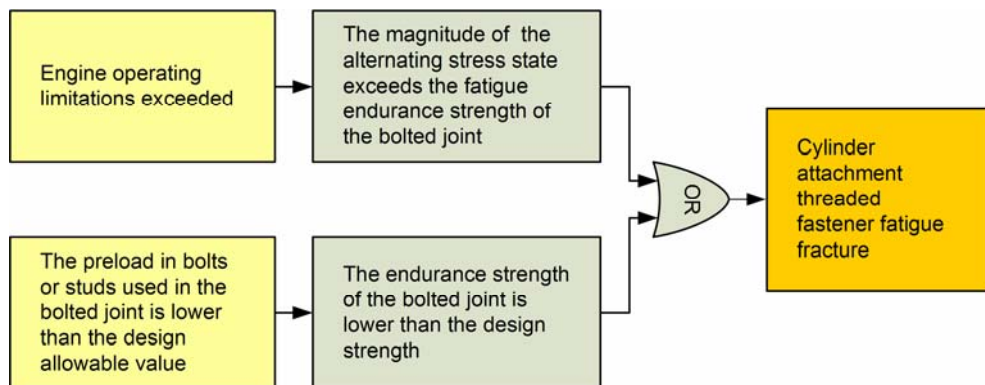
## 7.5 Connecting rod bearing housing fatigue fracture

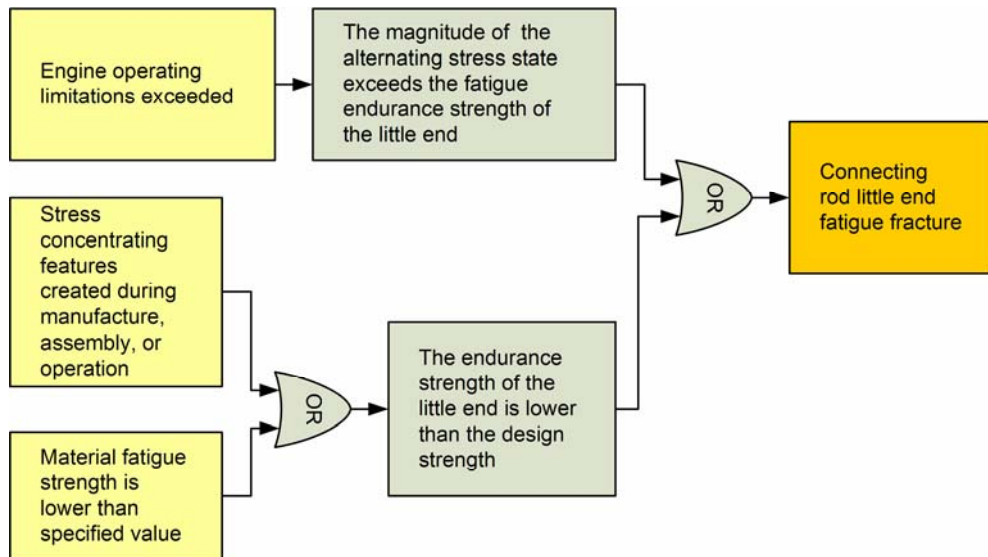
Each of the potential initiating events may be examined in more detail. For example, it is known that galling (adhesive wear) on the inner surface of the little-end housing is a potent initiator of fatigue cracking. However, galling cannot occur if the little-end bearing remains intact. Observations of galling between the little-end housing and piston pin, requires a sequence of events to occur that result in the breakup of the little-end bearing. These events may relate to the lubrication of the bearing, the magnitude of the bearing retention force, or an abnormal loading condition.

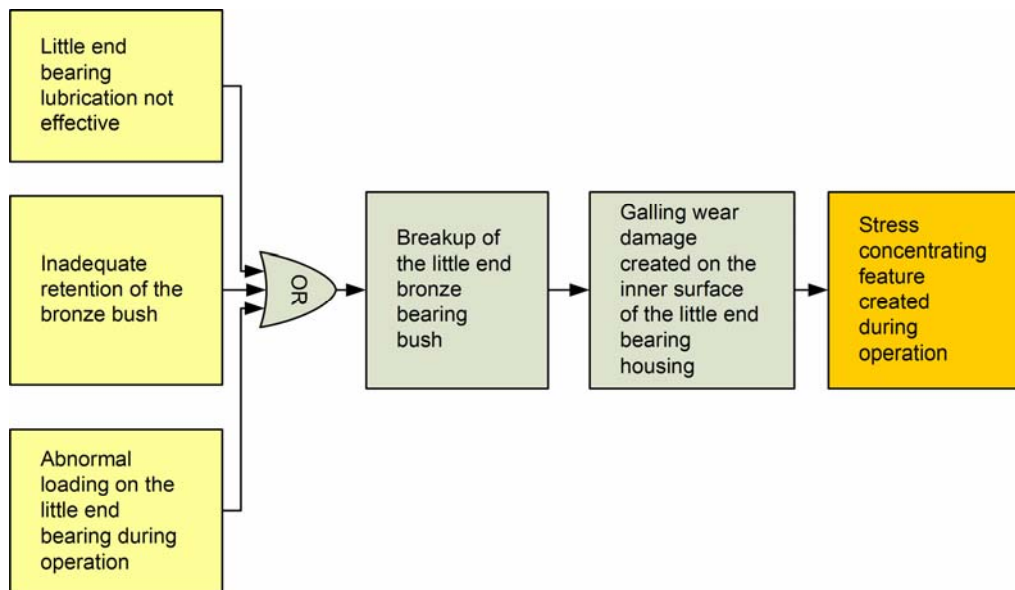
### 7.5.3 Connecting rod big-end fatigue fracture control

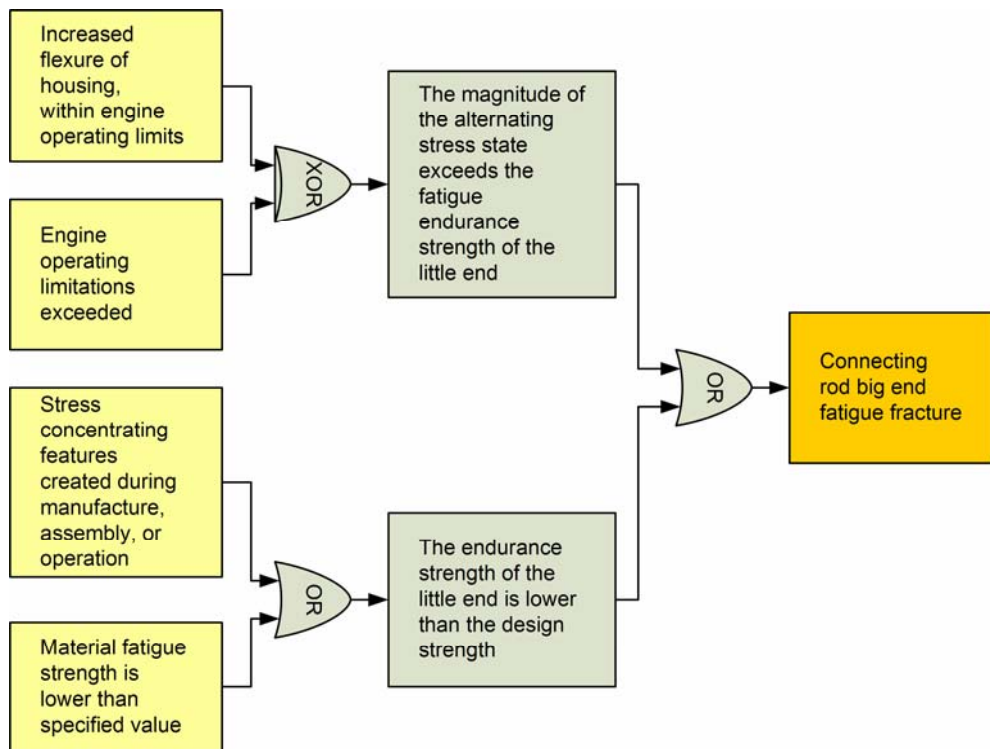
Each initiating event may be examined in more detail, for example, a fatigue fracture initiating on the housing outer surface, at a point of change in stiffness, may be associated with a chain of events that starts with the breakup of the big-end bearing inserts.

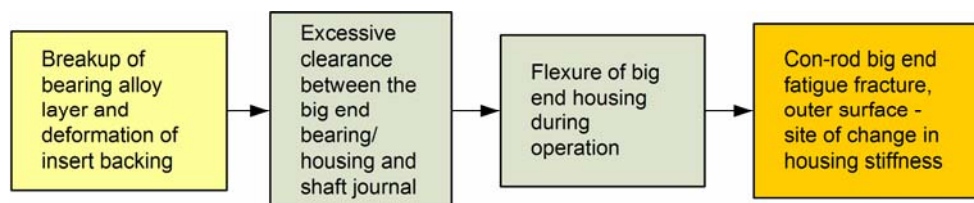
## 7.6 Crankshaft fatigue fracture

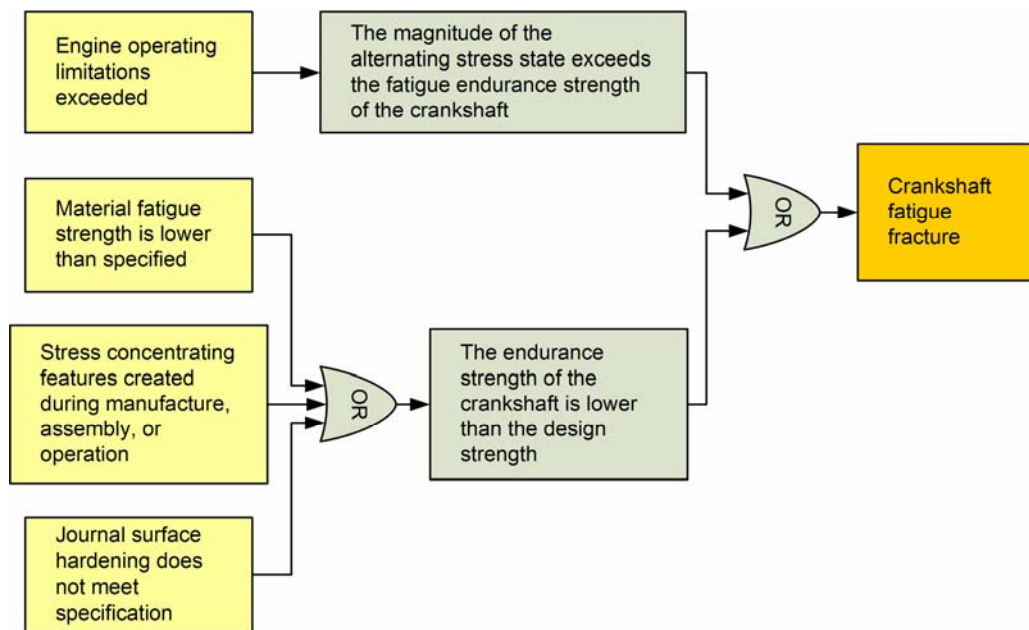
## 7.7 Powertrain plain bearing failure

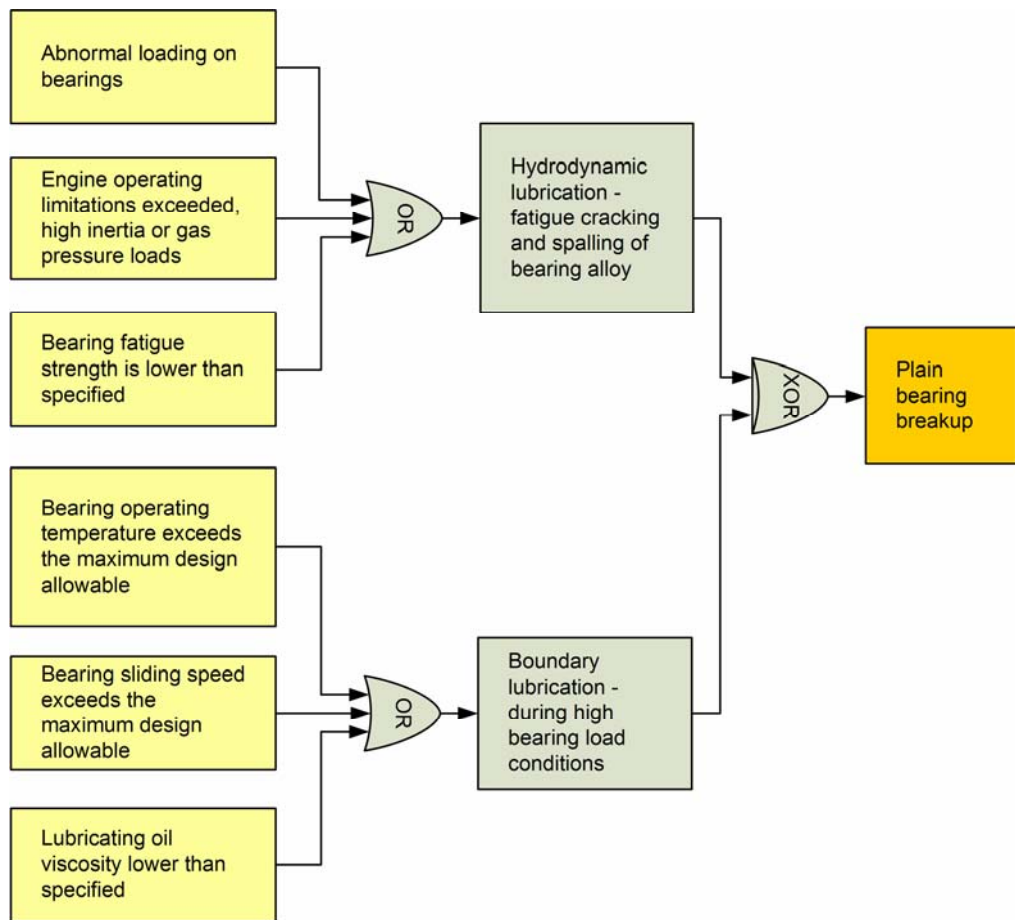
Plain bearings can also be considered to have failed if the bearing inserts are displaced from their housings and damage is created in other components, for example, housing surfaces or journal fillets. The control of bearing insert movement is based on creating a retention force of sufficient magnitude to resist the operational forces that act to move inserts during engine operation.

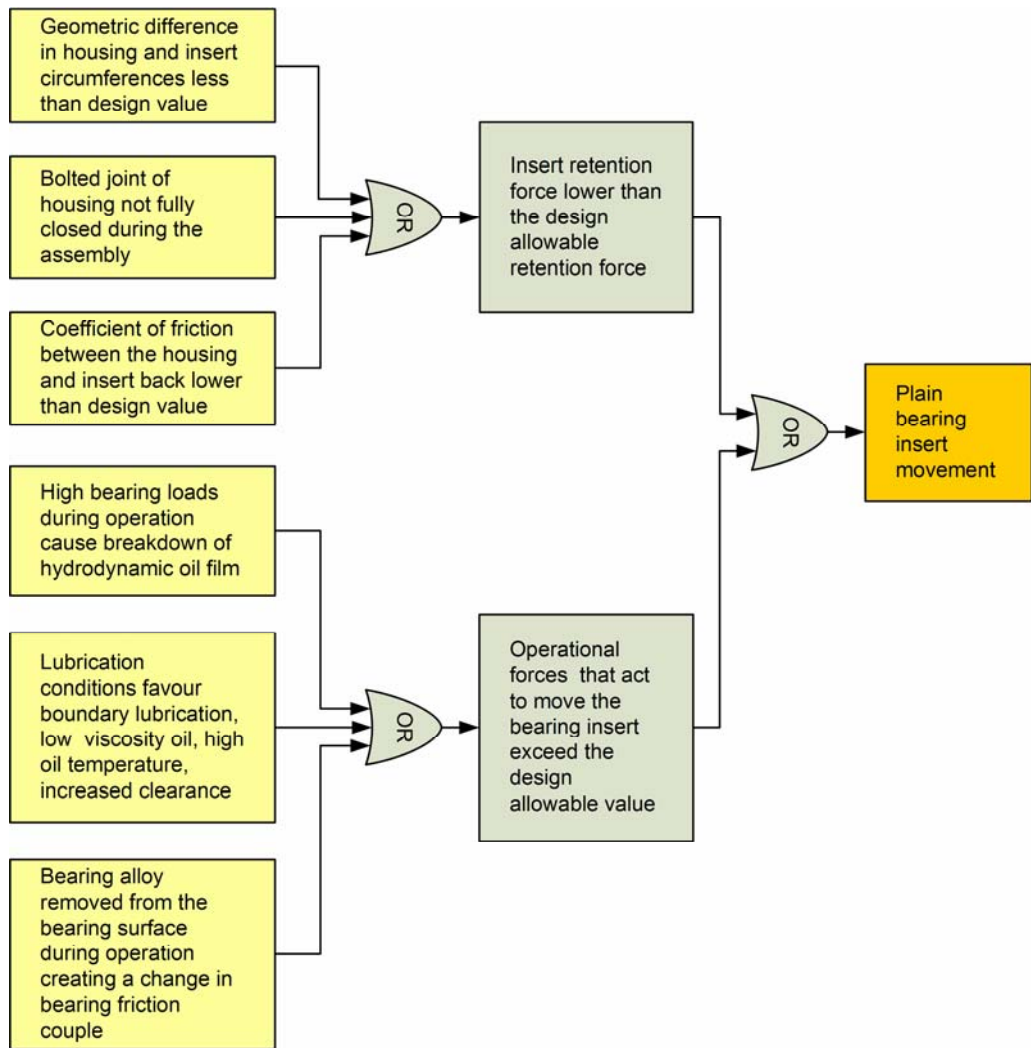
**Figure 7.14: Cause-and-effect diagram for plain bearing insert movement**

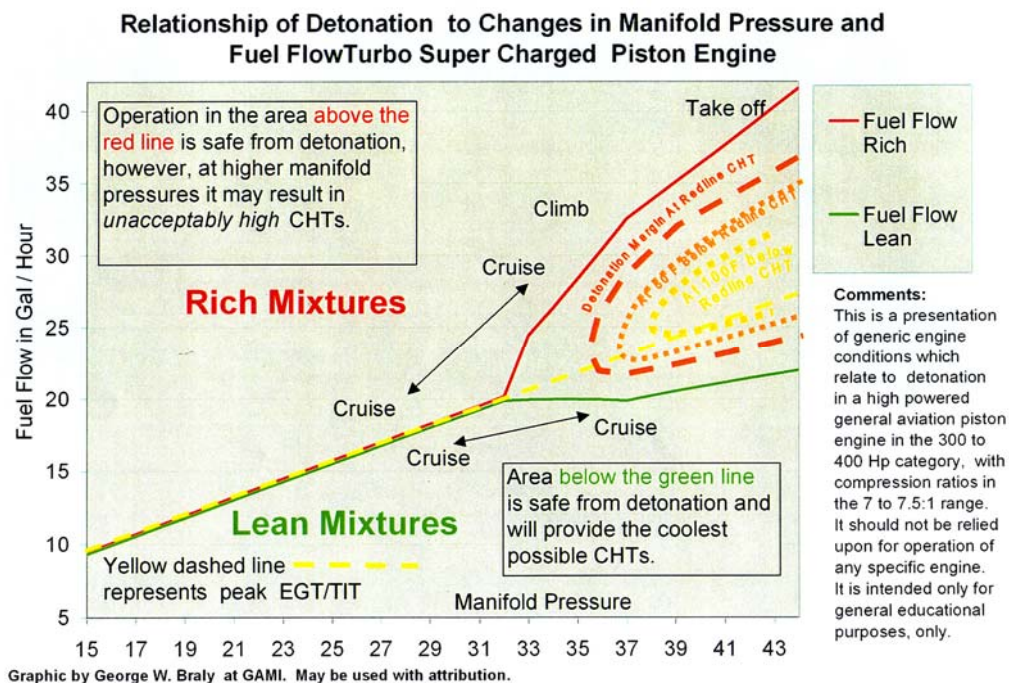
### ***Pre-ignition and multiple ignition events***

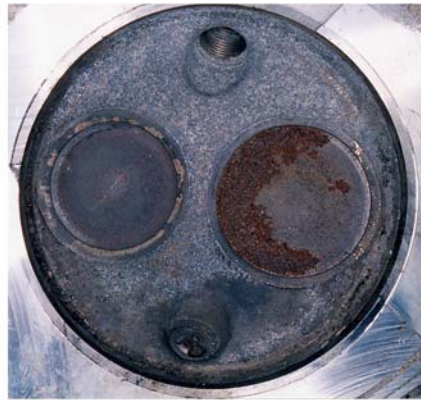
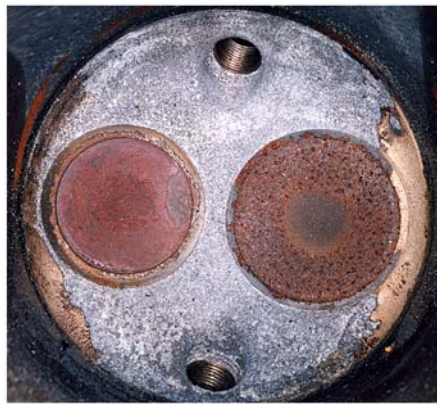
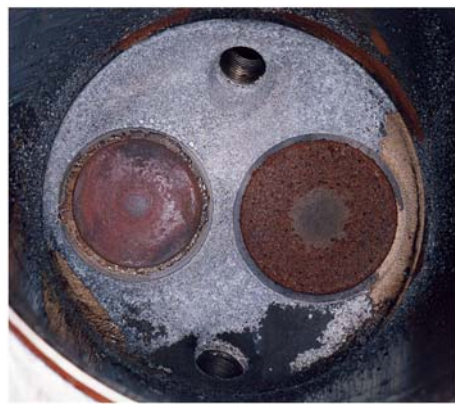
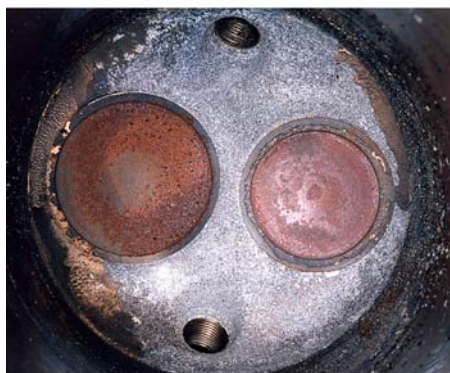
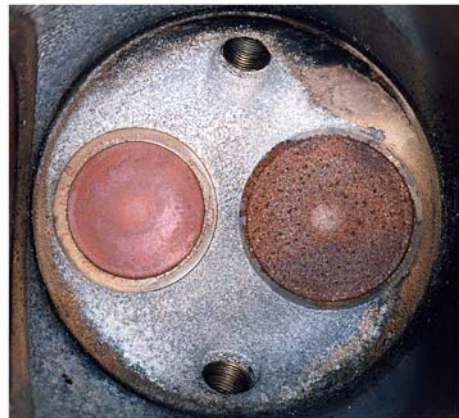
Figure 8.6: Piston surface condition, 2000/90, VH-MZK (left engine)

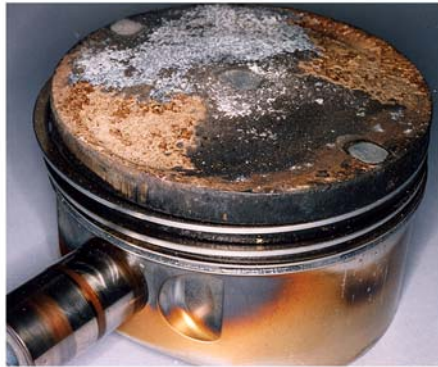
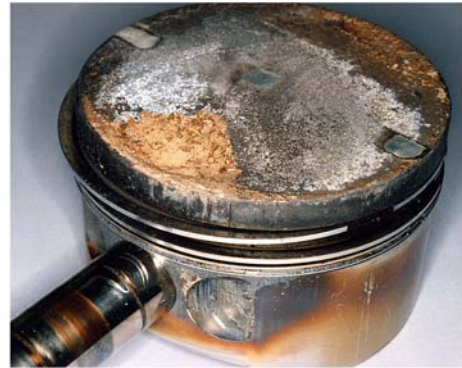
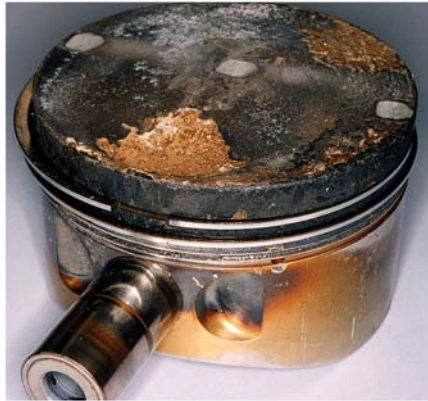
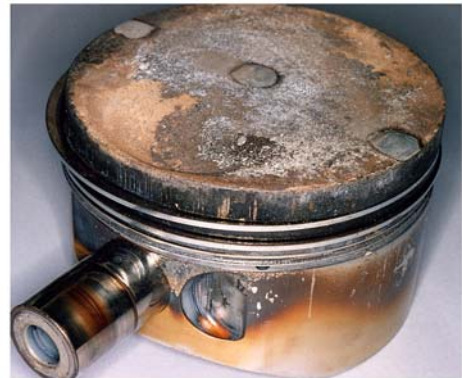
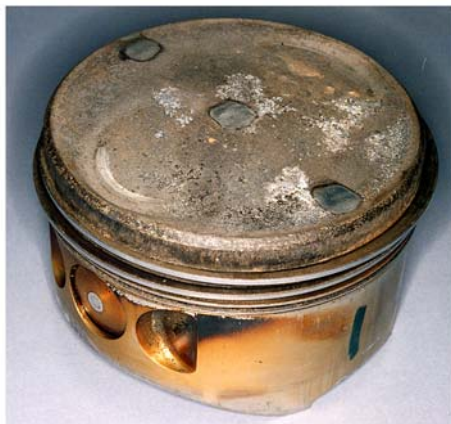
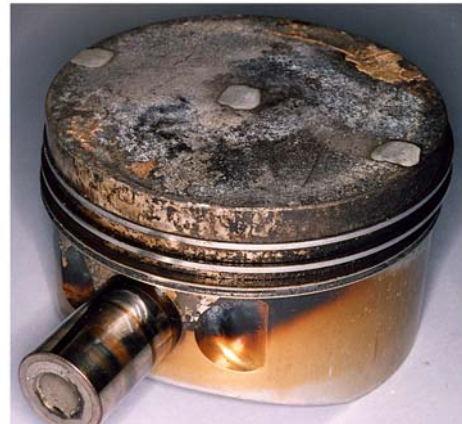
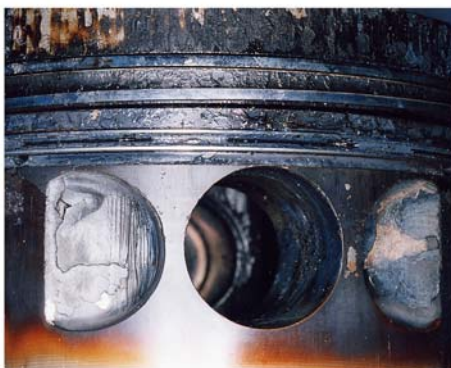
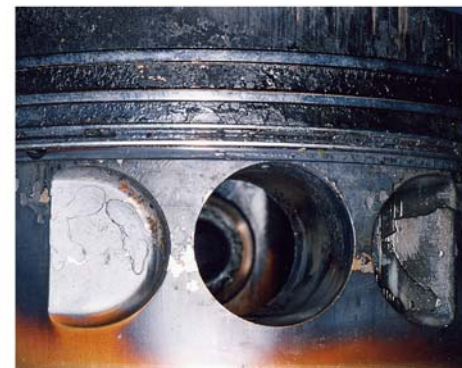
Figure 8.7: Piston surface condition, 2000/2157, VH-MZK (left engine)

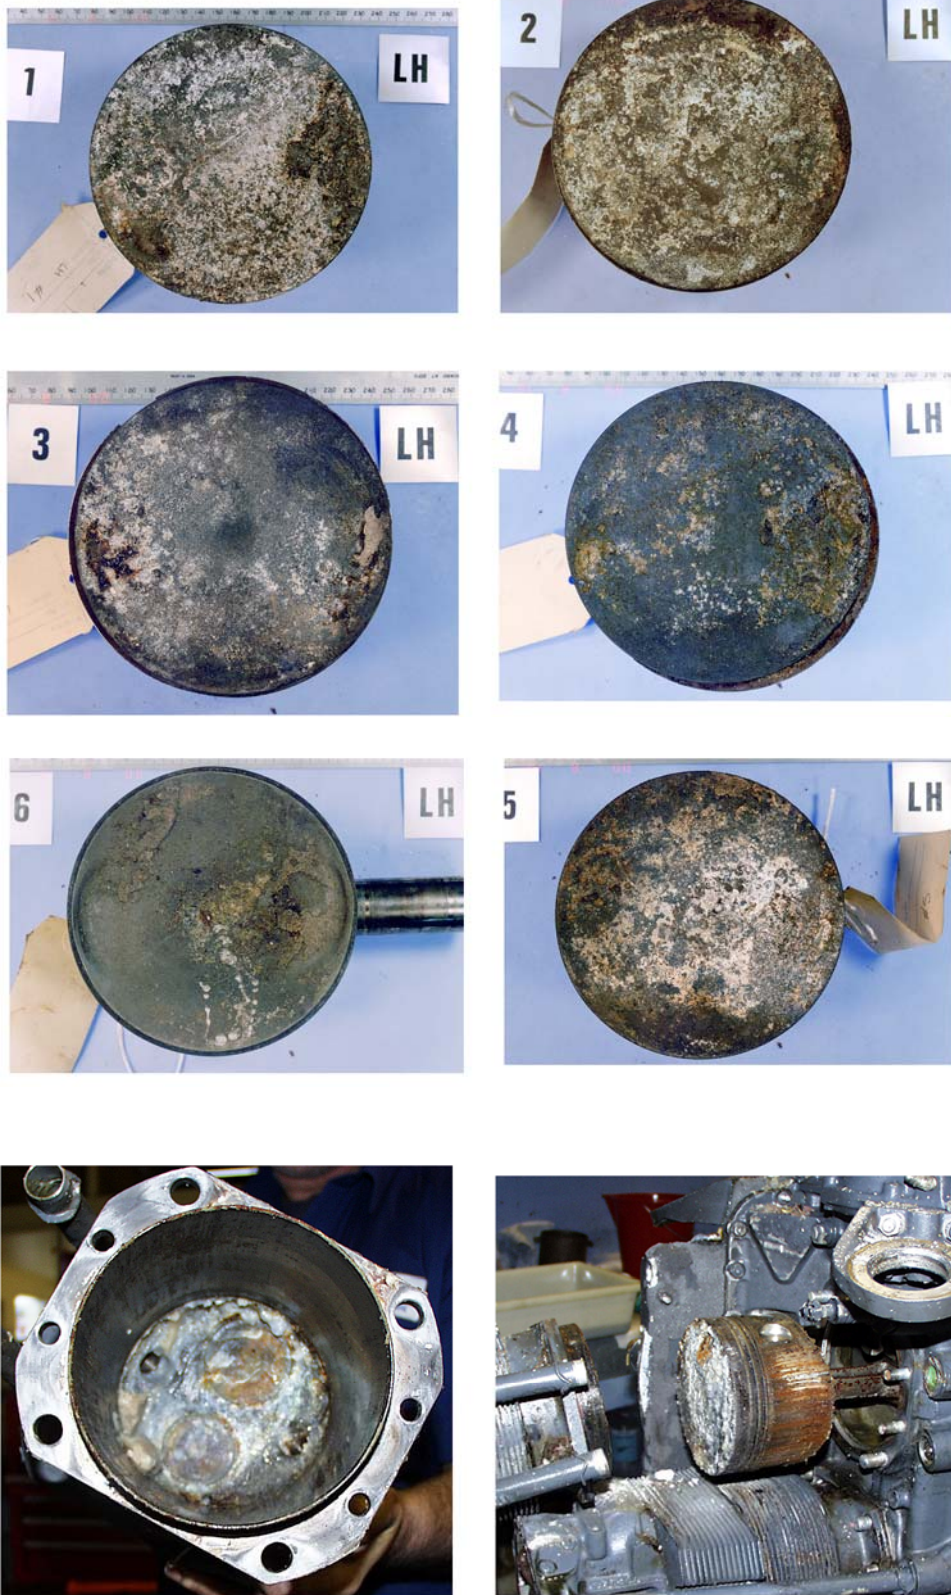
This engine was recovered after immersion in seawater for several days.

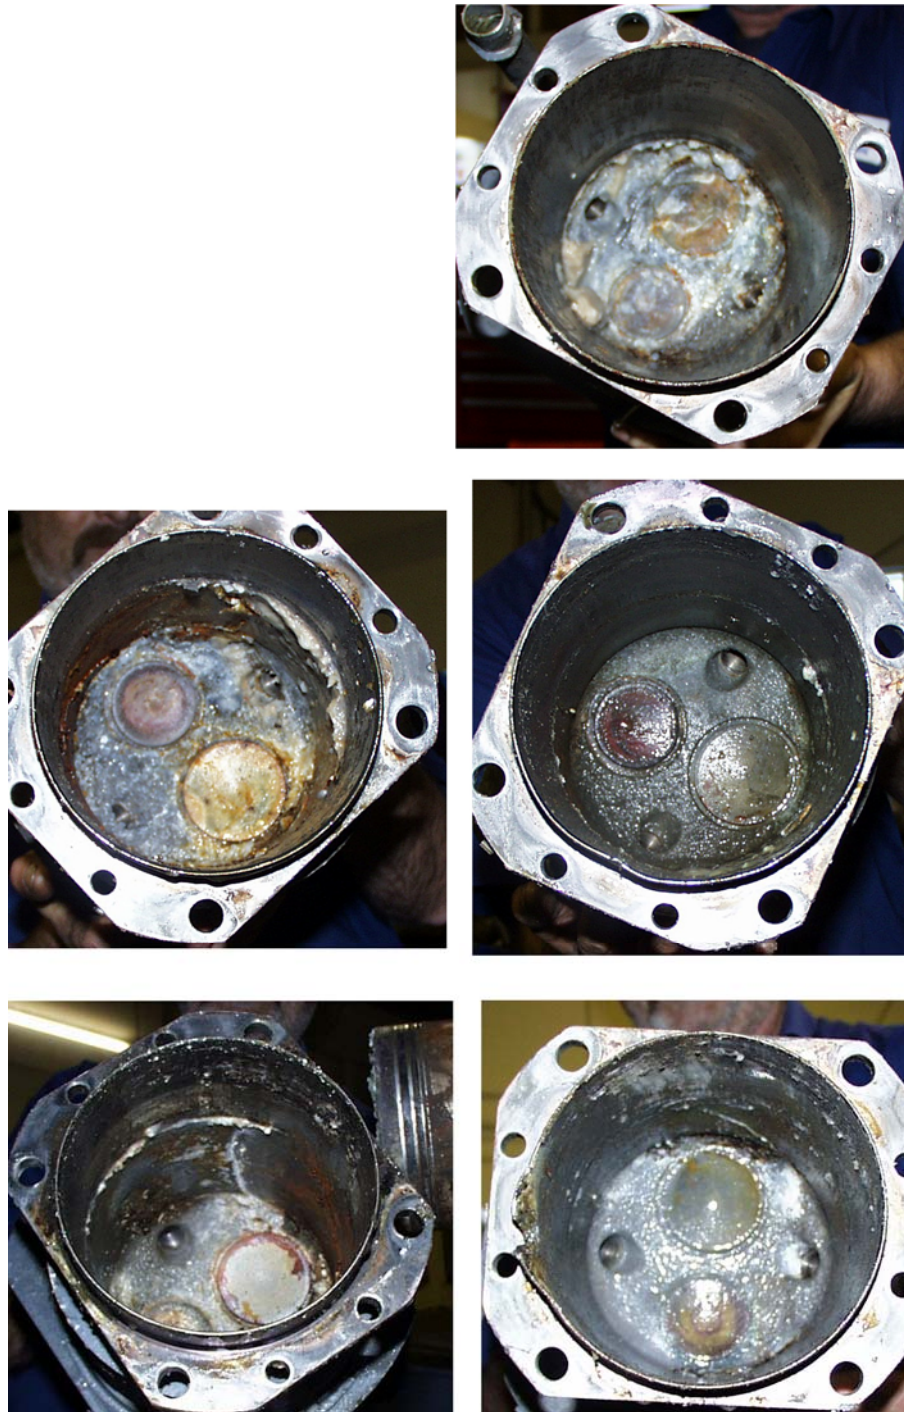
The condition of the combustion chamber surfaces at engine disassembly, showing the effects of immersion in seawater.
