Australian Government  
Australian Transport Safety Bureau

ATSB TRANSPORT SAFETY INVESTIGATION REPORT  
Aviation Research and Analysis Report – B20070191  
Final

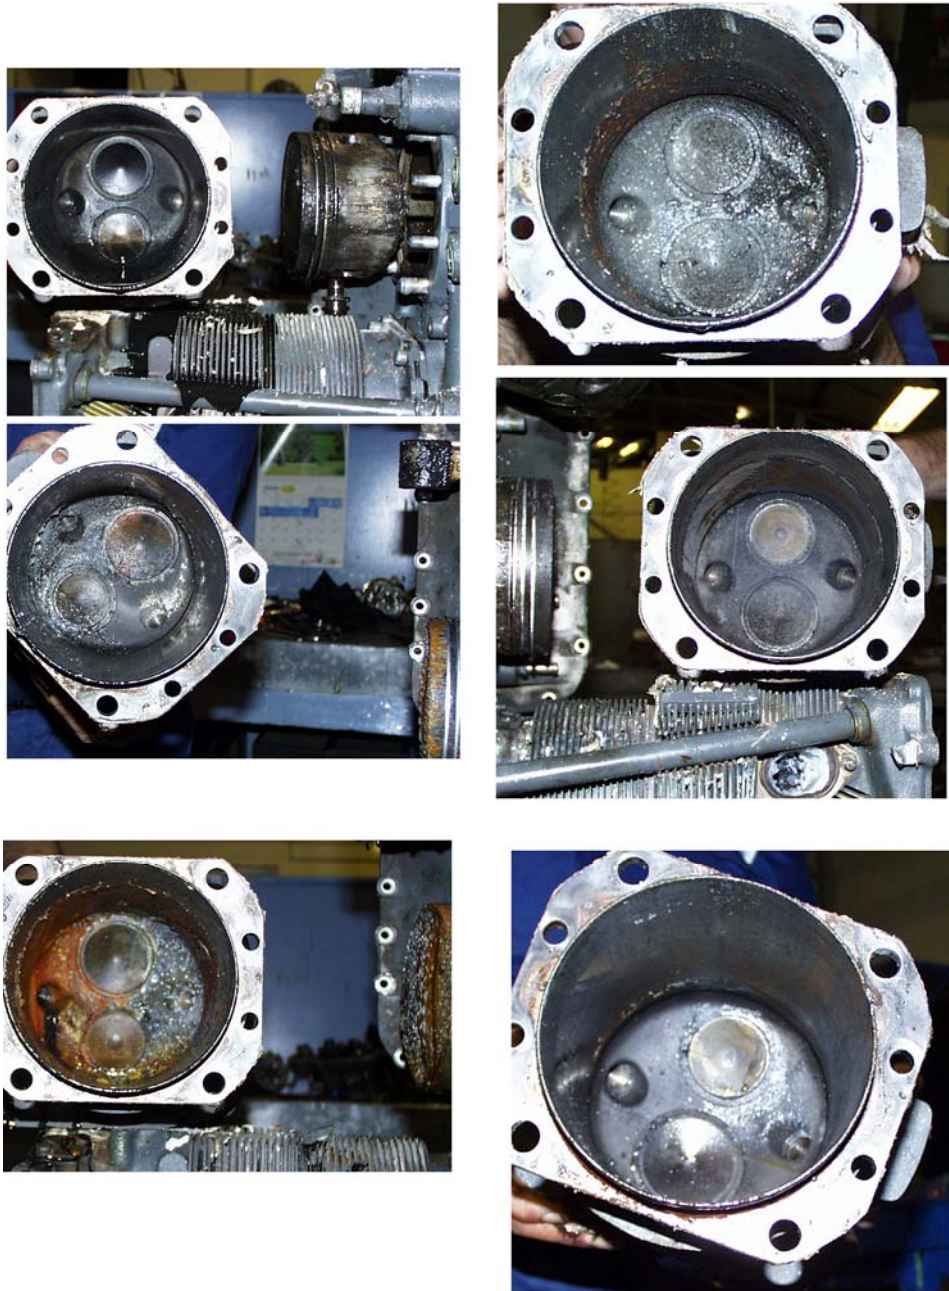
The condition of the combustion chamber surfaces at engine disassembly, showing the effects of immersion in seawater.

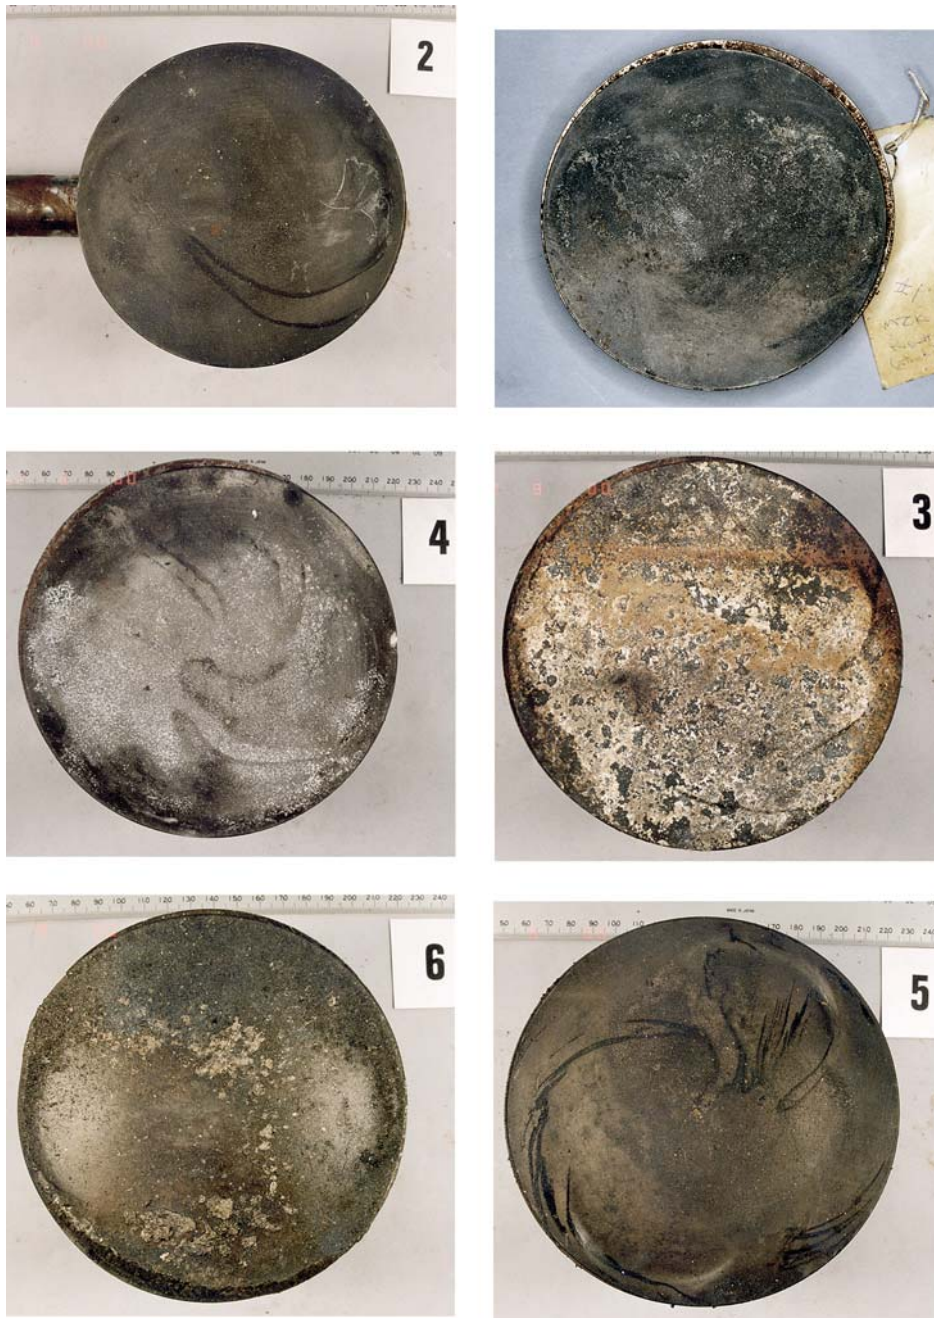
While the piston crown surfaces from this engine were affected by immersion in seawater, it is evident from the residual deposits on the pistons that the engine was operating under very different combustion conditions to the left engine (MZK) prior to engine failure, see figures 8.6 and 8.7, and other Lycoming TIO-540 engines, see for example figures 8.12 – 8.14.

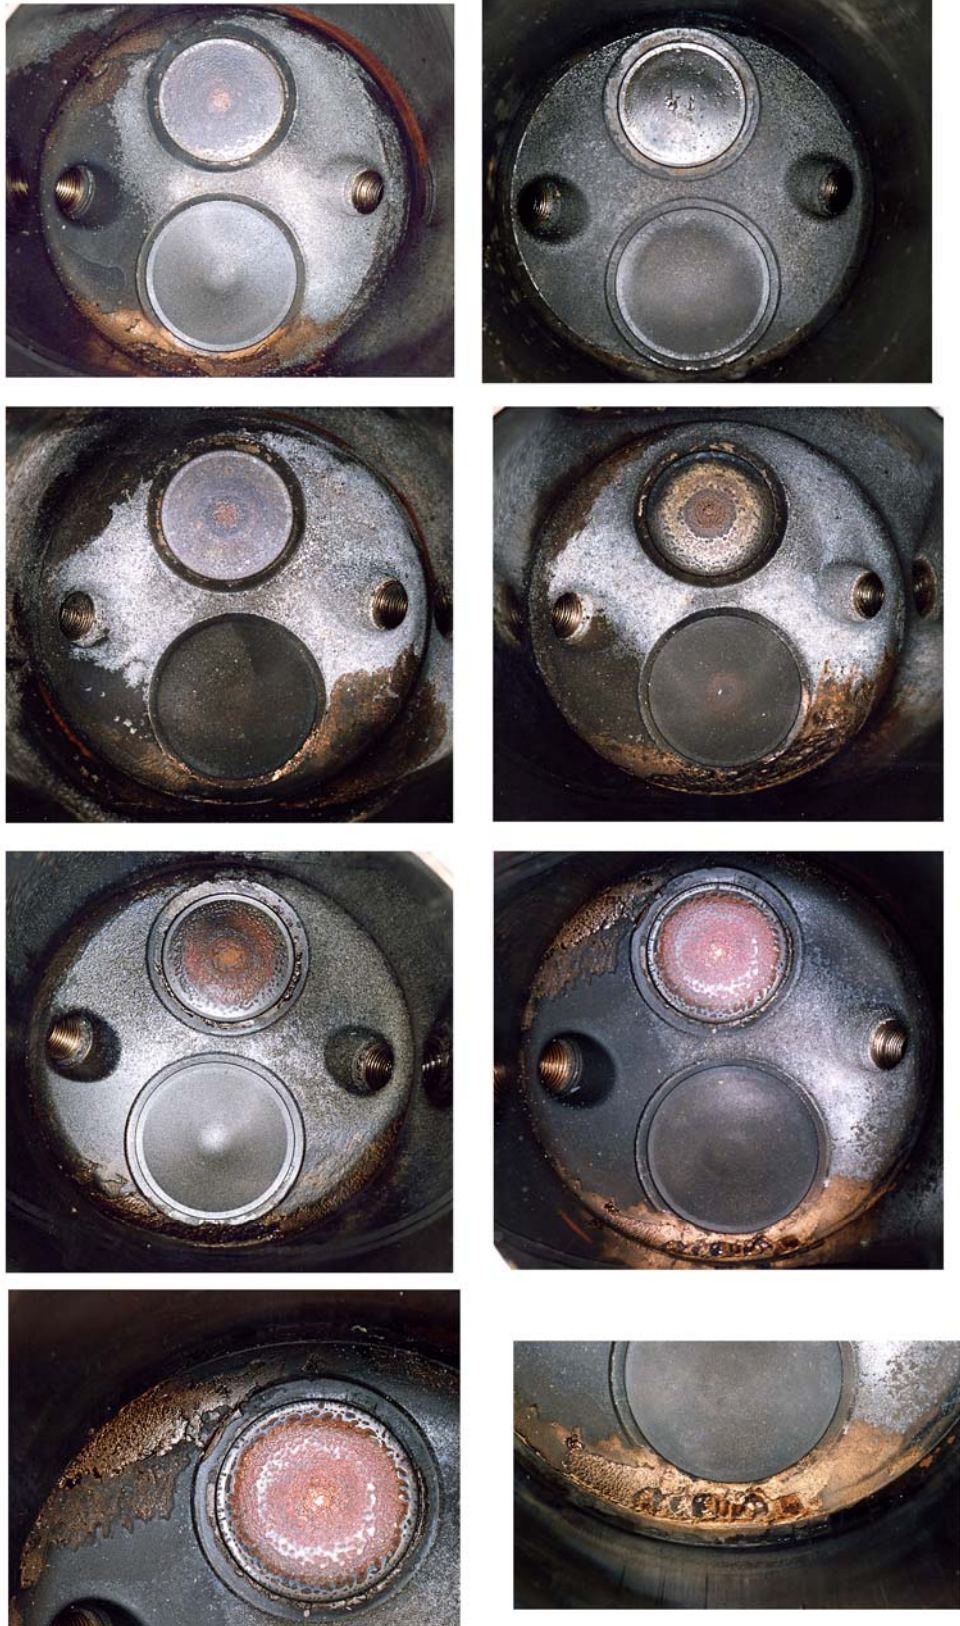
Figure 8.12: Piston surface condition, 2001/5866, VH-JCH (right engine)

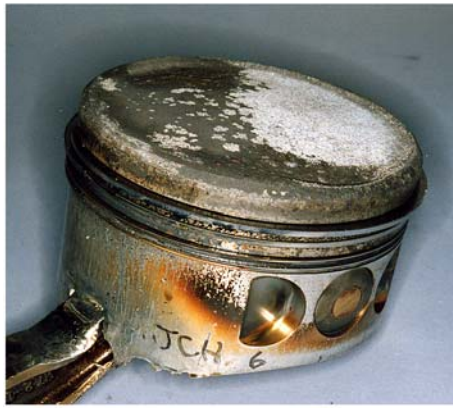
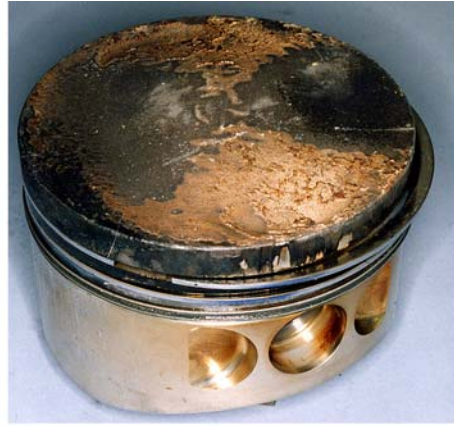
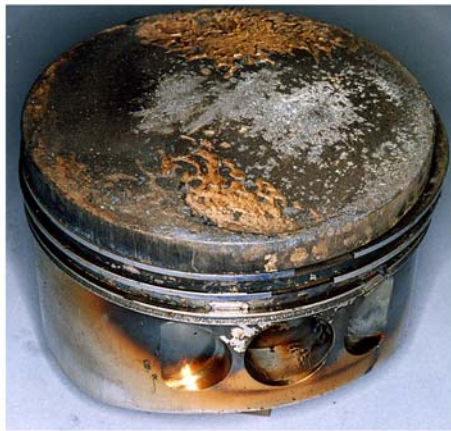
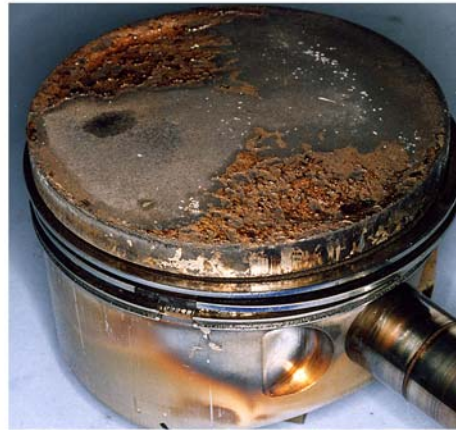
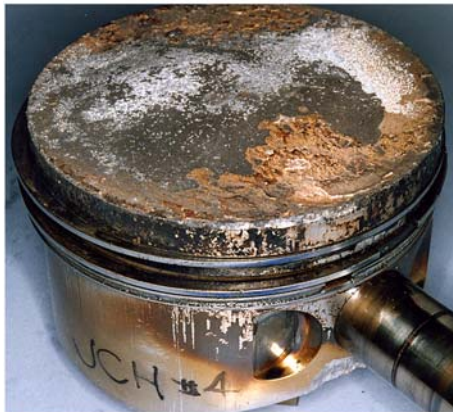
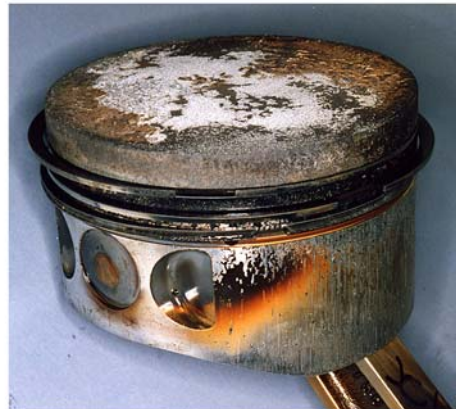
Figure 8.13: Piston surface condition, 2000/2276, VH-ODE (left engine)

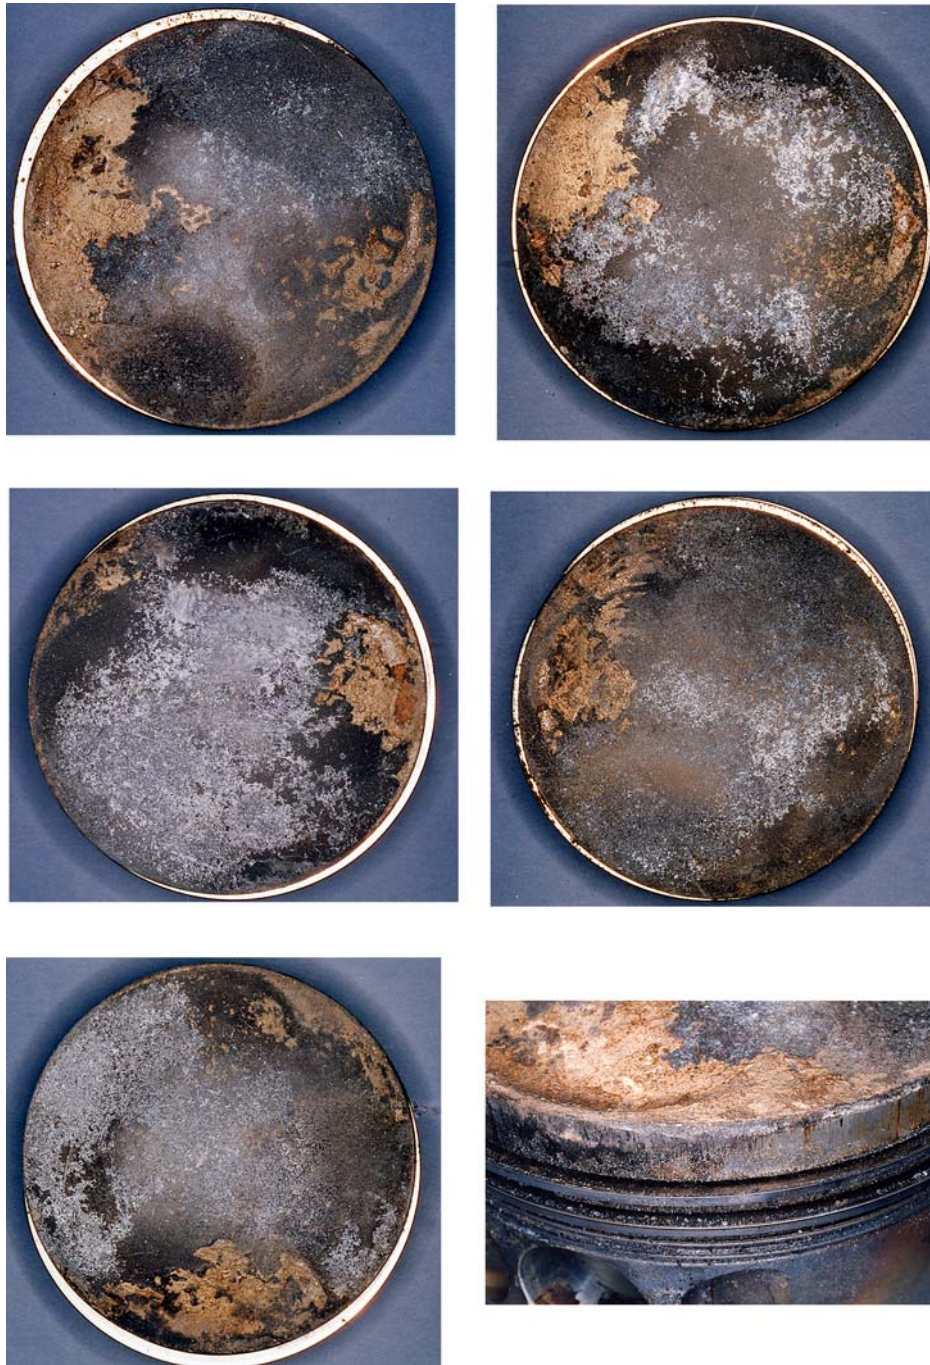
Figure 8.14: Piston surface condition, 2000/3675, VH-NPA (right engine)

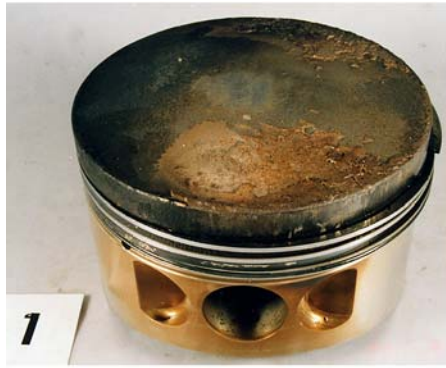
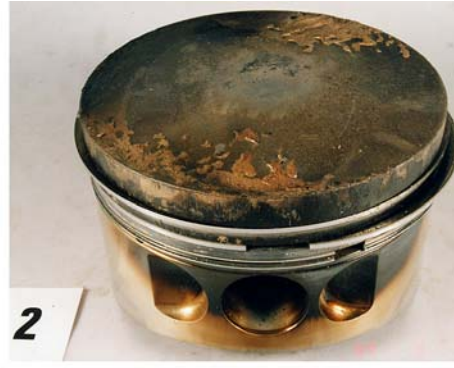
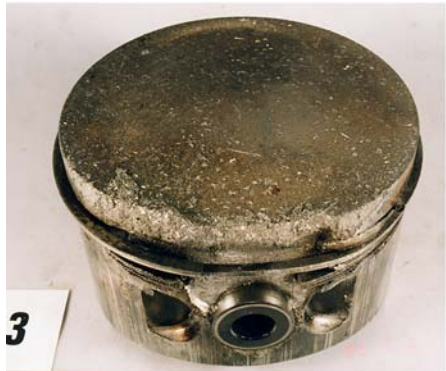
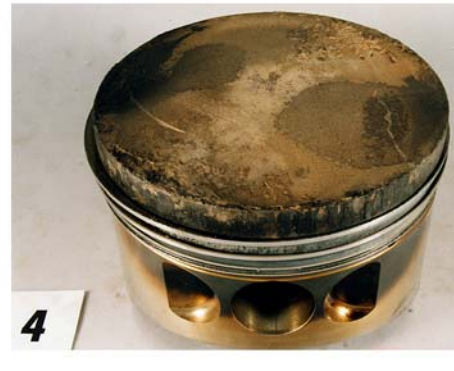
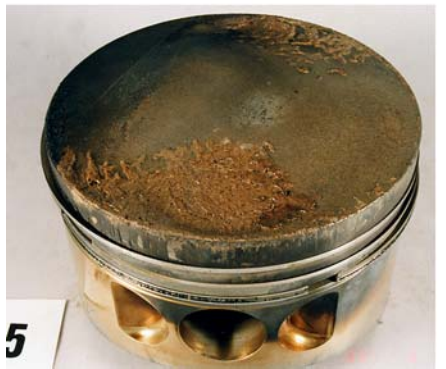
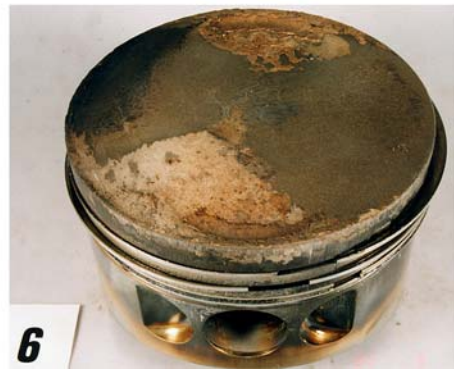
Figure 8.15: Piston surface condition, 2002/3474, VH-ACZ (left engine)

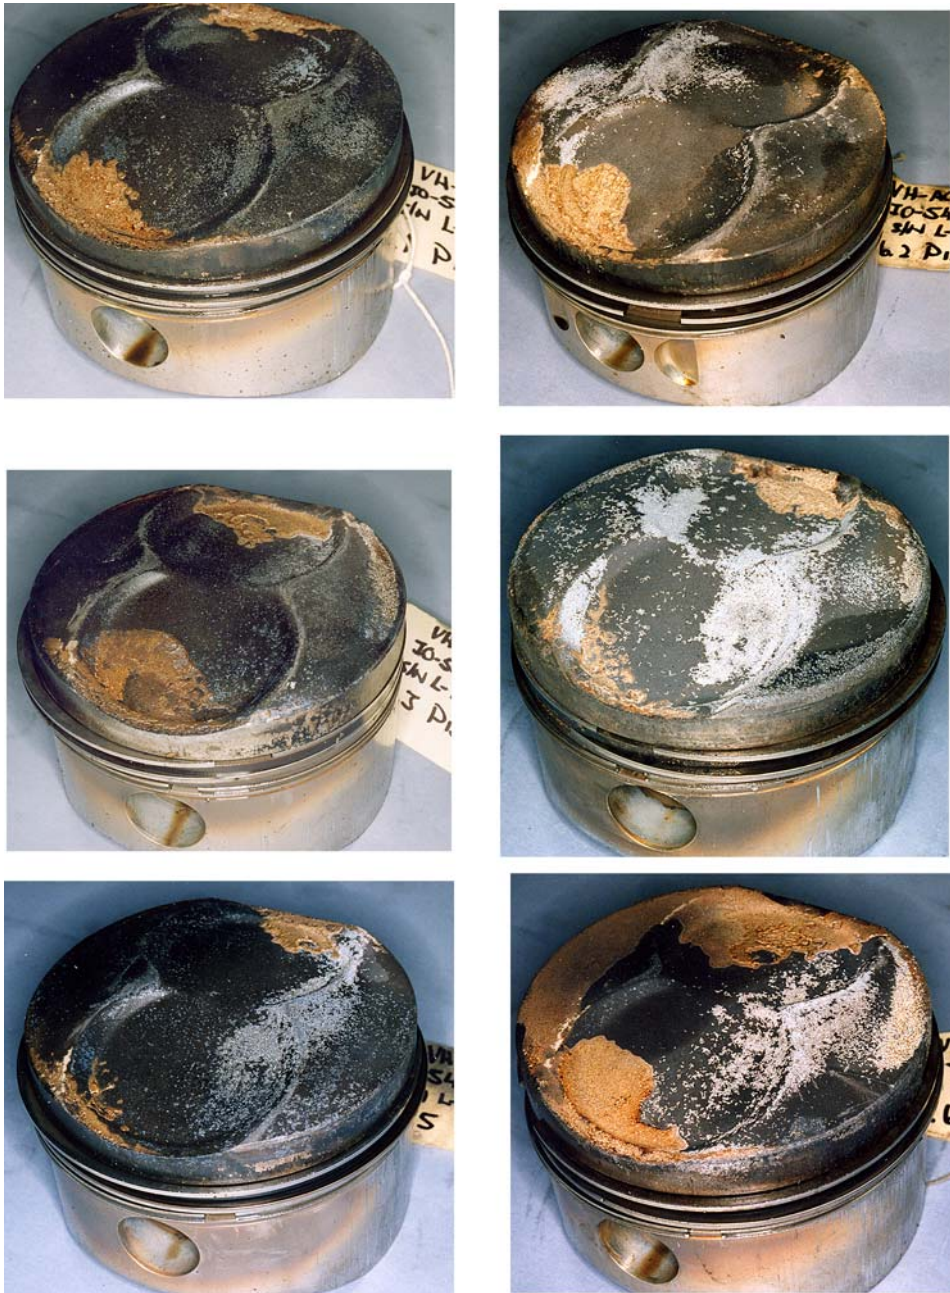
Figure 8.16: Piston surface condition, 2001/2544, VH-TTX (left engine)

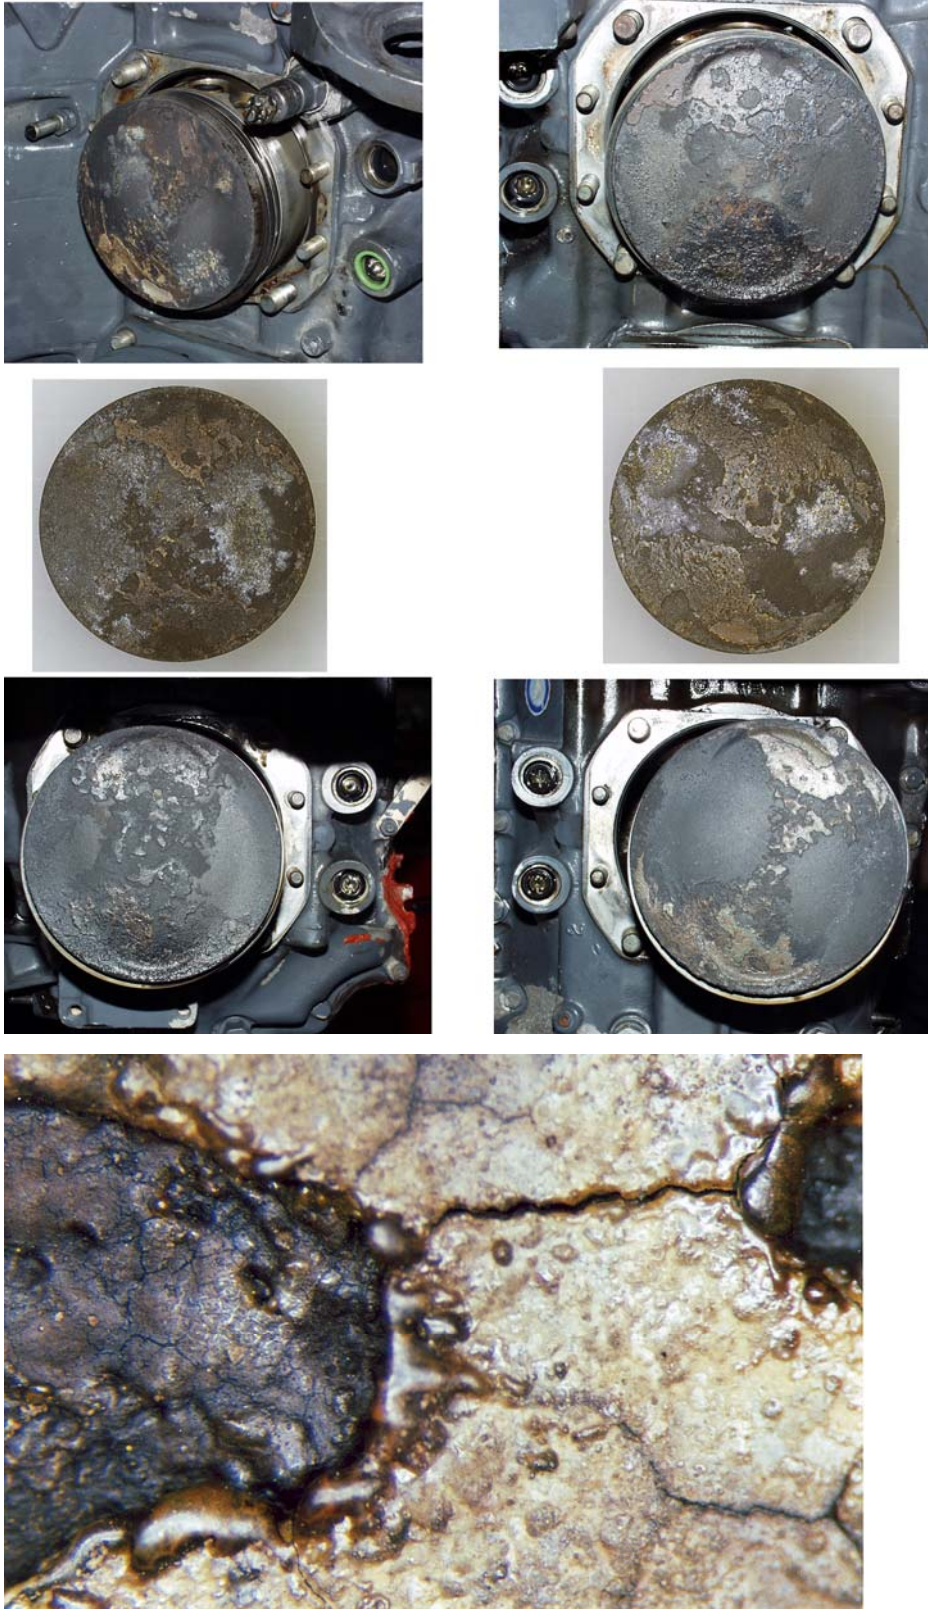
Detail of piston crown deposit showing the features created by deposit edge melting and resolidification

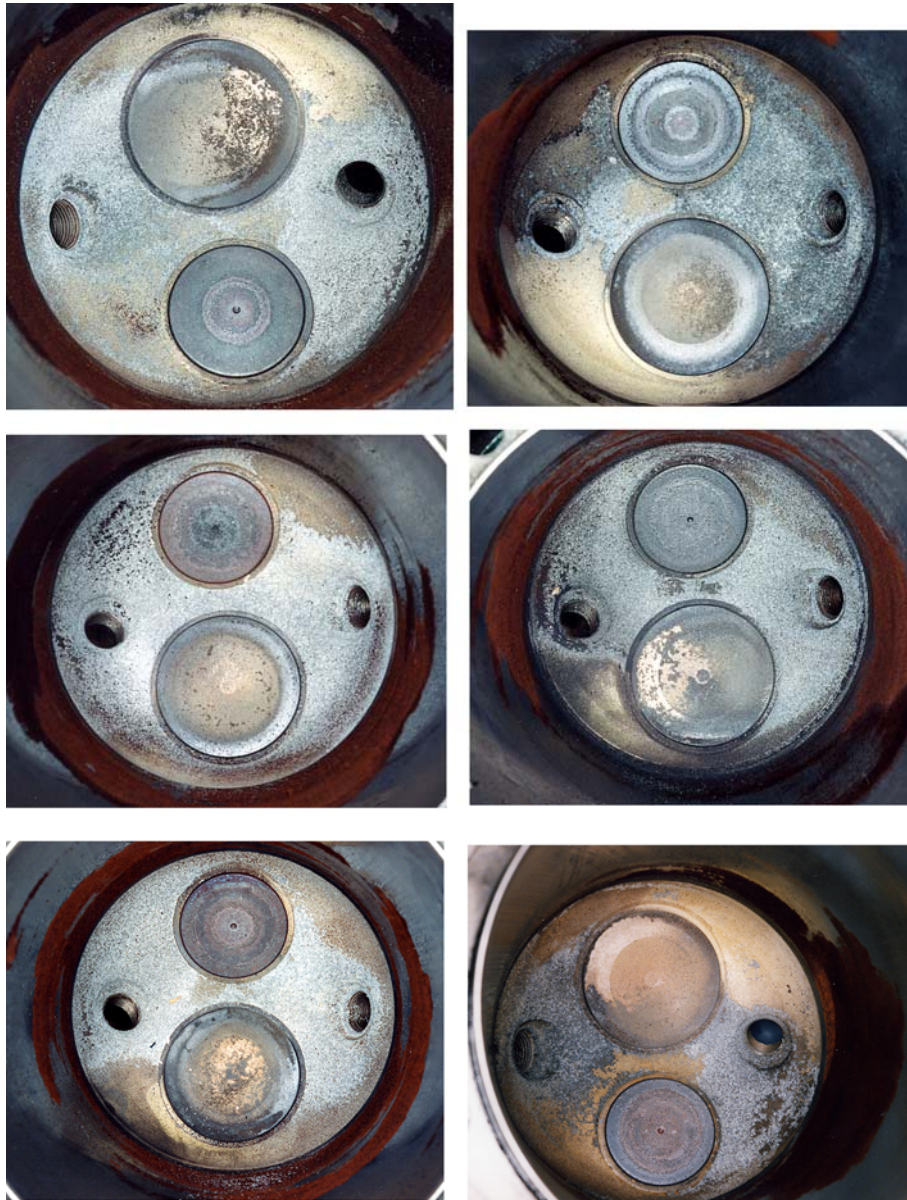
Figure 8.18: Piston surface condition, 2001/4799, VH-BEM (left engine)

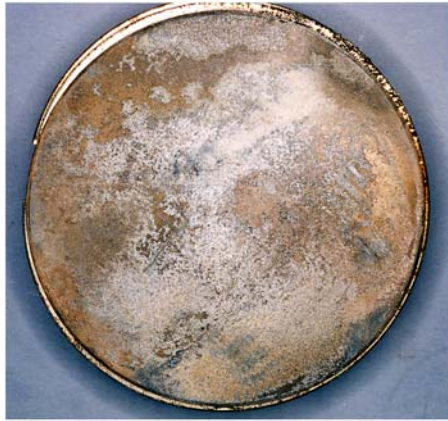
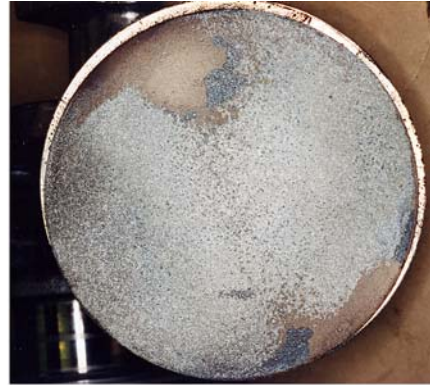
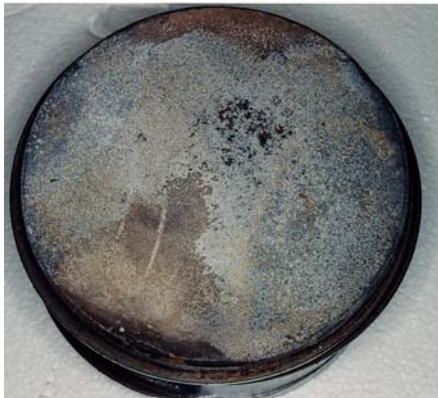
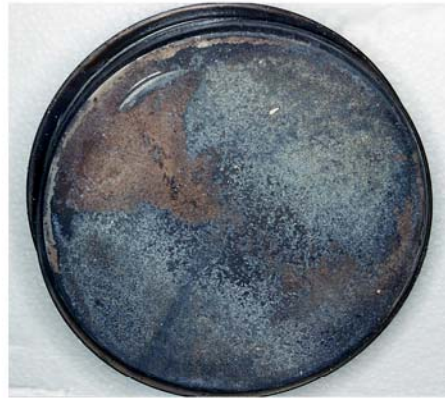
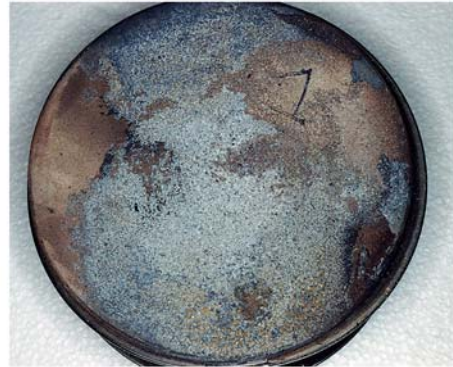
Figure 8.19: Cylinder head surface condition, 2003/2701, VH-OCF (left engine)

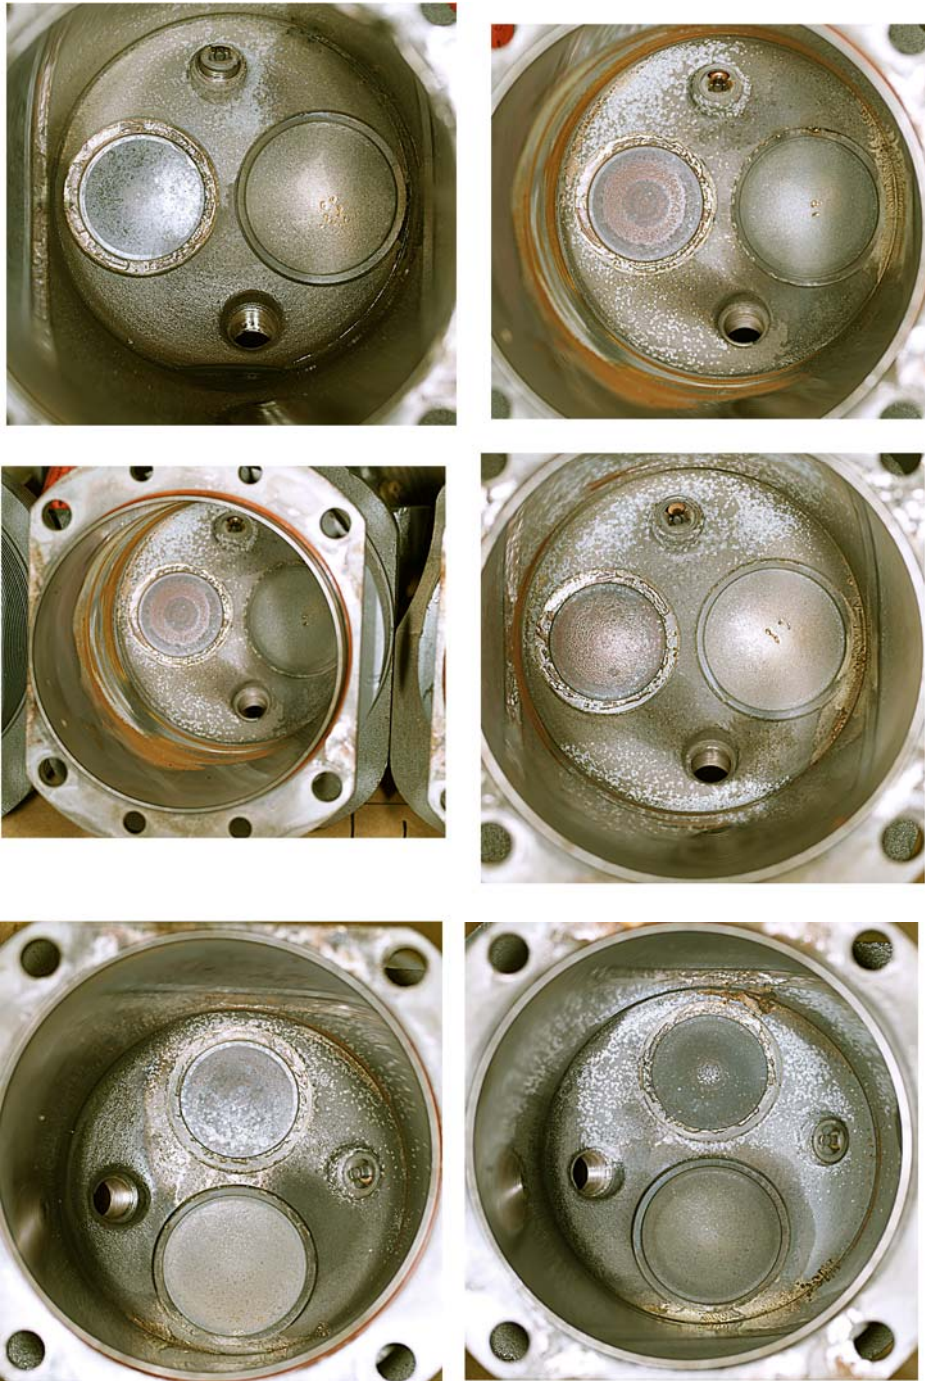
Figure 8.20: Piston surface condition, 2003/2701, VH-OCF (left engine)

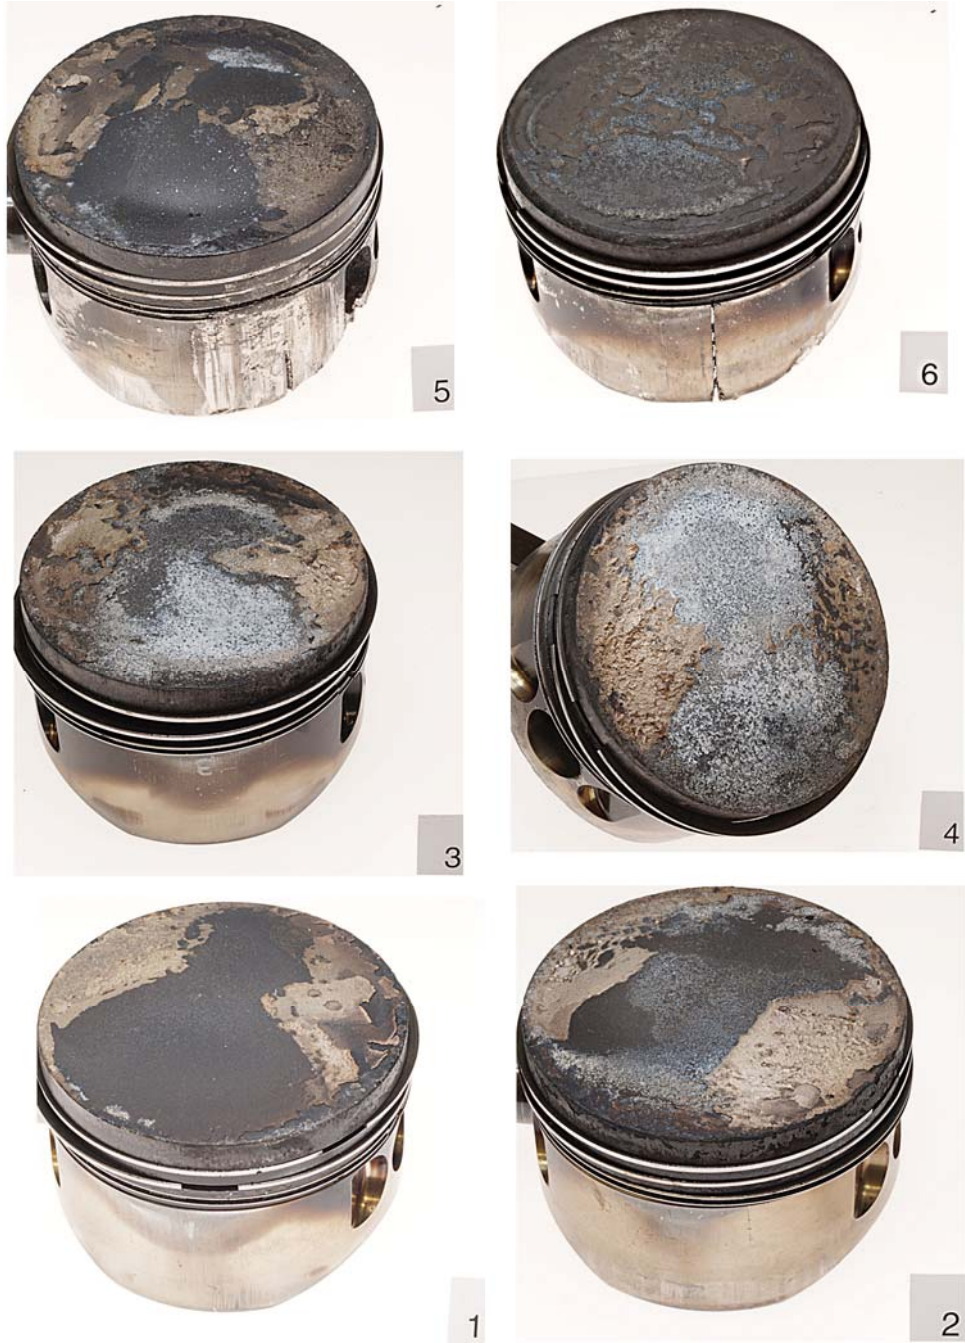
**Figure 8.21: Piston surface condition, 2001/1405, VH-LTW (left engine)**

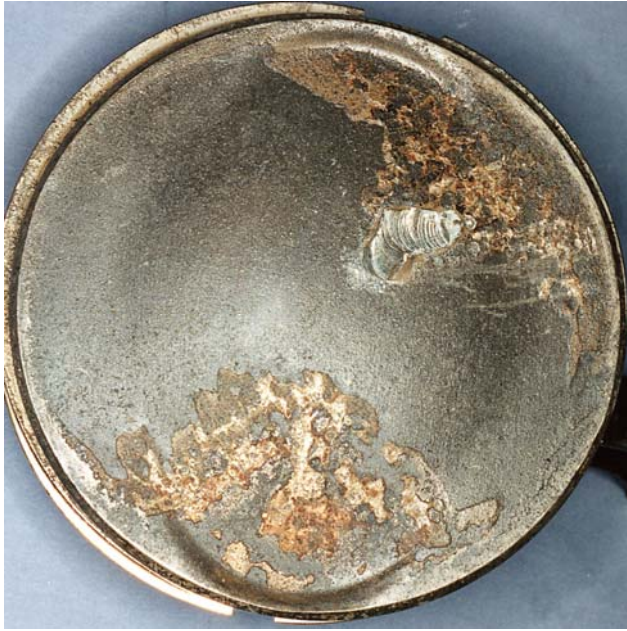
**Figure 8.22: Cylinder head surface condition, 2001/2885, VH-MJA (left engine)**

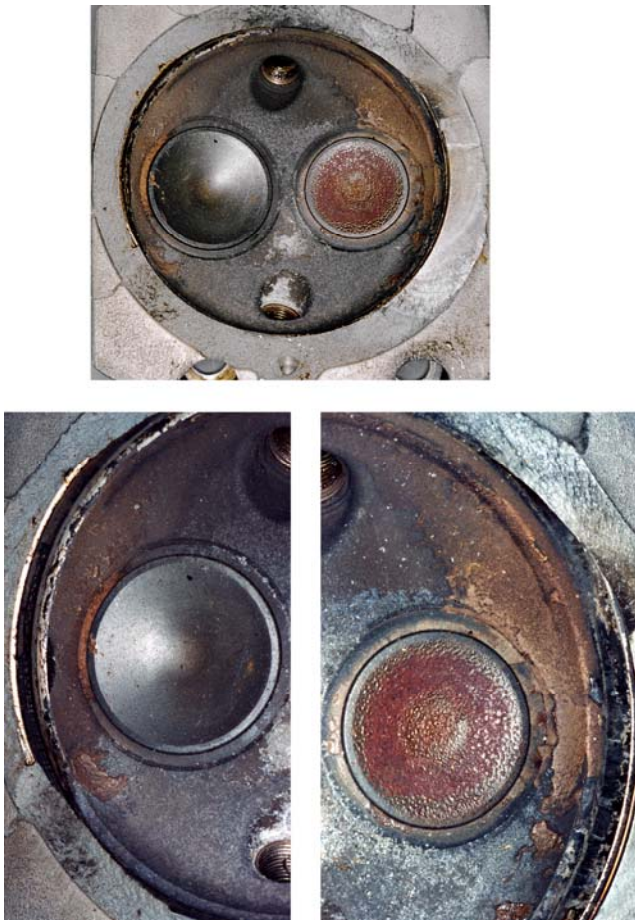
**Figure 8.23: Piston surface condition, 2000/1327, VH-BNN**

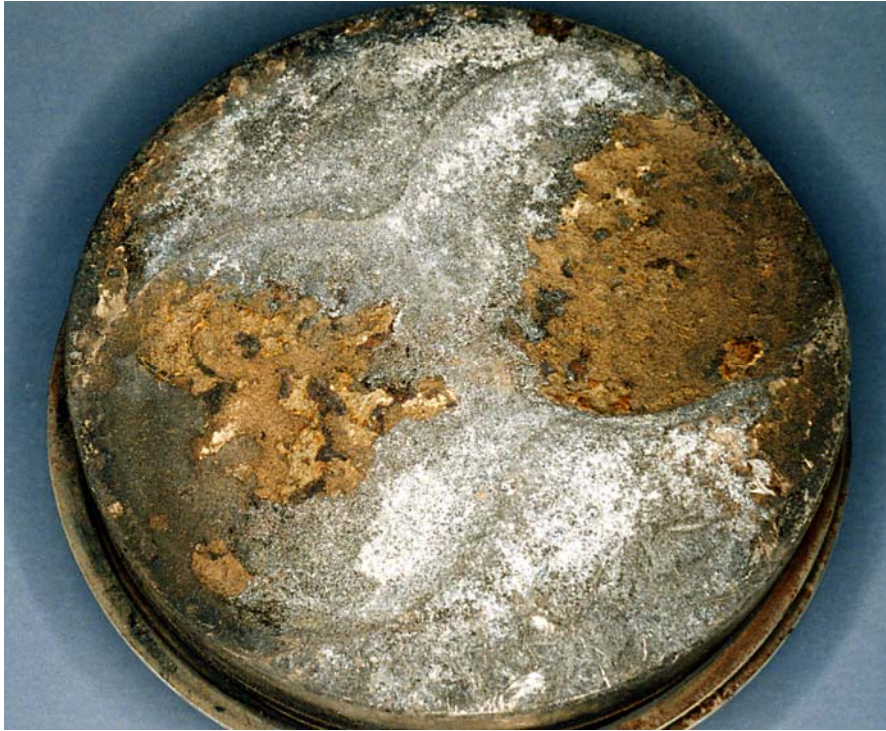
**Figure 8.24: Piston surface condition, 2004/2291, VH-VEC (right engine)**

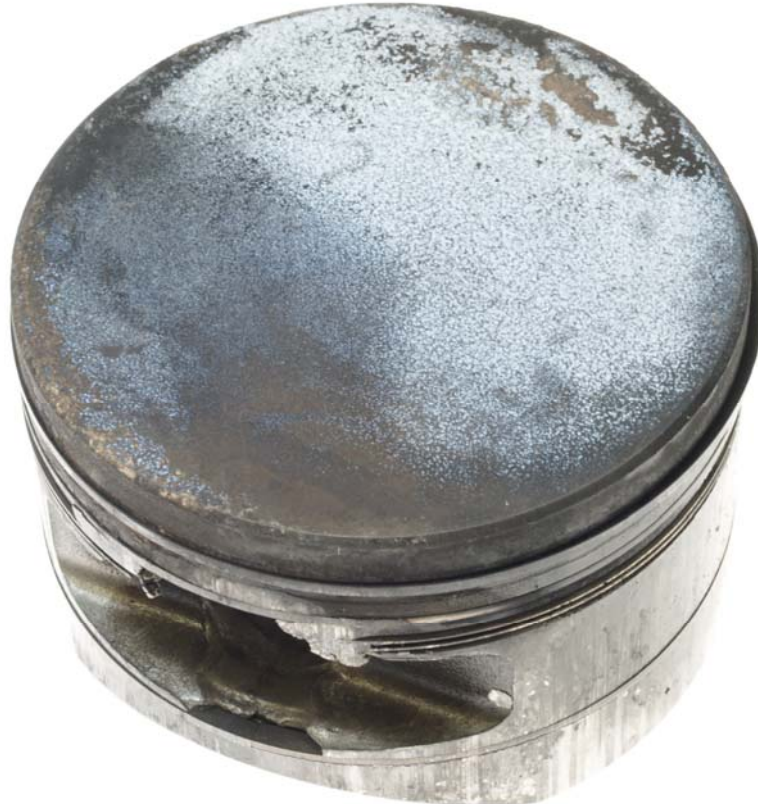
Lead oxybromide deposits may also form in low power engines. However, it is apparent in the example shown in figure 8.25 that localised heating to the deposit melting point has not occurred under the engine operating conditions.

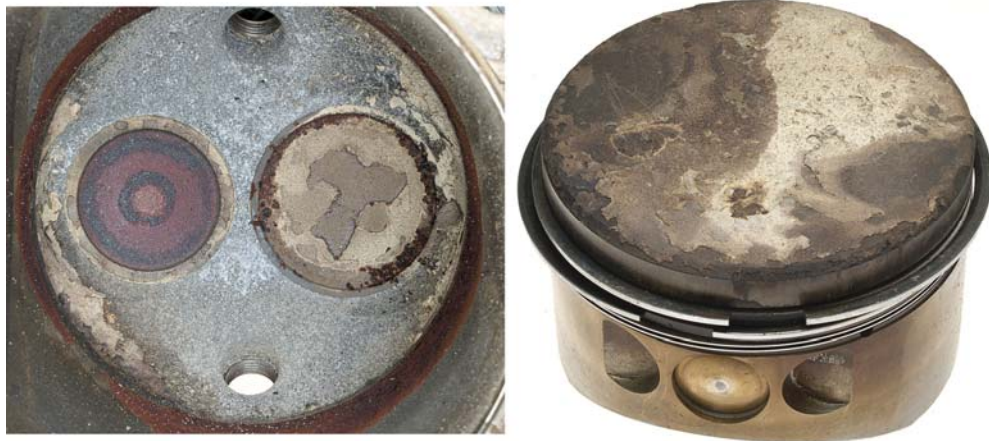
### 8.2.5 Engine control settings

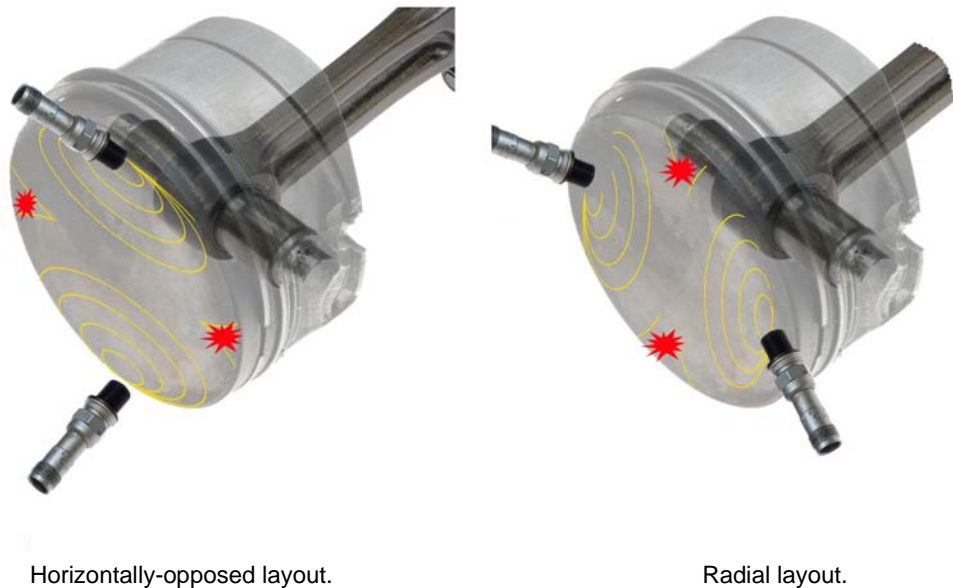
### ***Combustion chamber component temperature***

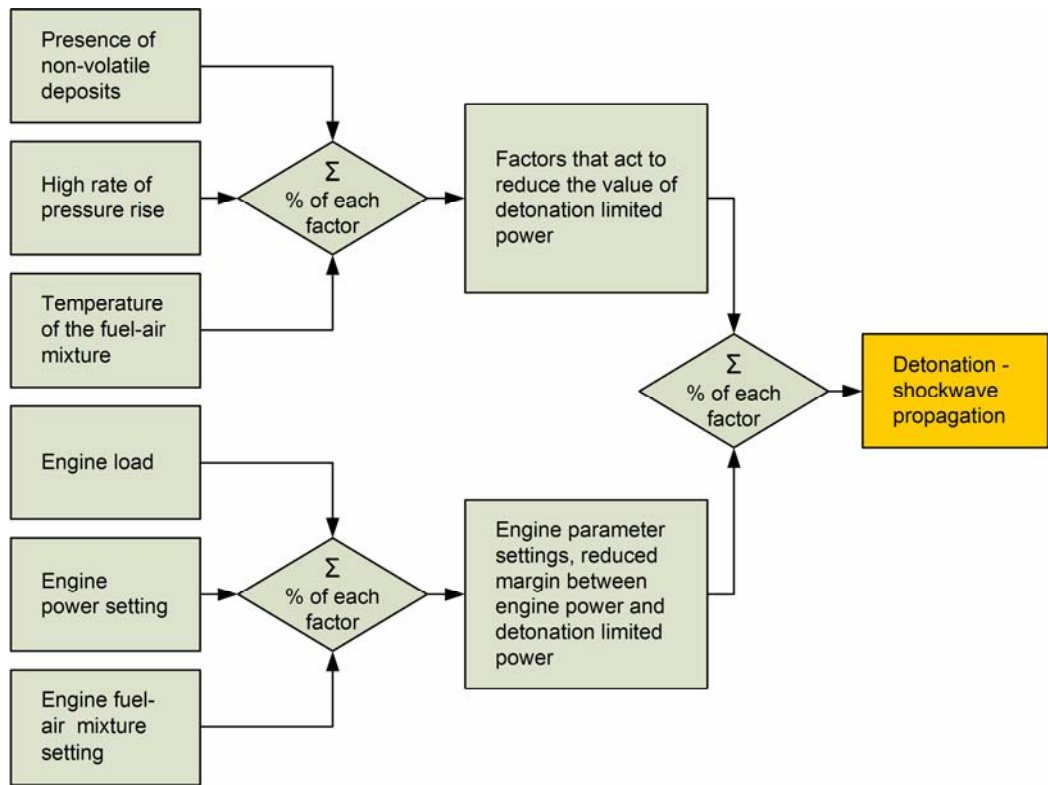
### 8.3 Factors associated with bearing surface breakup

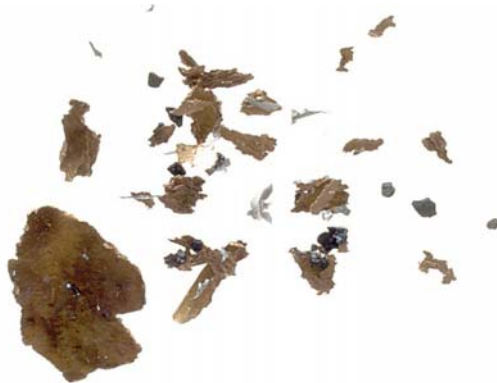
**Figure 8.32: No.1 connecting rod little end bush, VH-OCF (left engine)**

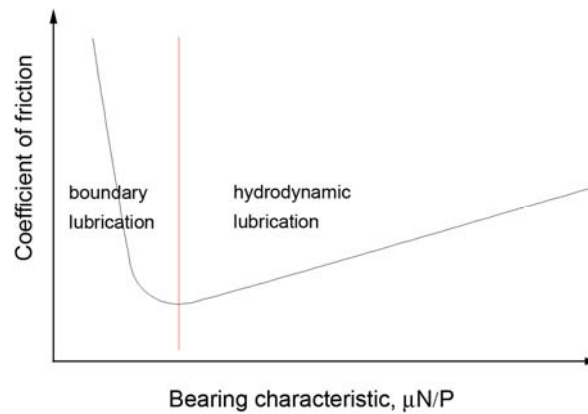
***Loads associated with oil-film breakdown***

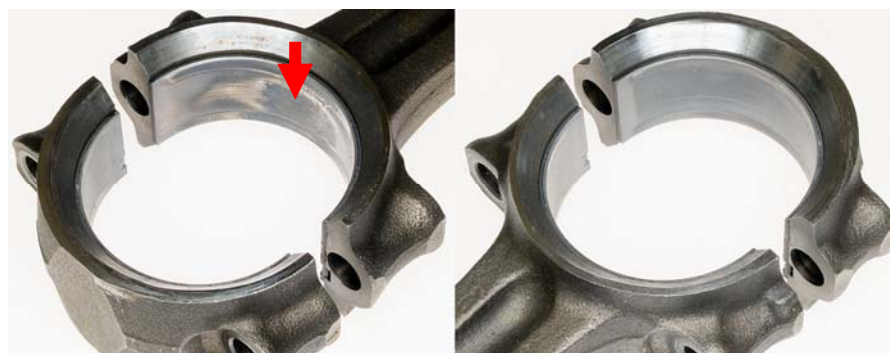
TCM GTSIO-520 engine, trimetal bearing inserts with a copper-lead intermediate layer.

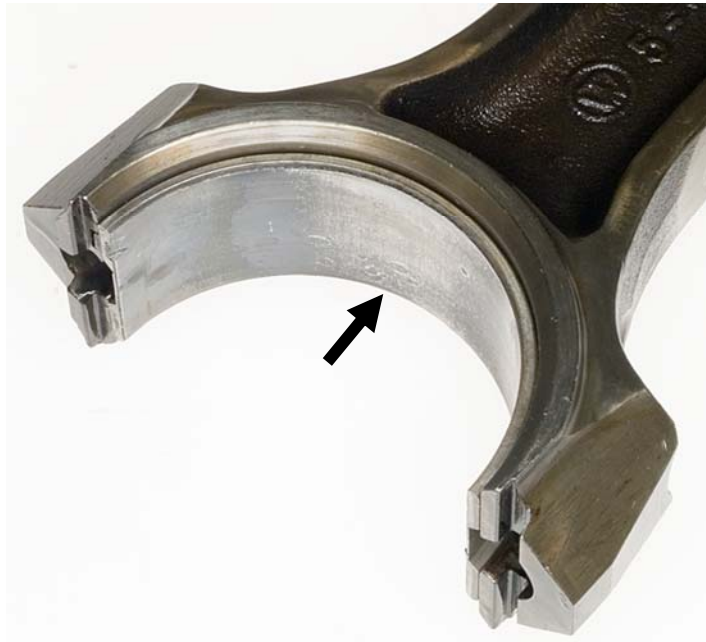
VH-TTX (left engine) No.5

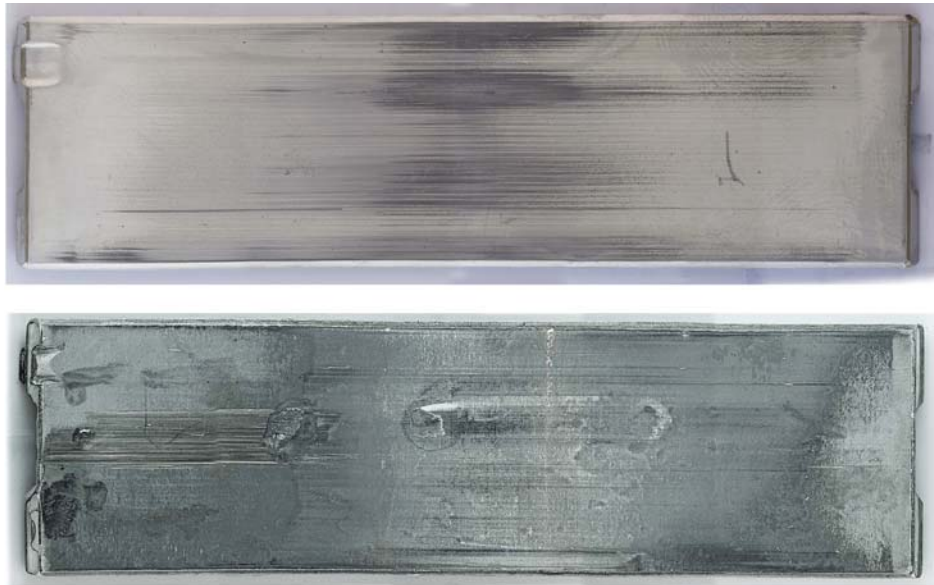
Examples of bearing surface wear from bearings that had been in service for a short time (top), and an engine that had been in service for approximately 1,300 hours (bottom).

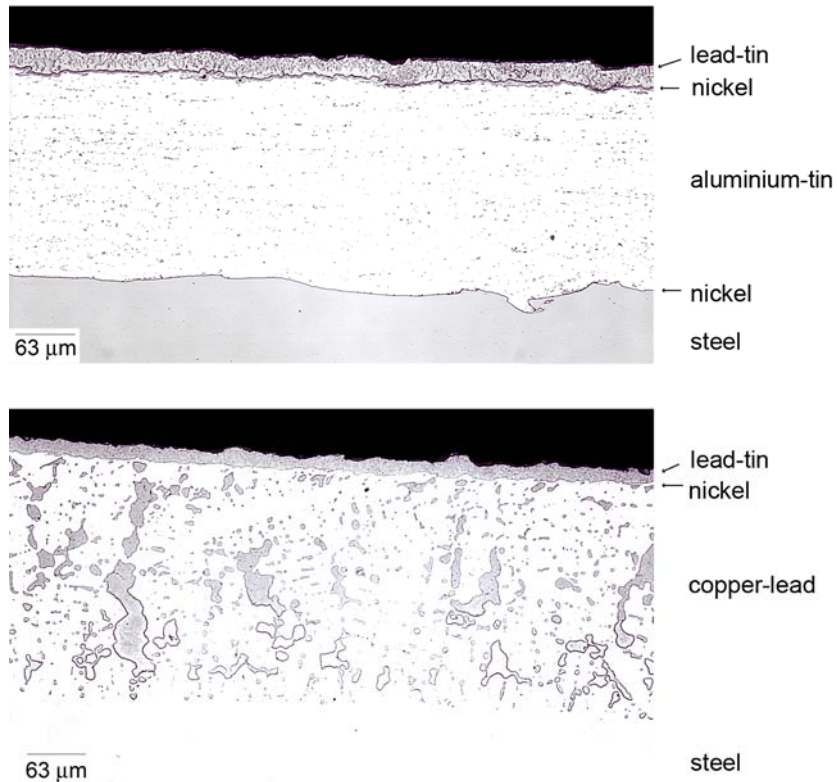
Note: the roughness of the bearing surface evident in the micrographs was created during the mounting of bearing sections in a mineral filled plastic mounting compound.

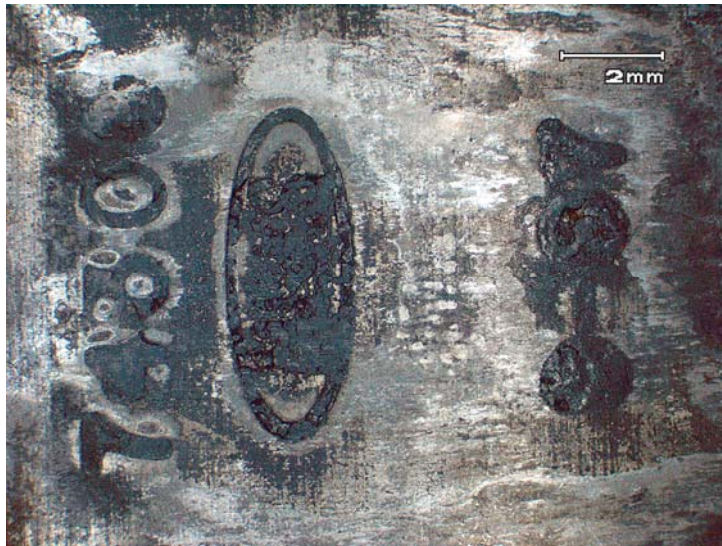
**Figure 8.39: An example of a bearing insert back showing the carbonised residue of oil included between the insert back and bearing housing**

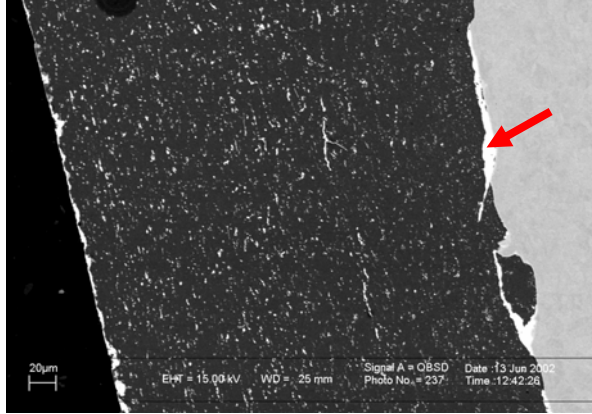
This section is taken through a region of surface layer wear, backscattered electron image. A coarse particle of tin at the interface between the intermediate layer and insert backing is arrowed.

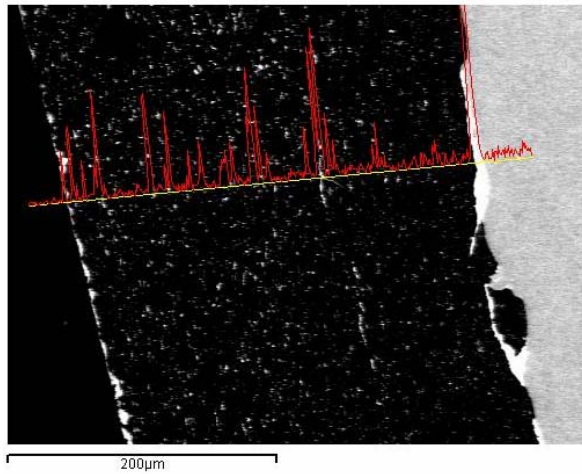
**Figure 8.41: Tin x-ray line scan, micrograph 8.41**
