Australian Government  
Australian Transport Safety Bureau

ATSB TRANSPORT SAFETY INVESTIGATION REPORT  
Aviation Research and Analysis Report – B20070191  
Final

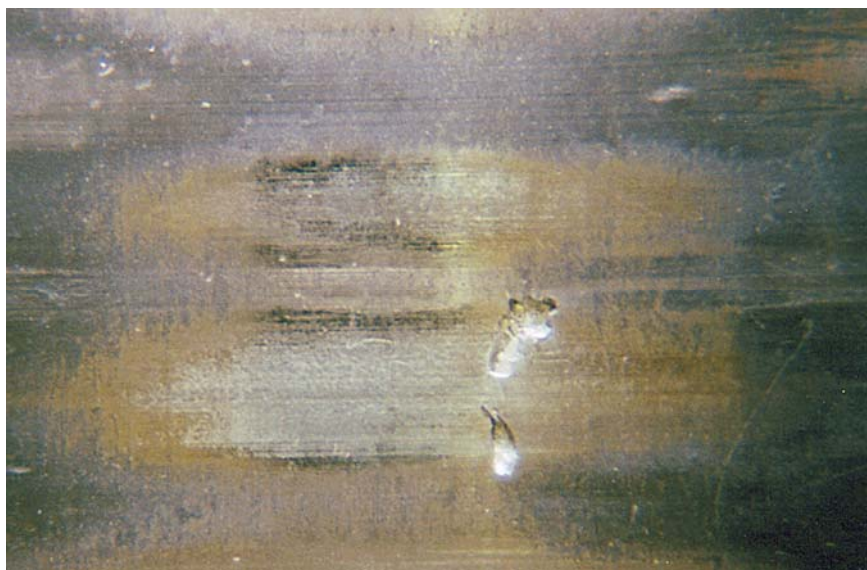
**Figure 8.43:** Bearing surface breakup, trimetal bearing with aluminium-tin intermediate layer, major defect report 99/1447, Piper PA 31-350, Lycoming LTIO-540-J2BD

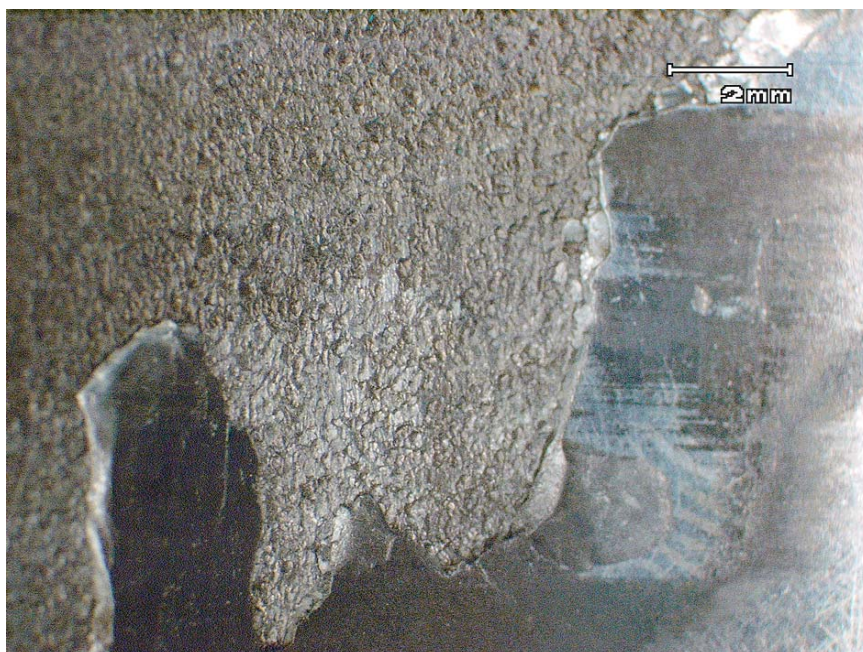
***Effect of the nickel plating between the lead-tin surface layer and the aluminium-tin intermediate layer***

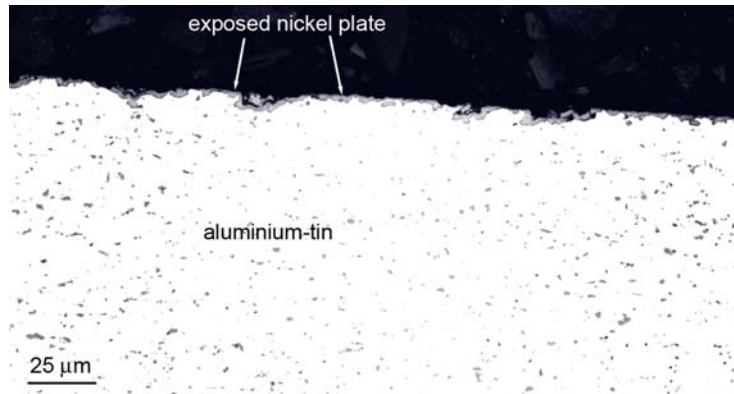
X-ray maps, figure 8.45, clearly show that in regions where the lead-tin surface layer has been worn through the nickel layer overlying, the aluminium-tin intermediate layer is exposed and remains adherent.

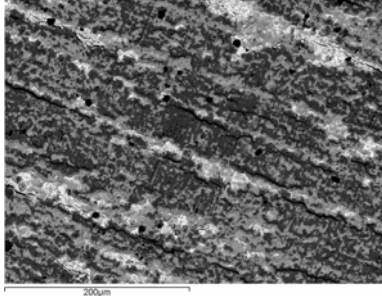
Backscattered electron image showing surface topography and compositional contrast. The light regions indicate the presence of high atomic number elements, e.g. lead. The dark regions indicate the presence of low atomic number elements, e.g. aluminium.

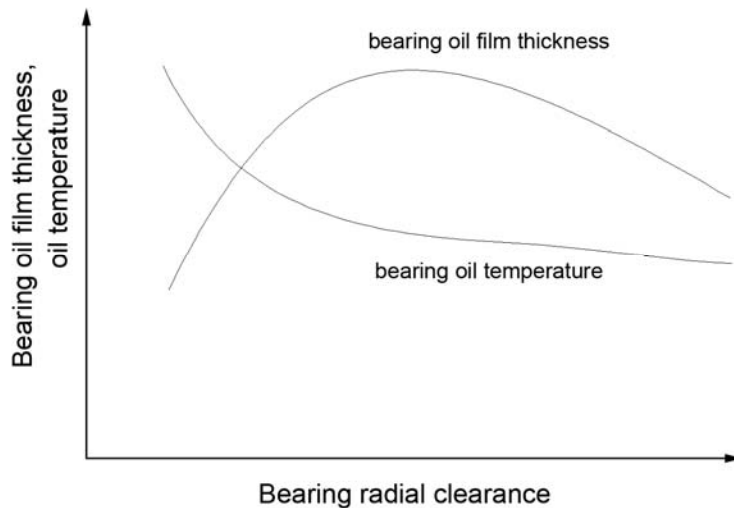
Crankshaft journals may wear during engine operation. The effects of journal wear may be corrected during engine overhaul by polishing the journals to an ‘undersize’ diameter, and installing ‘oversize’ bearing inserts. For Lycoming engines, journals may be reduced in diameter by 0.003in during overhaul. The oversize bearing inserts include a marking ‘M03’, (journal, minus 0.003in) with the bearing part number marking.

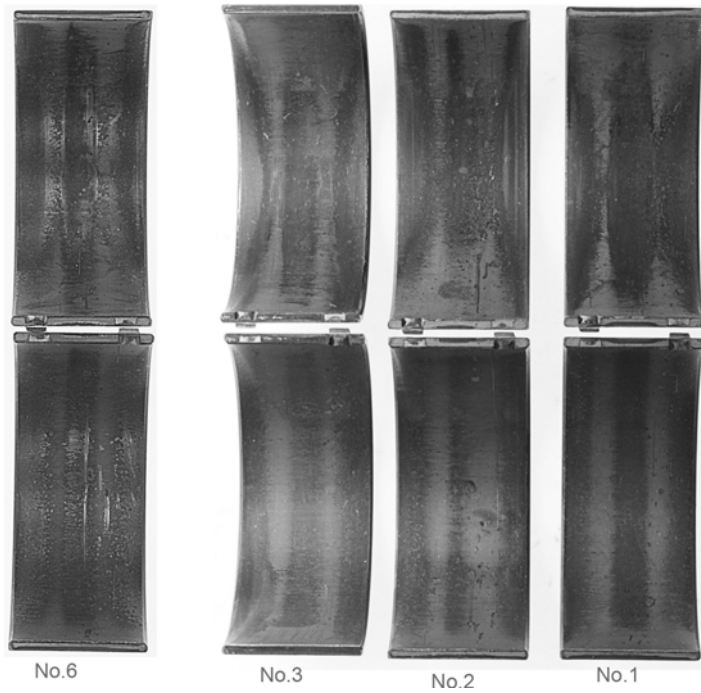
The inserts on the rod side of the big end bearings are shown at the top of the figure and the cap side inserts are shown at the bottom of the figure

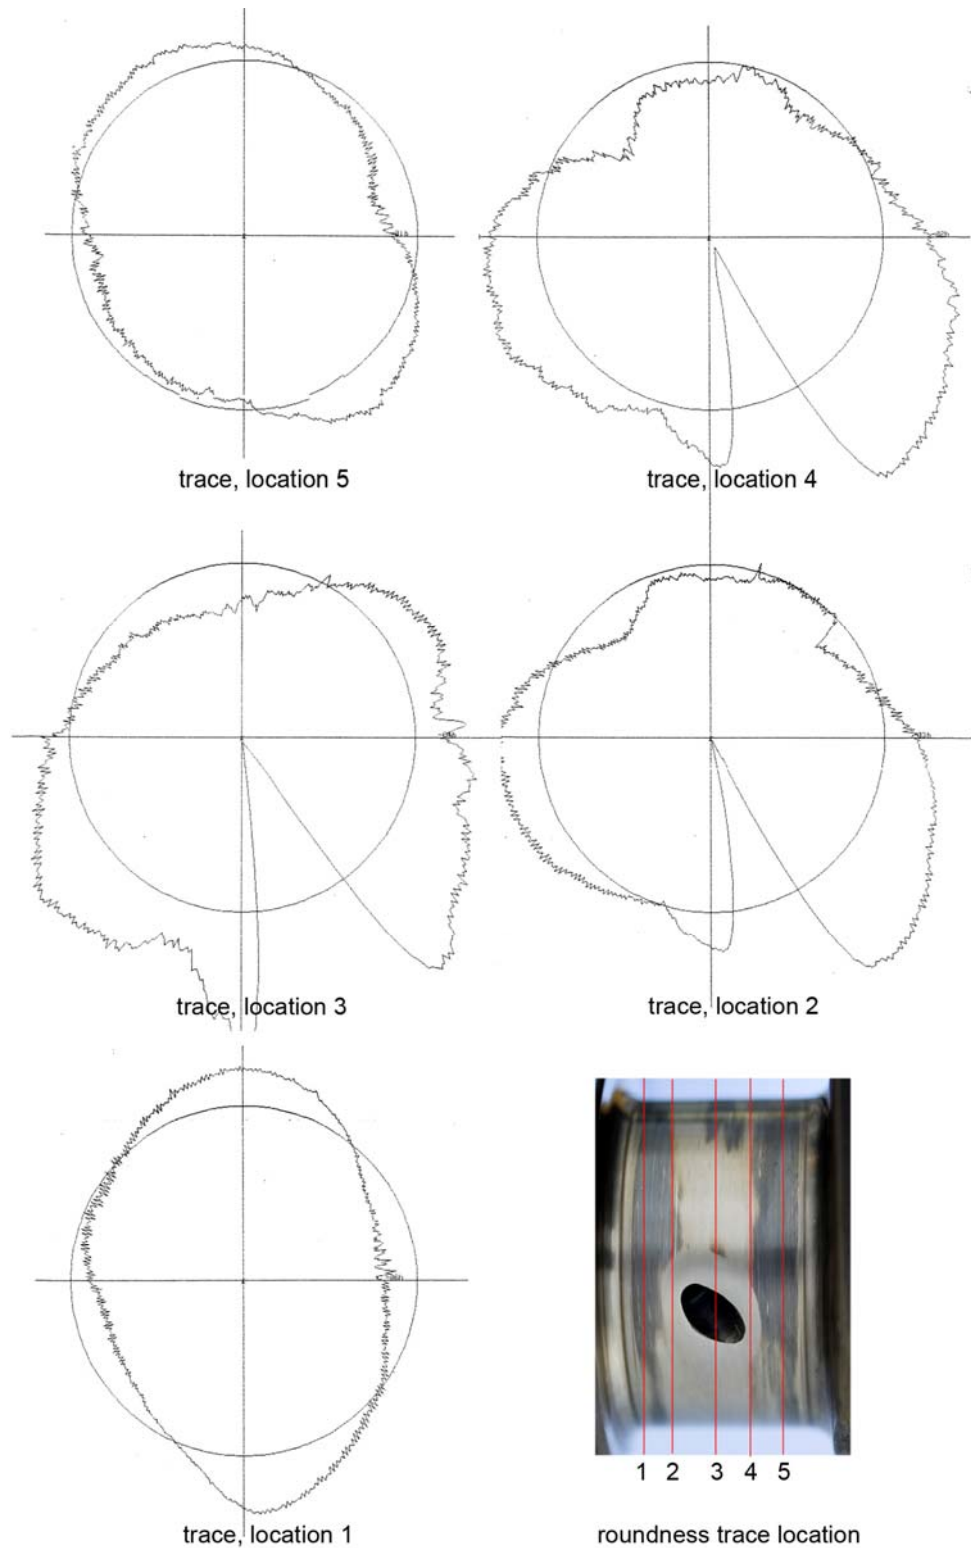
Notes: the reference circle is a least squares circle, the plot magnification is 5,000 times, trace 3 is over the oil hole, traces 2 and 4 are adjacent to the oil hole.

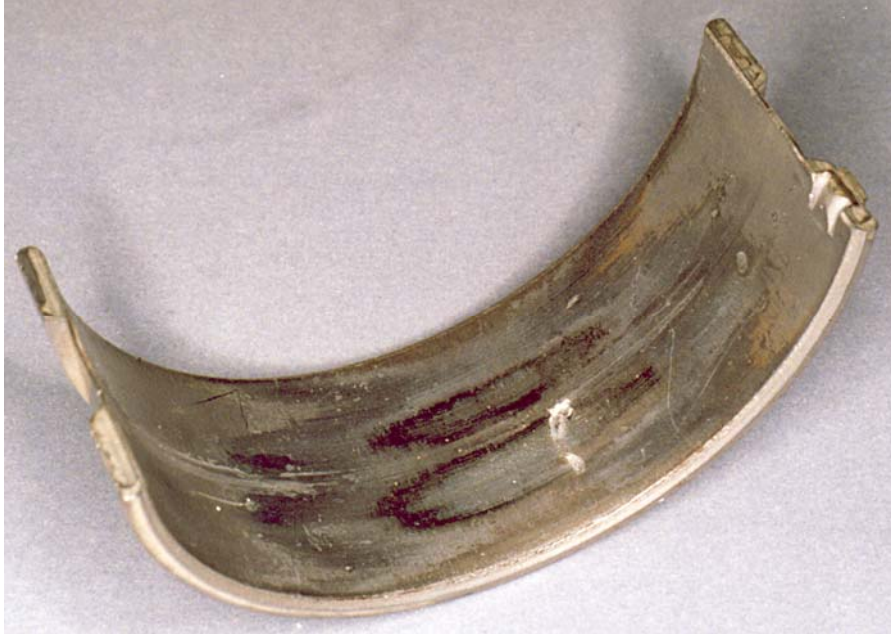
Bearing insert marked M03

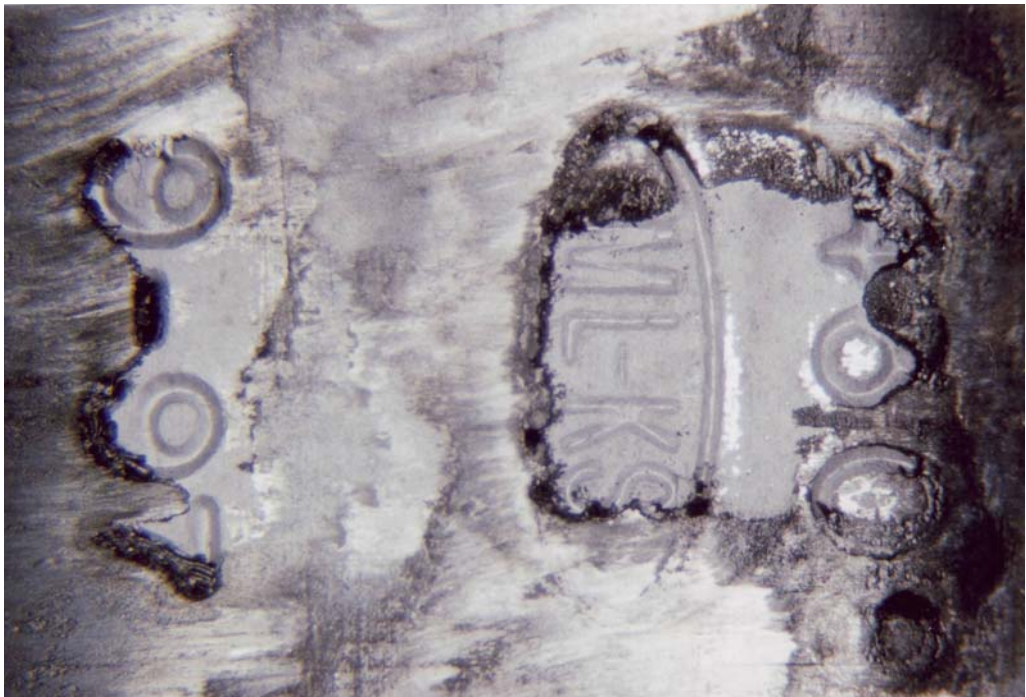
**Figure 8.55: Example of big-end insert back wear, occurrence 2001/5866, VH-JCH**

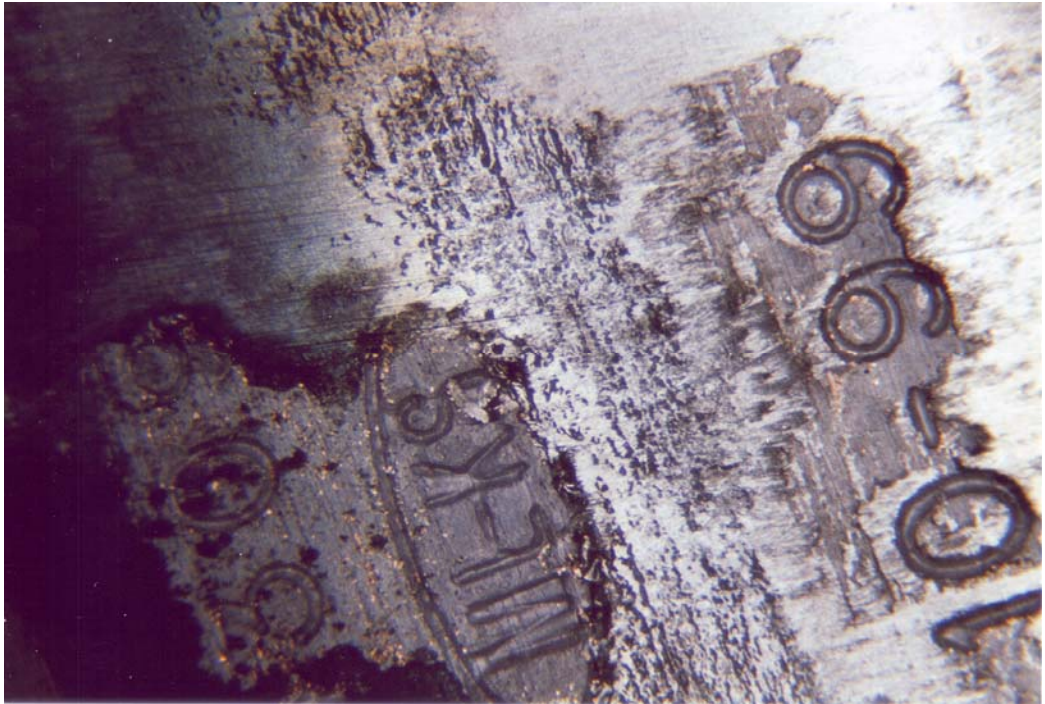
**Figure 8.56: No.4 big-end housing surface and insert wear, occurrence 2000/2157, VH-MZK (left)**

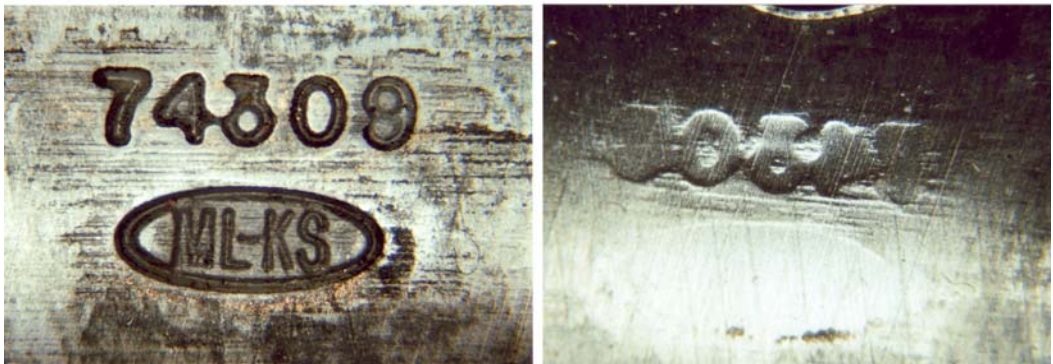
The insert back is shown on the left and the corresponding housing surface is shown on the right.

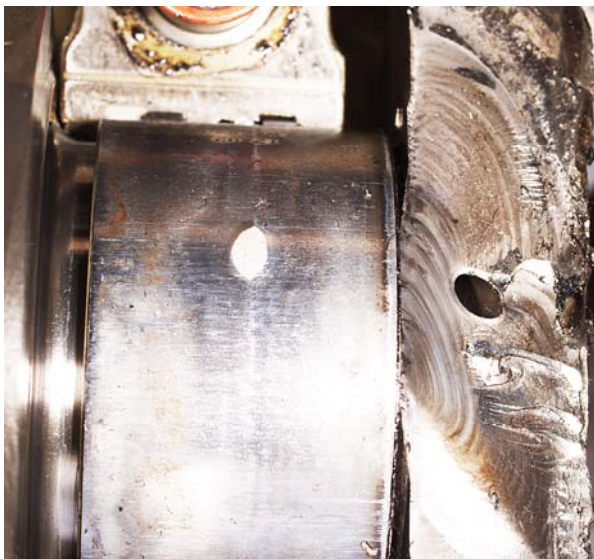
**Figure 8.60:** An example of the type of damage created in the main bearing journal radius through contact with the bearing insert, occurrence 2001/2544, VH-TTX

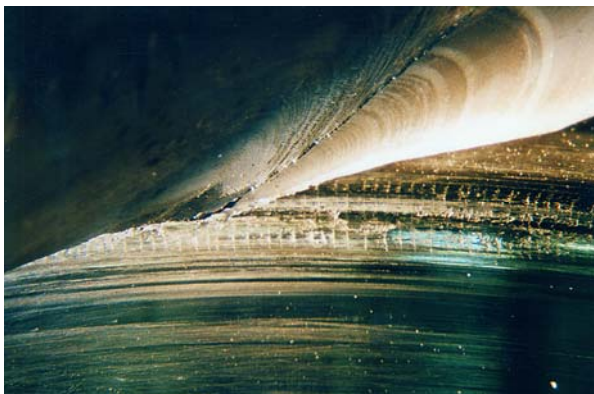
Note: the scoring damage is circumferential and the thermal expansion cracks in the nitrided surface are aligned in a radial direction.

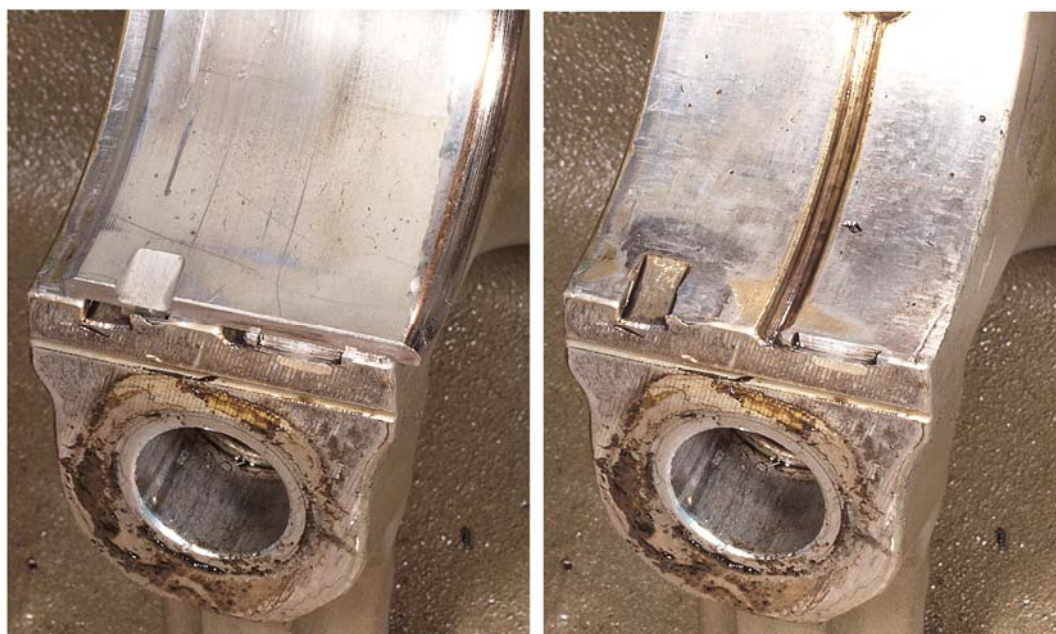
The extent of bearing displacement is shown on the left, and the extent of damage to the housing created by the bearing tang is shown on the right.

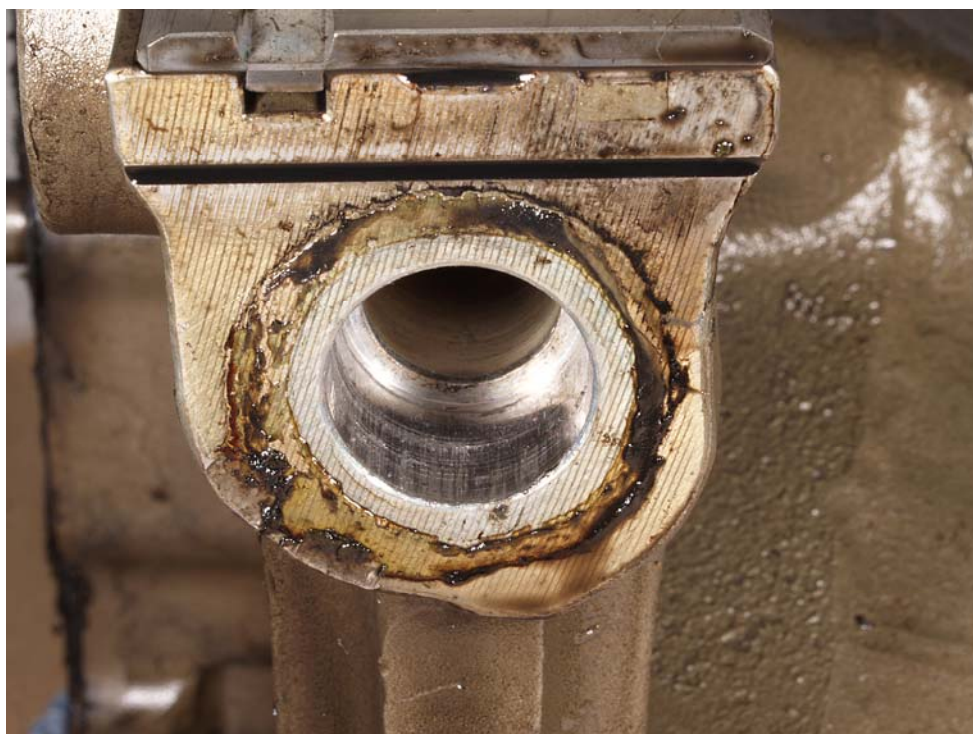
#### **8.4.4 Summary**

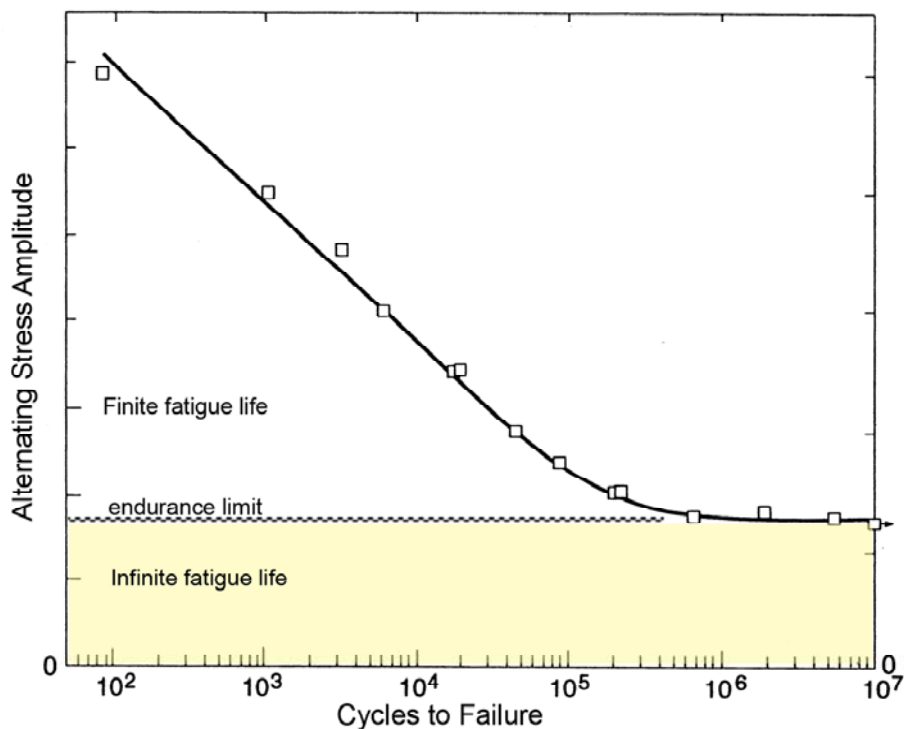
The fatigue endurance strength of a component is a function of; the material, component form, presence of stress concentrators, presence of residual stress, component surface finish, and the presence of surface hardening. It is well

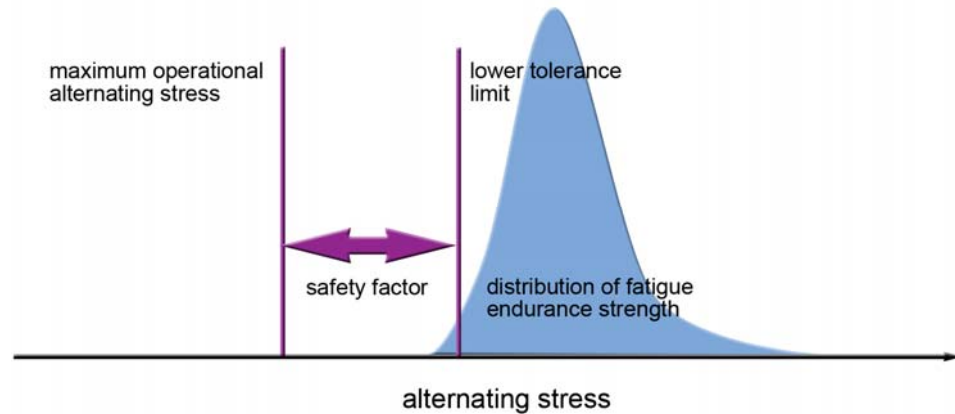
Fatigue failure will occur in some components from a batch of designed (part number) components if the magnitude of the alternating stress overlaps the distribution of endurance strength for the component, see figure 8.65.

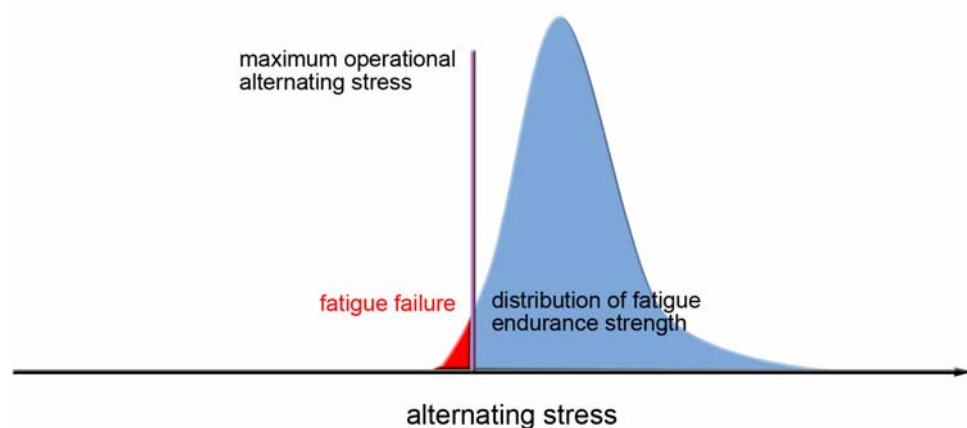
For the case of component designs that have passed certification testing and have demonstrated fatigue-free operational performance, component failure indicates that:

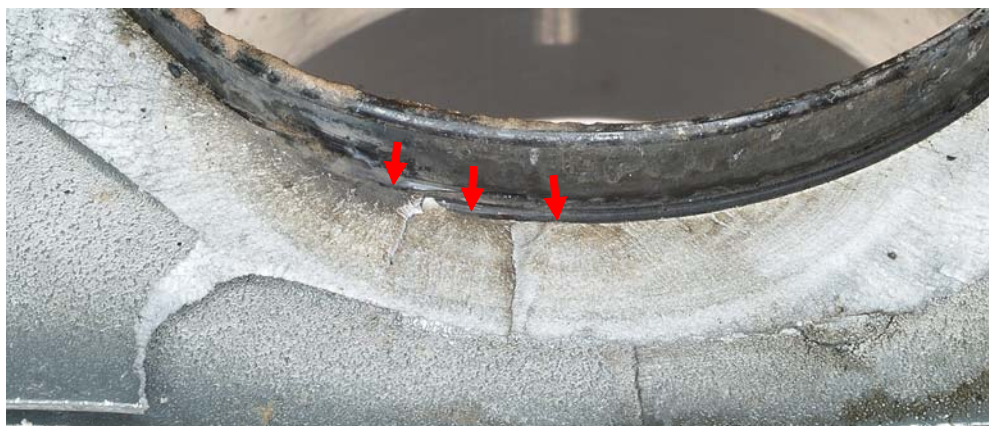
Fatigue cracking initiated at several sites at the head/barrel thread root (the general regions of crack initiation are arrowed), cracking propagated on a plane normal to the cylinder wall.

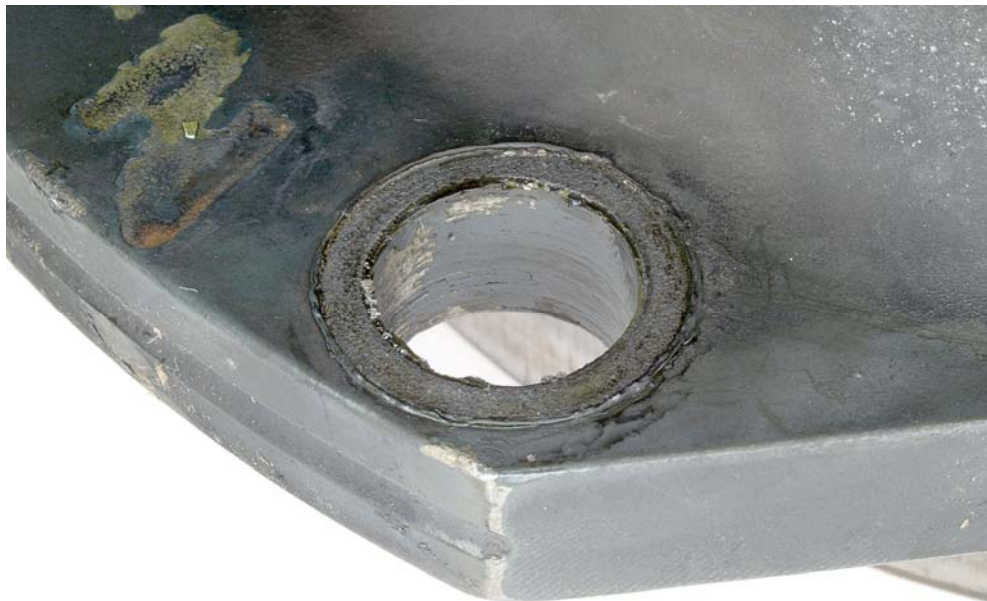
Note the presence of grey paint on the surface of the bolthole.

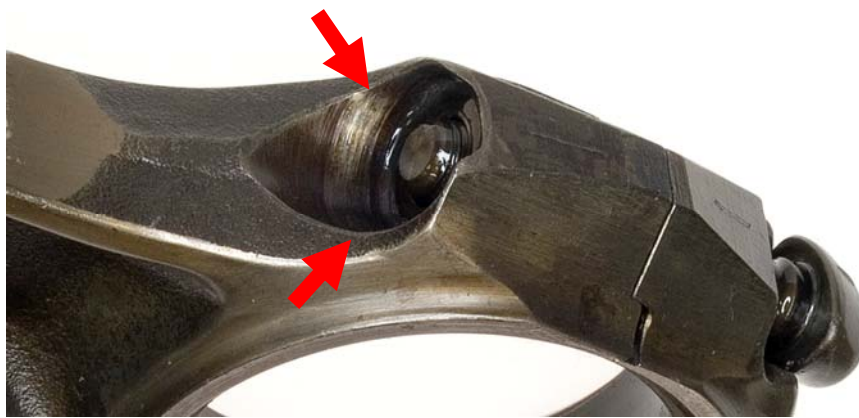
**Figure 8.71: A comparison of clearance between the crankshaft journal and connecting rod big-end bearing (left) and the big-end housing without the bearing inserts (right)**

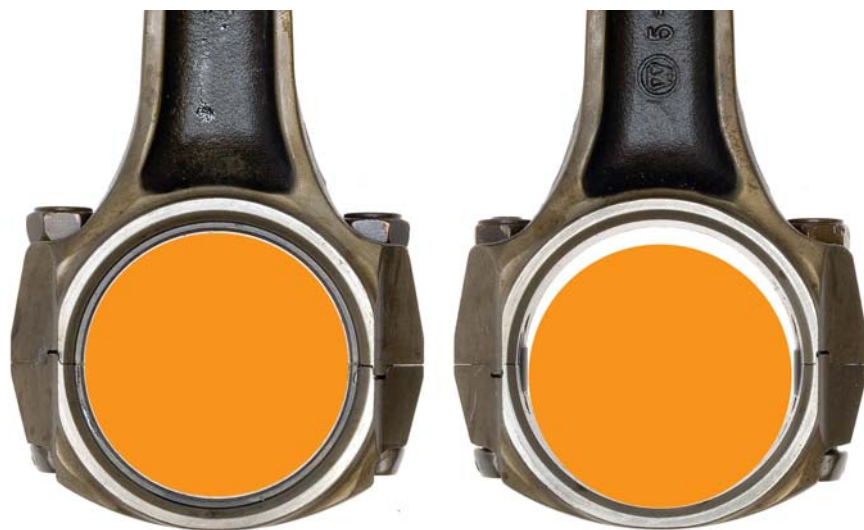
The diameter of the crankshaft journal is represented by the coloured circle.

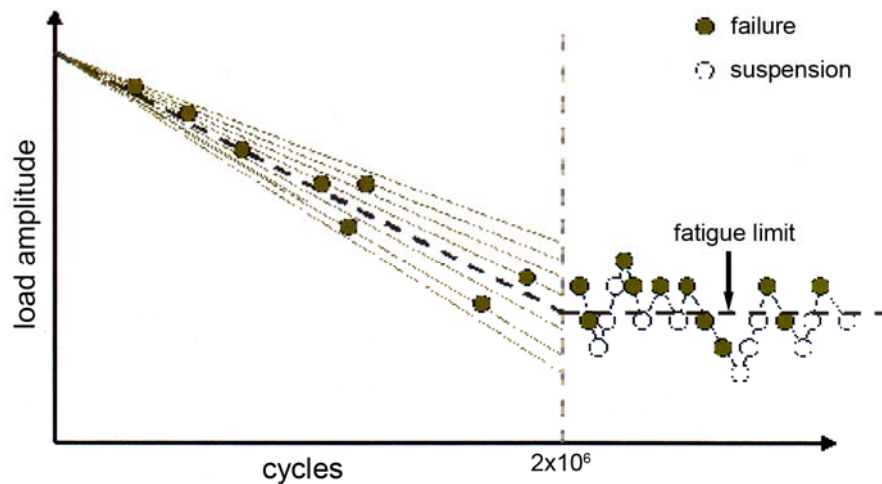
Two dominant fatigue failure modes have been identified by the designers of crankshafts (Piraner, Pflueger and Bouthier, 2002):

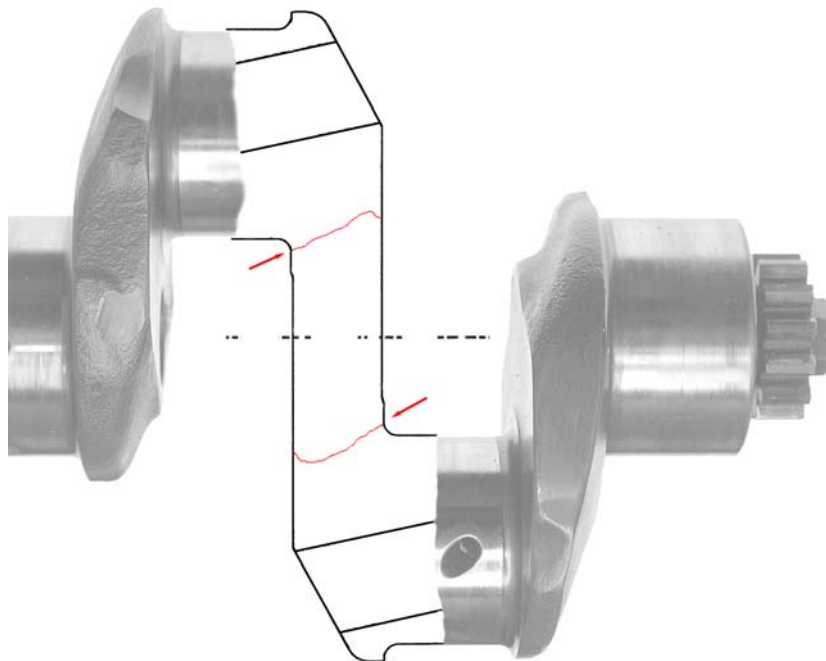
**Figure 8.74:** Schematic showing the distribution of crankweb bending stress at the forward fillet of a No.6 connecting rod journal

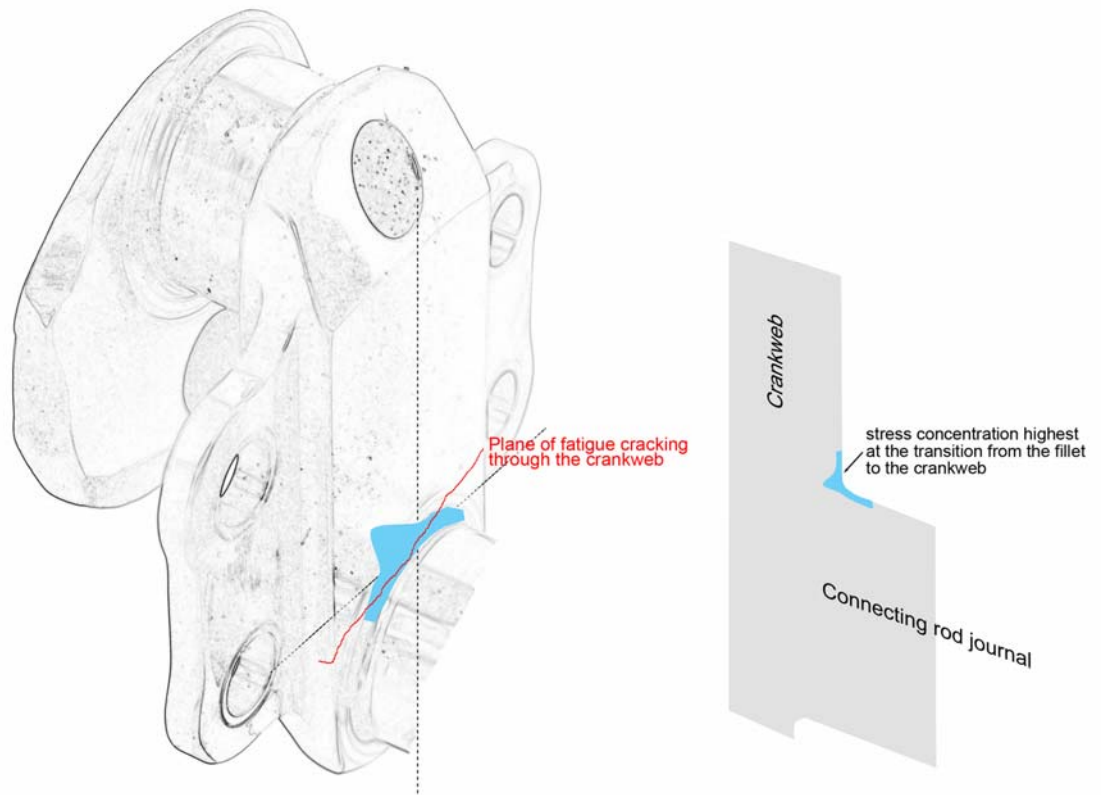
The orientation of the plane of fatigue cracking is related to the angular position of the crankweb at the time of maximum combustion pressure; for normal operation the peak pressure is developed approximately 20° after top centre.

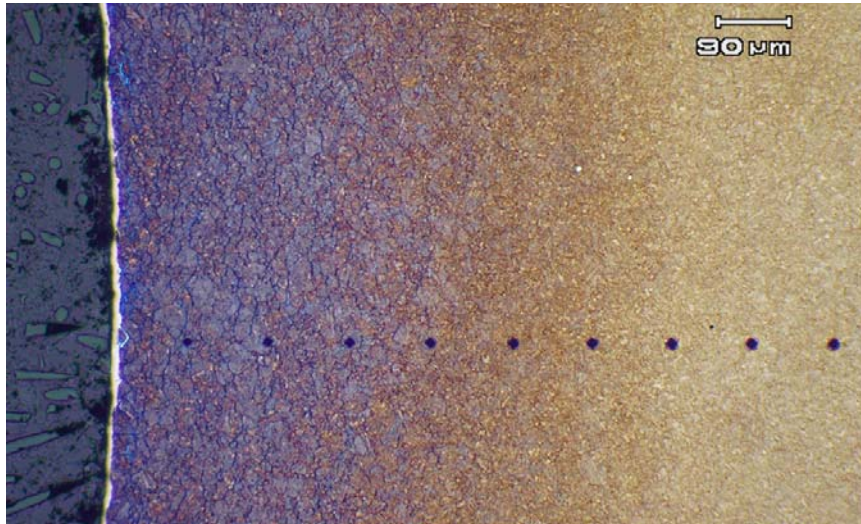
The plane of the section is perpendicular to the fillet radius. The extent of the effect of nitriding can be discerned by the change in colour from left to right (the unaffected core material is coloured straw on the right side of the micrograph). The square shaped features are microhardness indentations.

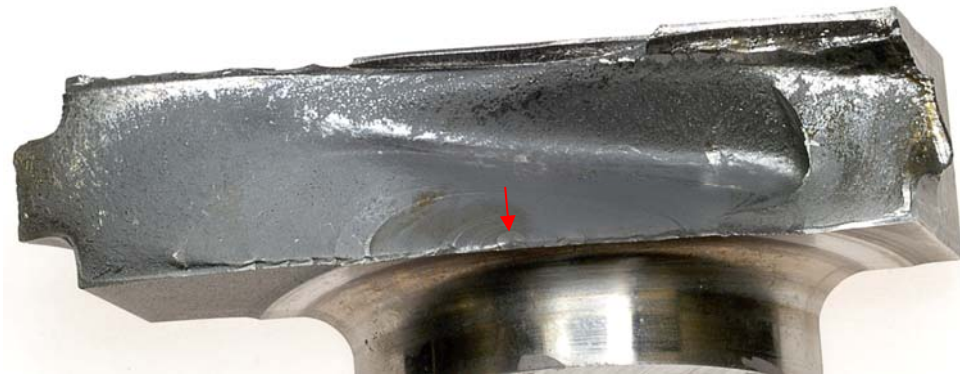
The site of fatigue crack initiation is arrowed.

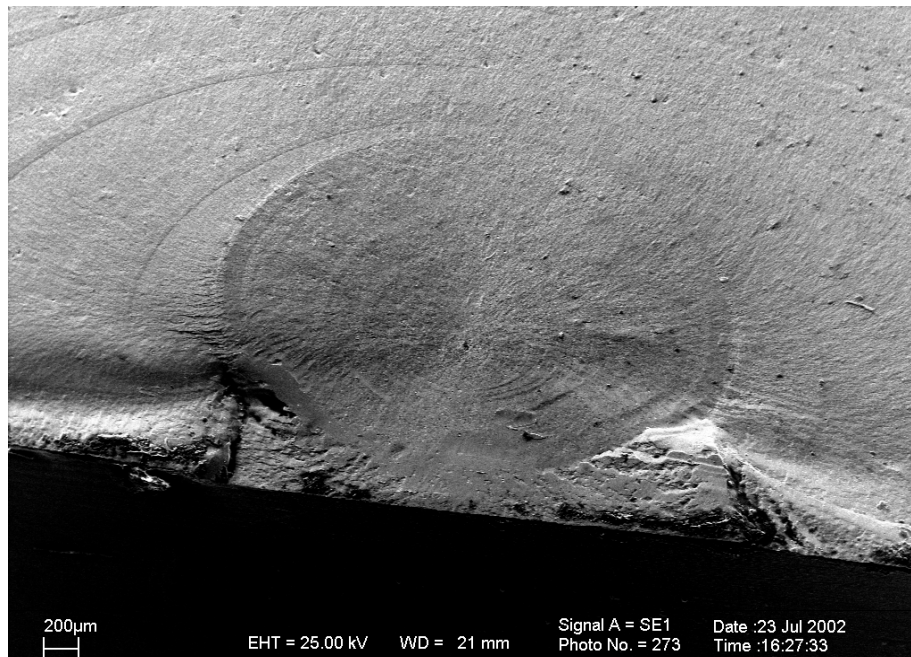
**Figure 8.78:** Scanning electron micrograph showing the site of fatigue crack initiation in more detail

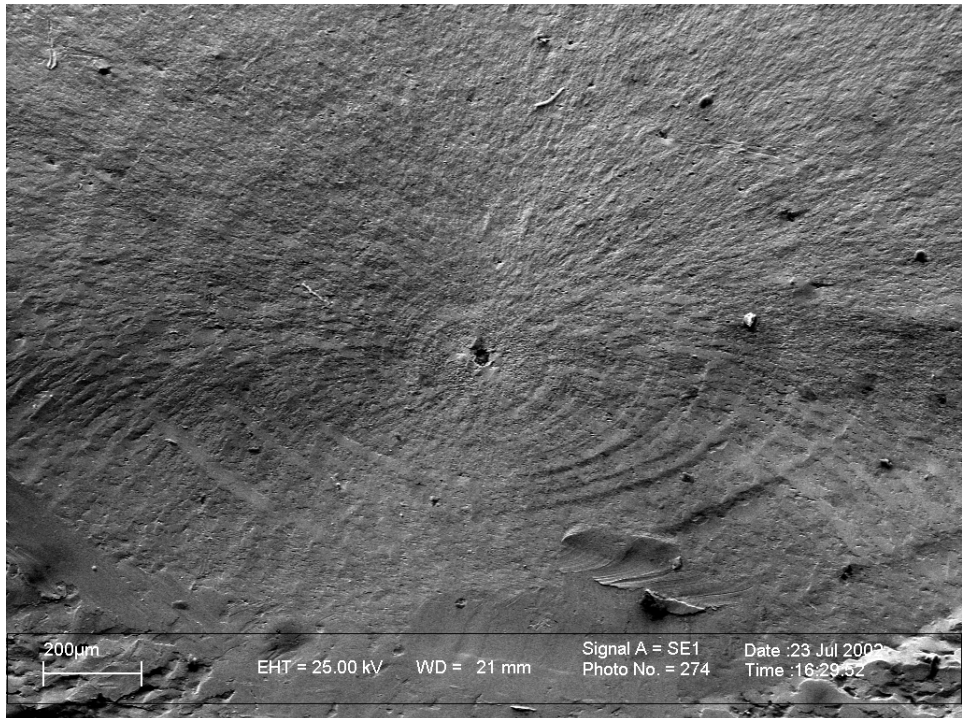
**Figure 8.79:** Scanning electron micrograph of the site of fatigue crack initiation at higher magnification showing that crack initiation occurred at an alumino-silicate inclusion

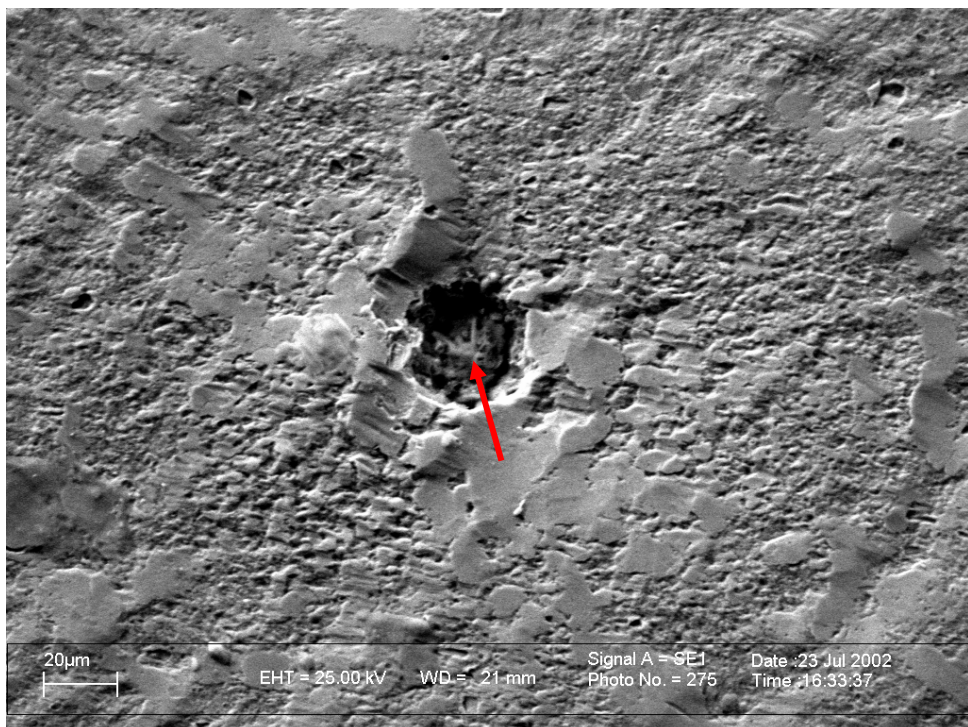
**Figure 8.80: Metallographic section through the No.1 connecting-rod journal fillet**

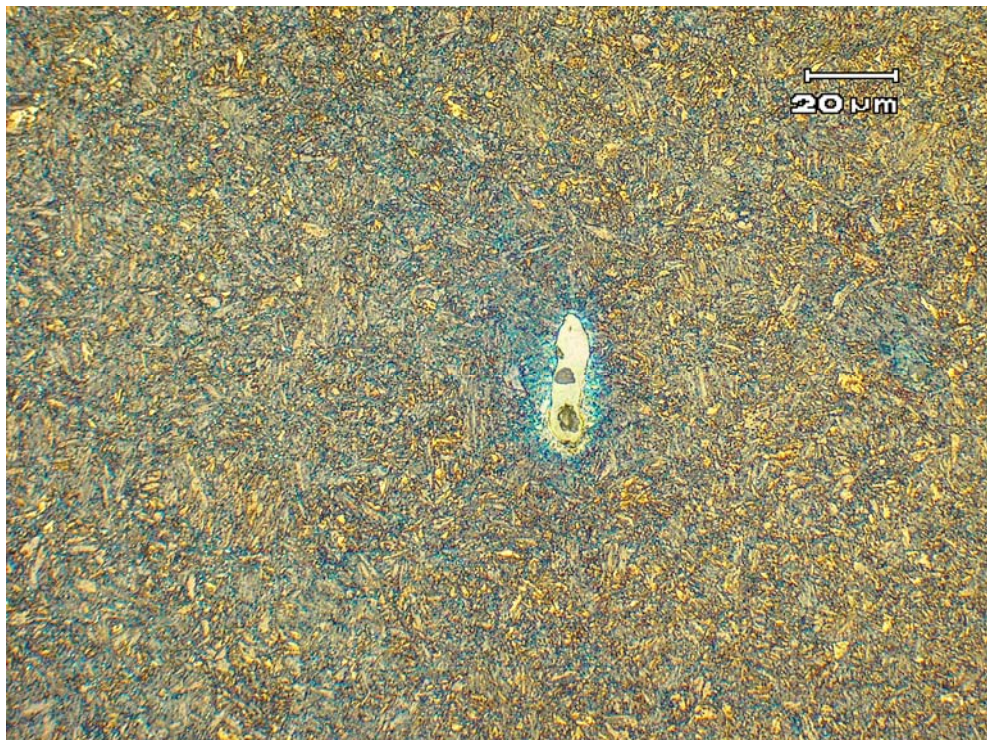
It is evident that fatigue crack initiation occurred at a material inclusion located in the region of applied stress concentration, created by crankshaft bending during engine operation (the transition between the fillet and crankweb), and the location of highest residual tensile stress (the transition from the hardened surface to the crankshaft core material).

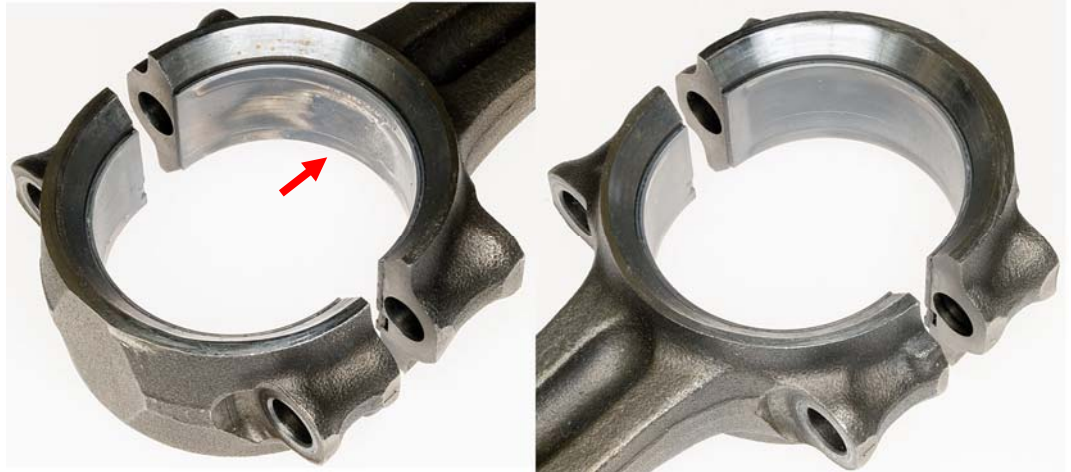
Resolution of the issues contributing to the fatigue fracture of this crankshaft requires the consideration of, both, material factors and the magnitude of combustion loads in the No.1 cylinder.

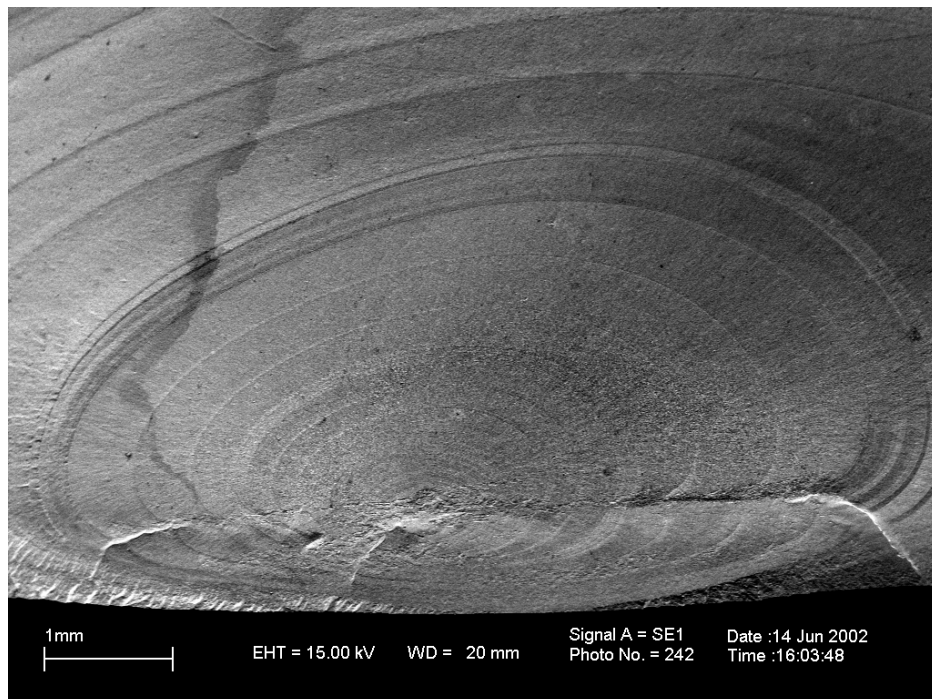
**Figure 8.84:** Detailed view of the region surrounding the site of fatigue crack initiation. The features of the initiation site had been obliterated by mechanical damage after the fracture of the crankweb

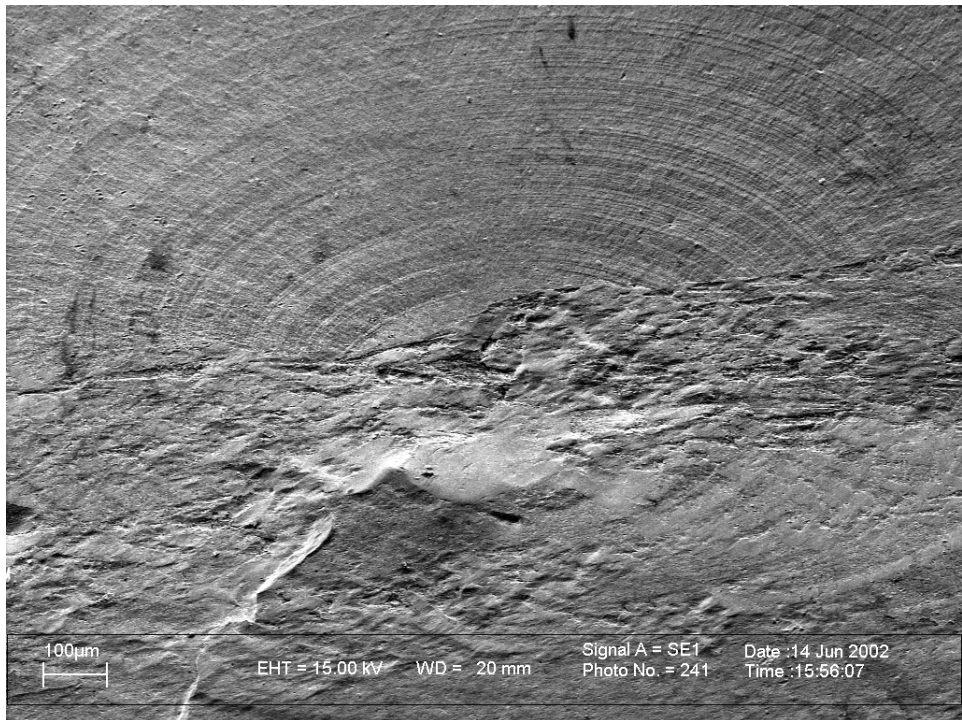
**Figure 8.85:** Scanning electron micrograph showing the plane of metallographic sectioning through the site of fatigue crack initiation

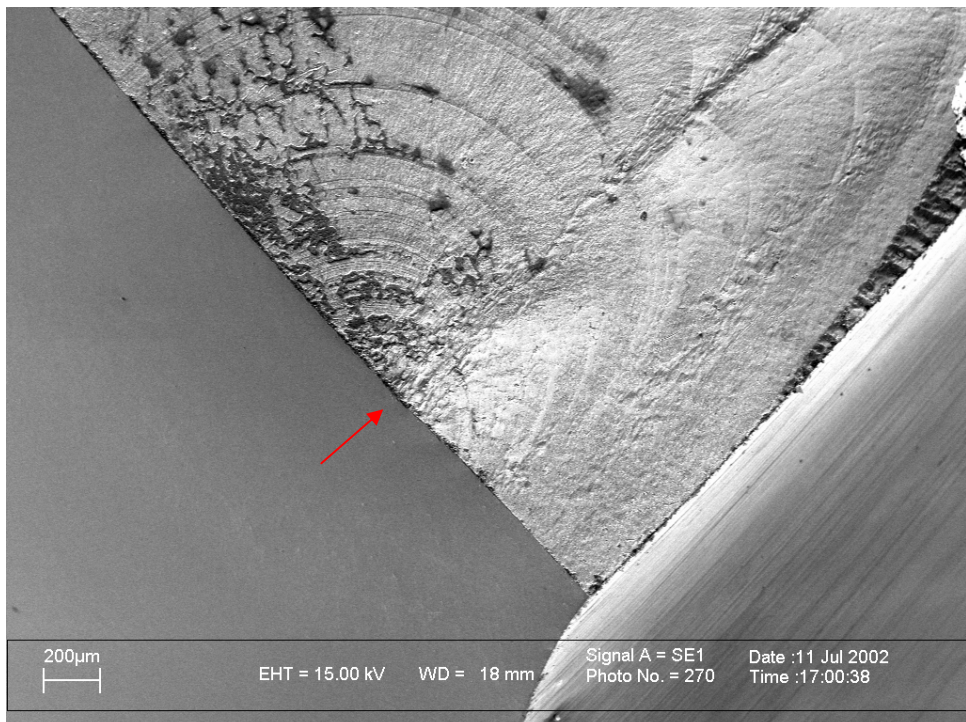
**Figure 8.86: Metallographic sections through the site of fatigue crack initiation etched (left) and unetched (right)**

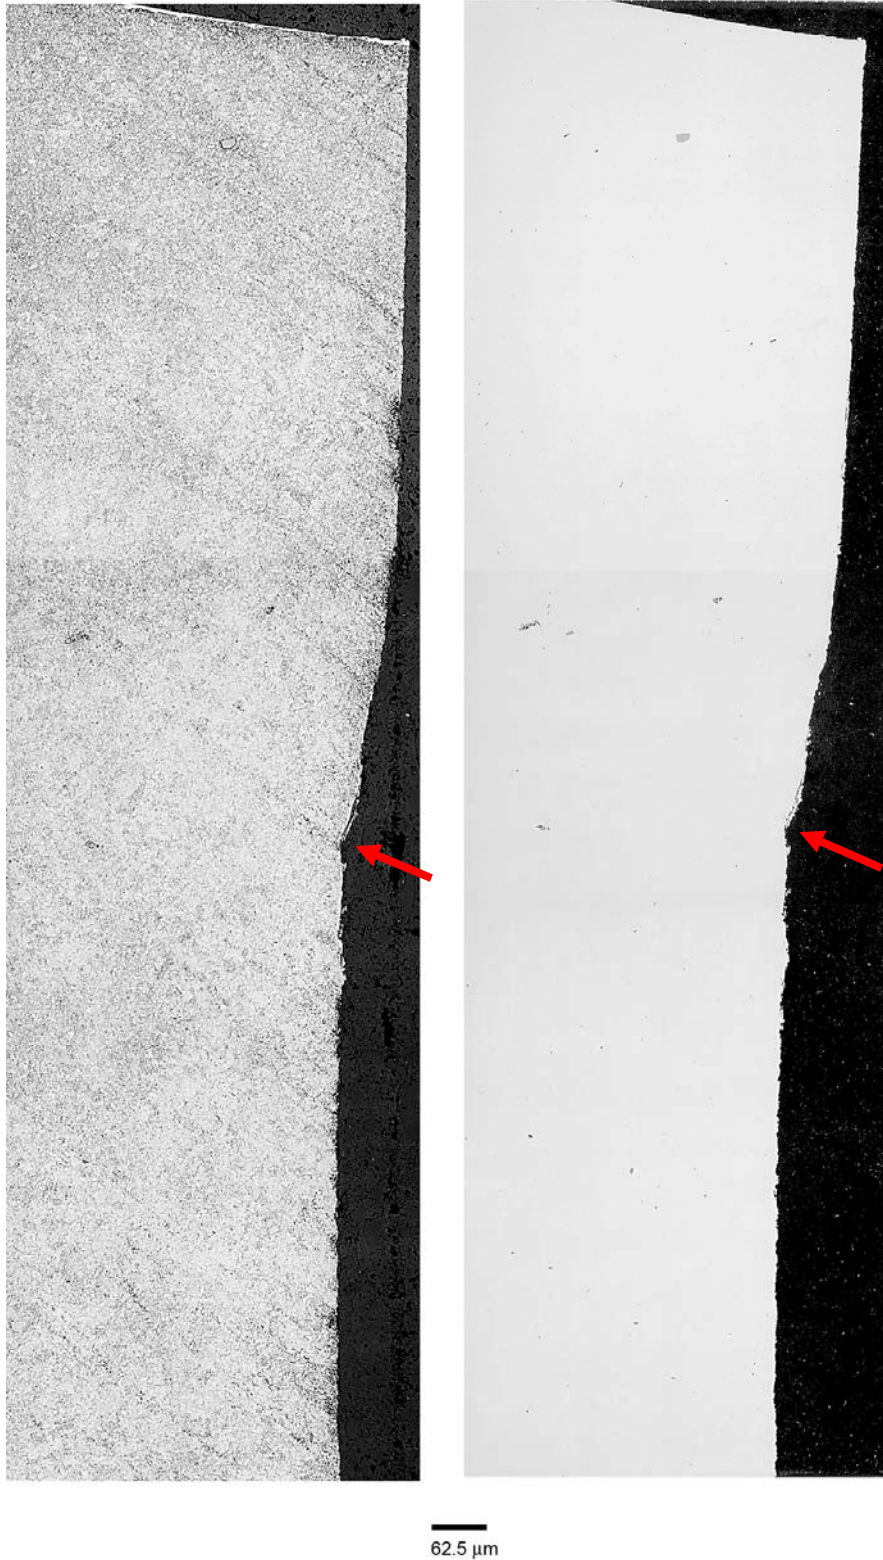
The site of fatigue crack initiation is arrowed. The unetched micrograph shows the nature and distribution of non-metallic inclusions.

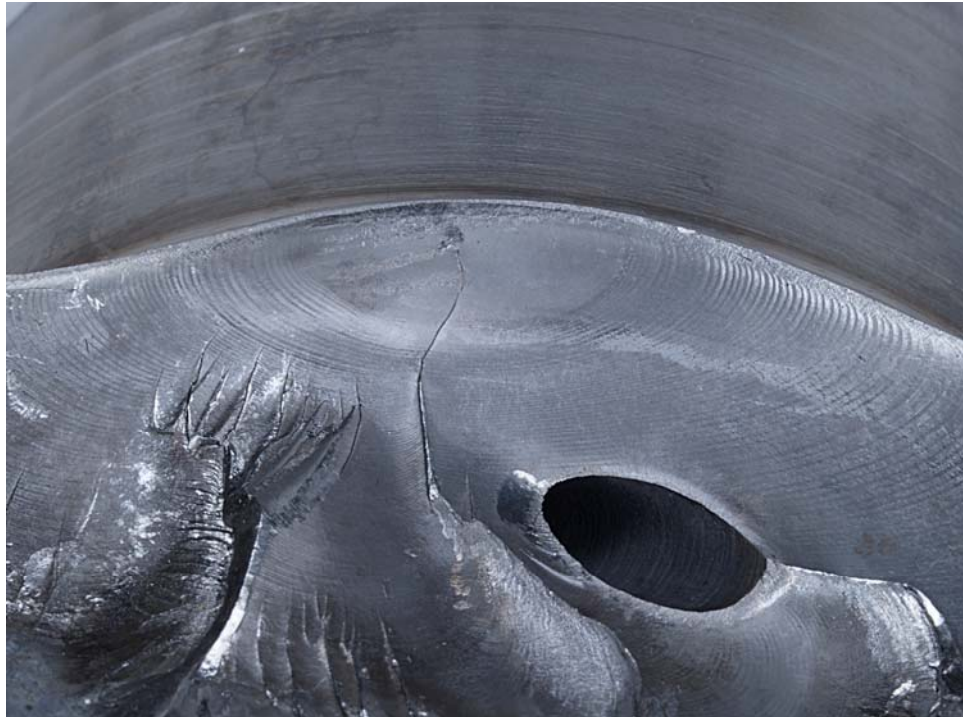
**Figure 8.88:** Scanning electron micrograph showing the region surrounding the site of fatigue crack initiation
