Australian Government  
Australian Transport Safety Bureau

ATSB TRANSPORT SAFETY INVESTIGATION REPORT  
Aviation Research and Analysis Report – B20070191  
Final

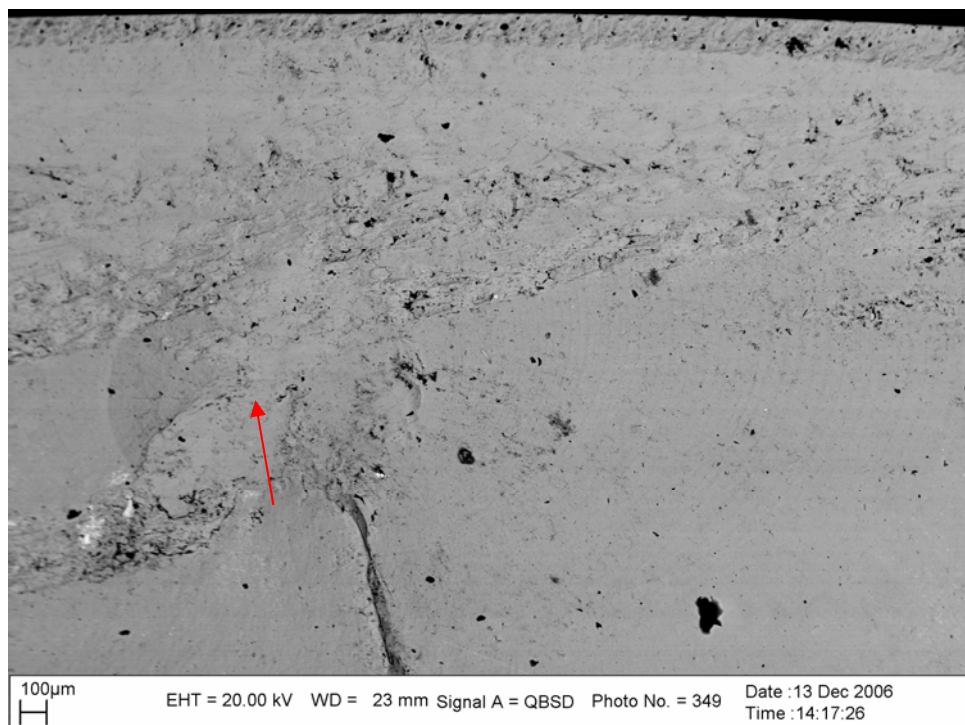
The site of crack initiation had been damaged mechanically following the fracture of the crankweb.

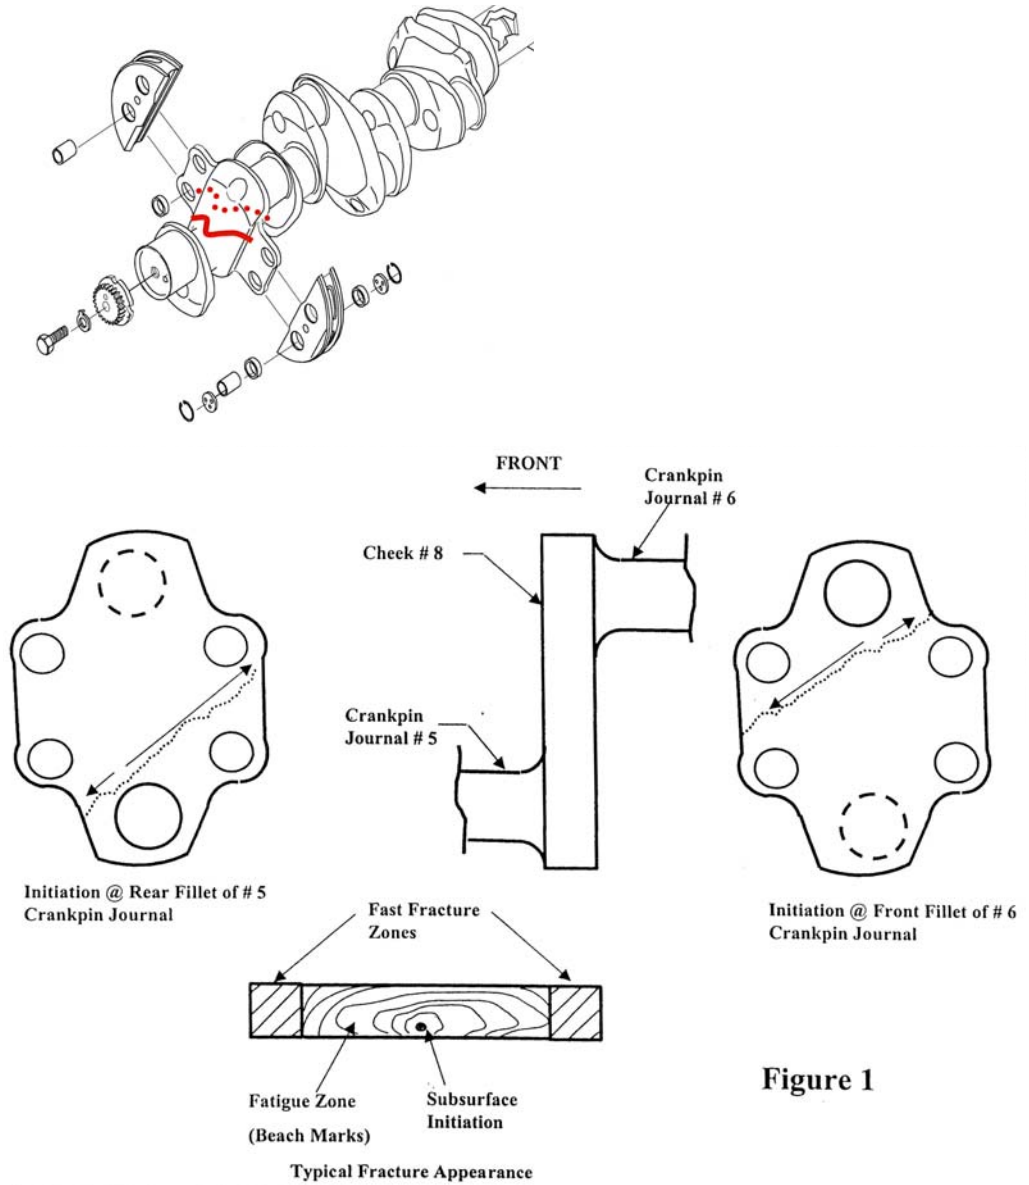
**Figure 8.89:** FAA diagrams showing the nature of fatigue cracking in the crankweb between the No.6 and No.5 connecting rod journals (GASIL, 2002, p.28)

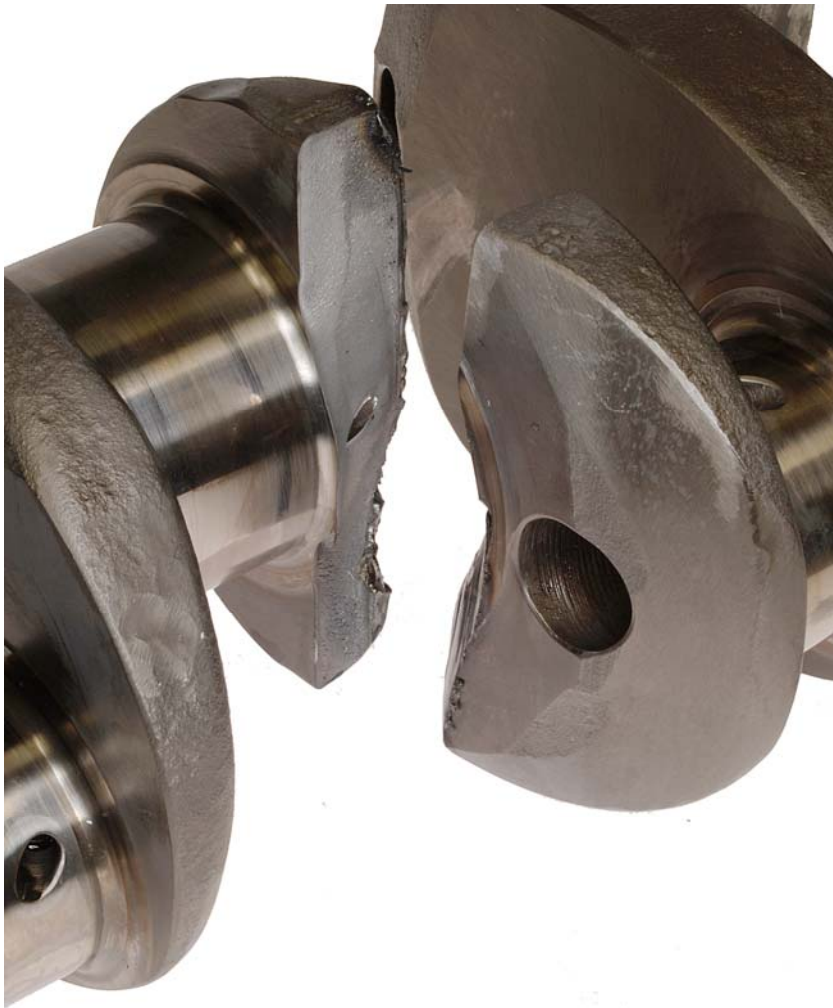
Fatigue crack initiation occurred at the transition of the fillet to the crankweb. The lack of fatigue crack progression marks indicates that crack growth occurred within the period of one flight.

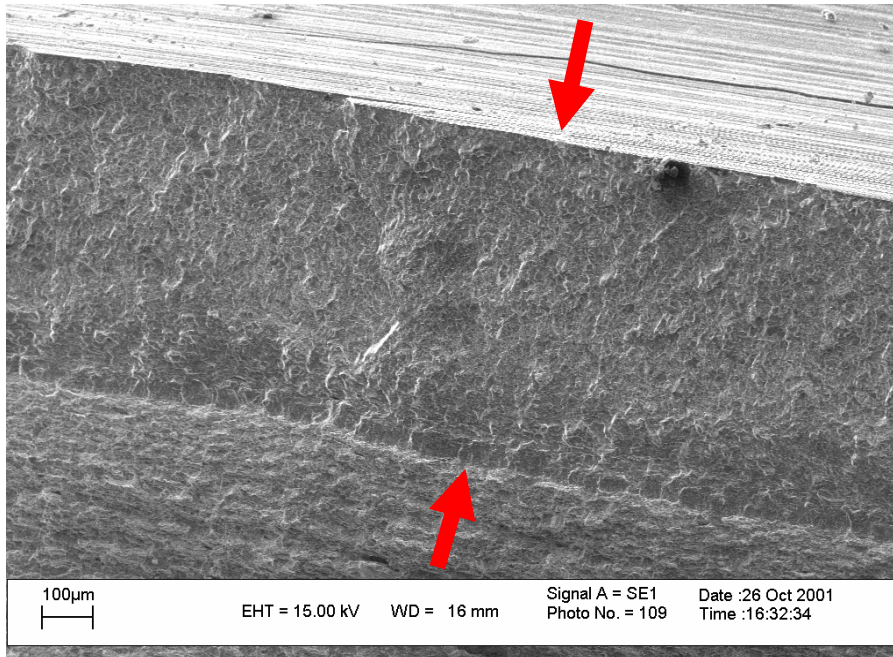
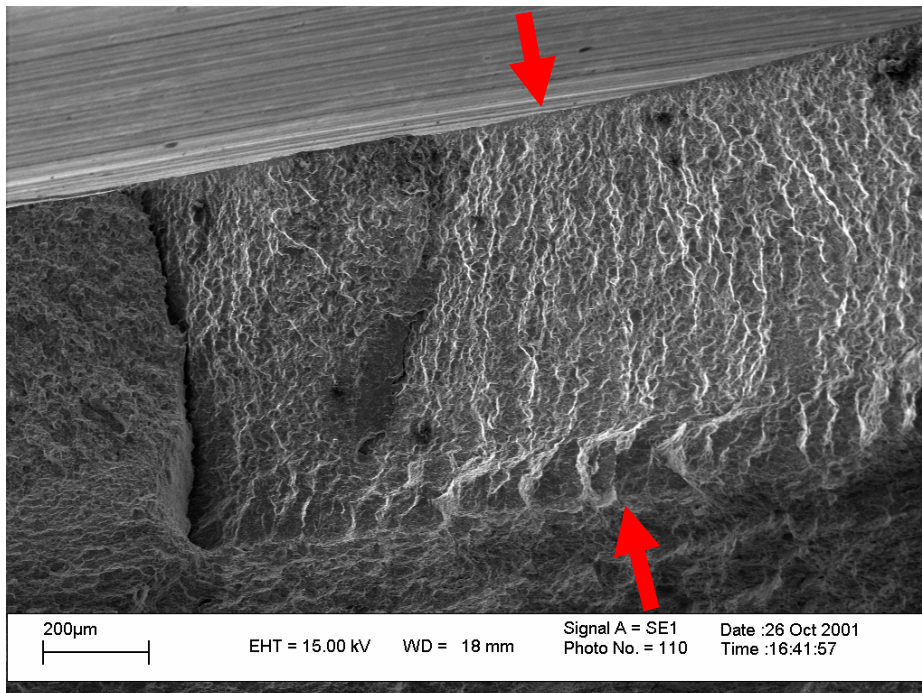
The depth of fatigue cracking is indicated by arrows. Crack initiation was not restricted to a specific material feature.

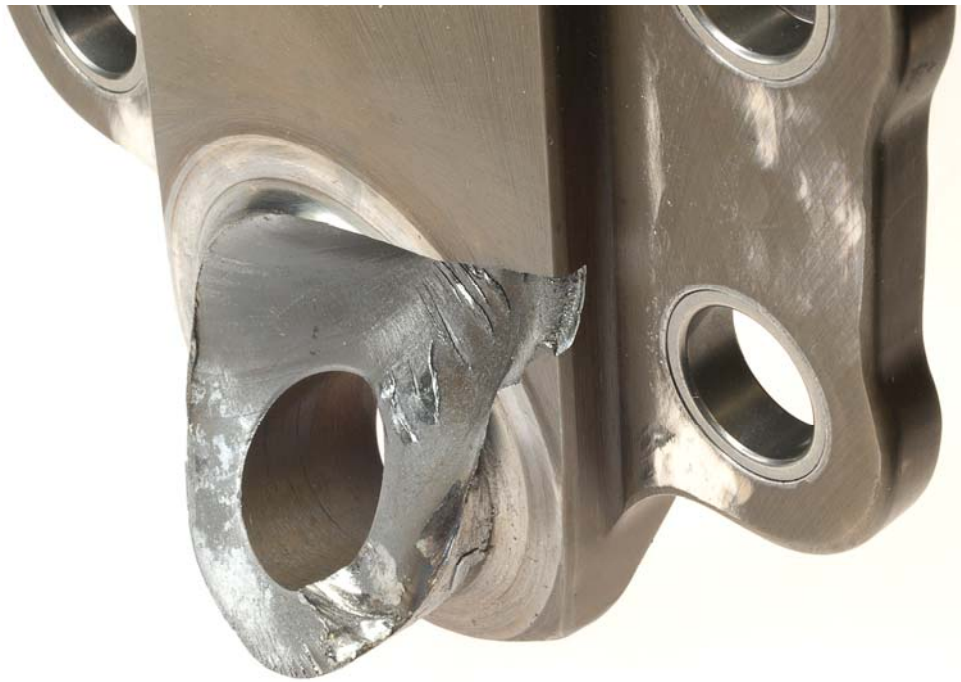
**Figure 8.93:** Detailed view of the fatigue crack initiation site, crankweb side

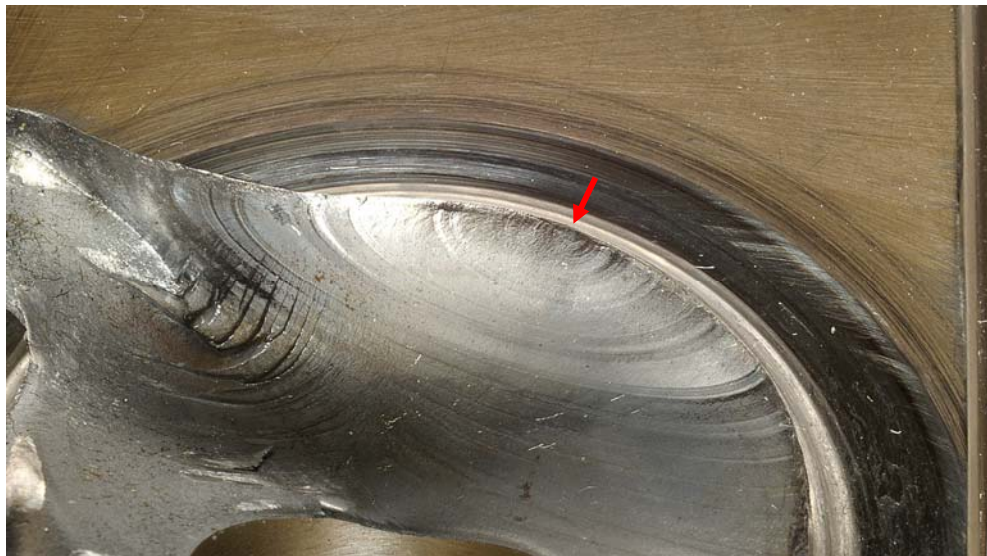
**Figure 8.94:** Detailed view of the fatigue crack initiation site, journal side

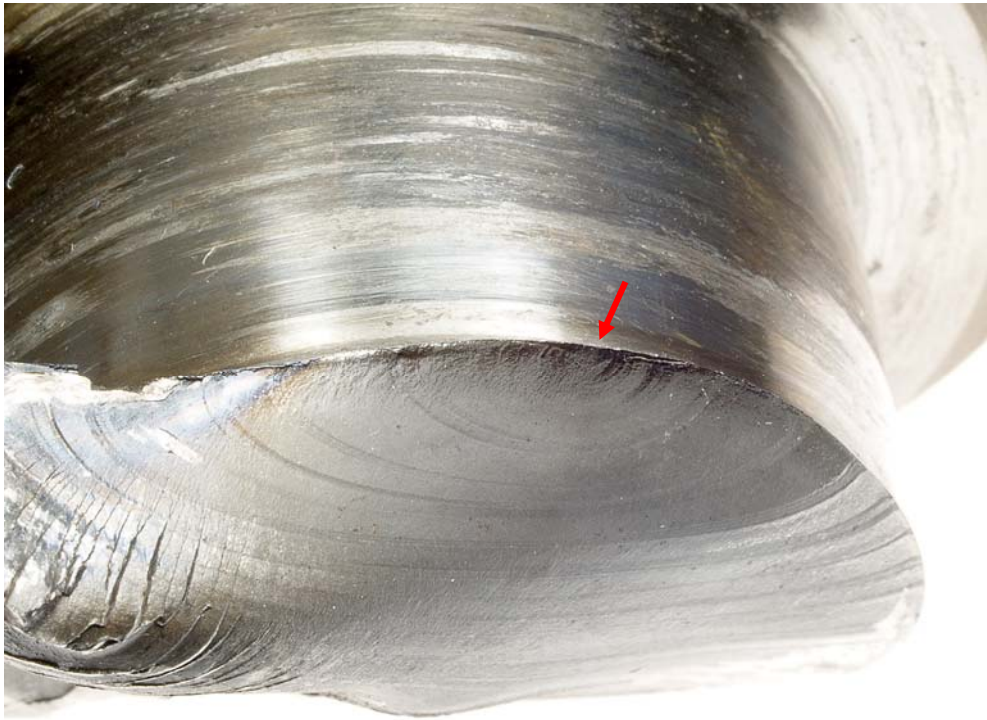
**Figure 8.95:** An example of fillet notching

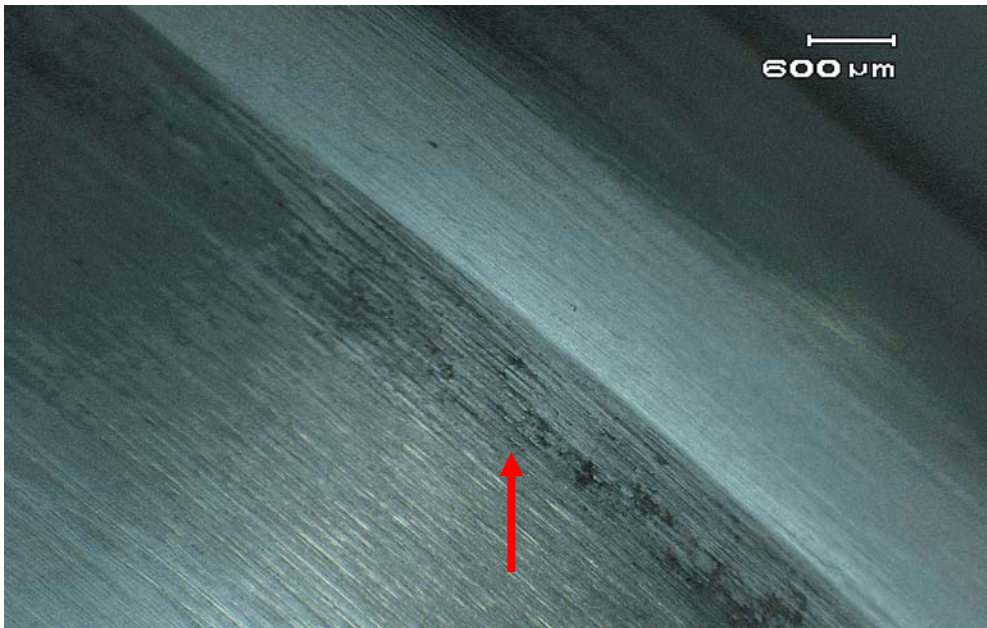
It is apparent, in this example, that while the site of fatigue initiation coincided with the predicted circumferential position of highest crankweb bending stress, the severe stress-concentrating feature created at the journal-to-fillet transition, during journal polishing, influenced the radial location of the initiation site in the fillet. The change in the site of crack initiation, with respect to the fillet, affected the plane of fatigue crack growth.

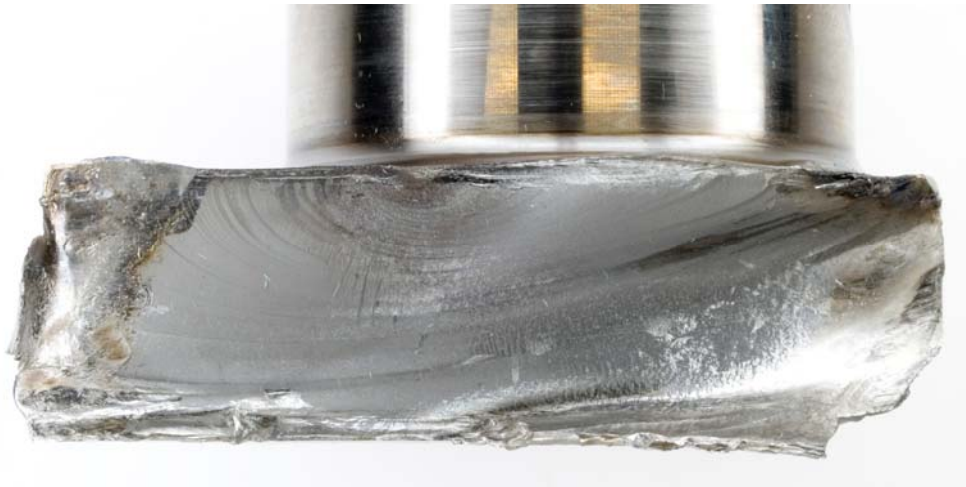
**Figure 8.97:** The region of rubbing contact damage, the site of fatigue crack initiation is arrowed

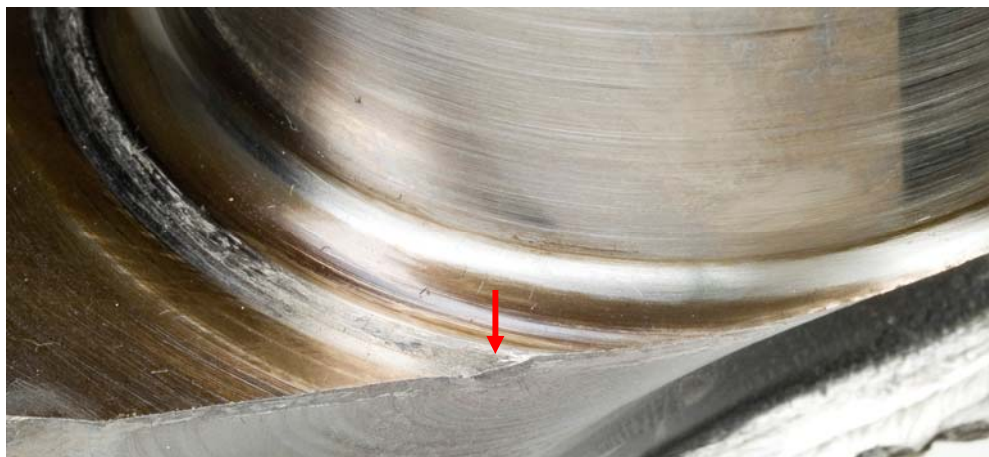
Examination of the connecting rod established that the sequence of events leading to the rubbing contact between the big-end housing and crankweb commenced with the fatigue fracture of a counterweight-pin retention plate in one of the counterweight assembly fitted to the crankweb. Connecting rod distortion occurred when the unrestrained counterweight pin was caught between the face of the counterweight and the connecting rod 'I' beam, figures 8.98 to 8.100.

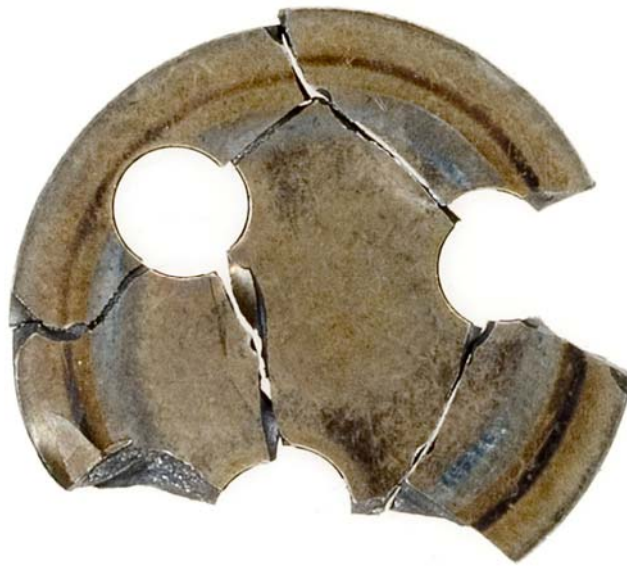
**Figure 8.99: The face of the counterweight showing evidence of localised deformation created as the pin was dragged between the counterweight and connecting rod**

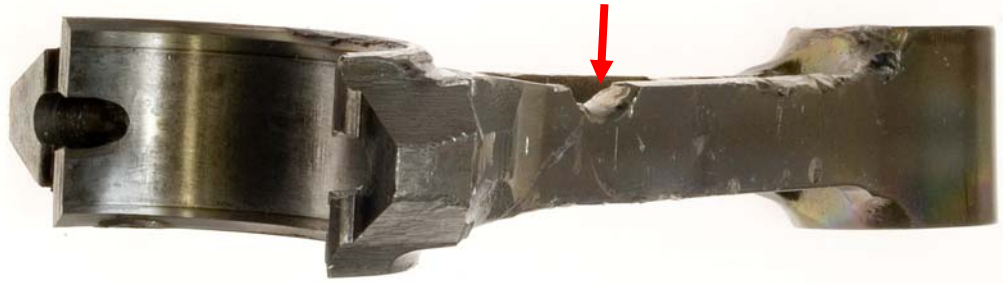
The region of damage created by the freed counterweight pin is arrowed.

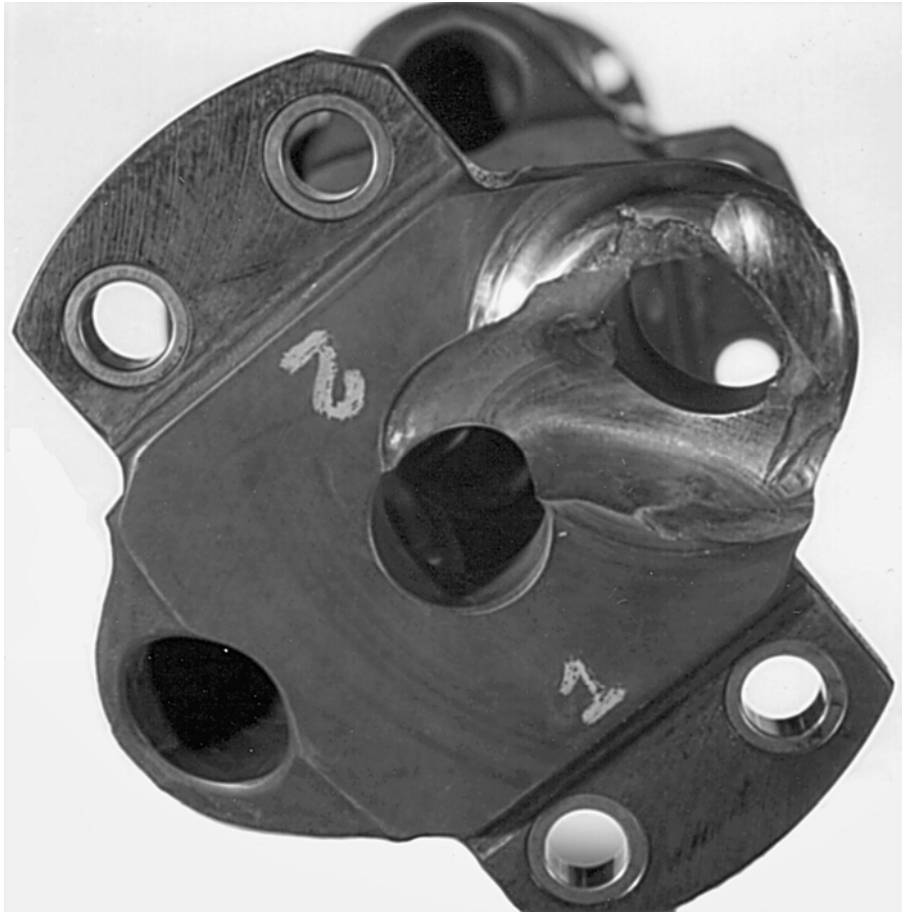
While the nature of the initiation site of fatigue fracture had been obliterated by damage created during continued crankshaft rotation, magnetic particle inspection of the shaft revealed the presence of other small cracks in the region of journal fillets. One of these crack indications was opened to allow the examination of crack surface features, figures 8.102 and 8.103.

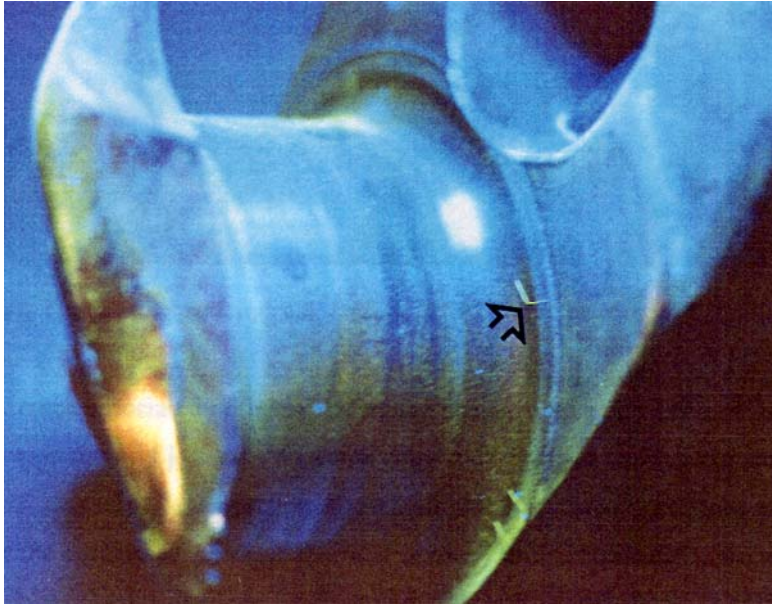
**Figure 8.103: The crack surfaces of the magnetic particle indication arrowed in figure 8.107**

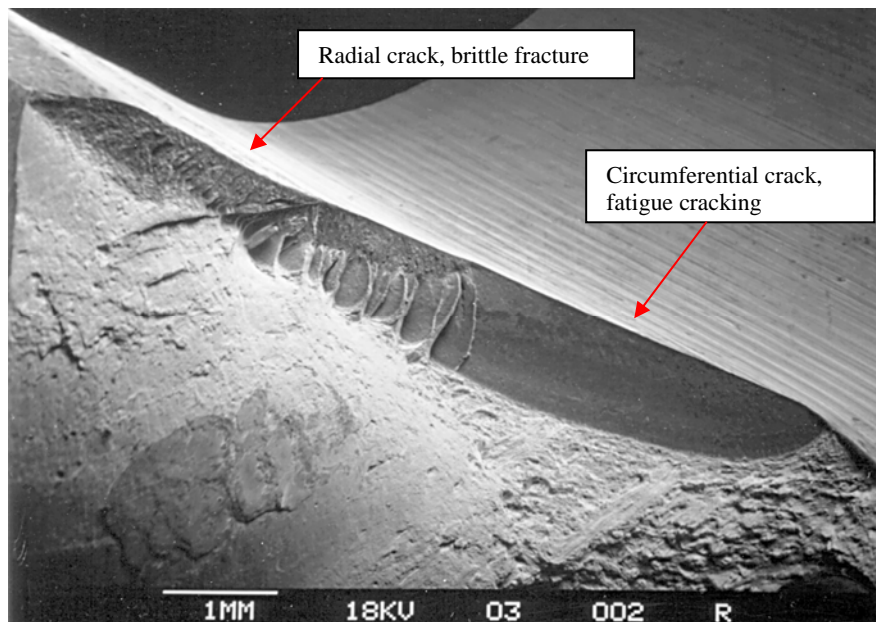
**Example 10:** Lycoming TIO-540-J2BD, major defect report 93/0787, crankshaft p/n 10346, s/n 73Y19.

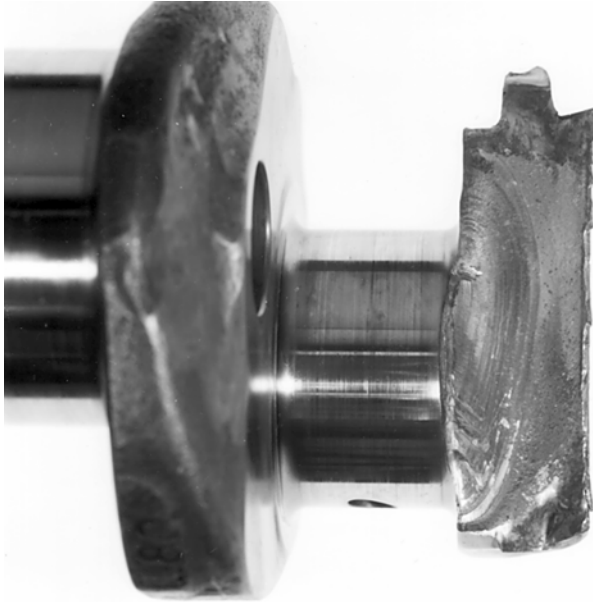
Fatigue cracking initiated at a number of locations in the rear fillet of the No.5 journal.

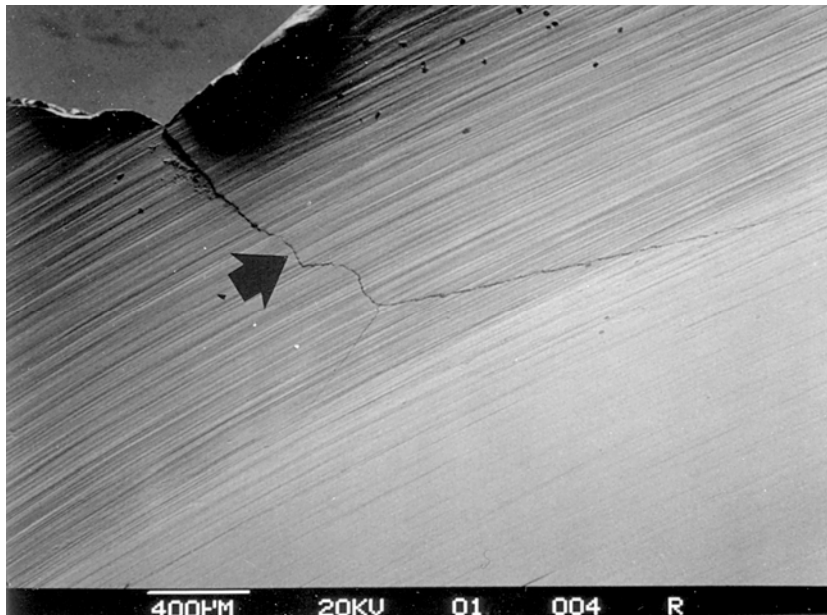
Figure 8.106: Crack surface features, region of cracking arrowed in figure 8.105

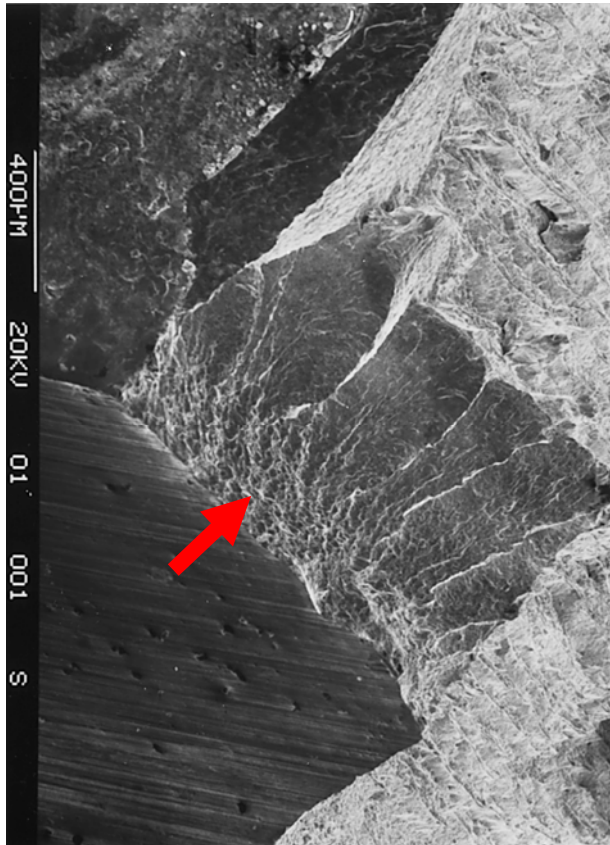
Note that the initial region of cracking, from the surface into the nitrated-zone displays the features of brittle fracture. Subsequent crack growth from the region of brittle fracture occurred as a result of fatigue crack growth.

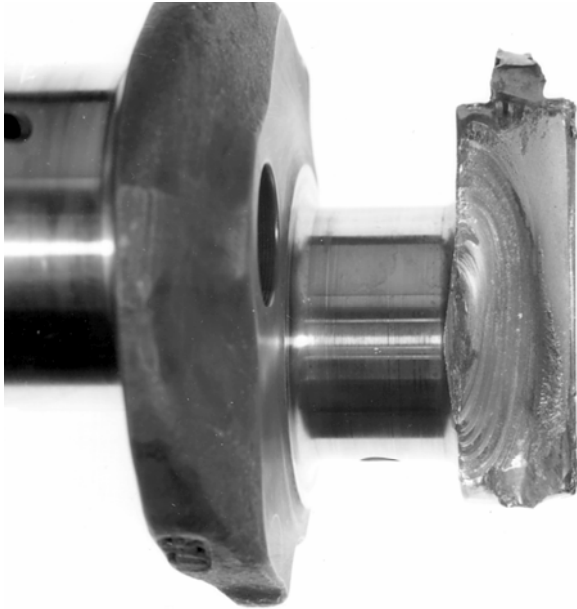
Fatigue cracking initiated at a number of locations in the rear fillet of the No.5 connecting rod journal.

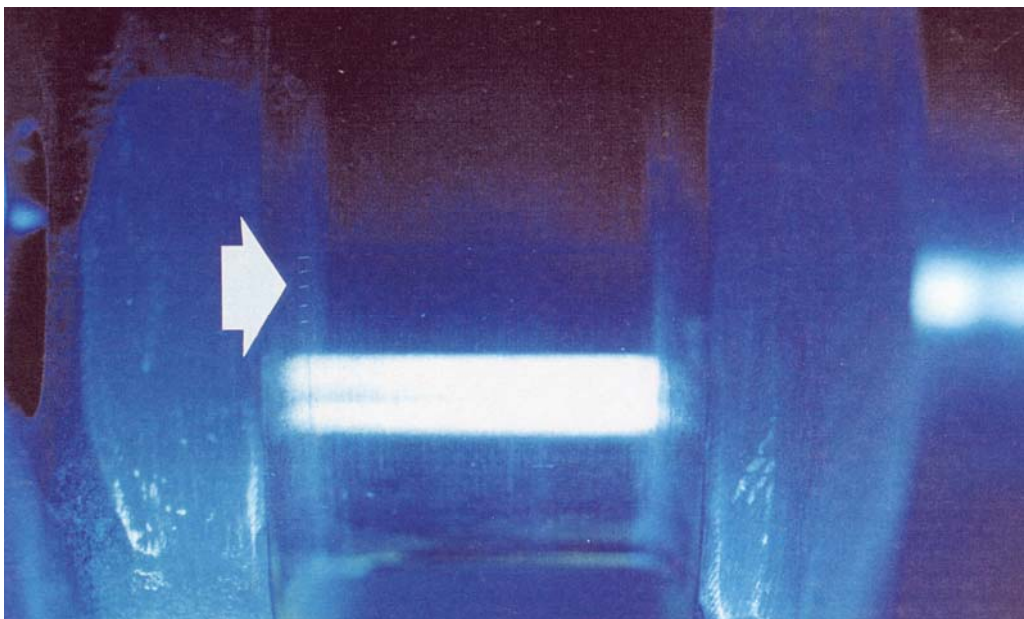
**Example 12:** Lycoming TIO-540-J2BD, major defect report 93/0158, crankshaft p/n LW 10346, s/n 69184.

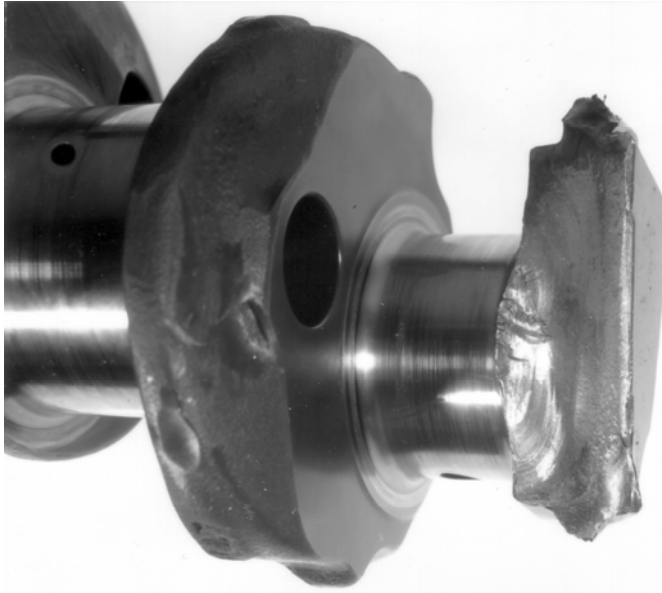
Fatigue cracking initiated at a number of locations in the rear fillet of the No.5 connecting rod journal.

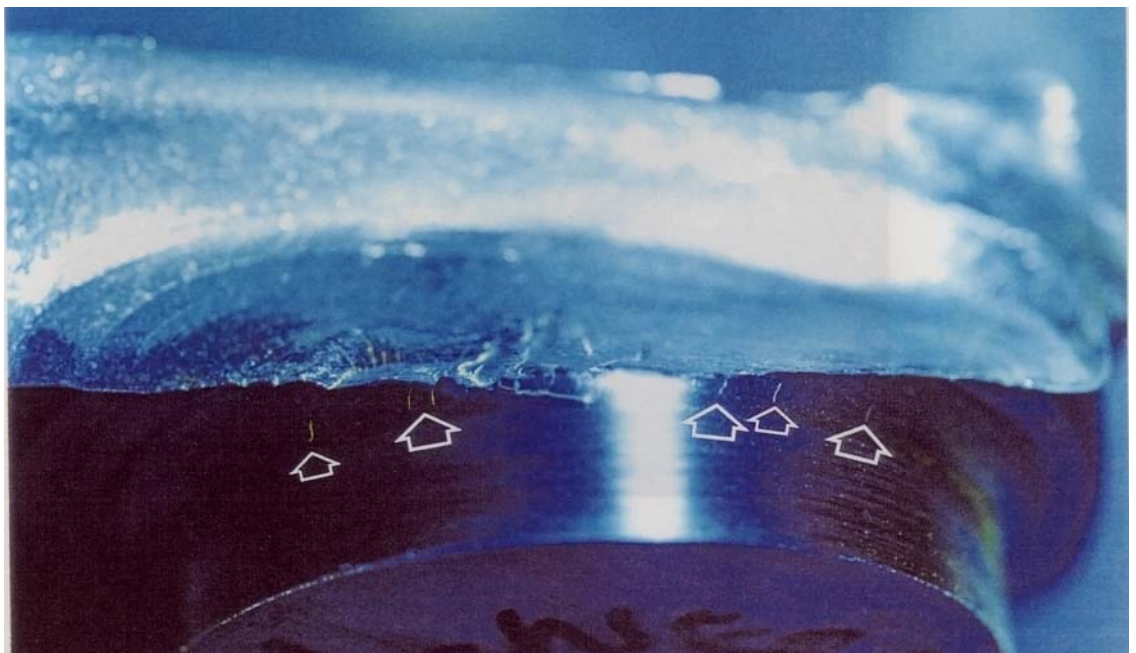
**Example 13:** Lycoming IO-360-A1B6, major defect report 92/0575, crankshaft, s/n 130583.

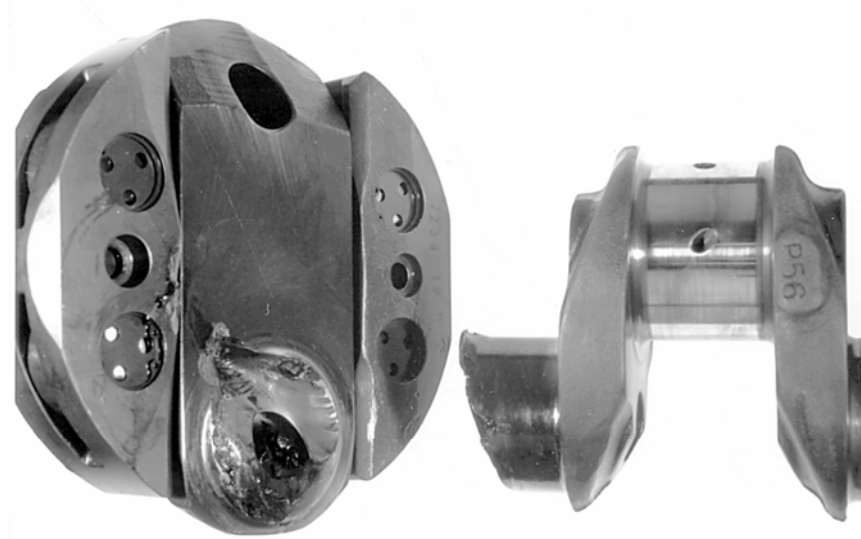
**Figure 8.112: Examples of magnetic particle inspection indications of thermal expansion cracks in the fillets of the No.4 connecting rod journal**

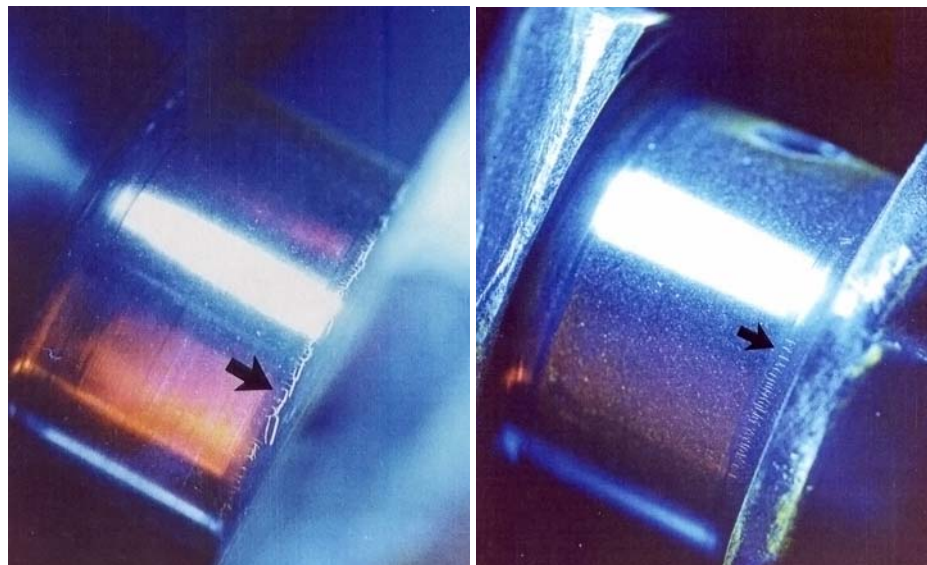
The crack indications (left) show that circumferential cracking has developed from the series of short thermal expansion cracks in the region of the No.4 journal between the crankwebs – the region of highest stress under crankshaft bending. The crack indications on the opposite side of the journal are shown on the right of the figure.

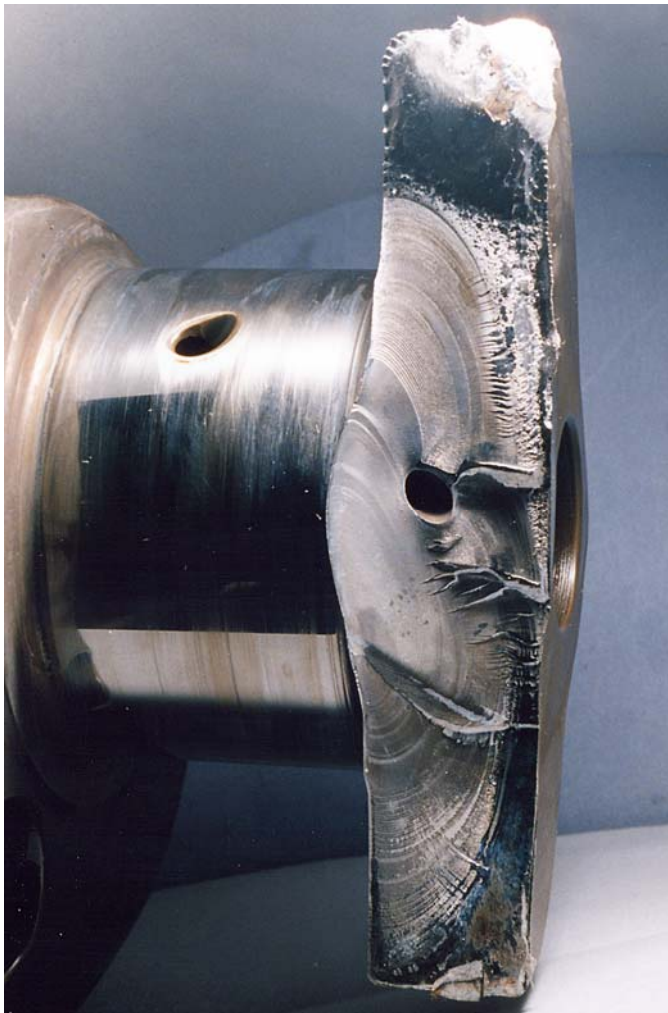
Fatigue cracking initiated in the forward fillet of the No.4 main bearing journal.

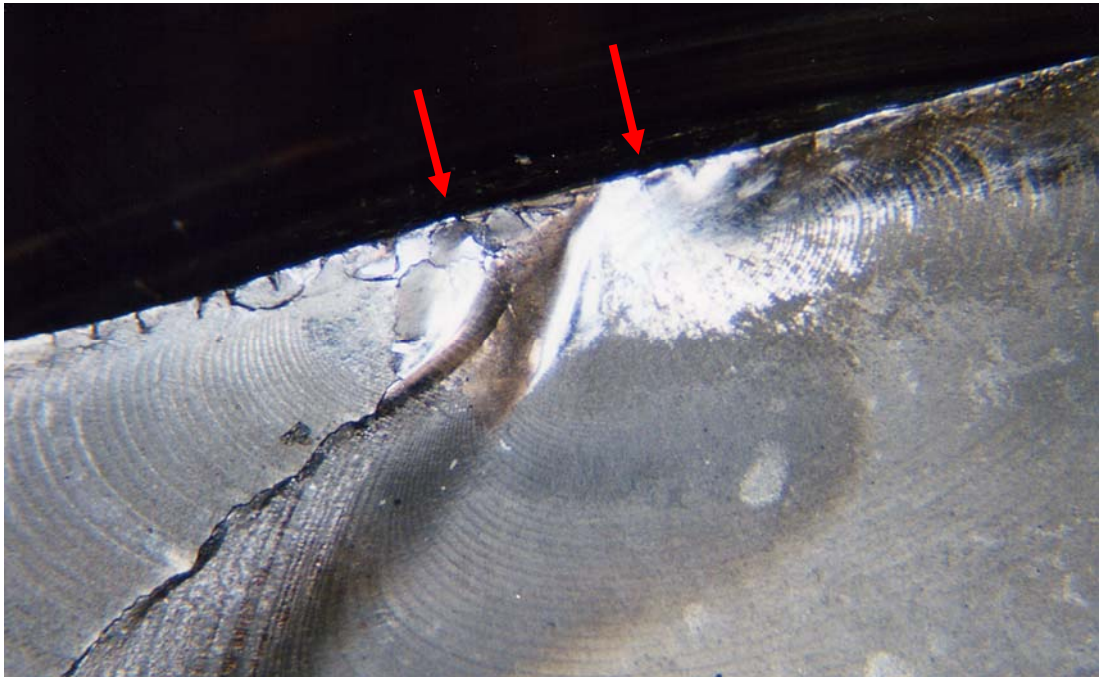
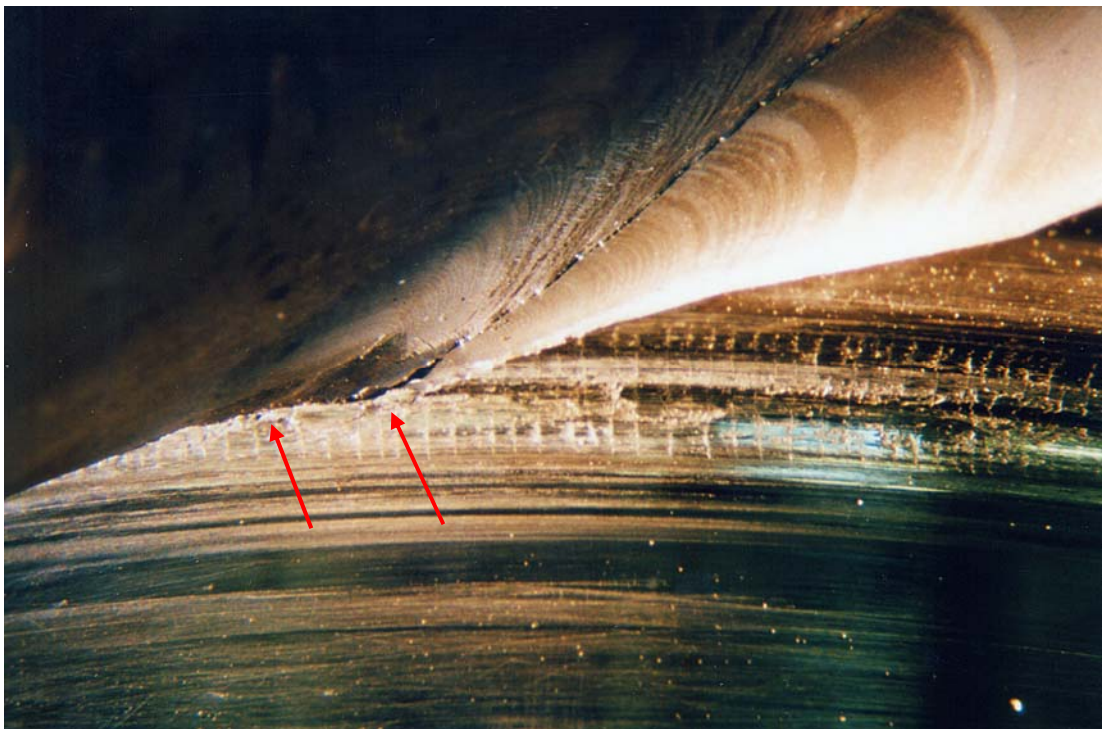
The damage created by the contact between the main-bearing inserts and the main-bearing fillet comprises of a series of thermal expansion cracks (oriented perpendicular to the fillet) and notching/scoring of the fillet.

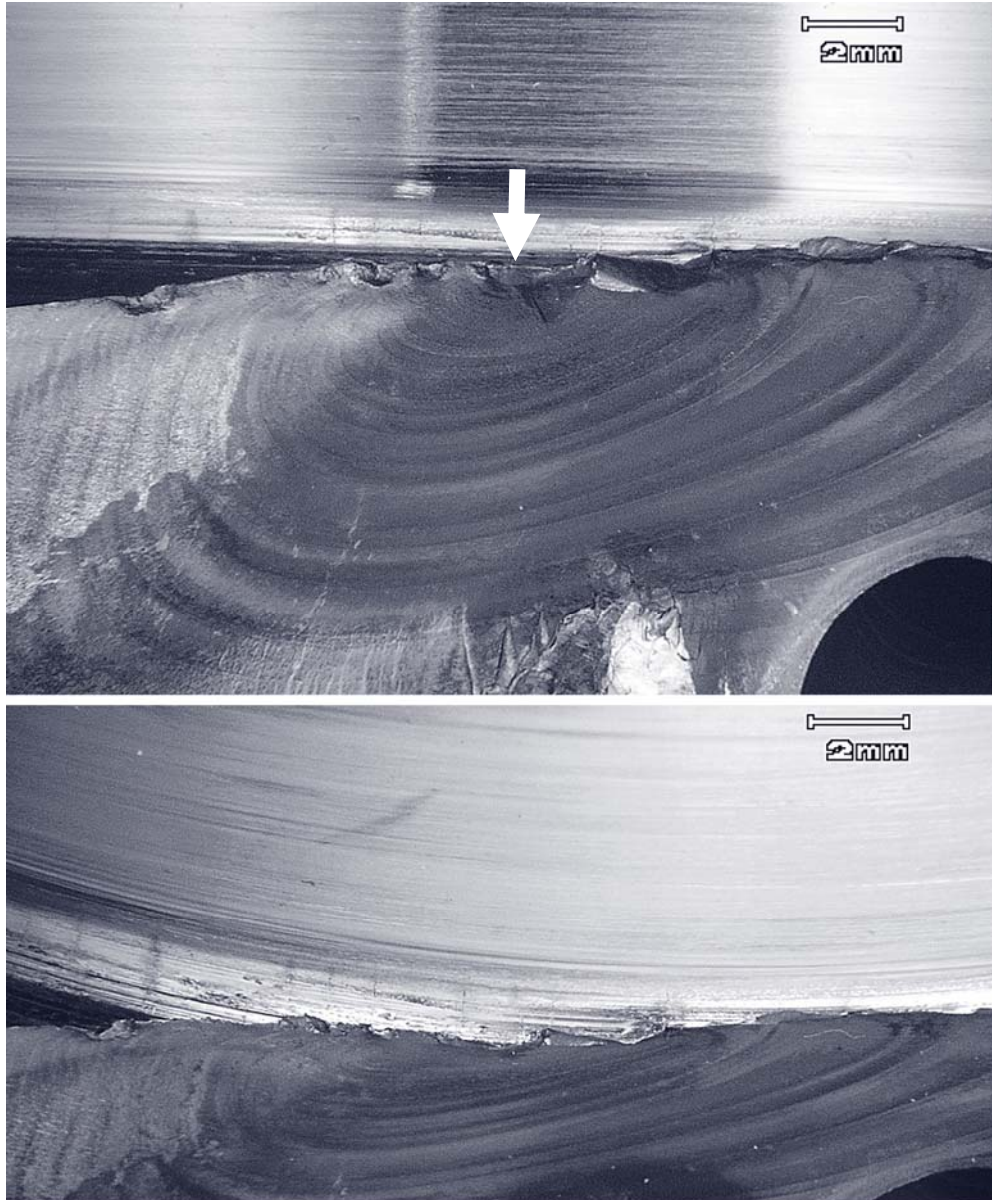
The location of the fatigue crack initiation is indicated with an arrow. Rubbing contact between the edge of the bearing insert and journal fillet created circumferential scoring and a series of short cracks (oriented perpendicular to the fillet).

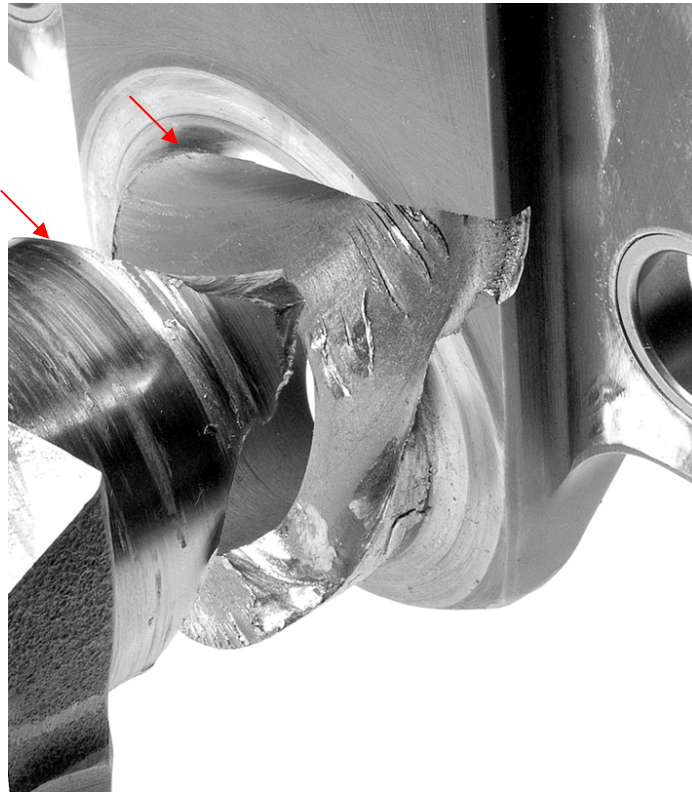
The location of the site of fatigue crack initiation is arrowed

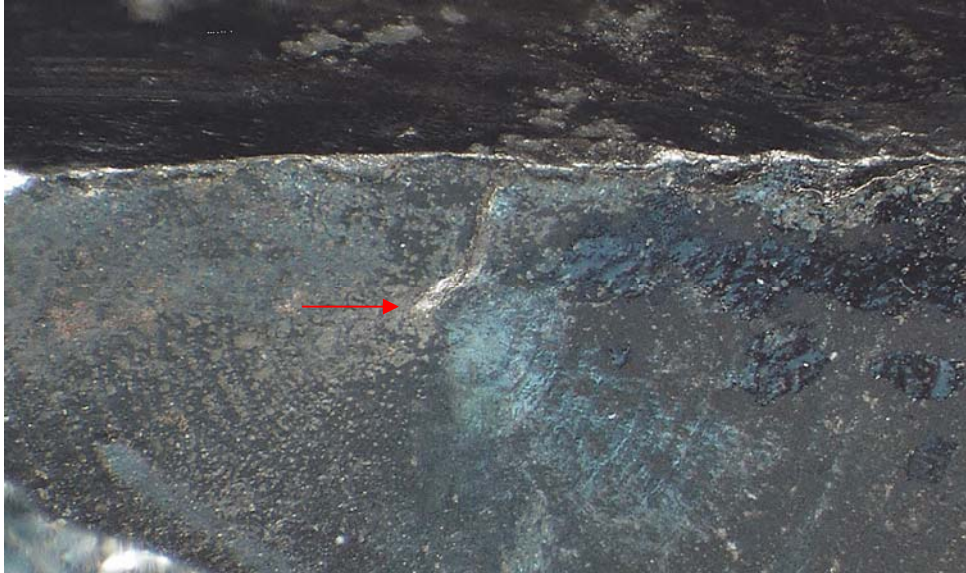
Light micrograph, the site of fatigue crack initiation is arrowed.

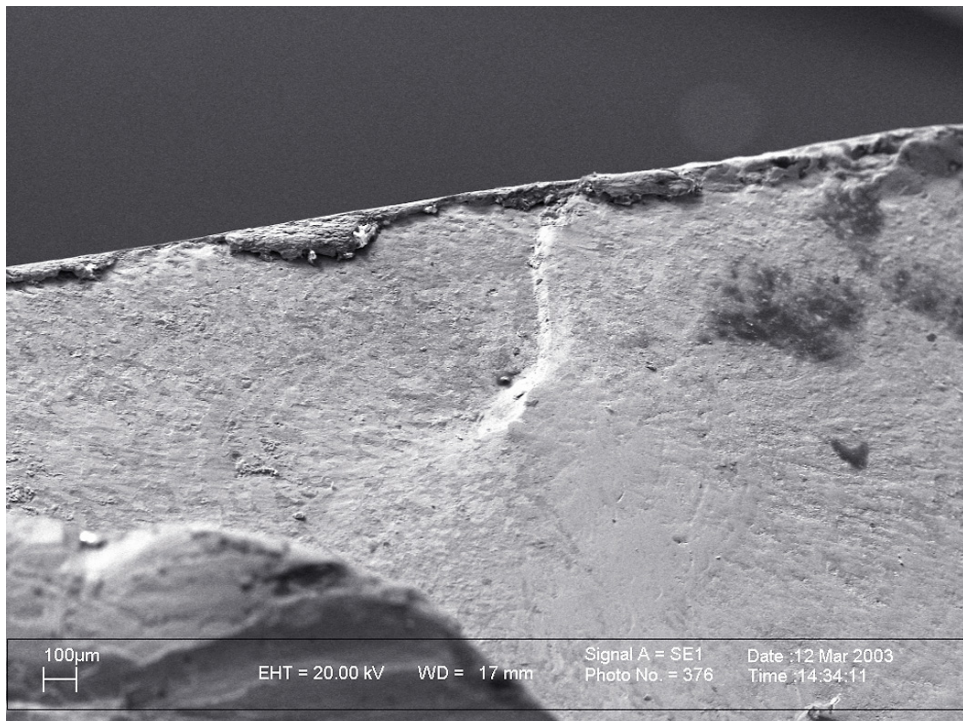
Scanning electron micrograph.

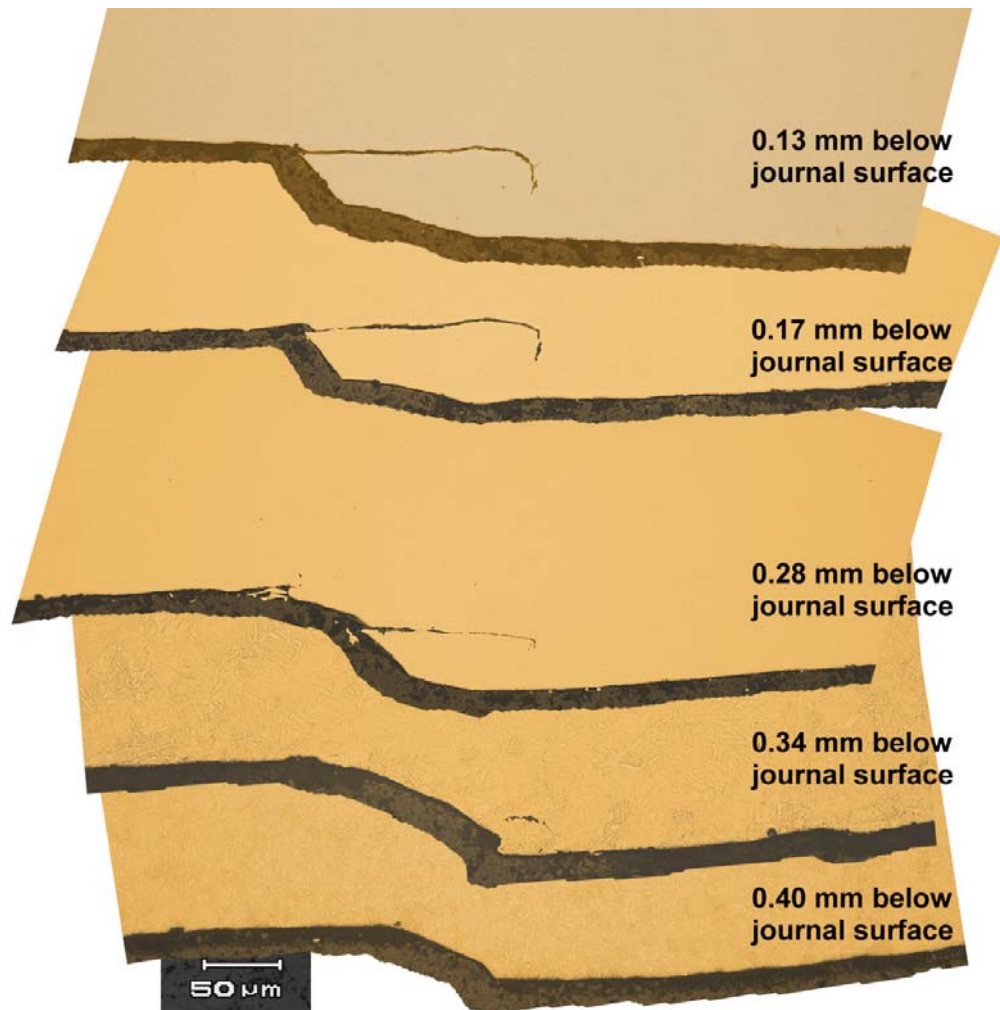
**Figure 8.119:** The microstructural features present in the section 0.13 mm below the journal surface

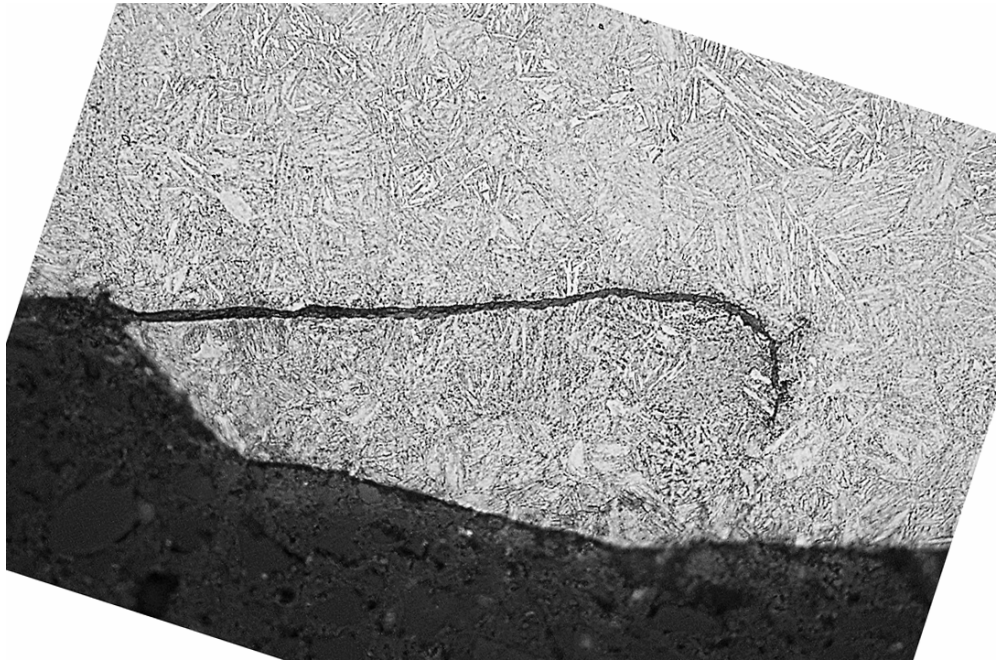
**Figure 8.120:** The microstructural features present in the section 0.28 mm below the journal surface
