Australian Government  
Australian Transport Safety Bureau

ATSB TRANSPORT SAFETY INVESTIGATION REPORT  
Aviation Research and Analysis Report – B20070191  
Final

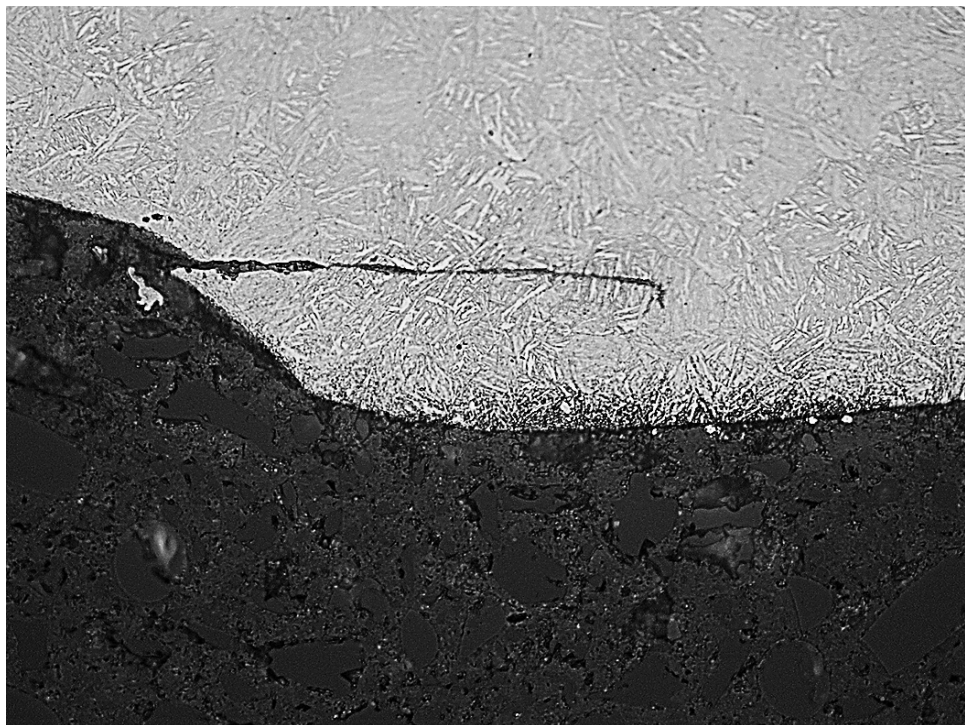
**Figure 8.121:** Detailed view, section 0.17 mm below the surface, scanning electron micrograph

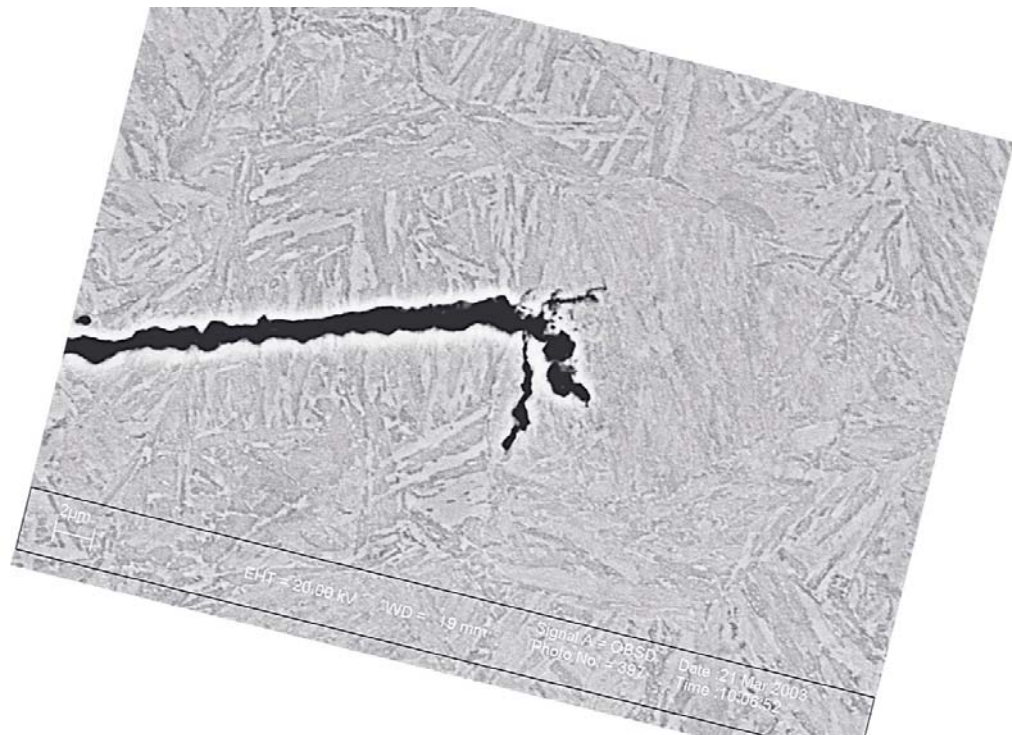
**Figure 8.123: Metallographic section taken through the planar feature on the crankweb side of the fracture, perpendicular to the journal surface**

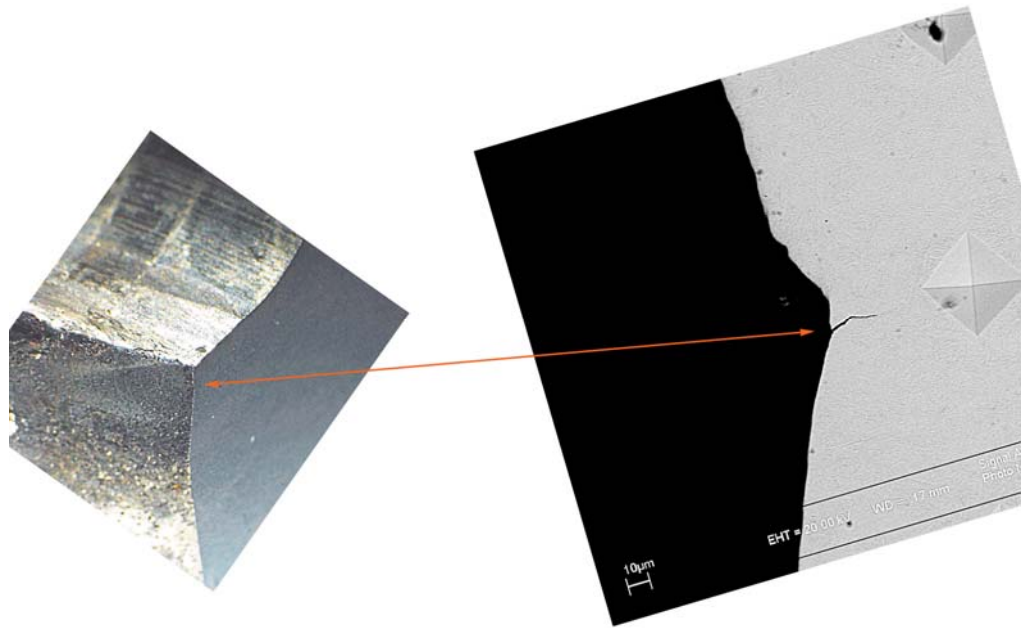
The section shows a crack-like defect (oriented perpendicular to the fillet) at the site of fatigue initiation.

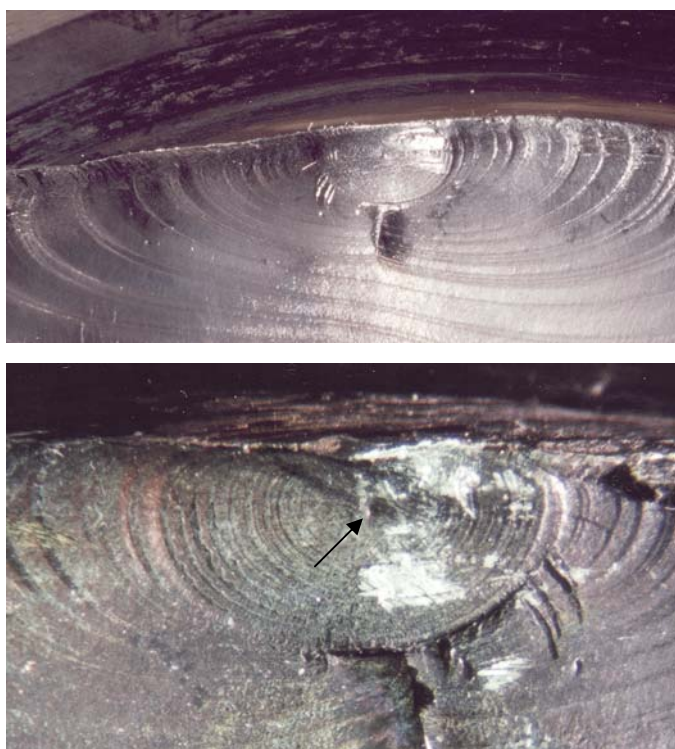
The crankweb side of the fracture is shown at the top of the figure, the journal side of the fracture is shown at the bottom of the figure. The site of fatigue crack initiation is arrowed.

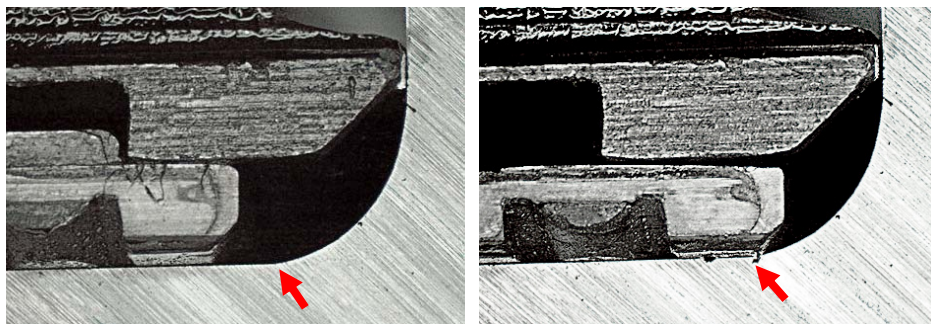
The location of fatigue crack initiation for occurrences 2000/2157 and 2001/5866, with respect to the fillet, is arrowed.

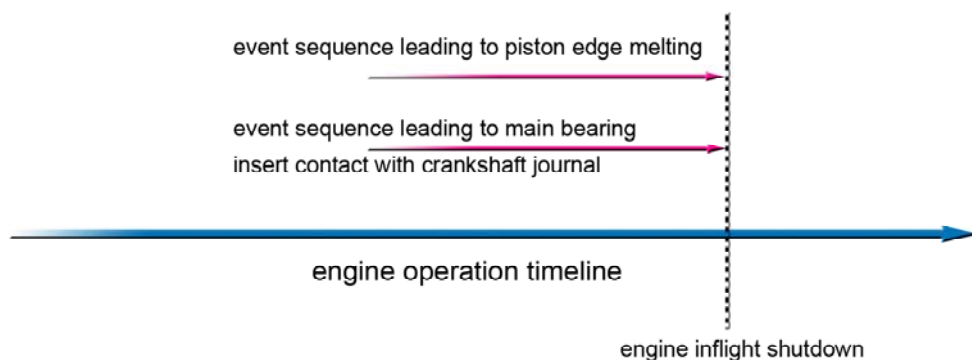
**Figure 8.127: Major defect report 94/1135, example 8**

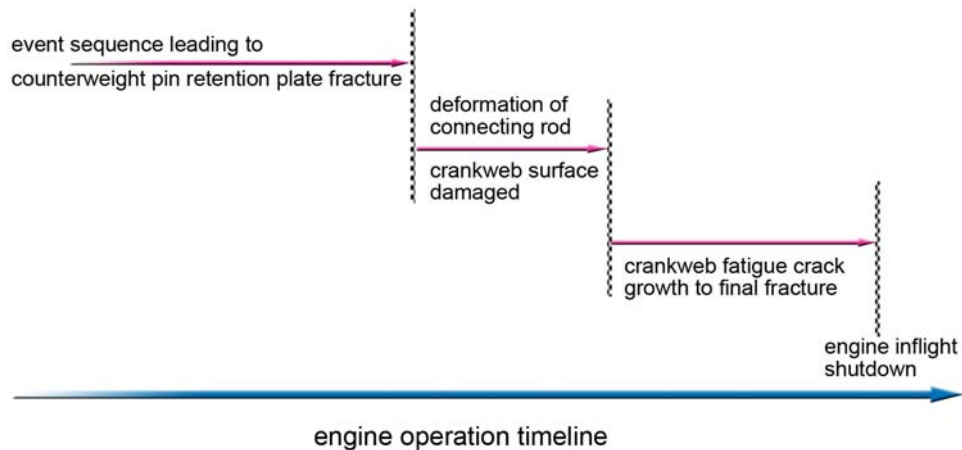
Refer to figures 8.96 to 8.100.

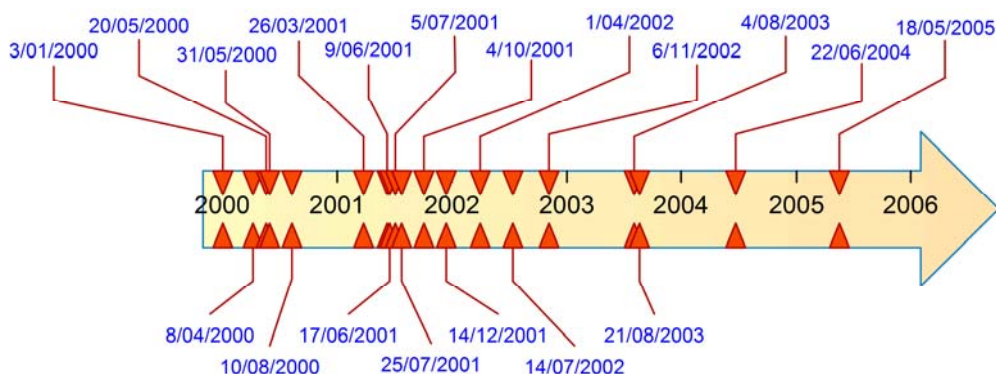
### 9.3 Corrective actions

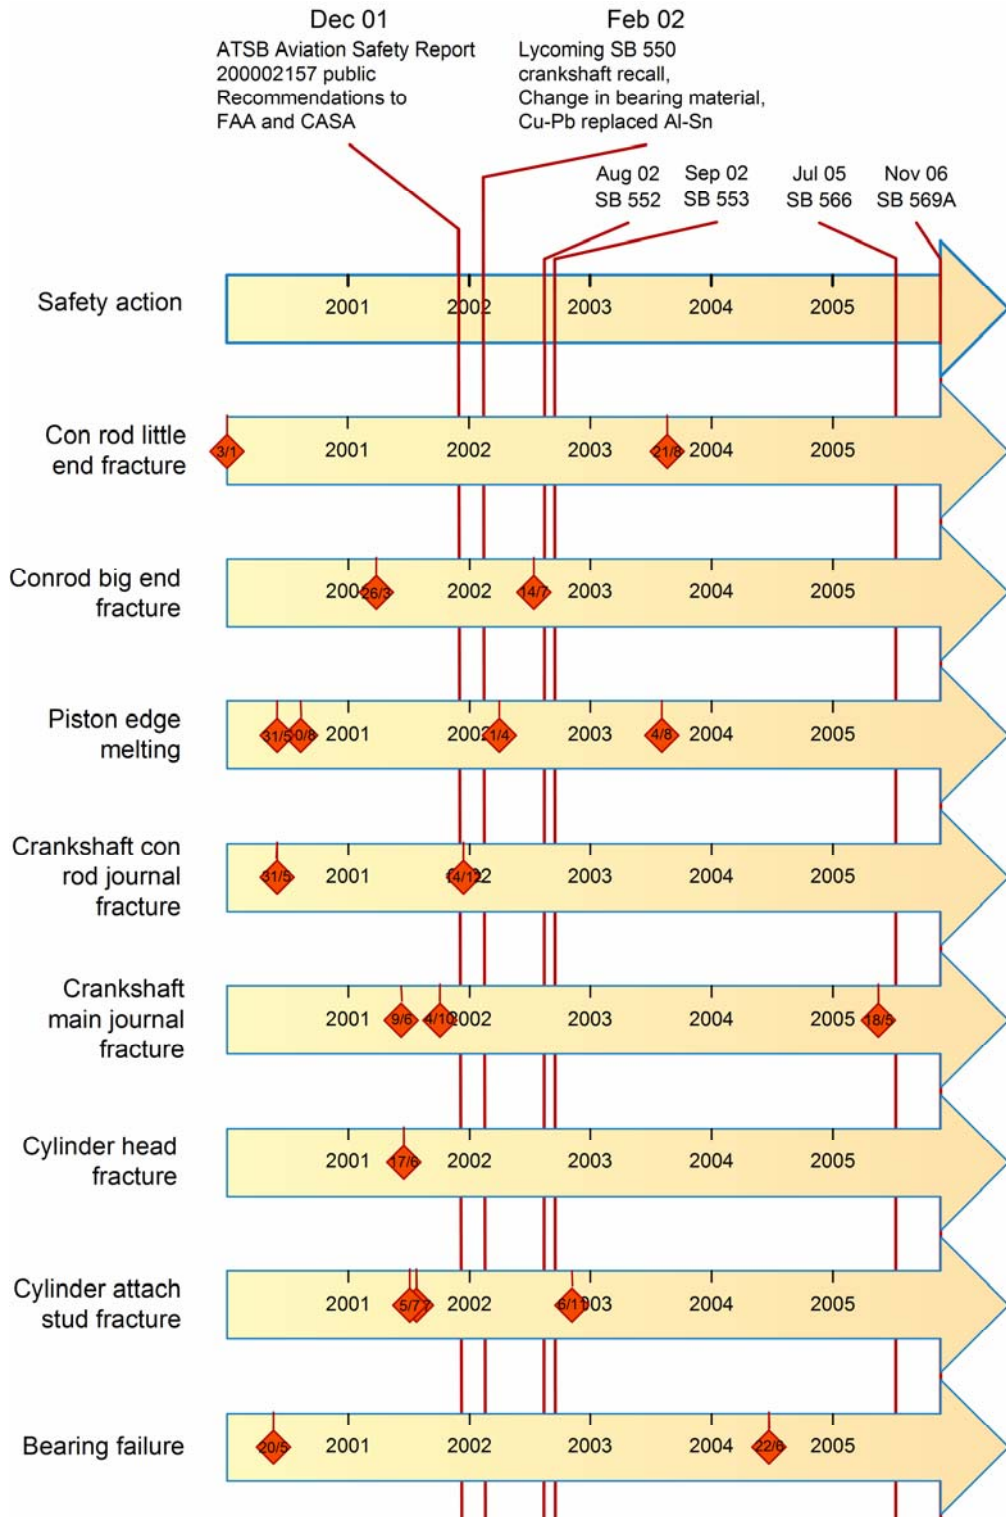
### 9.4.1 Feedback barriers
