Fatal aircraft accident at Canley Vale

Investigation briefs

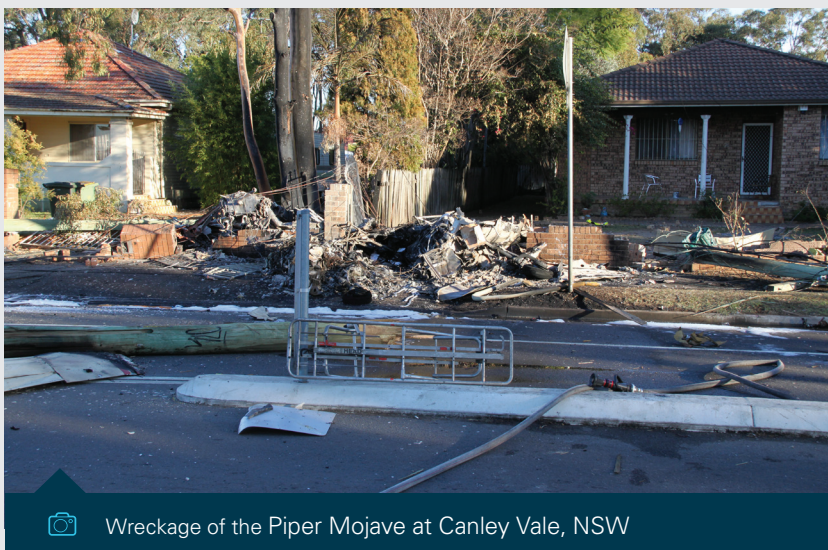
At about 0806 Eastern Standard Time, the aircraft collided with a powerline support pole at Canley Vale. Both occupants died in the accident and the aircraft was destroyed by the impact forces and an intense post-impact fire.

Wreckage of the Piper Mojave at Canley Vale, NSW

about the operation of the engines. The investigators discovered that when the pilot reported to ATC that he was turning the aircraft around, there had been surging of an engine which was consistent with uneven fuel distribution to the cylinders.

It was found that following the shutdown of the right engine the aircraft's airspeed and rate of descent were not optimised for flight

with one inoperative engine. In addition, the spectral analysis indicated it was unlikely that the left engine was being operated at maximum continuous power as the aircraft descended. As a result, the aircraft descended to a low altitude over a suburban area and the pilot was then unable to maintain level flight, which led to the collision with terrain.

The Civil Aviation Safety Authority has since started a project to amend advisory material relating to multi-engine aircraft training and operations to include guidance information about engine problems encountered during the climb and cruise phases of flight. This amended guidance material will include information about aircraft handling, engine management, and decision-making during these phases of flight. ■

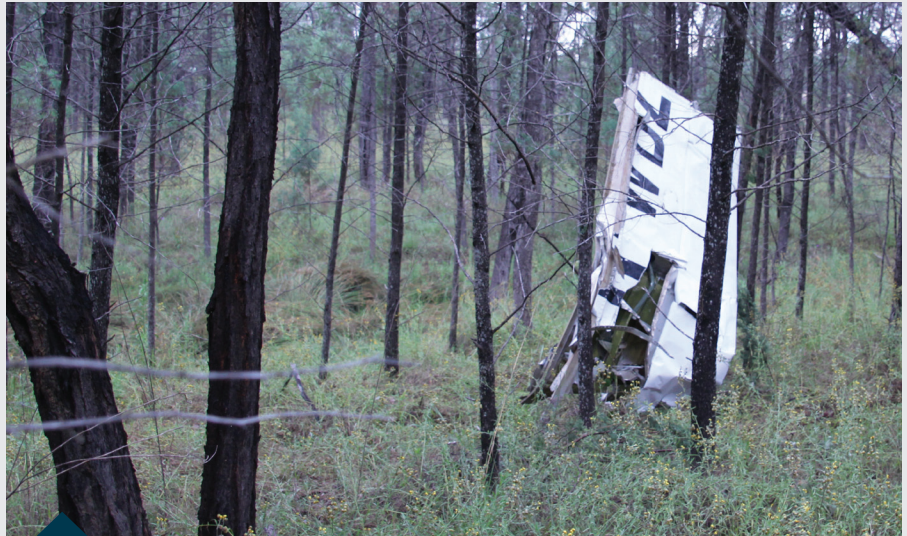
Wreckage of the Cessna 210, 100 km NNW Roma, Queensland

tail separated. The aircraft had been structurally sound before the separation and no aircraft system defects were identified. The investigation found that thunderstorms had been recorded in the area, and cruise power setting had been maintained until an onboard engine monitoring system ceased recording.

Although the precise circumstances leading to the accident were not known, a combination of aircraft airspeed with the effects of turbulence and/or control inputs generated stresses that exceeded the design limits of the

Airspeed is a critical factor in the stress sustained by an aircraft. Pilots need to be aware of the manoeuvring speed for the aircraft weight, and to control the airspeed so as not to exceed that value when full control deflection is required or severe turbulence or wind gust are encountered. ■
