Australian Transport Safety Bureau

The Australian

Preliminary report on the Strikemaster ex-military jet crash near Bathurst

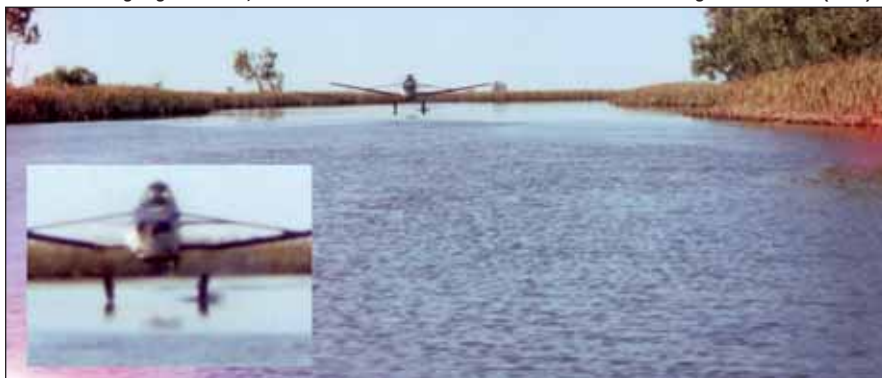
The pilot was reported to have been known to conduct 'high-risk' aerial activities, including aerobatic flight in agricultural aircraft. A number of photographs taken shortly before the final flight showed him conducting low passes over the water-ski site with the aircraft's main wheels in contact with the surface of the water. During the accident flight he was reported to have conducted very low passes over a departing vehicle, more low passes over the water with the main wheels in contact with the water's surface and what was described to be manoeuvres consistent with aerobatic flight.

The investigation concluded that the pilot was probably conducting an aerobatic flight manoeuvre from which collision with terrain could not be prevented. ■

Cessna 188B Agwagon aircraft, VH-ZIP at water-ski area. Note left main wheel contacting water surface (inset)

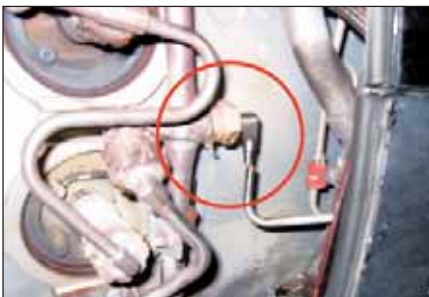
While on a scheduled passenger flight from Brisbane, Australia, to Los Angeles, US, the crew of the Boeing Company 747-438 aircraft, registered VH-OJD, observed excessive fuel use by the number-three engine. After confirmation that the engine had a fuel leak, the flight crew conducted an in-flight engine shut-down and diverted the aircraft to Sydney. Inspection of the engine found a fuel manifold drain line had fractured. Detailed examination of the drain line revealed that it had been subjected to high cycle fatigue (HCF), which led to its failure. The HCF was attributed to harmonic resonance from a combustor rumble of unknown origin. As a result of extensive testing of the engine, the manufacturer redesigned the drain line and reviewed its attachment (clipping) arrangements.

As a result of this investigation, the engine manufacturer re-designed the fuel manifold drain line for replacement on all applicable engines under a service bulletin (RB211-SB71-F152) released on 4 August 2006. This service bulletin also provides more detailed information to operators regarding fuel line clipping arrangements on these engines.

After the incident the operator conducted a fleet-wide inspection of the welded joints on the drain lines for evidence of cracking. No defects were found. The operator also subjected the incident engine to extensive testing with the engine manufacturer to identify the underlying cause of the combustor rumble. However, at the time of releasing this report, no determination had been made. On completion of the testing, the engine was scheduled to undertake a full refurbishment before being returned to service.

The operator also indicated that it would incorporate the manufacturer's service bulletin and replace all drain lines within their fleet on receipt of the new parts. ■
