Australian Transport Safety Bureau

# The Australian

# Aviation Safety Investigator

## Final ATSB investigation report on Condobolin in-flight breakup 4-fatality accident

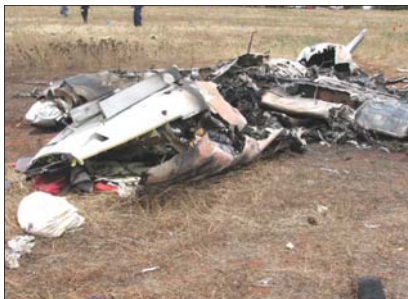
The ATSB's final investigation report into a Piper Chieftain accident near Condobolin, NSW on 2 December 2005, resulting in four deceased persons, confirms that the aircraft broke up during flight when its structural limits were exceeded in the vicinity of thunderstorms.

The absence of an on-board recording device on the aircraft prevented a full analysis of the circumstances of the breakup. However, while post-impact fire damage limited the extent to which some of the aircraft's systems, including the fuel and electrical systems, could be examined, wreckage examination did not reveal any pre-existing fault or condition that could have weakened the aircraft structure and caused it to break up at a load within the design load limit.

Analysis of the prevailing weather indicated that, immediately before the accident, the aircraft was likely to have been surrounded to the east, west, and south by a large complex of thunderstorms. That situation may have limited the options available to the pilot to avoid any possible hazardous phenomena associated with the storms.

### ATSB safety recommendation R20070025

The Australian Transport Safety Bureau recommends that the Civil Aviation Safety Authority, in consultation with Airservices Australia, review the requirements for the dissemination of SIGMET information with a view to

minimising differences between air traffic control procedures contained in the Aeronautical Information Publication and those contained in ICAO Doc.4444 and ICAO Doc.7030.

### ATSB safety recommendation R20070026

The Australian Transport Safety Bureau recommends that Airservices Australia, in consultation with the Civil Aviation Safety Authority, review the requirements for the dissemination of SIGMET information with a view to minimising differences between air traffic control procedures contained in the Aeronautical Information Publication and those contained in ICAO Doc.4444 and ICAO Doc.7030. ■

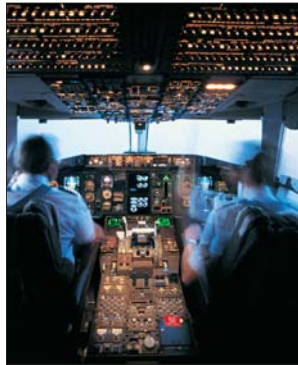
A Boeing Company 767-300 aircraft, registered VH-OGP, was being operated on an overnight international passenger flight from Nagoya, Japan to Cairns, Qld. On board the aircraft were a pilot in command (PIC), a copilot, seven cabin crew and 162 passengers. The copilot was the pilot flying for the sector and had just completed a period of crew rest. The PIC handed back the control of the aircraft to the copilot at about 1600 UTC and got up to go to the toilet. The copilot heard a bang and turned to see the PIC had collapsed on the cockpit floor. There was no response from the PIC to the copilot's questioning. The copilot switched on the cockpit lights and saw that the PIC appeared to be staring into space and remained unresponsive. The copilot then alerted the cabin service manager to come to the flight deck.

At approximately 1650 UTC, the PIC had recovered sufficiently to return to the cockpit, where he remained for the duration of the flight. A PAN call was transmitted when the aircraft entered the Australian Flight Information Region and emergency services were placed on standby for the aircraft's arrival and landing at Cairns.

The PIC was subsequently examined and cleared to return to flight duties by a Designated Aviation Medical Examiner (DAME). The DAME determined that the PIC probably had been affected by a gastro-intestinal illness that had previously been experienced by members of the PIC's family. A Norovirus gastro-intestinal disorder was prevalent in the Queensland region at the time. ■
