A review of the effectiveness of emergency locator transmitters in aviation accidents

ATSB Transport Safety Report
Aviation Research Investigation
AR-2012-128
Final – 21 May 2013

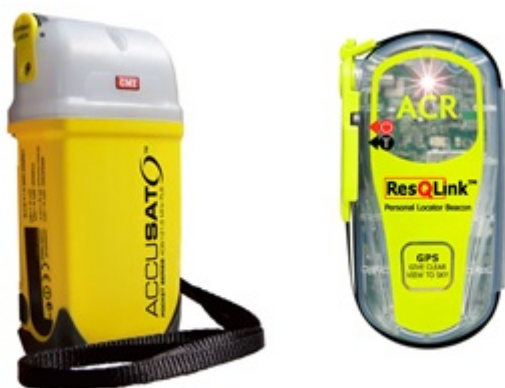
Figure 2: Two examples of typical PLBs

These beacons are designed for personal use and are usually smaller in size (roughly pocket sized). Originally intended for personal land use (for example, hiking or remote 4x4 driving), these devices are now finding use in other environments. Changes to the Civil Aviation Regulation 1988 (CAR) 252A mean that since 31 July 1997, a PLB or EPIRB may be used as an alternative to an airframe mounted ELT, provided the requirements to be an eligible portable ELT are met (see Appendix A for details). Thus, it is common for the same PLB to be used by an owner for bushwalking and for recreational boating or in a general aviation aircraft. PLBs are manually activated and are required to operate continuously for 24 hours once activated.

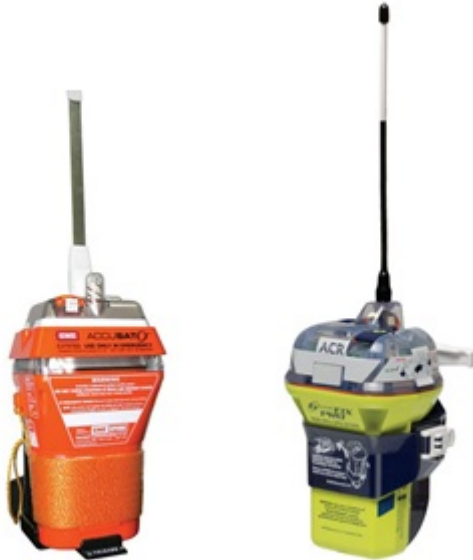
Figure 3: Two typical examples of EPIRBs

Intended for ships, boats and maritime personnel, EPIRBs are water proof and designed to float. EPIRBs can be either manually activated, water activated, or both, and are required to operate for a minimum of 48 hours continuously once activated.

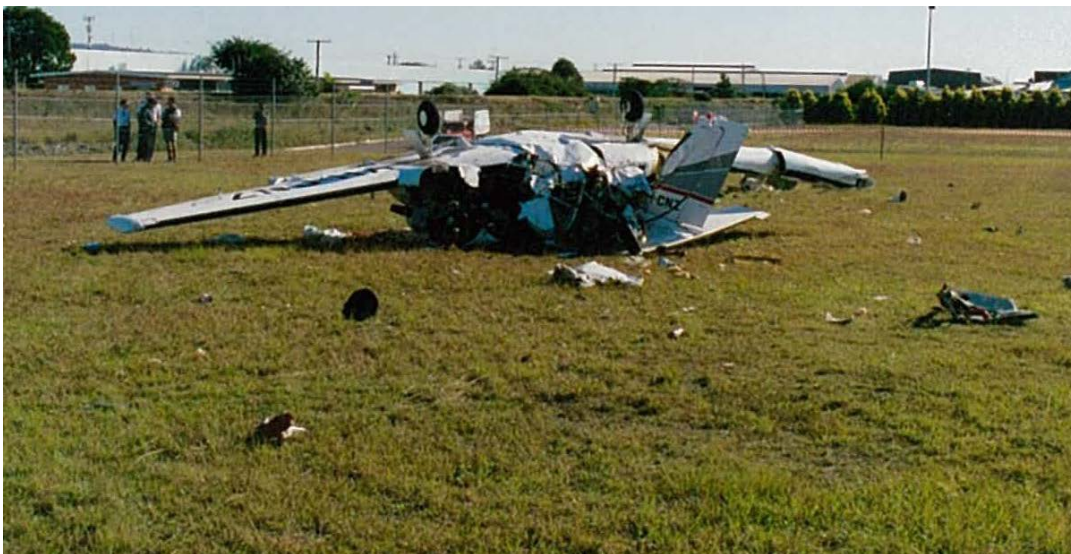
Figure 7: Wreckage of the Piper Twin Comanche near Archerfield Airport, Qld

During the initial investigation response by the ATSB, it was noticed that the aircraft was fitted with what appeared to be a reasonably new ELT. Examination of the wreckage found that the ELT was mounted in a fixed cradle on the right side of the fuselage, immediately behind the rear cabin bulkhead. The beacon did not activate as a result of the initial impact. On the day following the accident when the on-site investigation work was complete, the wreckage was transported to a nearby hangar by a tilt bed truck. As the wreckage was lowered from the truck and came into contact with the concrete floor of the hangar, the ELT activated. Closer examination showed that the ELT and cradle had been fitted to the aircraft incorrectly, in that the base of the ELT was facing in the wrong direction.

While the ELT survived the collision with terrain and was fully functional, incorrect installation resulted in it not activating as intended. This type of ELT was fitted with only a single plane g-switch (3-axis g-switches are now available) that required it to be fitted so that the impact forces are felt through the base of the unit. This requires that this type of ELT be fitted with the base aligned in the direction of travel.

An advantage of ELTs with a g-force activated switch that only operates in one axis is that they are not likely to accidentally activate due to turbulence, however, this may result in the ELT not activating in some types of accidents where there is not a high forward load in the aircraft impact (such as in an in-flight breakup, or in a hard landing). Additionally, the use of a g-switch designed to operate in a particular spatial orientation means correct positioning and installation is critical in ensuring the device can function as intended, as demonstrated in this accident.

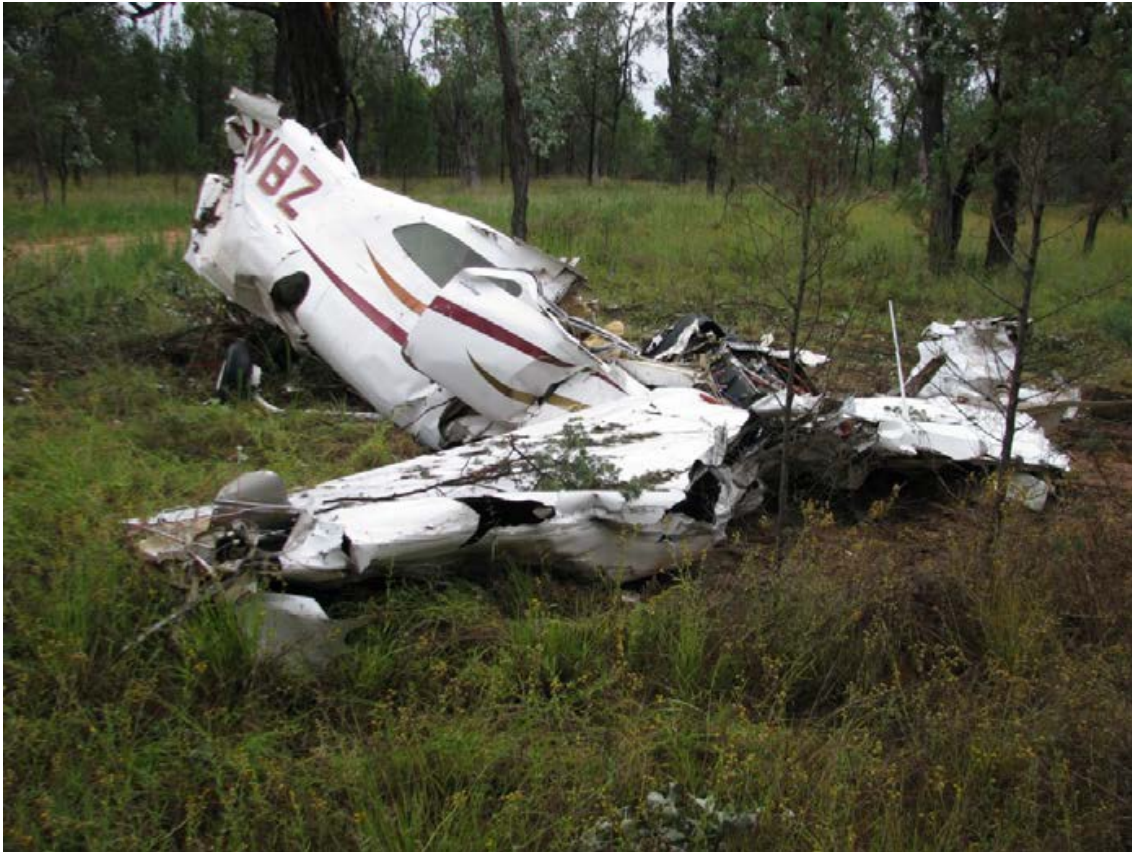
Figure 8: Wreckage of the Cessna 210M near Injune, Qld

On 7 December 2011, the owner-pilot of a Cessna 210M was conducting a private flight under visual flight rules from Roma to Dysart in Queensland. Thunderstorms with associated cloud, rain and severe turbulence were forecast for the area. About 30 minutes into the flight, the outer sections of the wings and parts of the tail separated. The aircraft collided with terrain, fatally injuring the pilot.

In situations like in-flight breakups, aircraft debris is likely to be scattered over a wide geographic area, and while an ELT may have activated and survived, it may not indicate the location of the main aircraft wreckage. Although the ELT survived and activated in this accident, during the impact with terrain it detached from its fuselage mounting tray, separating the unit from the aerial cable. Broken antennae and disconnected antenna cables are a commonly observed reason for ELTs not functioning as intended in some high-g force accidents, as either case greatly reduces the transmission range. This is particularly the case in accidents where the aircraft fuselage is seriously disrupted, as in controlled flight into terrain (CFIT) and in-flight break-ups. In this accident, AMSA did not receive position information from the ELT itself, but from on-board mobile phones; a technique which is becoming increasingly frequent.

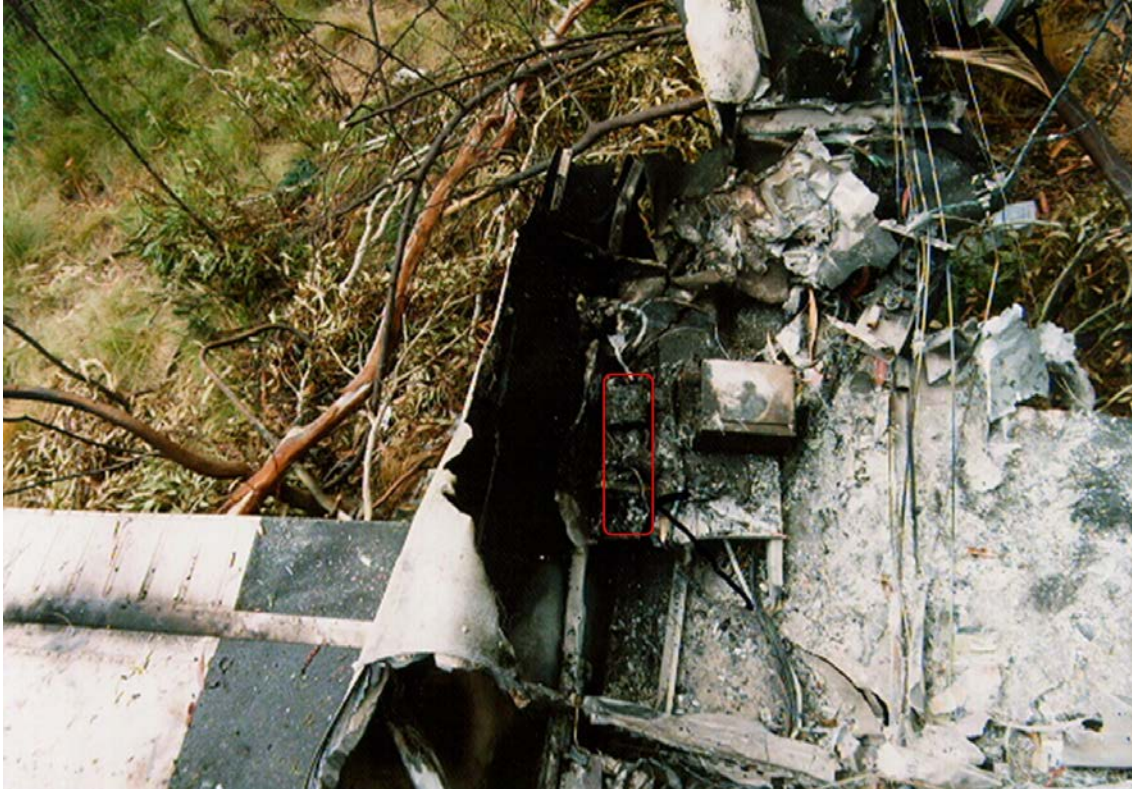
Figure 9: Wreckage of the Piper Cherokee 37 km east of Coolah, NSW (the location of the burnt ELT is outlined in red)

The ATSB investigation into this accident found that the aircraft collided with trees during a right turn, at a rate of descent of about 2,500 ft/min. The impact severed the outboard section of the right wing. The aircraft then collided with other trees before striking the ground. The right fuel tank had ruptured as the aircraft descended through the trees and an intense post-impact fire had consumed the cabin area and the fuselage section immediately behind the cabin. Although the

accident was survivable, both the pilot and passenger received extensive burns while escaping from the burning wreckage. The pilot died some time later from his injuries, before the aircraft and surviving passenger were located by SAR personnel. An ELT, mounted in the aft cabin area of the aircraft, was destroyed by the fire. While it was not possible to determine if the ELT had activated during the accident sequence, no signal from the ELT had been received by the satellite monitoring system. The pilot was known to possess a personal ELT; however, this was not located after the accident.

Unfortunately, fixed ELTs are not particularly fire resistant and there have been a number of investigated accidents where there was a post-impact fire in which the ELT burnt before a signal was received. In this accident, one of the occupants survived with serious wounds for approximately 40 hours after impact before succumbing to these injuries. Had the ELT survived the initial impact and subsequent fire long enough to send a signal, it may have shortened the time taken for SAR to locate and arrive at the accident site, and could have improved the survivability of the accident.

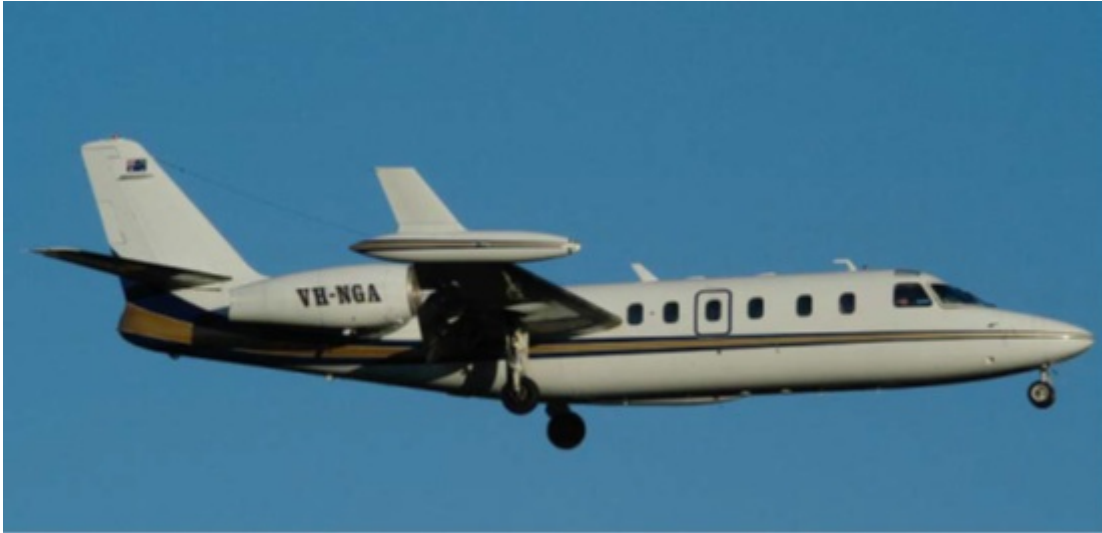
Figure 10: The Israel Industries Westwind 1124A.

On the night of 18 November 2009, an Israel Aircraft Industries Westwind 1124A (Figure 10) ditched into the sea 5 km SW of Norfolk Island Airport. All six occupants survived the ditching and were able to egress the aircraft and were later rescued by boat crews from Norfolk Island.

The aircraft was fitted with a fixed, fuselage mounted 406 MHz ELT. The ELT was equipped with a g-switch and could be manually activated by a switch in the cockpit. The aircraft was also equipped with four personal locator beacons (PLBs) that could be carried separately and manually activated. Two of these beacons were installed in the life rafts, and one of the remaining beacons was equipped with Global Positioning System (GPS) equipment, which would enable it to transmit its position when it was activated. The aircraft occupants were unable to retrieve any of the PLBs or the life rafts before they exited the aircraft after the ditching. The aircraft-mounted ELT was not GPS-equipped. A geostationary satellite received one transmission from that ELT and the information associated with that transmission was received by AusSAR 8 minutes after the aircraft ditched. AusSAR was able to identify the owner of the ELT, but was not able to assess its location from the one transmission.

Although EPIRBs are required to be waterproof, there is no such requirement for fixed ELTs, which could have contributed to this ELT failing 8 minutes after ditching.

The 8 minutes in which the ELT was functioning was sufficient for only one signal to be received by satellites. This first signal contained the unique hex identifier but not any position information. As a result, the registration of the ditched aircraft was received but not any information regarding its location. Had the ELT been GPS-enabled, it is possible that further information regarding its location could have been transmitted in the first signal; however, this is still not guaranteed as the GPS chip requires some time to acquire its location once activated. Although the aircraft registration can be a good starting point for a SAR investigation, rescuers must wait for confirmation of the beacon's position before sending a search and rescue team, so a non-GPS equipped ELT can potentially increase the SAR response time. For very little additional expense, GPS equipped ELTs significantly increase the accuracy of positional resolution from approximately 5 km (non-GPS) to approximately 120 m for GPS-enabled ELTs.

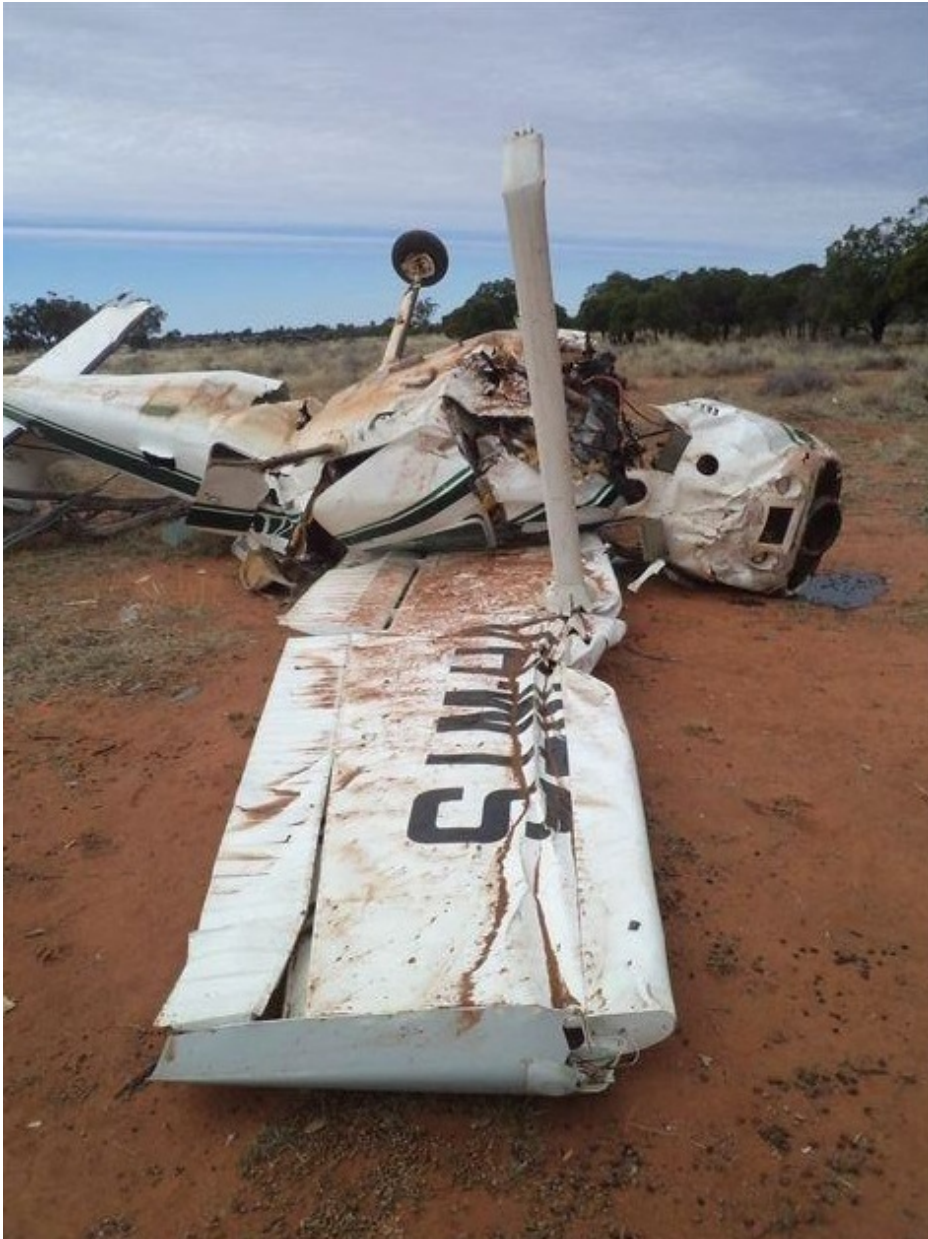
Figure 11: Wreckage of the Cessna 182P in the vicinity of Mayvale Station, Qld

On 19 June 2012, a Cessna 182P suffered a partial power loss just after take-off from Mayvale Station (near Cunnamulla), Queensland due to the use of contaminated fuel. The aircraft rapidly lost altitude, and during an attempted forced landing, the aircraft clipped a tree and collided with the ground. The aircraft was destroyed, coming to rest inverted, and the pilot was seriously injured.

The fixed fuselage mounted ELT did not activate during the impact. The reason the ELT did not activate was not determined in the ATSB investigation, but may have been due to shielding or disruption of the ELT antenna when the aircraft came to rest inverted. The pilot was also carrying a PLB on the accident flight, but it was not on his person. Due to injuries sustained in the accident, the pilot was unable to retrieve the PLB from the wreckage. Fortunately, the aircraft was still in the vicinity of the station, and the seriously injured pilot was rescued about 3 hours after the accident.

The ATSB has investigated many general aviation aircraft accidents where the pilot attempted a forced landing, and the aircraft came to rest inverted after impacting trees, ruts, or other obstacles. In many of these accidents, the ELT failed to operate. This is typically due to either the antenna (typically located on the upper surface of the fuselage) being disrupted in the impact or by the signal being shielded by the upturned fuselage.

This case also highlights the importance of carrying PLBs on your person (rather than loose in the aircraft or mounted to the instrument panel) so that they are within arm's reach if objects are displaced, if you are unable to reach the instrument panel, or if you are thrown clear of the aircraft in an accident .

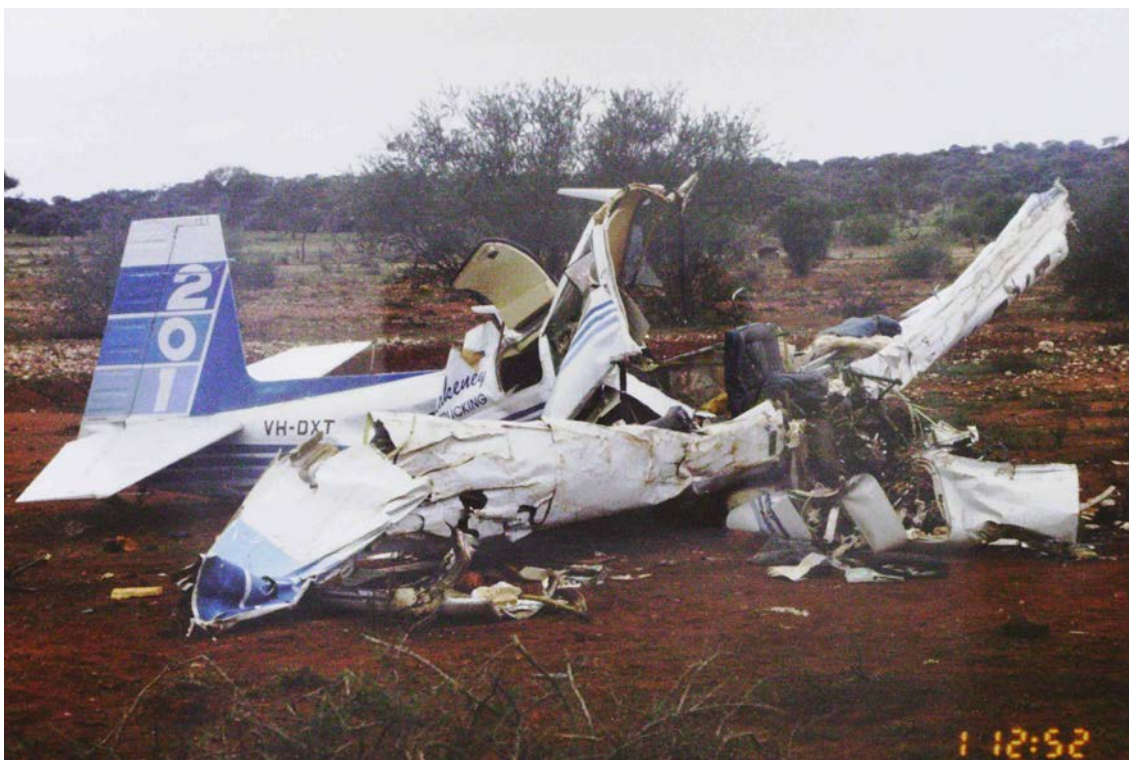
Figure 12: Wreckage of the Mooney M20J at Melita Station, WA

On 29 June 1998, a pilot and passenger were travelling in a Mooney M20J from Jandakot to Laverton, Western Australia, via Melita Station to deliver some equipment. On arrival at Melita Station, the pilot overflew the airstrip in a low level circuit. At the completion of the downwind leg, the aircraft banked sharply to the left onto an apparent final approach. A station hand saw the aircraft fly close to the ground for half of the strip length, before adopting a nose-up attitude. The engine noise increased but sounded laboured, before stopping when the aircraft was about 100 ft above ground level. The aircraft then pitched nose-down, and impacted the ground in a near-vertical attitude. The aircraft was destroyed, and both pilot and passenger were fatally injured.

The aircraft was fitted with an ELT and although it appeared to be correctly mounted and connected, the ELT did not activate at the time of the accident. The ELT had a remote instrument panel-mounted activation switch which was selected to 'arm' and the switch on the ELT unit itself was selected to 'auto'. The ATSB investigation could not determine why the ELT had not operated during the accident. When tested during the investigation, it operated normally.

There are many cases like this one where there is simply no explanation as to why an ELT failed to activate during a high g-force impact. In this case, the ELT was found by the ATSB to be intact after the impact; the mounting was intact, the unit itself undamaged, and the co-axial antenna cable still attached. Both the switch on the ELT, as well as the remote switch on the instrument panel were found to be in the correct setting, and a functional test of the ELT unit after being removed from the aircraft confirmed that it operated as expected.
