Derailment involving freight train 5WB7

Casino, New South Wales, on 17 March 2022

ATSB Transport Safety Report
Rail Occurrence Investigation
RO-2022-004
Discontinuation notice – 22 December 2023

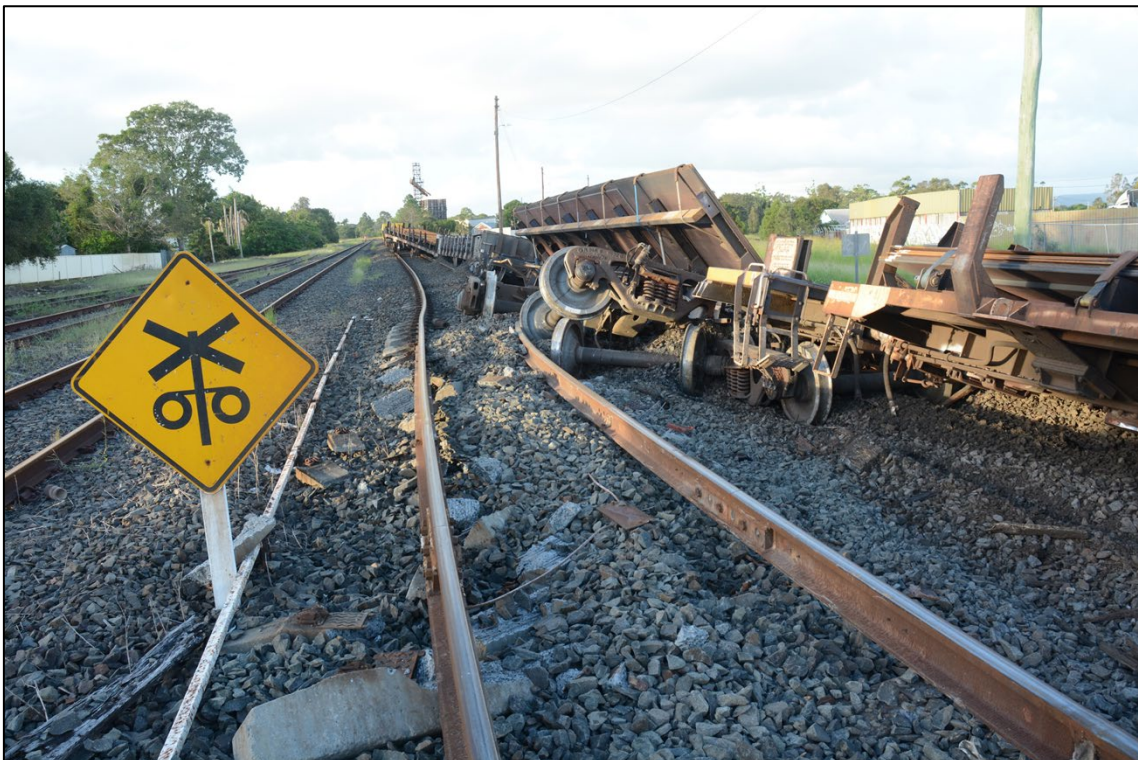
Cover photo: Wreckage of forward portion of derailed train 5WB7 at Casino.
Source: Office of Transport Safety Investigations (OTSI).
