Safety Advisory Notice

Number: RO-2022-001-SAN-01

Automatic coupler operation and design features

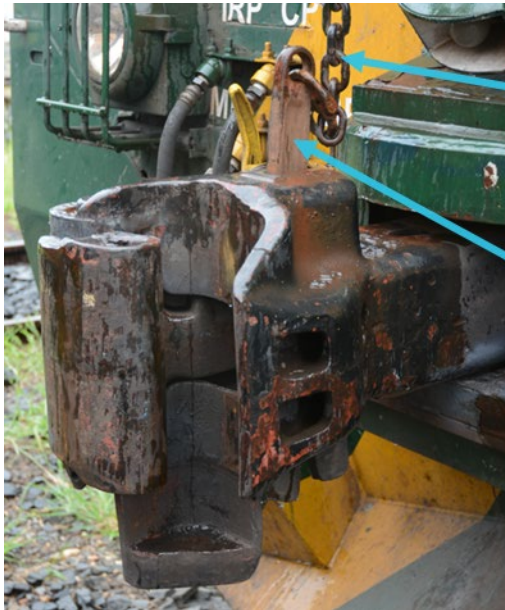
Figure 1: Top operated coupler

While top operated couplers provide a clear visual cue when the knuckle is unlocked, specifically, the lifter pin is significantly raised above the coupler assembly (Figure 1), the range of movement and vision of a lifter pin on a bottom operated coupler is markedly reduced (Figure 2).

Due to significant limitations in visual cues, a positive stretch test, particularly of bottom operated couplers, is essential for verifying that the knuckle is locked at the conclusion of a coupling manoeuvre.

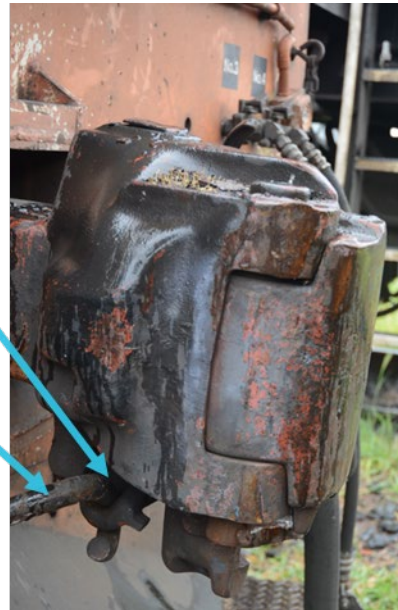
Figure 2: Bottom operated coupler

Control rod linkage

Lifter pin
