Cockpit Visibility Study

Supporting AO-2023-001 – Midair collision involving Eurocopter EC130 B4, VH-XH9, and Eurocopter EC130 B4, VH-XKQ, Main Beach, Gold Coast, Queensland, on 2 January 2023

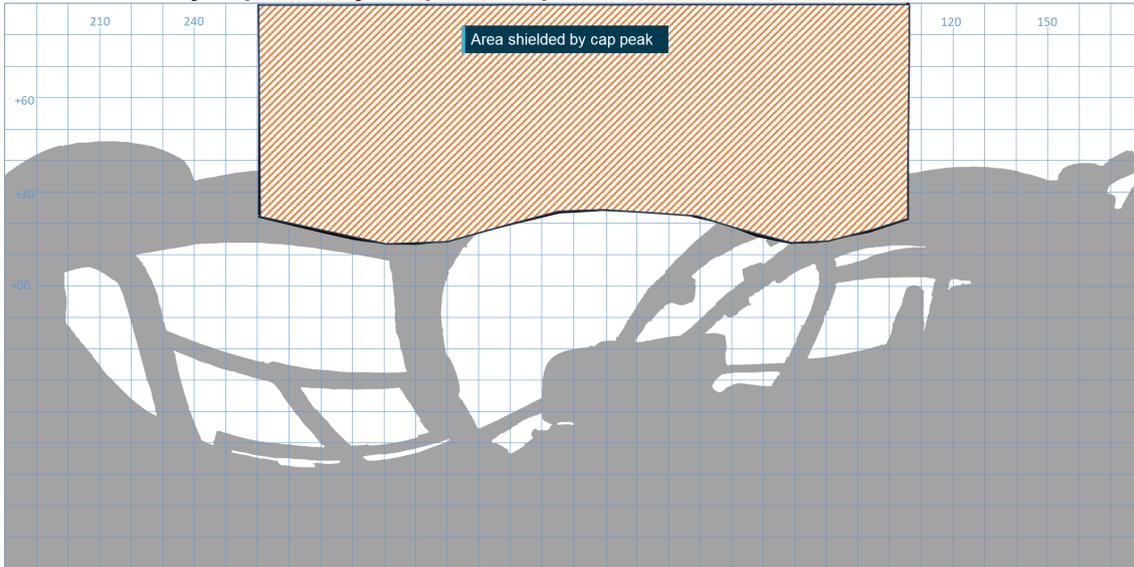
The cap’s peak extended at a slight downward angle from the cap’s body so that the front of the peak sat lower than the body of the cap. To assess how this would impact the pilot’s FOV, the ATSB placed the cap over the lens of a spherical camera to simulate the position of the cap relative to the pilot’s eyes and captured an image from the simulated position. Based on this image, the area of the FOV from the pilot’s eye position that would be obscured by the cap’s peak was determined (see Figure 15). A pilot wearing the cap would have been able to see objects in this area. The area where the cap’s peak obscured the pilot’s FOV was verified by identifying the boundaries of the FOV of an ATSB investigator of the approximate height of XKQ’s pilot seated in the left seat of the helicopter while wearing the cap.

Figure 15: Equirectangular view of the cockpit from the pilot’s eye position showing the area of visibility impacted by the pilot’s cap brim

The pilot of XKQ was wearing a Sea World Helicopters cap for the accident flight. This cap was a ‘trucker’ style, with a solid front panel embroidered with the Sea World Helicopters logo and the remaining panels were of mesh construction. While onsite conducting 3D modelling in support of this study ATSB personnel examined an exemplar Sea World Helicopters cap and photographs, 3D scans and measurements of it to help determine its potential impacts on the pilot’s FOV. The exemplar cap had an approximate peak width of 130 mm, height of 40 mm and depth of 80 mm at the centre. It is important to note that the peak of the cap is manipulable and so the impact of the peak of the pilot’s actual cap may have differed slightly from the exemplar.

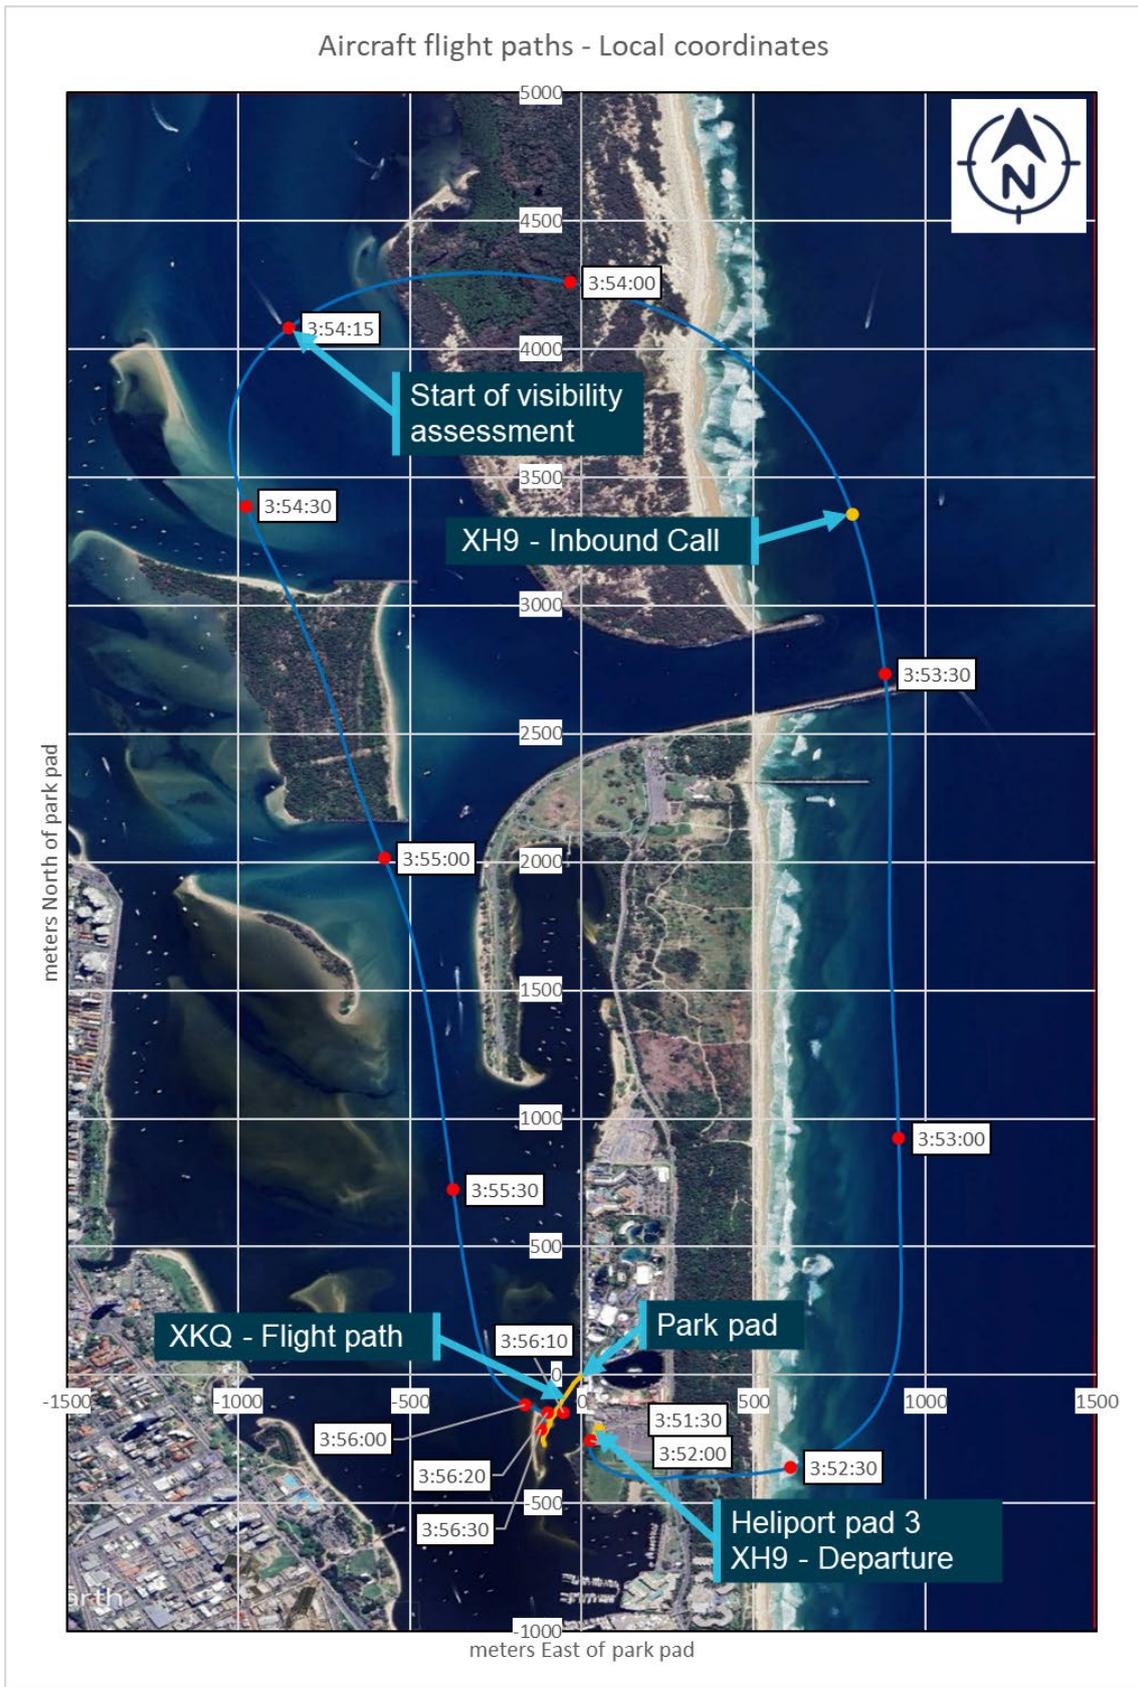
Figure 25: Aircraft flight paths in local cartesian coordinates

Note: Satellite image was taken near high tide. Sandbar was exposed at the time of the accident.
 Source: Google Earth and ATSB, annotated by the ATSB

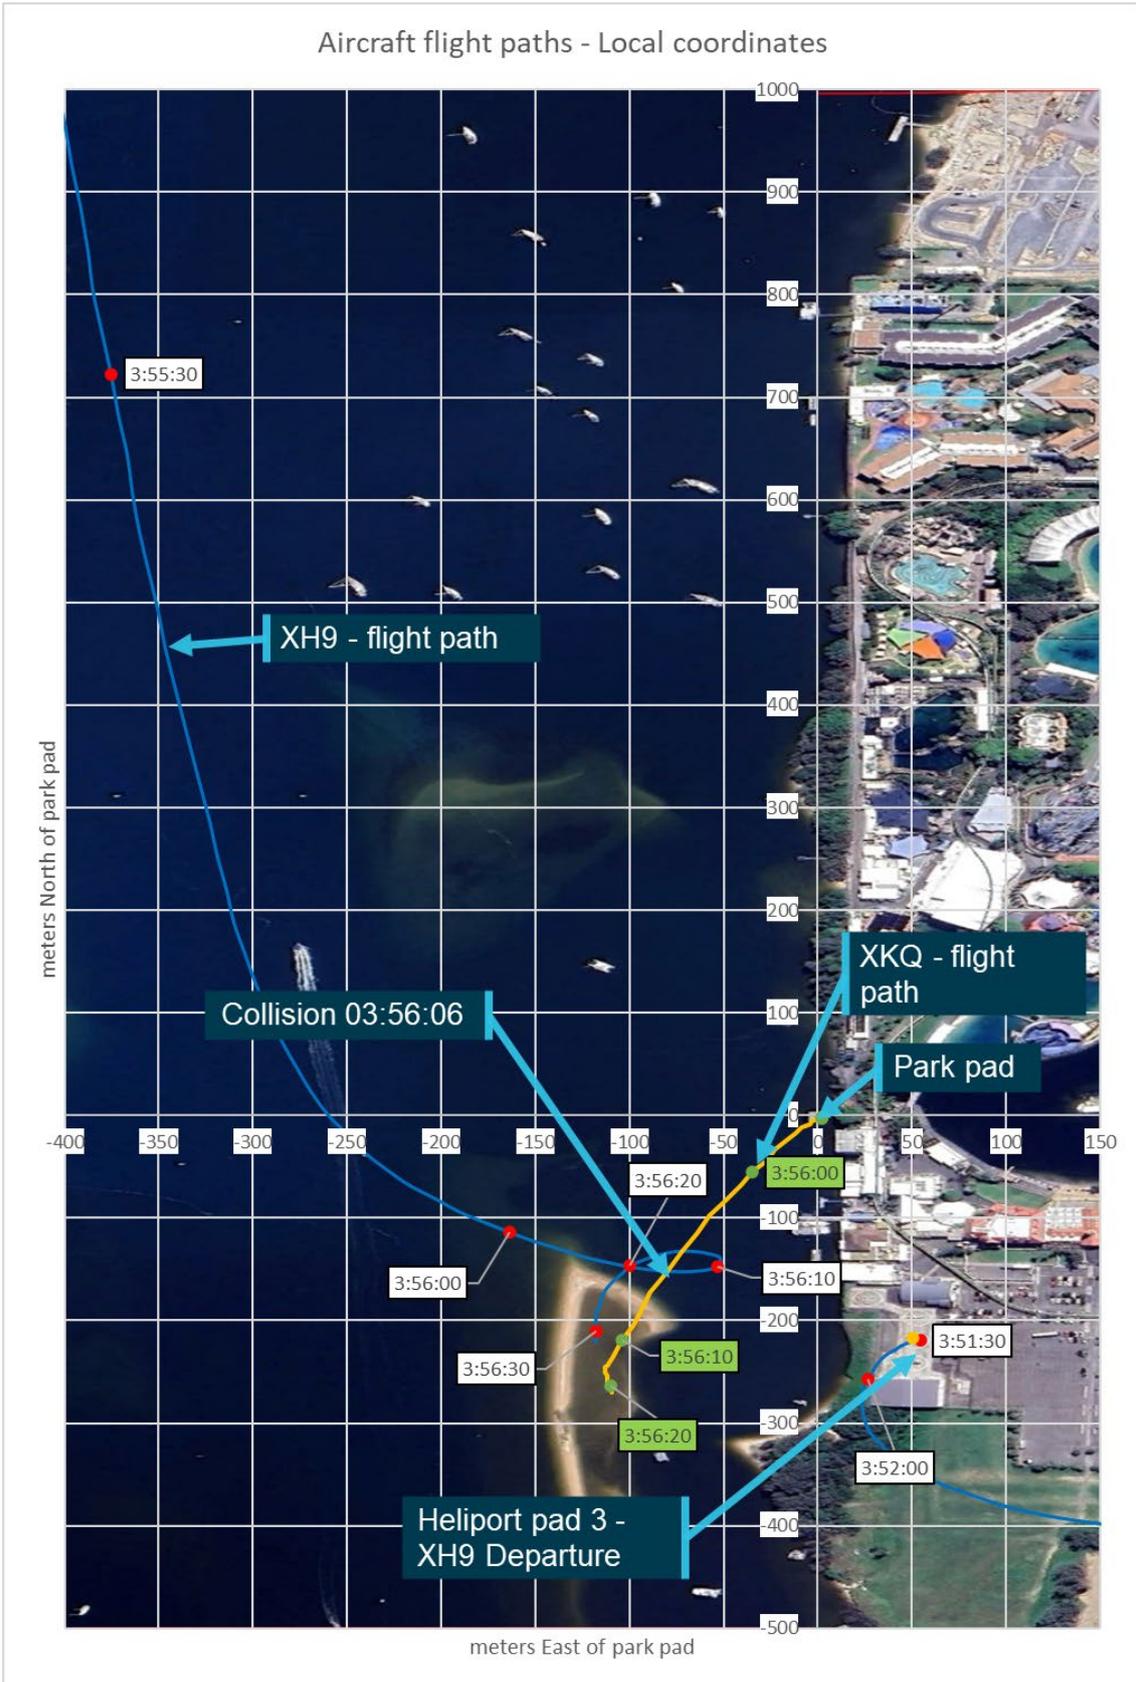
Figure 26: Close up of collision location flight paths – local cartesian coordinates

Note: Satellite image was taken near high tide. Sandbar was exposed at the time of the accident.
 Source: Google Earth and ATSB, annotated by the ATSB

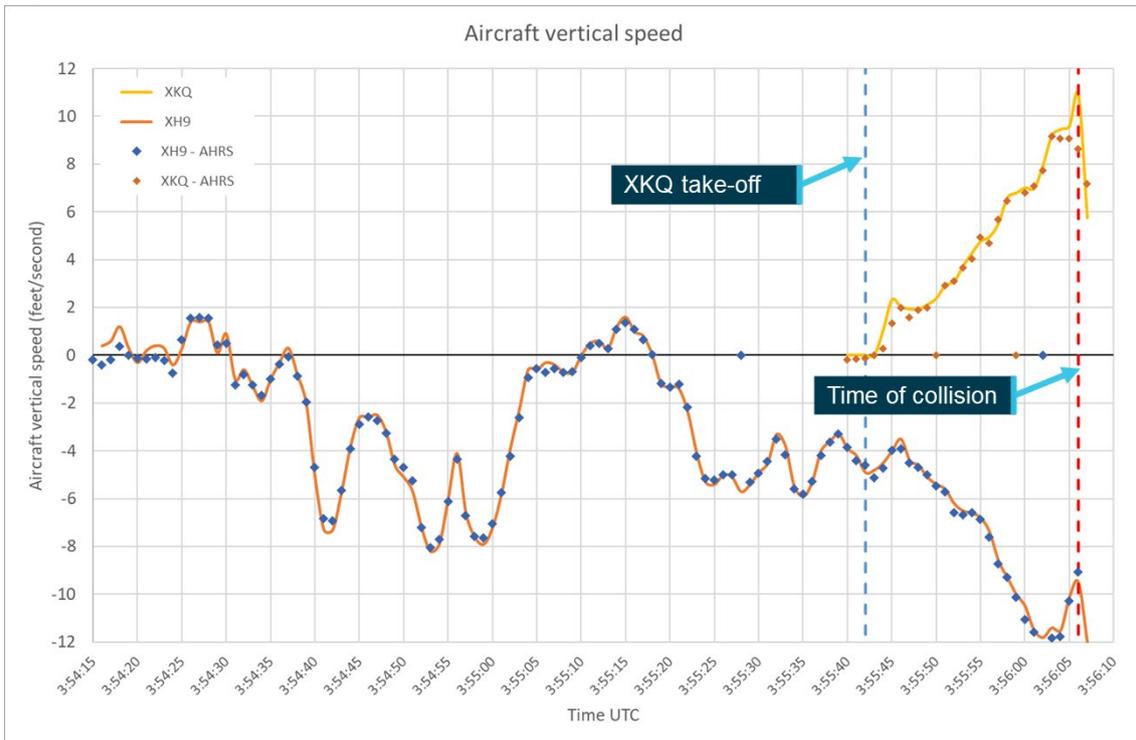
Figure 35: Vertical speed comparison chart

The Spidertracks AHRS unit also records vertical speed in metres per second based on vertical position information received from the GPS unit. The ATSB used the corrected vertical position information from the AHRS unit to confirm the vertical speeds that the AHRS unit was producing. As it had been determined that there were 2 constant offsets being applied, for the ellipsoidal error and to bring XKQ onto the pad, these would not impact the calculated vertical speed. Figure 35 shows the ATSB calculated vertical speed in comparison with the vertical speed value obtained directly from the AHRS unit. As the AHRS unit records vertical speed in metres per second the comparative analysis was completed in metres per second.

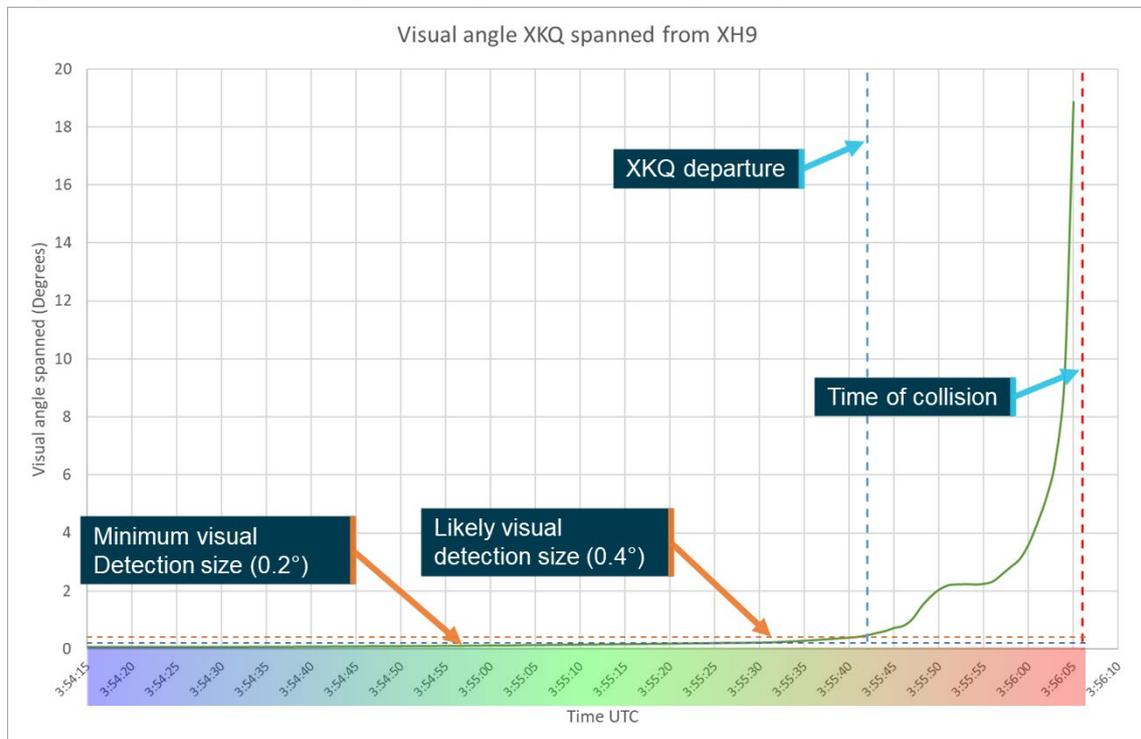
Figure 41: Plot of visual angle XKQ spanned from the pilot’s position in XH9

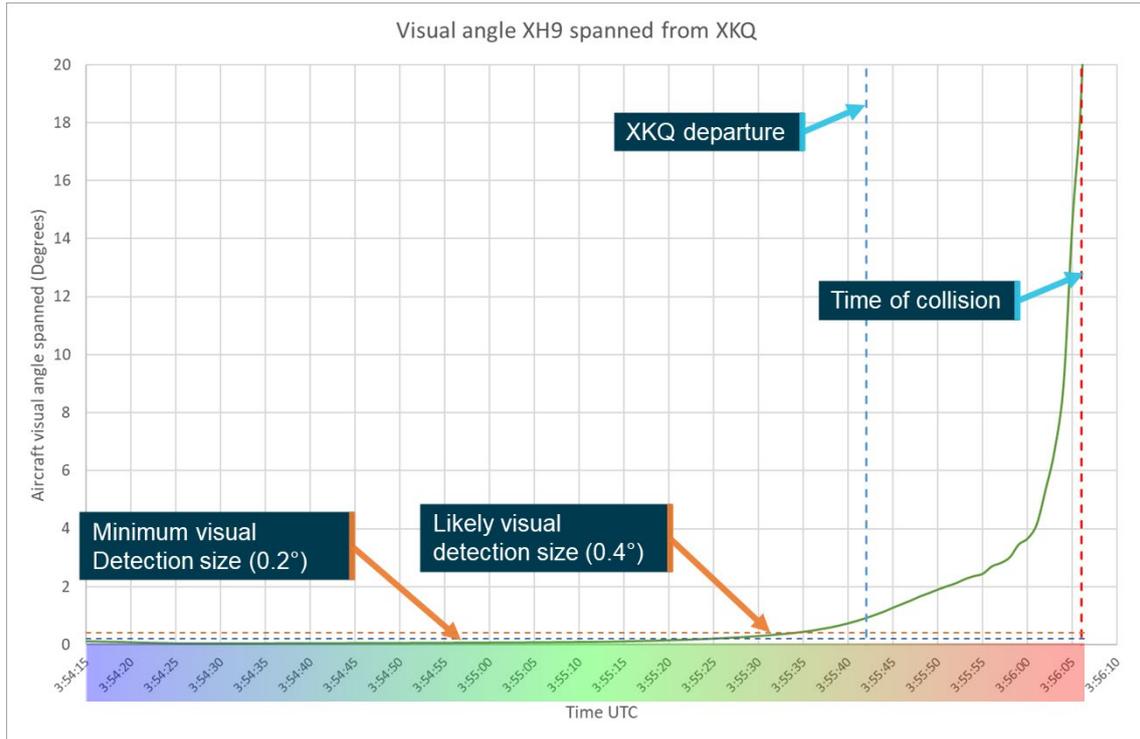
Figure 42: Plot of visual angle XH9 spanned from the pilot’s position of XKQ

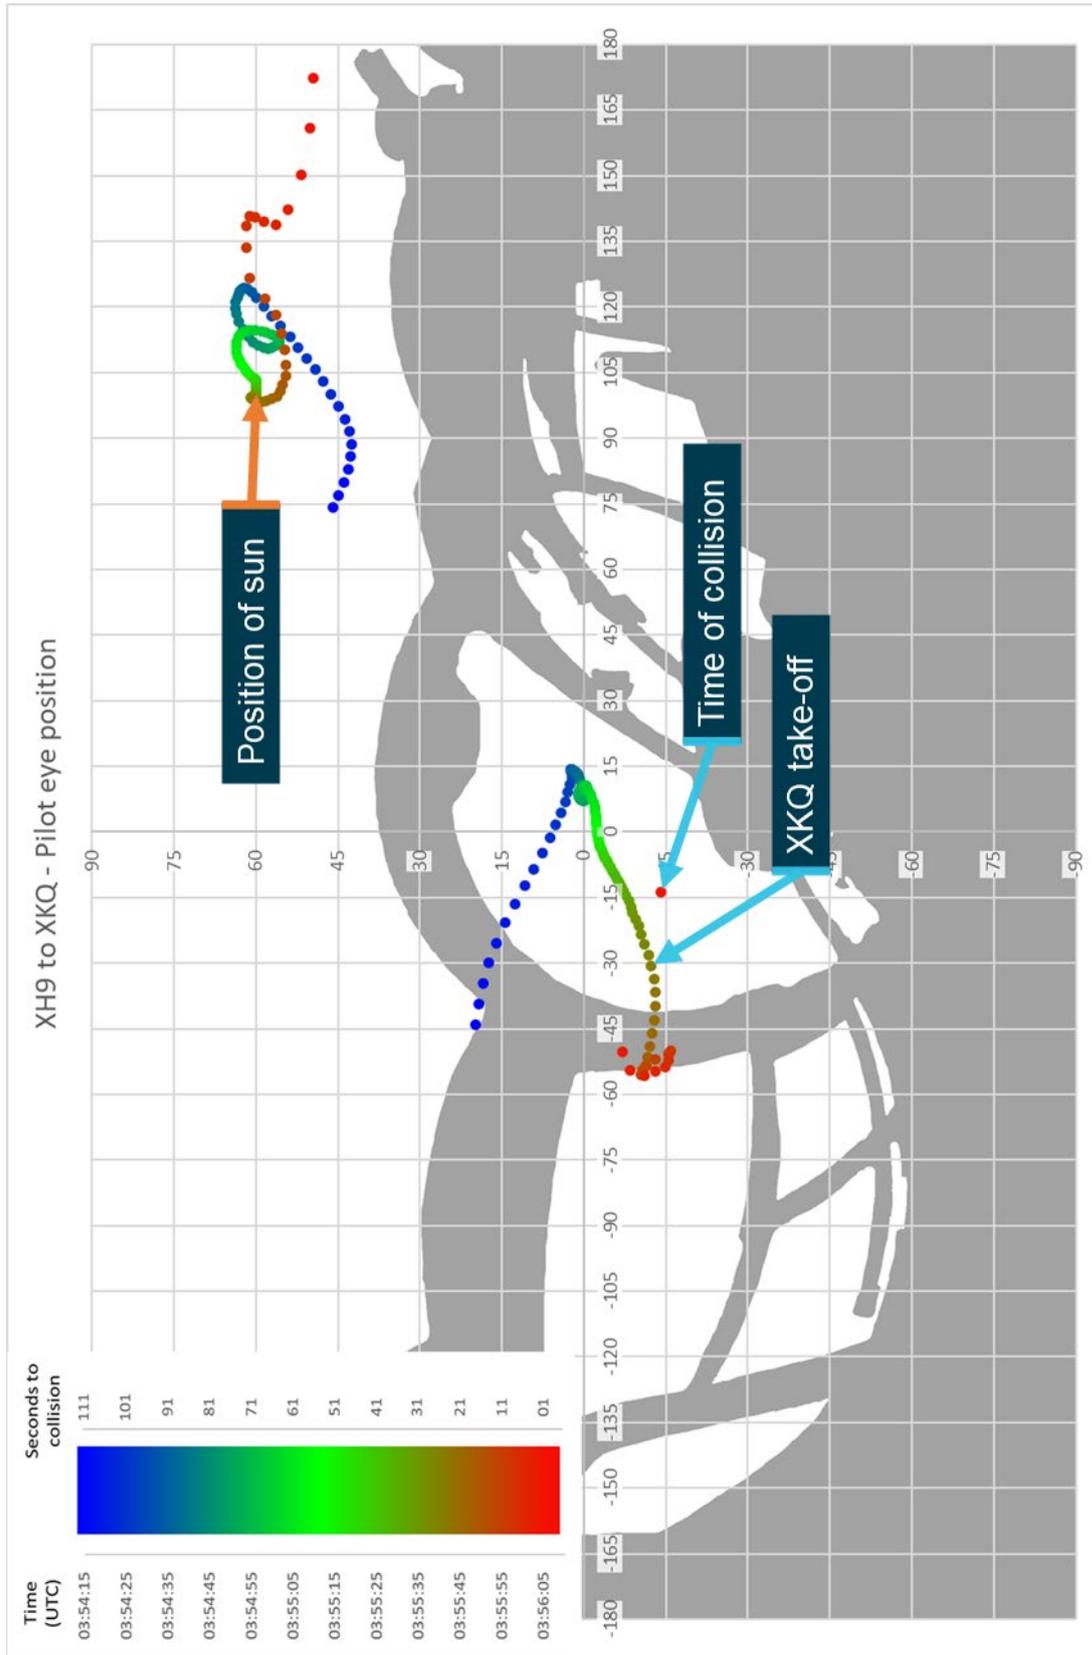
Figure 44: Relative position of XKQ from XH9 overlaid on pilot's view

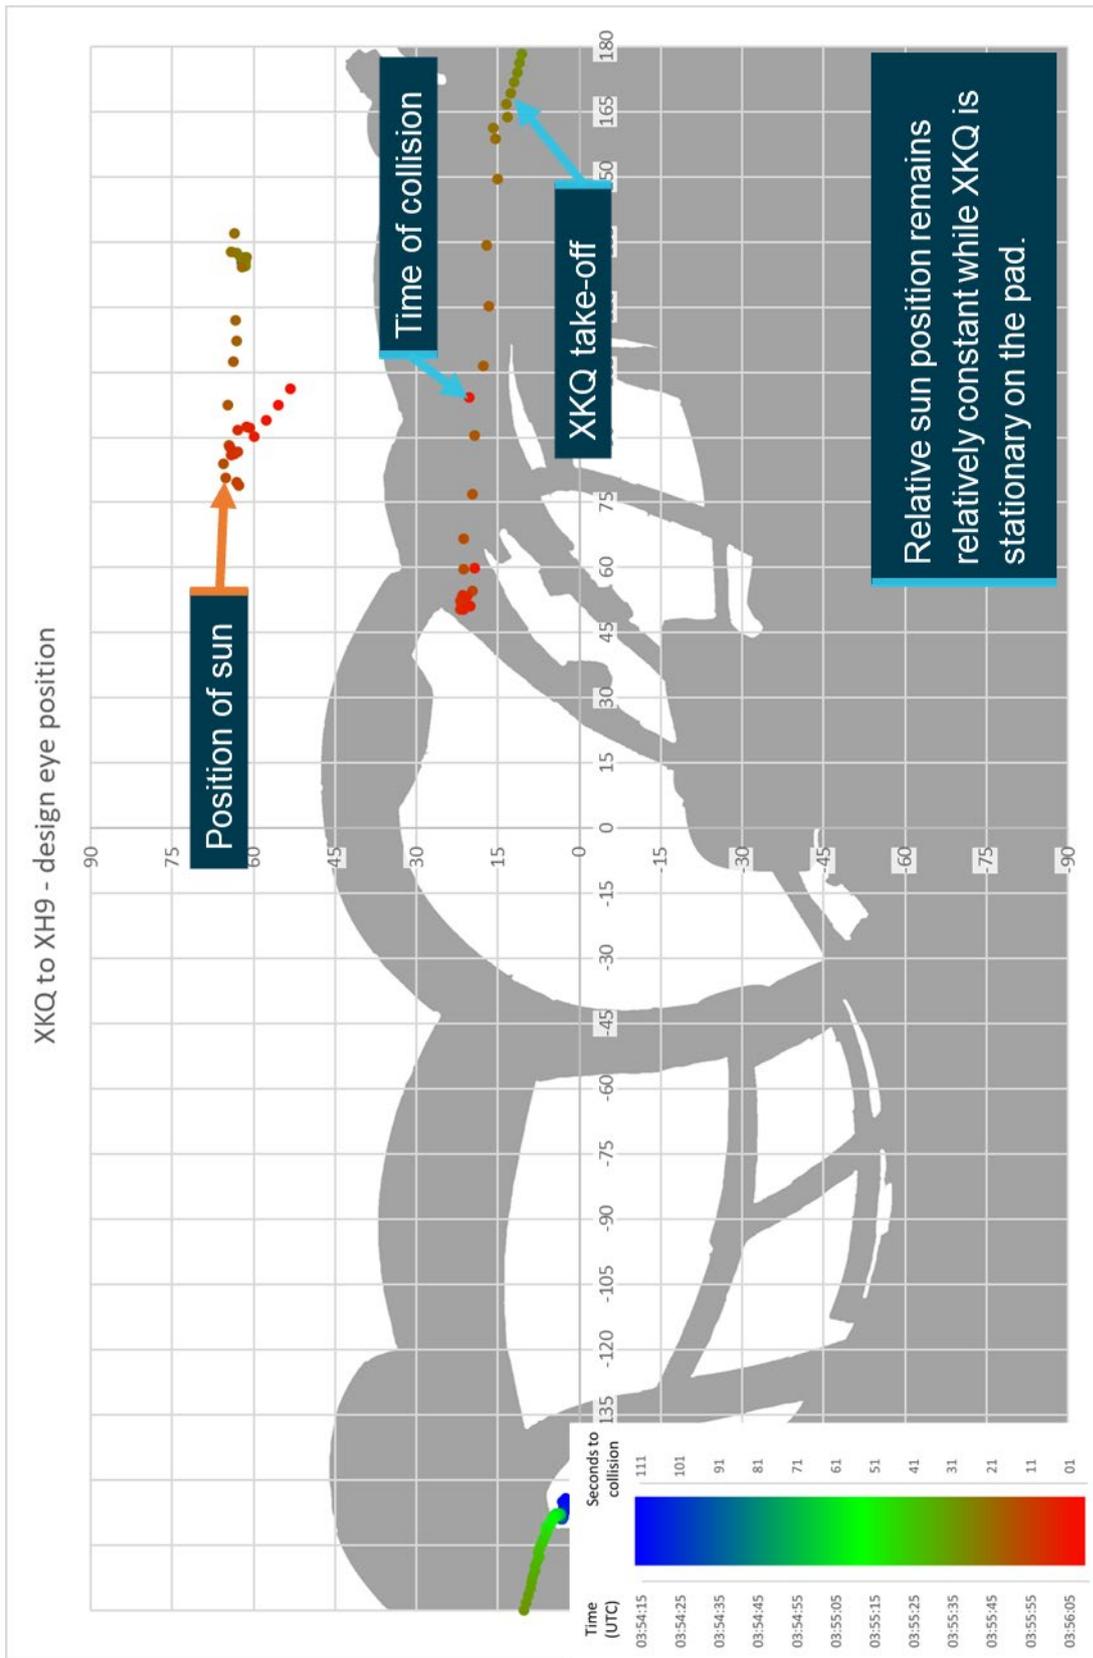
Figure 52: Relative position of XH9 from XKQ overlaid on pilot's view

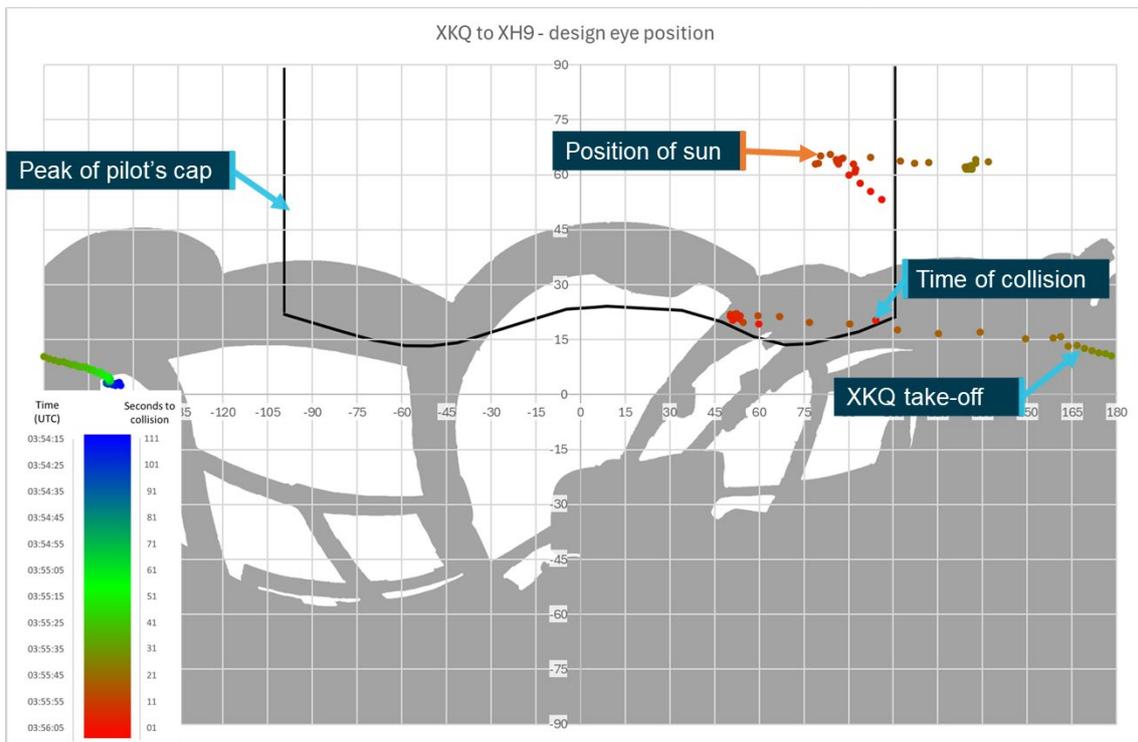
Figure 53: Relative position of XH9 from XKQ overlaid with shielding of pilot’s cap

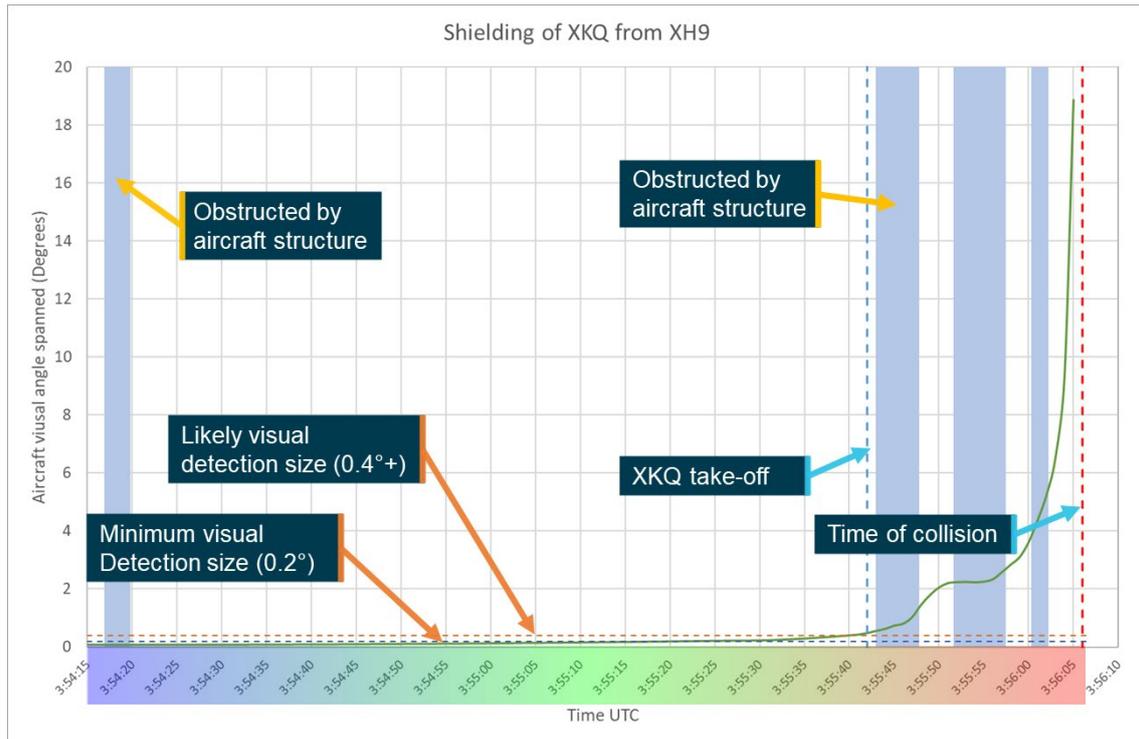
Figure 54: Target aircraft obstruction periods pilot of XH9

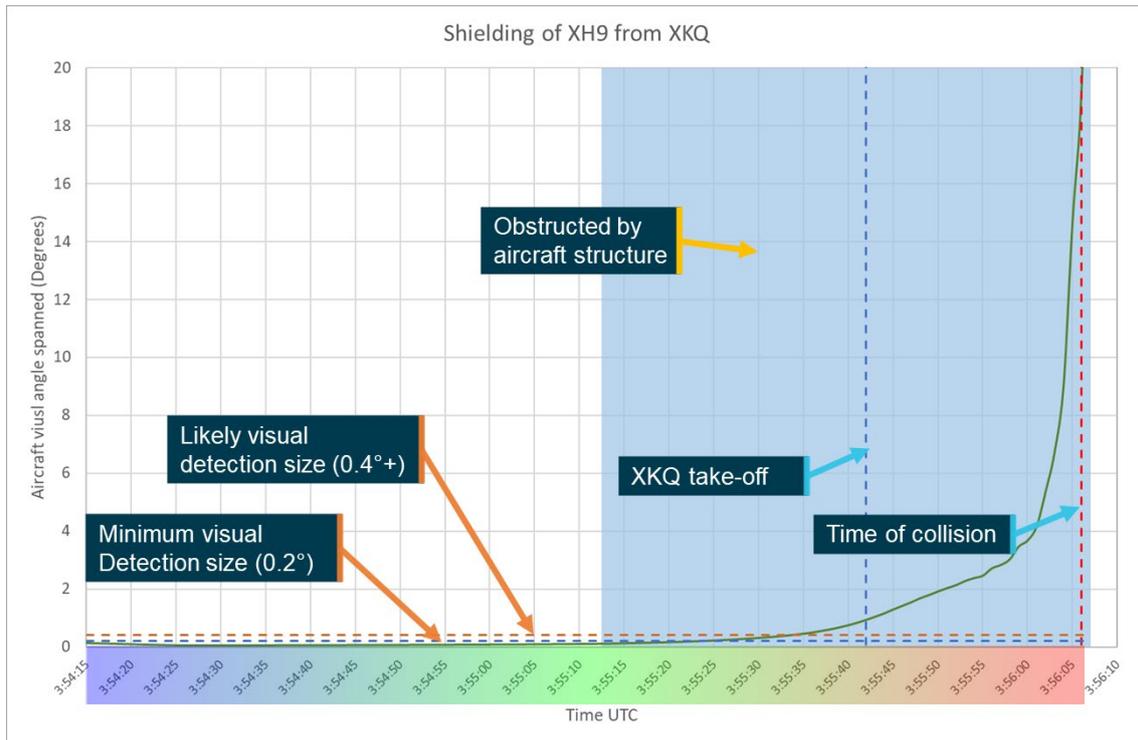
Figure 55: Target aircraft obstruction periods pilot of XKQ

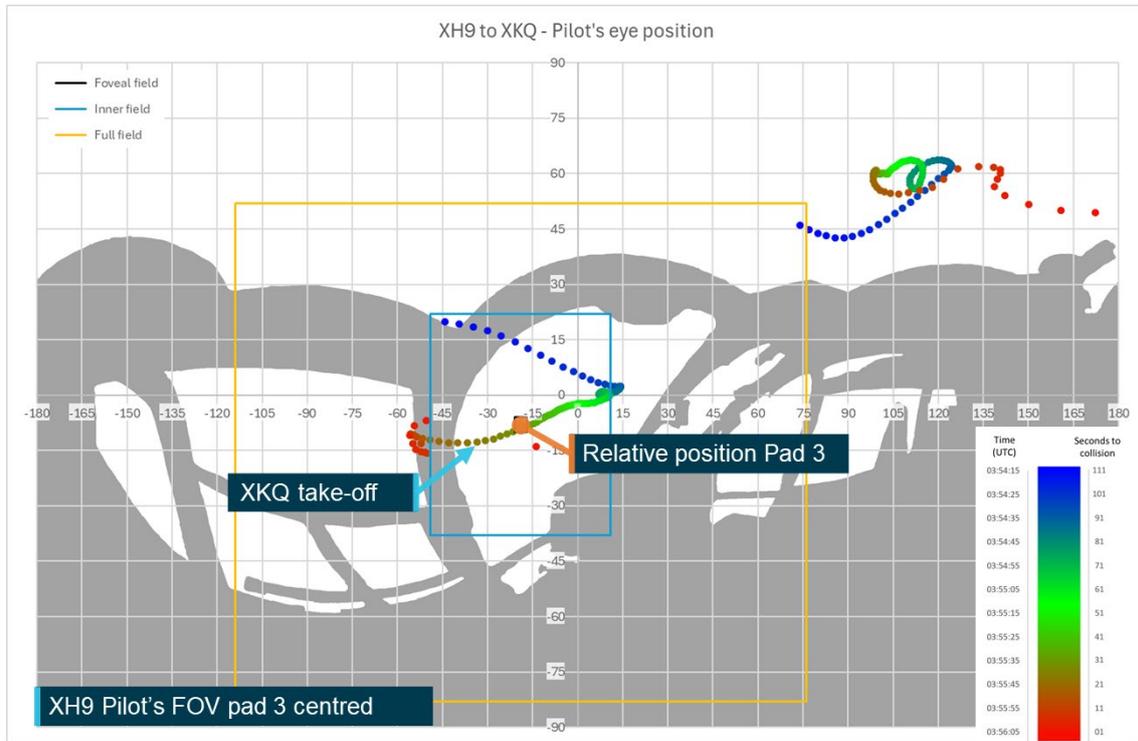
Figure 103: XH9 pilot's FOV centred on heliport pad 3 when XKQ takes off

Note: As the foveal region has been centred on the relative position of pad 3 the marker indicating this position is larger than the depicted foveal region and appears behind the marker for the relative position of pad 3.
Source: ATSB

In addition to the consideration of these rotations 2 additional scenarios were assessed based on evidence presented in the investigation report. The first was that the pilot of XH9 was focused on their approach to the helipad and a boat passing across their approach path. The ATSB sought to assess the impact on the detectability of the target aircraft if the pilot was looking at their aiming point, pad 3 of the operator's heliport, at the time that XKQ lifted from the pad. The relative position of the pad from XH9 was calculated throughout the study window, the position at the time that XKQ lifted from the pad was plotted and the field of view was centred on this position. The time that XKQ lifted from the pad was chosen as this was a time that the aircraft was changing threat status, and the movement provided an increased opportunity for detection. Figure 103 shows the pilot's FOV centred on the relative position of the helipad at the time the XKQ lifted from the park pad. At the time XKQ departed the pad XH9 was still north of the park pad meaning that both XKQ and pad 3 of the heliport were to the pilot's left, pad 3 appears closer to the centre as it is further south than XKQ on the park pad. The rotation, -19° azimuth and -8° elevation, to centre the pad means that the target aircraft was within the inner field of the pilot's FOV increasing the likelihood of detection. It is important to note that this analysis only considers the potential impact of the relative position of the target aircraft and not the impact of the environment around the target aircraft.

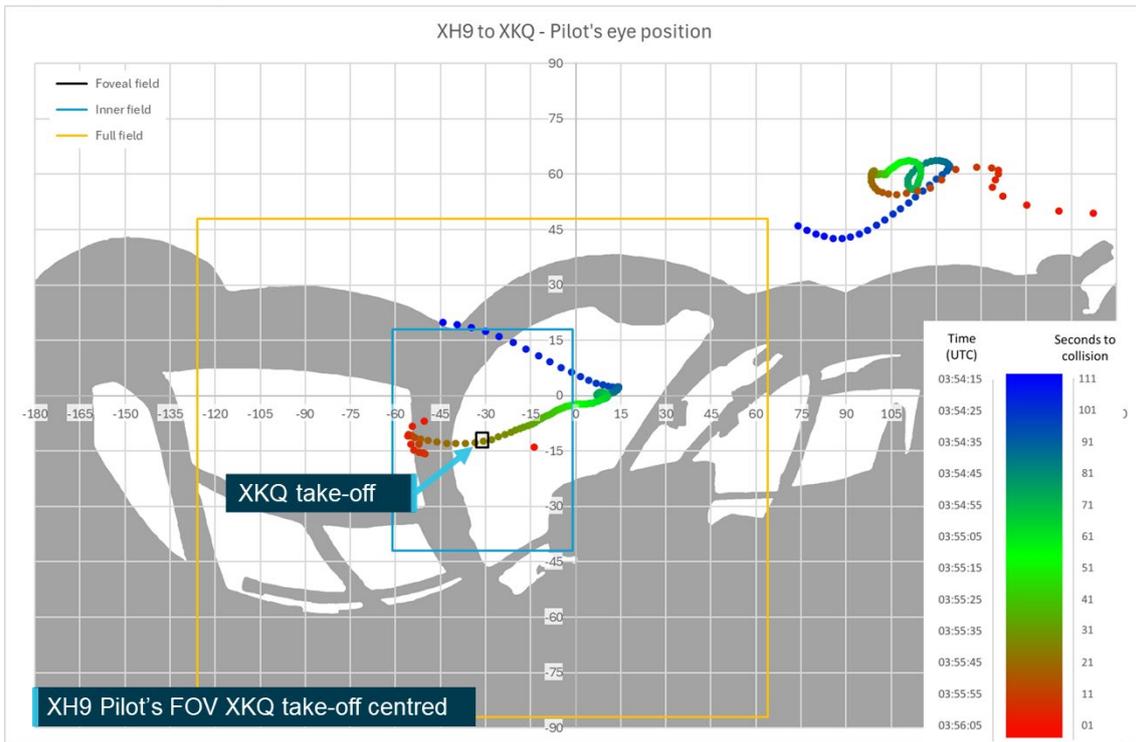
The second scenario considered how far the pilot would need to rotate their eyes to look directly at the target aircraft as it departed the park pad. Figure 104 focuses the centre of the FOV at the position of the target aircraft at the time it lifted from the park pad. To centre the foveal region on the departing aircraft and gain the maximum detection opportunity for its change in status would have required rotations of -31° azimuth and -12° elevation. These are well within the 55° limit of human eye rotation. However, it has been identified that for movements greater than $20\text{--}30^\circ$ of azimuth the head will rotate so the eyes do not need to go to the limits of their rotation (Franchak, McGee, & Blanch, 2021), subsequently this rotation may be better represented by rotations as presented in both the eye position and eye rotation sections of the *Sensitivity analysis*.

Figure 104: XH9 pilot's FOV centred on XKQ as it takes off

In the case the pilot did rotate only their eyes to observe the lifting aircraft into their foveal region the pilot would also have brought a significant section of aircraft structure into the inner region of the FOV limiting their opportunity to detect other threats. As stated in the previous section this only considers the relative position of the aircraft and not the impact of the environment around it. In addition to centring XKQ on the pilot's FOV, it takes the view further away from the sun, reducing the likelihood of direct or indirect impact of the sun on the pilot's visual acuity.

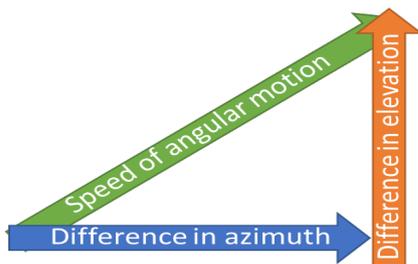
Figure 106: Calculation of speed of angular motion

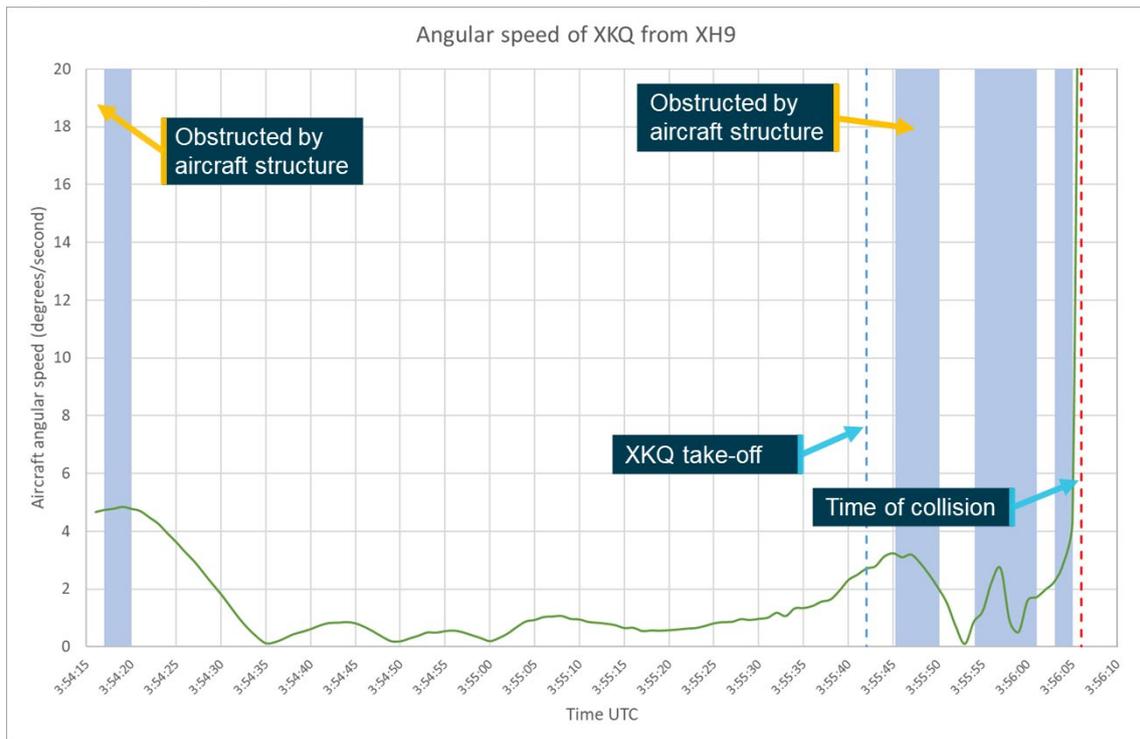
Figure 107: Angular speed XKQ from XH9

Between the time that XKQ lifted from the pad at 03:55:42 and the time it was initially obscured by cockpit structure at 03:55:45, the total angular motion averages 3°/sec which was above the detectable threshold. However, during this period XKQ did not move laterally only increasing height by 5 m. Subsequently there was little to no lateral scene relative movement and so the detection relied on elevational scene relative movement. The elevational speed averaged 0.2°/sec during this time. This movement is theoretically detectable when in proximity of a stationary structure, as it was from 03:55:44, however the target aircraft is only visible for 2 seconds giving a very limited opportunity for the movement to draw the pilot’s attention. Additionally, the cockpit pillar is a vertical structure, and the elevation movement will be parallel to it rather than at an angle or perpendicular. This will mean fewer reference points against which the movement can be sighted and compared to, decreasing the likelihood of detection.

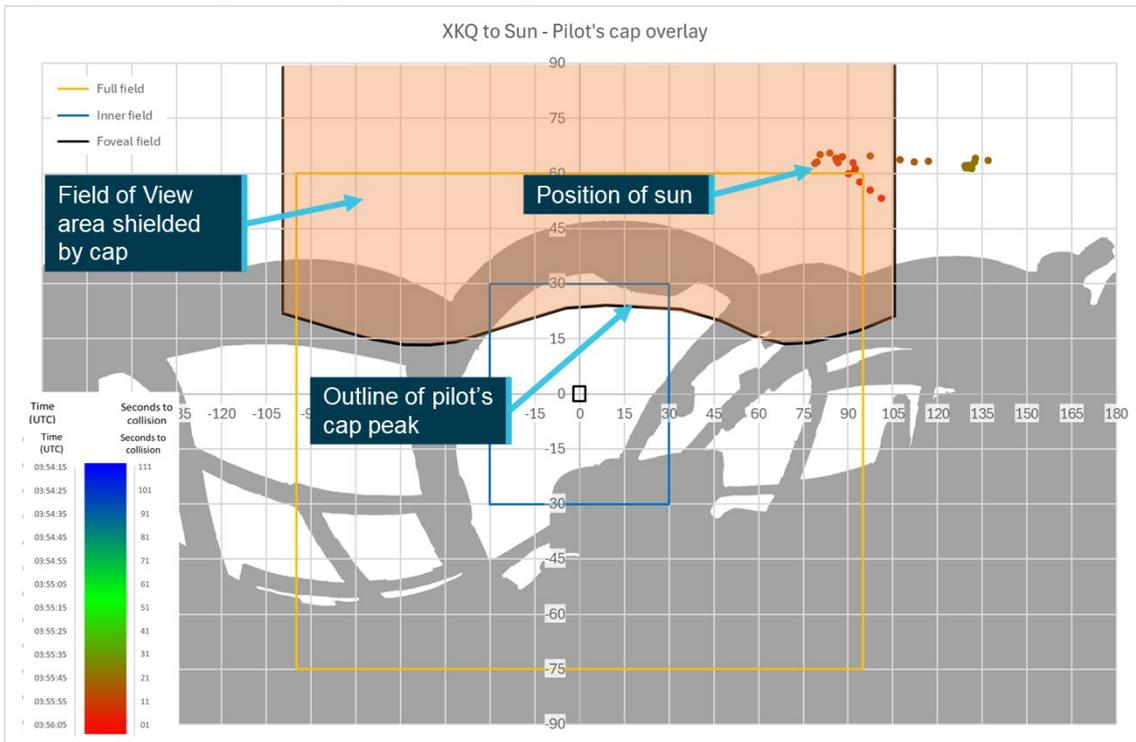
Figure 113: XKQ pilot – cap sun shielding

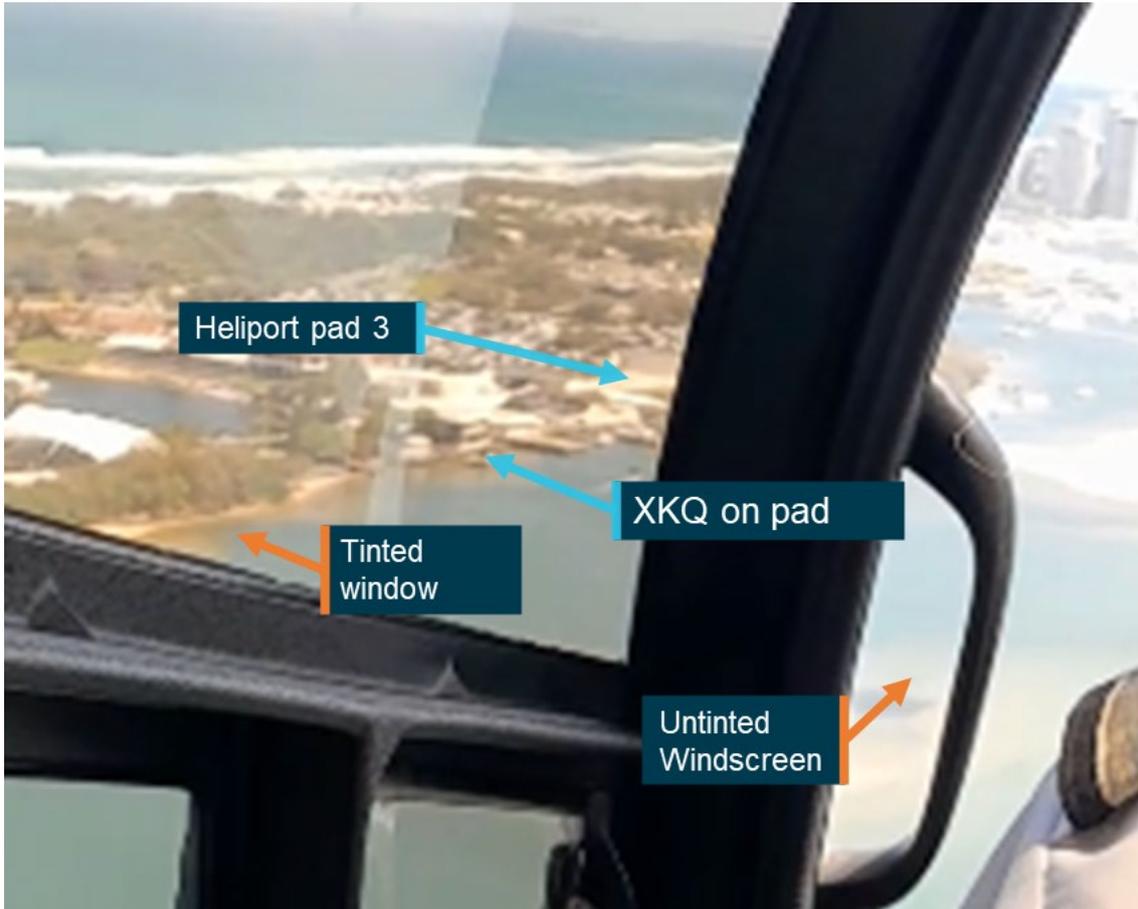
Figure 117: Camera footage from XH9 03:55:14 showing window and visibility of XKQ
