Railway Level Crossing Safety Bulletin

Overview

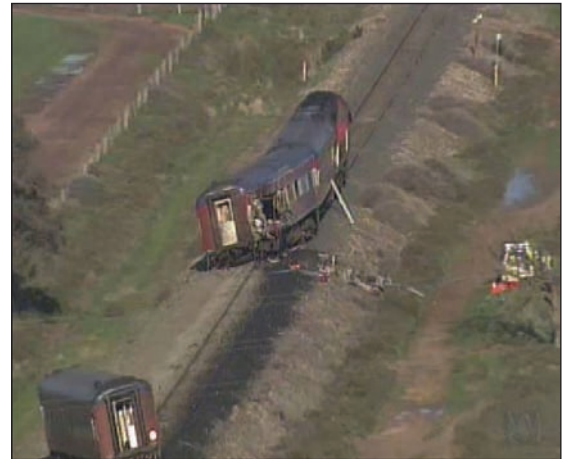
Some recent accidents have involved significant loss of life, the worst case being the tragic accident at Kerang when a semi-trailer collided with a Melbourne-bound passenger train on 5 June 2007. Eleven people were killed and 20 injured in this accident.

Figure 1: Kerang accident site

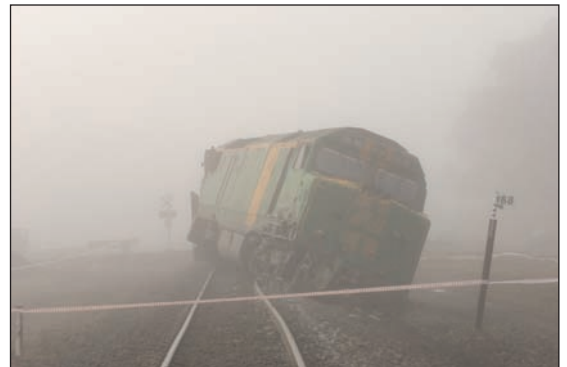
Visibility at the time of the accident was reduced to between 20 and 50 metres due to thick fog. Yet, the calculated speed of the B double truck at impact was up to 78 km/h. It is clear that the truck was not being driven according to the environmental conditions at the time and, tragically, the truck driver saw the train at the crossing too late to stop.

Figure 3: Fog at Lismore accident site

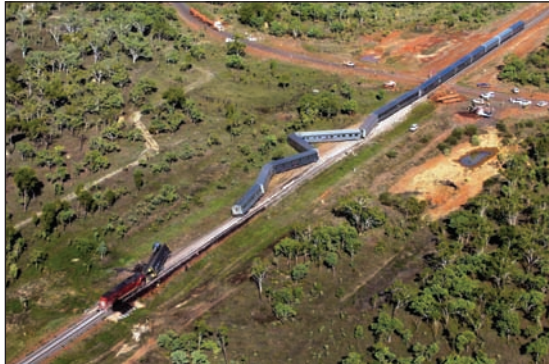
The truck driver had been engaged in road building which involved using the level crossing about 30 times per day for the previous month. He was very familiar with the road and the crossing. During the month, he had only seen four trains. He did not have to slow his road-train for any of these, so on the day of the accident he was not expecting to stop for a train at the crossing. The truck driver also had severe hearing loss which compromised his ability to hear the train horn. The train horn was sounded by the train driver three times as the train approached the crossing. However, the truck driver only heard the last blast when it was too late to avoid the collision.

The truck driver stated that he did not stop at the level crossing 'Stop' sign. Indeed, it was found to be common practice for the drivers of other road-trains in the area to conduct 'rolling stops'. It is acknowledged that in certain situations a 'rolling stop' is good driving practice as it reduces the

stresses on the prime mover's transmission. However, a 'Stop' sign at a level crossing means that motorists must stop to be able to adequately sight a train and thus avoid a collision.

Figure 4: The Ghan accident site

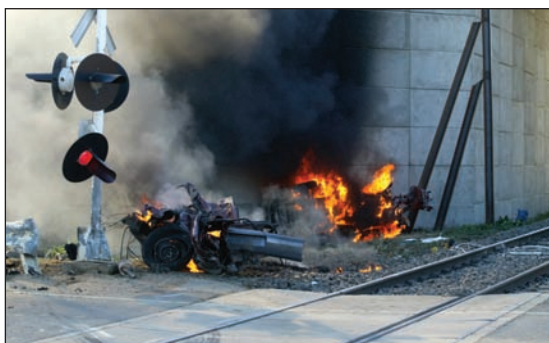
This accident occurred when a sedan was driven into the path of an XPT passenger train at an active level crossing. Although not a heavy vehicle accident, the underlying factors of distraction and driver impairment are common in level crossing accidents.

The deceased driver of the sedan was found to have a cannabis concentration to a level where his driving performance was almost certainly impaired. It is a fact that alcohol, illicit drugs, and certain medications can exacerbate the effects of fatigue, reduce the ability to concentrate and impair the ability to judge distances and speed.

Motorist distraction can be attributed to many things such as the operation of mobile telephones, checking paperwork on the run, tuning a radio, selecting a music track, a conversation with a passenger in the vehicle, or just plain boredom. In this instance, phone records indicated that the car driver's mobile rang just as he was approaching the level crossing.

Figure 5: Burning wreckage of sedan at Albury
