External assistance to Recreational Aviation Australia (RA-Aus) - Fatal Accident - Evektor Sportstar 24-4148 - 12 km SE Bindoon ALA, WA

21 December 2007

Abstract

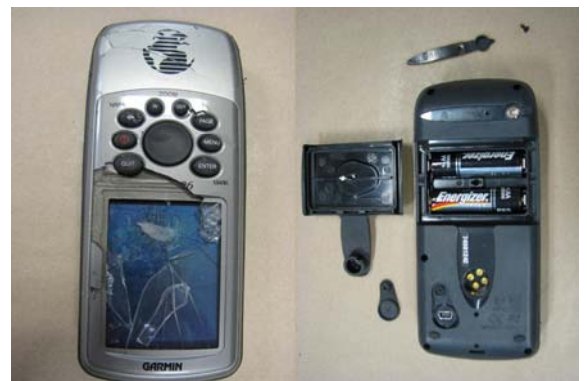
Figure 1: Garmin GPSMAP 96 as received

The Garmin GPSMAP 96 unit, S/N 74301242, had a damaged screen and case. Upon disassembly, the ribbon between the keypad and the main circuit board was found to have been broken. A new display screen and keypad circuit board were placed into the unit from a serviceable GPSMAP 96 unit. The data was recovered using Garmin MapSource software (Reference 2) onto a desktop computer (Windows XP) via the appropriate serial cable in accordance with the instructions in the Garmin pilot guide (Reference 3). A 1.13 MB GPX file was recovered (file name AllTracks24-4148.gpx). This file, when viewed using the manufacturer's software (Reference 2), comprised 10,000 track points in 67 track logs, one route and 13 waypoints.

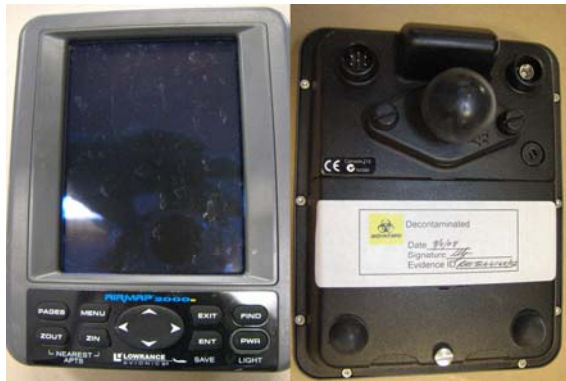
Figure 2: Lowrance AirMap 2000c as received

The Lowrance AirMap 2000c unit, S/N 101178693, was undamaged. Power was applied to the unit and data was saved to the flash memory of the secure digital/ Multimedia Card (SD/MMC) in accordance with the procedures in the Lowrance instructions (Reference 7). A 20KB USR file was recovered (file name DATA.usr). This file, when viewed using the manufacturer's software (Reference 5), comprised one trail of 2,000 data points, nine routes and 26 waypoints.

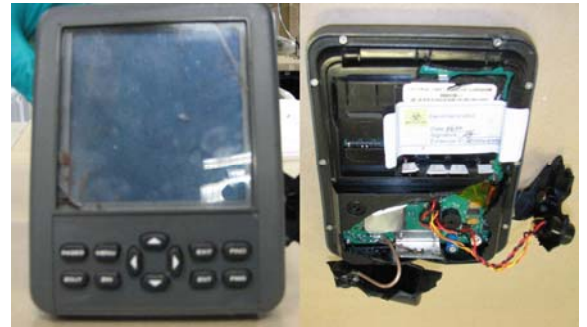
Figure 3: Lowrance AirMap 1000 as received

The Lowrance AirMap 1000 unit, S/N 11805699, had a broken case and cracked screen. The unit was decontaminated using a bleach solution prior to disassembly. Several internal components within the unit were visibly damaged and a crystal oscillator had separated from the circuit board. The crystal oscillator was replaced from a serviceable unit. The circuit board P/N 017-0746-OC Rev C, S/N E2110790434 was placed into a serviceable unit and was able to be powered.

The GPS was powered up and data was saved to an SD/MMC card in accordance with the Lowrance instructions (Reference 6). A 19KB USR file was recovered (file name DATA.usr). This file, when viewed using the manufacturer's software (Reference 5), contained one trail of 2,000 data points, one route and 16 waypoints.
