Flight path infringement involving a Cessna 172M, VH-EJM and a vehicle

Townsville Airport, Queensland on 10 September 2015

ATSB Transport Safety Report
Aviation Occurrence Investigation
AO-2015-122
Final – 28 January 2016

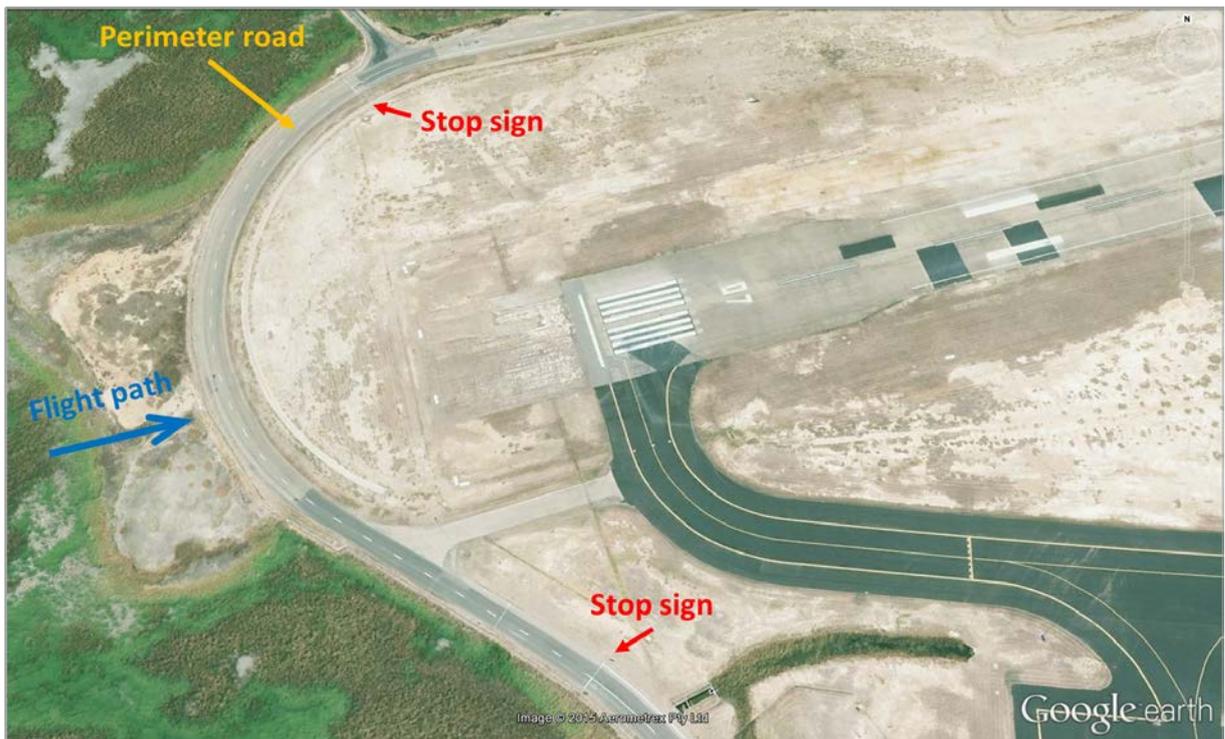
Figure 1: Townsville airport perimeter road near runway 07

The student was flying the aircraft and on mid-final for a touch-and-go landing on runway 07, when the instructor noticed a truck on the perimeter road, near the threshold to runway 07. The truck had not held at the stop sign. The stop sign required all vehicles to stop, look for aircraft, and not proceed unless there was no aircraft landing (Figure 1).

The Department of Defence conducted an investigation into the serious incident. They determined that a contractor, driving a truck on the western perimeter road, failed to stop at the stop sign near the threshold of runway 07. VH-EJM missed the top of the truck by about 4 to 5 metres and the aircraft landed without incident.

- briefing material for contractors has been updated placing greater emphasis on safety around runways.
- flashing lights have been installed on the stop signs, for the under-run service road, to improve observation of the sign by drivers.
