Birdstrike involving Glasair Sportsman GS-2, N666GM

near Bathurst, New South Wales, 24 December 2015

ATSB Transport Safety Report
Aviation Occurrence Investigation
AO-2016-001
Final – 27 July 2016

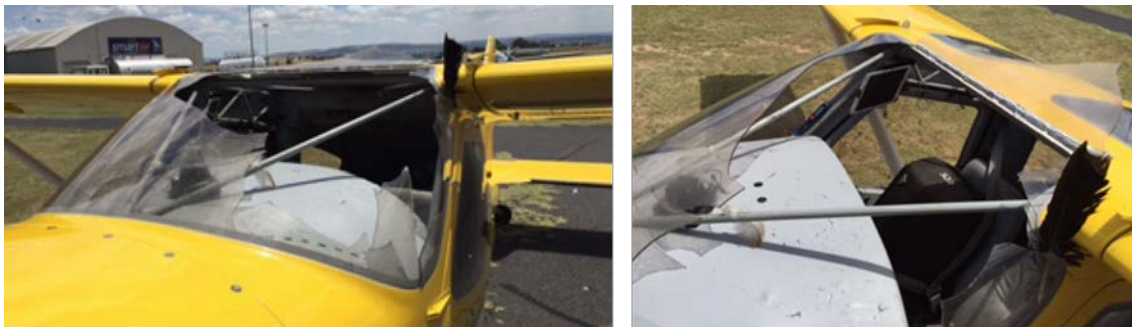
The bird broke through the windscreen on the left side of the aircraft and struck the pilot. The collision left the pilot with serious facial injuries and they were temporarily unable to see (due to the effects of the impact). The pilot had been wearing a headset and spectacles, which were both dislodged and damaged during the collision.

Figure 1: Damage to the aircraft windscreen

After landing, the Airport Safety Officer met the aircraft and provided the pilot with parking instructions. The pilot shut the aircraft down and medical services were called. Aside from the damage to the windscreen (Figure 1) and some relatively minor marks around the propeller, there appeared to be no other damage to the aircraft. The remains of the bird were retrieved from the cockpit (Figure 2).

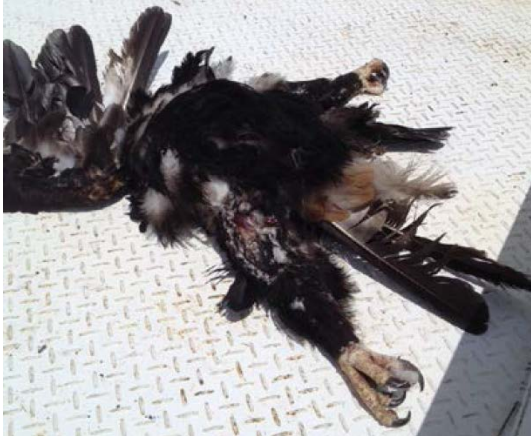
Figure 2: Some of the bird remains retrieved from the cockpit
