Safety Advisory Notice

To pilots of canopy-equipped aircraft

Number: AO-2014-164-SAN-012

Is your canopy secured?

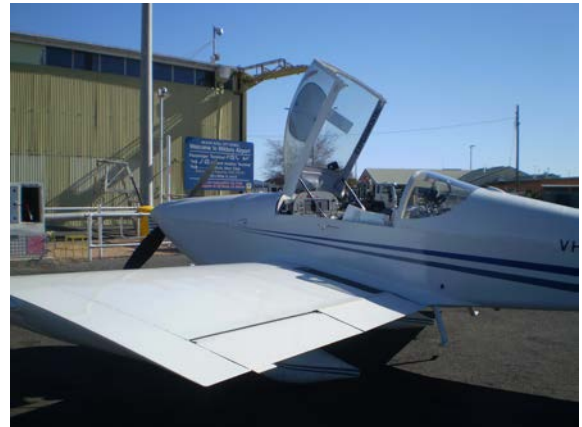
The liberation of the items from the aircraft's interior indicated that the tip-up (forward-hinged) canopy likely opened in-flight. While the ATSB was unable to determine how the canopy opened and the effect on aircraft control, there were indications the pilot was attempting to respond to the situation. However, for reasons undetermined, recovery did not occur before the impact with the ground. The ATSB found that, in a number of Van's models, the in-flight opening of a tip-up canopy may potentially result in a significant pitch down tendency that may affect aircraft control.

Tip-up canopy open (Source: Supplied)

AO-2014-164-SAN-012: The consequences when an aircraft canopy opens in-flight, including on other than Van's aircraft types, can vary from being relatively benign to significant, such as a sudden pitch down. In any event, in the first instance, pilots should expect an element of startle and distraction. The detection of an unsecured canopy prior to take-off could prevent in-flight control issues resulting in injury or aircraft damage. The ATSB advises pilots to be vigilant and to confirm the security of their aircraft's canopy prior to take-off.
