# Near-collision and operational event involving Beech Aircraft Corp B200, VH-OWN and VH-LQR

Mount Hotham, Victoria | 3 September 2015

**ATSB Transport Safety Report**  
Aviation Occurrence Investigation  
AO-2015-108  
Final – 27 June 2018

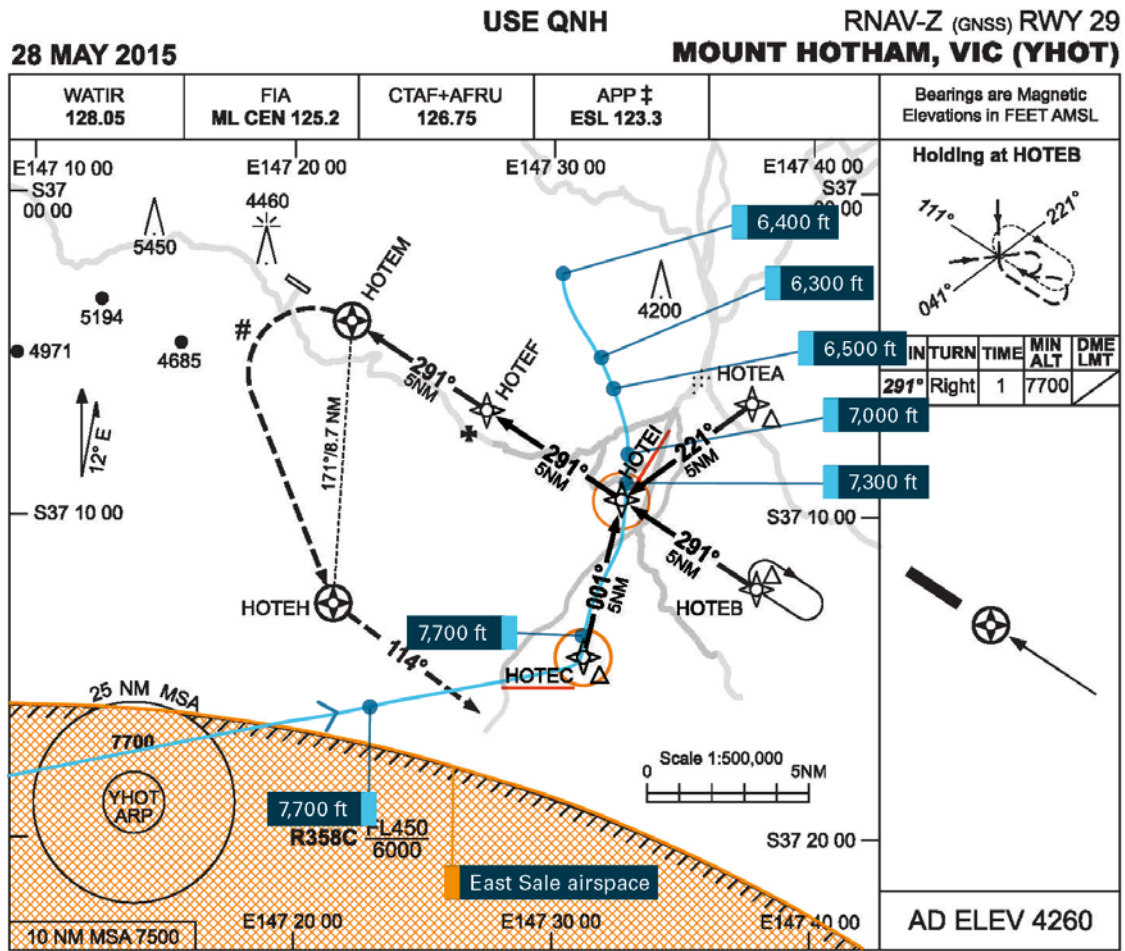
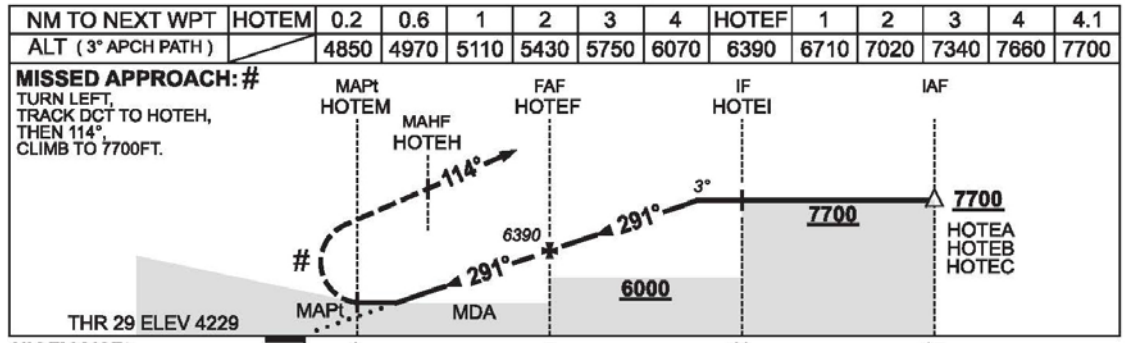
Figure 1: Partial radar data for the first approach conducted by VH-OWN

The first aircraft to arrive in the Mount Hotham area was a Beech Aircraft Corp B200 King Air (King Air), registered VH-OWN (OWN). At about 0829, the pilot of OWN commenced the RNAV (GNSS) approach for runway 29<sup>2</sup> from the south via the initial approach fix (IAF) waypoint HOTEK (EC)<sup>3</sup> using the autopilot, but experienced tracking difficulties on reaching the intermediate fix waypoint HOTEI (EI) (Figure 1).

Radar data showed that from EC to EI, OWN descended to 7,300 ft, 400 ft below the minimum permitted safe altitude. At 0830 the aircraft did not turn to intercept the inbound approach track at EI, but instead continued tracking to the north of the prescribed approach path and continued to descend to 6,300 ft. In response to the tracking difficulties, the pilot eventually discontinued the approach.

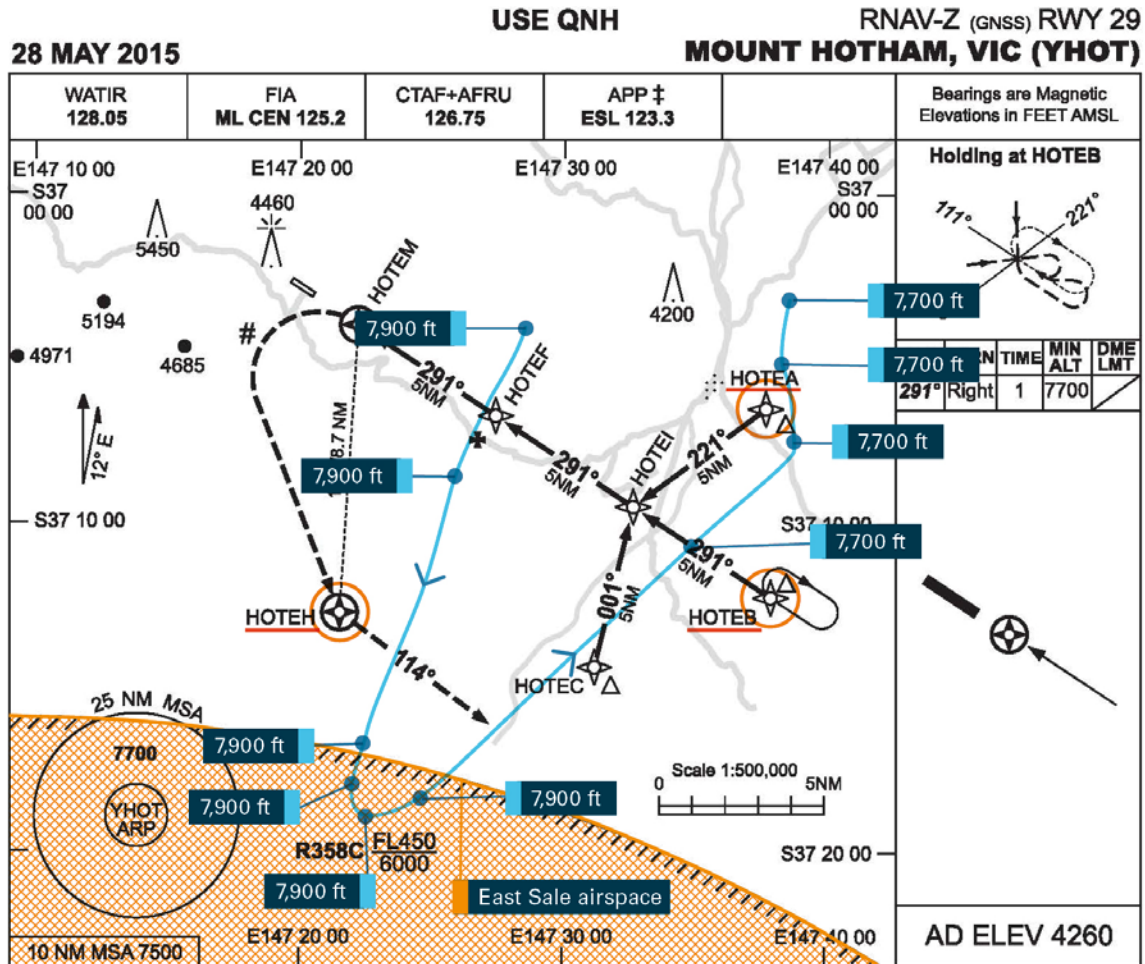
Figure 2: Partial radar data for the second approach conducted by VH-OWN

The pilot then climbed the aircraft to the minimum safe altitude of 7,700 ft while still tracking towards the north, rather than via the prescribed missed approach track. At 0834, the pilot of OWN advised the air traffic controller (controller) that he was in the missed approach, and commenced manoeuvring in the airspace in the Mount Hotham area, as the other charter aircraft progressively arrived for the RNAV (GNSS) approach for runway 29 (Figure 2).

Due to surveillance limitations to the north of Mount Hotham, surveillance data for OWN was not available to the controller from 0832 to 0838. During that time, the aircraft tracked from the east of Mount Hotham at 6,400 ft, to a position about 4 NM (7 km) east of the airfield at 7,900 ft. At 0838, the aircraft's position did not match the pilot's reported tracking details, though the controller did not comment on the erroneous tracking when providing the pilot with position information.

VH-OWN's track overlaid on the RNAV (GNSS) approach chart for Mount Hotham. Source: Airservices Australia, annotations by the ATSB

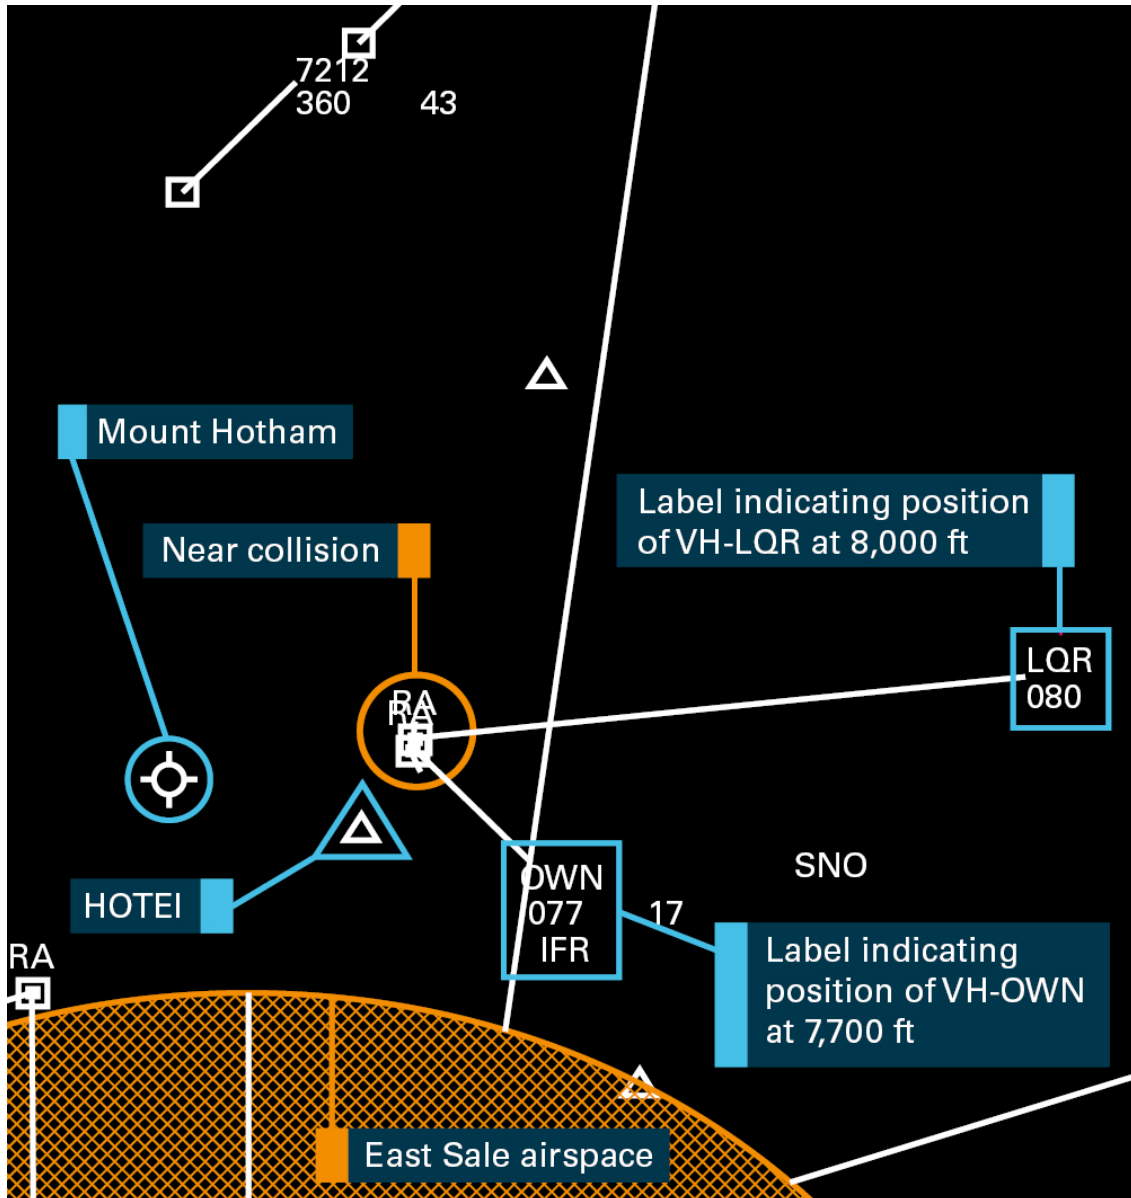
**Figure 3: Radar data showing the near-collision between VH-OWN and VH-LQR**

From 0849, when LQR was about 18 NM (33 km) north of EA at flight level (FL) 141<sup>5</sup> to 0854 when the aircraft was about 1 NM (2 km) north of EA at 8,200 ft, surveillance data for LQR was not available to the controller. Surveillance data remained available for OWN during that period that showed the aircraft tracked to the east of EI and towards EA at 7,700 ft.

Department of Defence radar data showing the near-collision between VH-OWN and VH-LQR. This information was not available to the Airservices Australia air traffic controller. Source: Department of Defence, annotations by the ATSB

Although not available on the controller’s surveillance display, data from the Department of Defence radar to the south of Mount Hotham at East Sale, Victoria, showed that OWN passed 300 ft below LQR, just north of EA at 0853 (Figure 3).

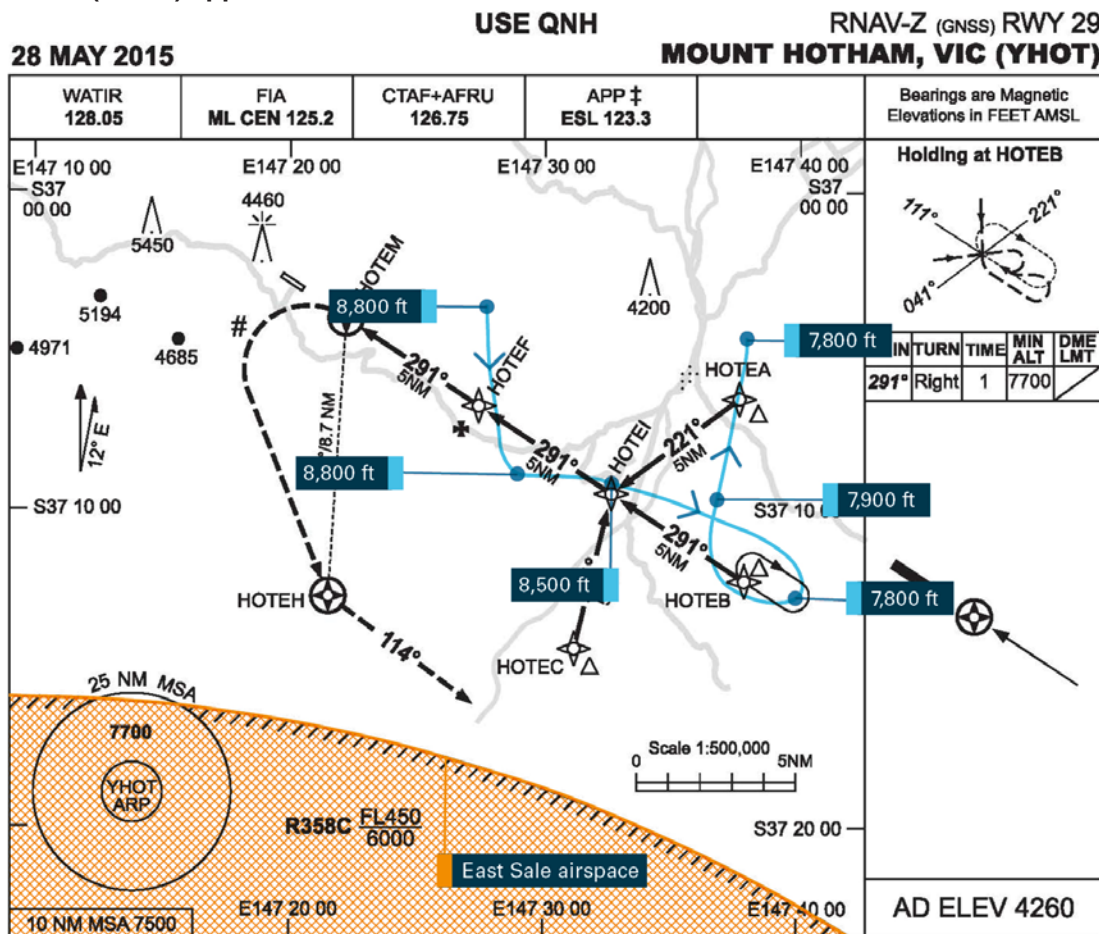
**Figure 4: Partial radar data for the third approach conducted by VH-OWN overlaid on the RNAV (GNSS) approach chart for Mount Hotham.**

The pilot of OVN then attempted another approach (Figure 4) and experienced similar tracking difficulties. Radar data shows that the pilot again continued to descend to the north of the RNAV (GNSS) approach track to 5,800 ft, with the pilot later stating that he became visual and clear of cloud during the descent. The aircraft was then observed to carry out significant manoeuvring close to the ground while establishing the aircraft on short final to the runway before landing at about 0918.

VH-OWN’s track overlaid on the RNAV (GNSS) approach chart for Mount Hotham. Source: Airservices Australia, annotations by the ATSB

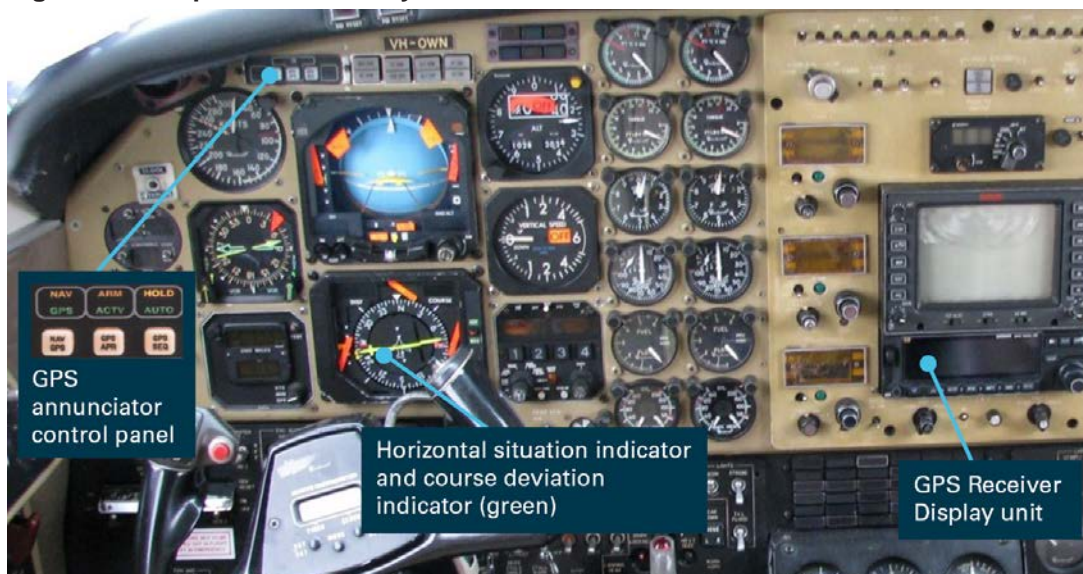
**Figure 5: Cockpit instrument layout of VH-OWN**

In addition to other flight guidance instruments, VH-OWN (OWN) was equipped with a single certified GPS capable of conducting IFR enroute navigation and non-precision approach procedures.<sup>9</sup> The installation consisted of the Garmin GPS 155 receiver display unit (RDU), an external antenna, an annunciation control unit and the horizontal situation indicator (HSI).<sup>10</sup> The RDU received and processed signals from up to 12 GPS satellites to determine the aircraft's position, altitude and time. Software within the unit provided information to the pilot for navigating the aircraft through a series of earth-referenced waypoints. The RDU, horizontal situation indicator and annunciator control unit were located on the instrument panel (Figure 5).

The image depicts the aircraft on the ground with no power to the systems, and the insert of the expanded GPS annunciator panel is representative of the one installed in the aircraft. Source: ATSB

The navigation information was presented on the RDU in various user-selectable forms on a liquid crystal display. This information included groundspeed, aircraft track, distance, bearing and time to the next waypoint, and a graphical course deviation indicator (CDI). Selection of navigation data and presentation of the navigation information was controlled by the pilot using function keys and rotary knobs on the face of the unit. The display also presented various messages regarding the navigation mode and operational status of the receiver.

The pilot's HSI could present course deviation indications based on information derived from the GPS receiver. When GPS was selected for display on the HSI, the CDI reflected the same graphical CDI displayed on the RDU.

- select the navigation source between GPS or ground-based VHF navigation aids for presentation on the HSI (controlled by the GPS NAV button and annunciated by the GPS or NAV indicator),
- manually 'arm' and 'disarm' a non-precision approach (controlled by the GPS APP button and annunciated by the ARM or ACTV indicator),
- pause the automatic sequencing of waypoints (controlled by the GPS SEQ button and annunciated by the HOLD or AUTO indicator) (Figure 5).

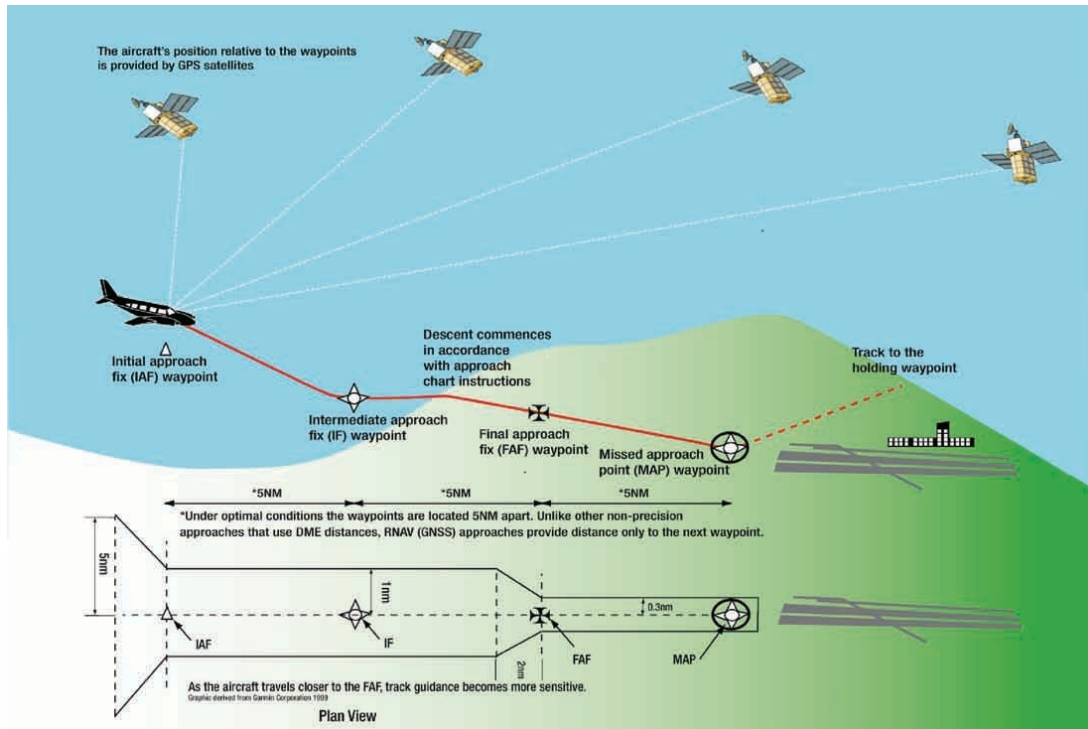
Figure 6: Generic RNAV (GNSS) approach

Once past the IF, the waypoint indicator displayed on the RDU changes to the FAF, and the estimated distance and time to the FAF is shown on the RDU. From 2 NM (3.7 km) from the FAF, the CDI scale will gradually change from 1 NM (1.8 km) either side of the track to 0.3 NM (600 m) by the time the FAF is reached so the pilot can more accurately track to the runway.

As the aircraft approaches the FAF, the same process occurs as for approaching the IF, except the pilot must normally start the descent. Some approaches start the descent before the IF but this is not the case for Mount Hotham. To maintain the appropriate constant angle approach path, the pilot can use the altitude profile in the altitude/distance table on the approach chart for guidance.
