| Notification Source Details | |
|--|--|
| Summary | Aircraft accident. |

ATSB Reference: 202000768 **Category:** Accident
Investigation: No
Date and Time: Saturday, February 29, 2020 2:29 AM UTC
Location: Batchelor (ALA), 140° M 2Km
State: NT **Country:** Australia
Latitude: -13.0745 **Longitude:** 131.0353
Highest Injury: Serious
Occurrence: Operational - Terrain Collisions - Collision with terrain
Site Access: Accessible
Dangerous Goods: Nil

Summary: During approach, the engine failed and the pilot conducted a forced landing. The pilot sustained serious injuries and the aircraft was substantially damaged.

RE: Technical / Engineering Report for ATSB

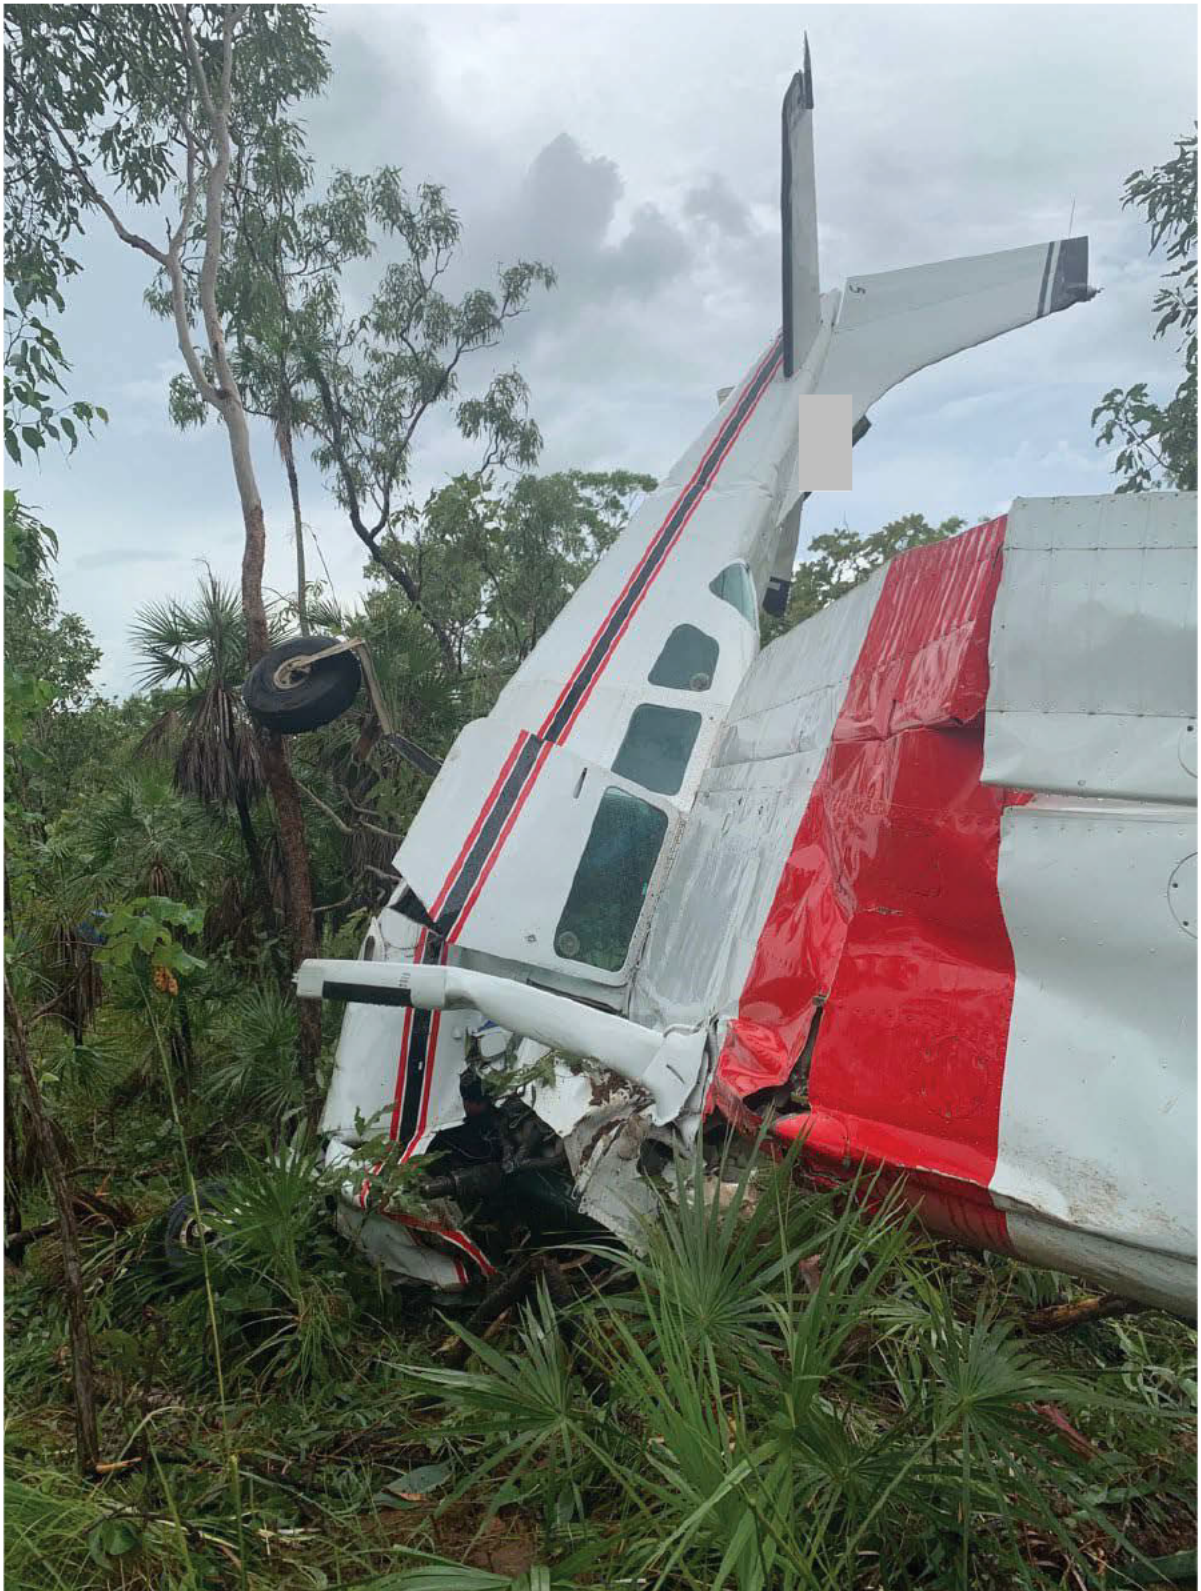
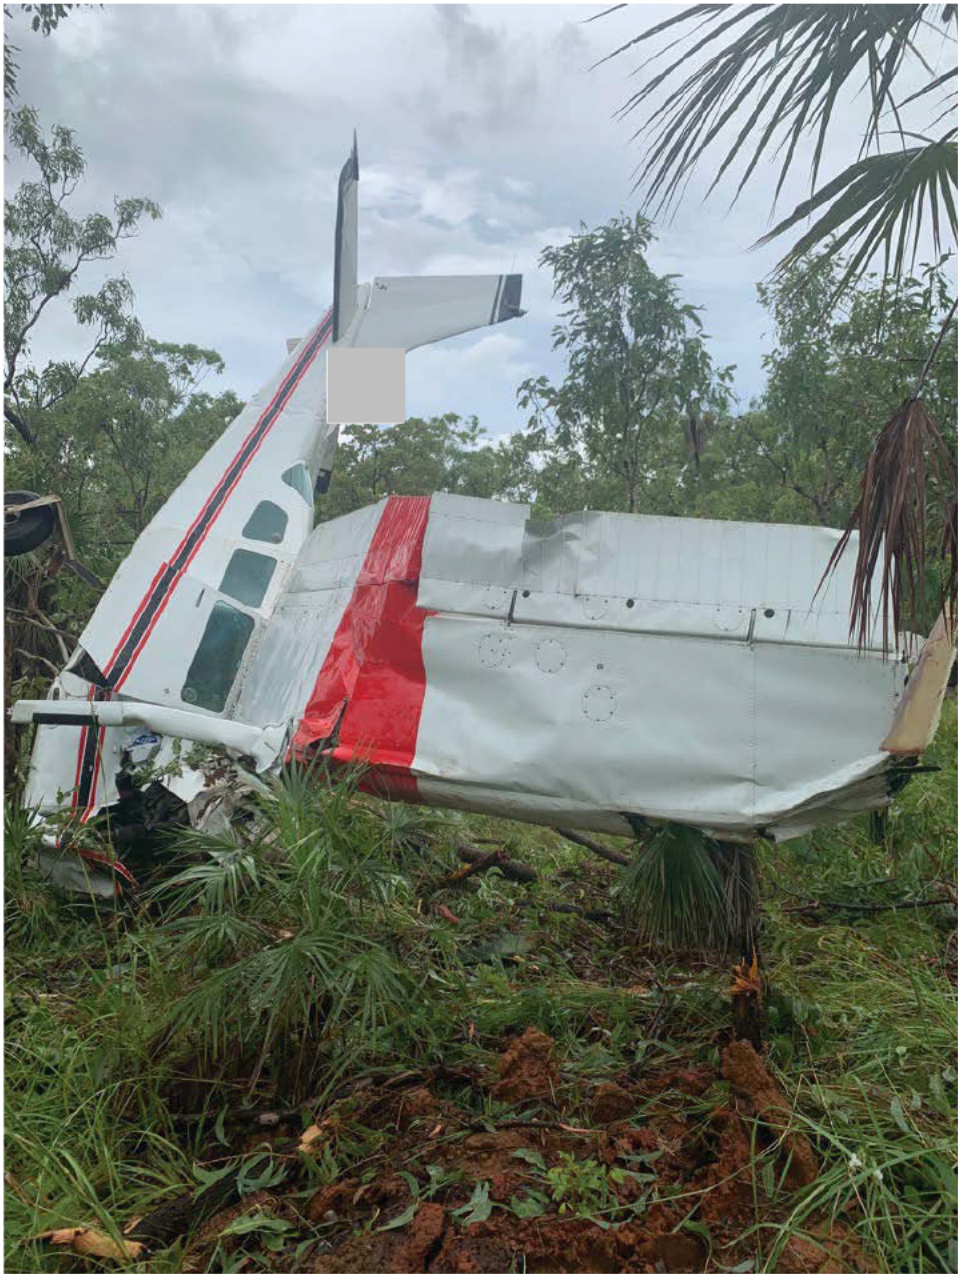
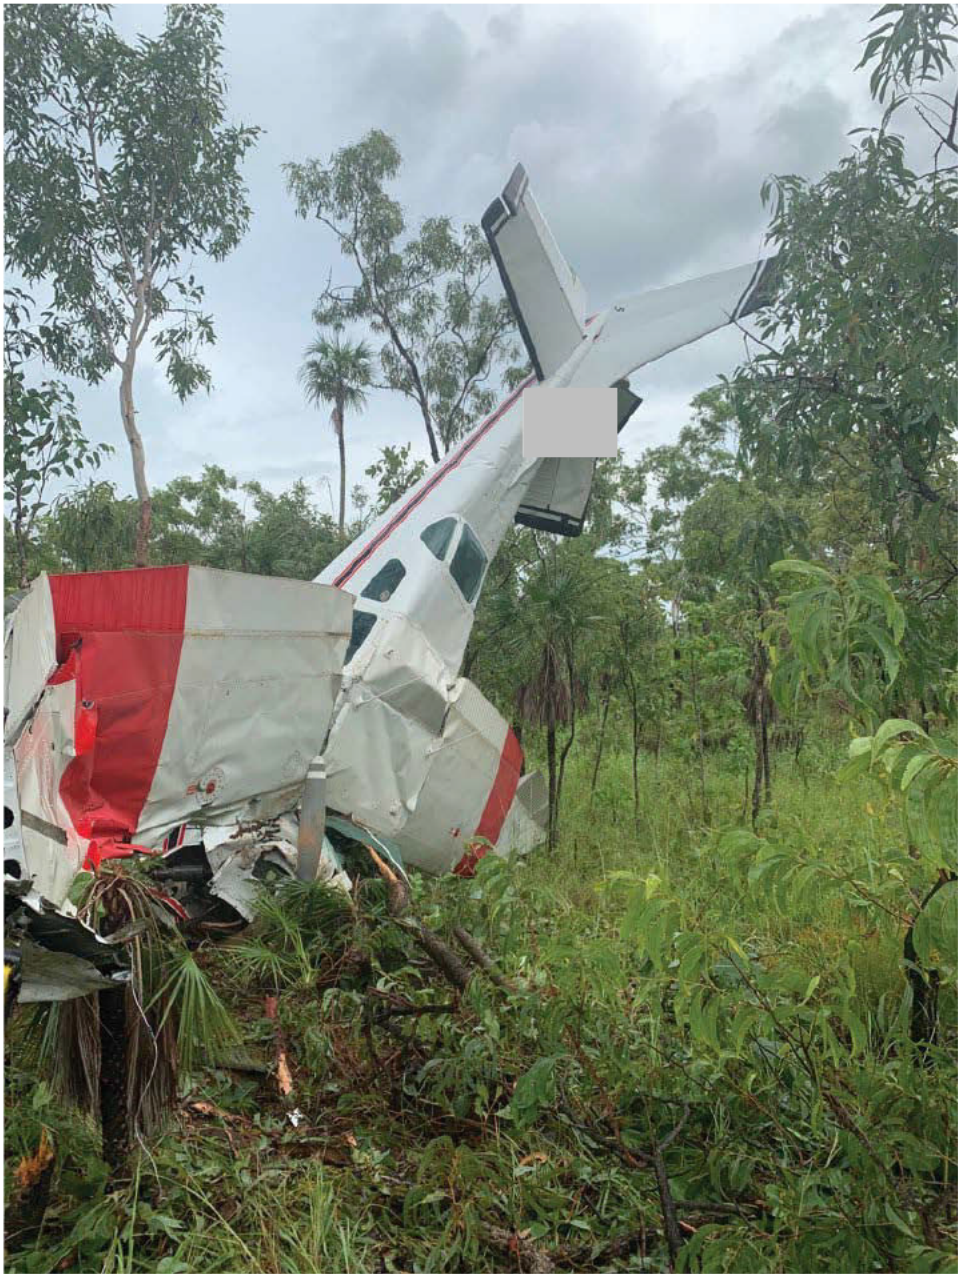
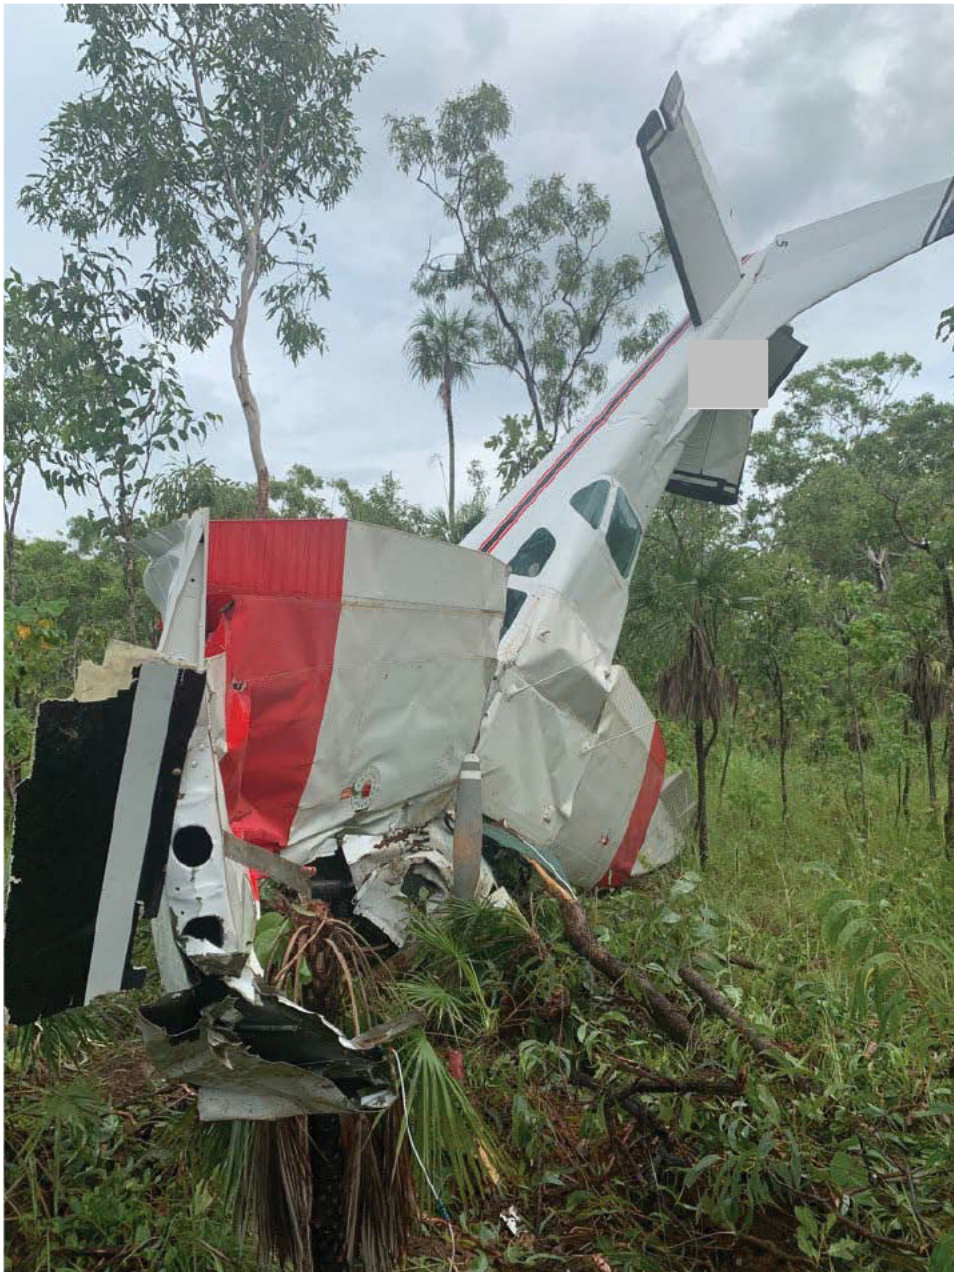
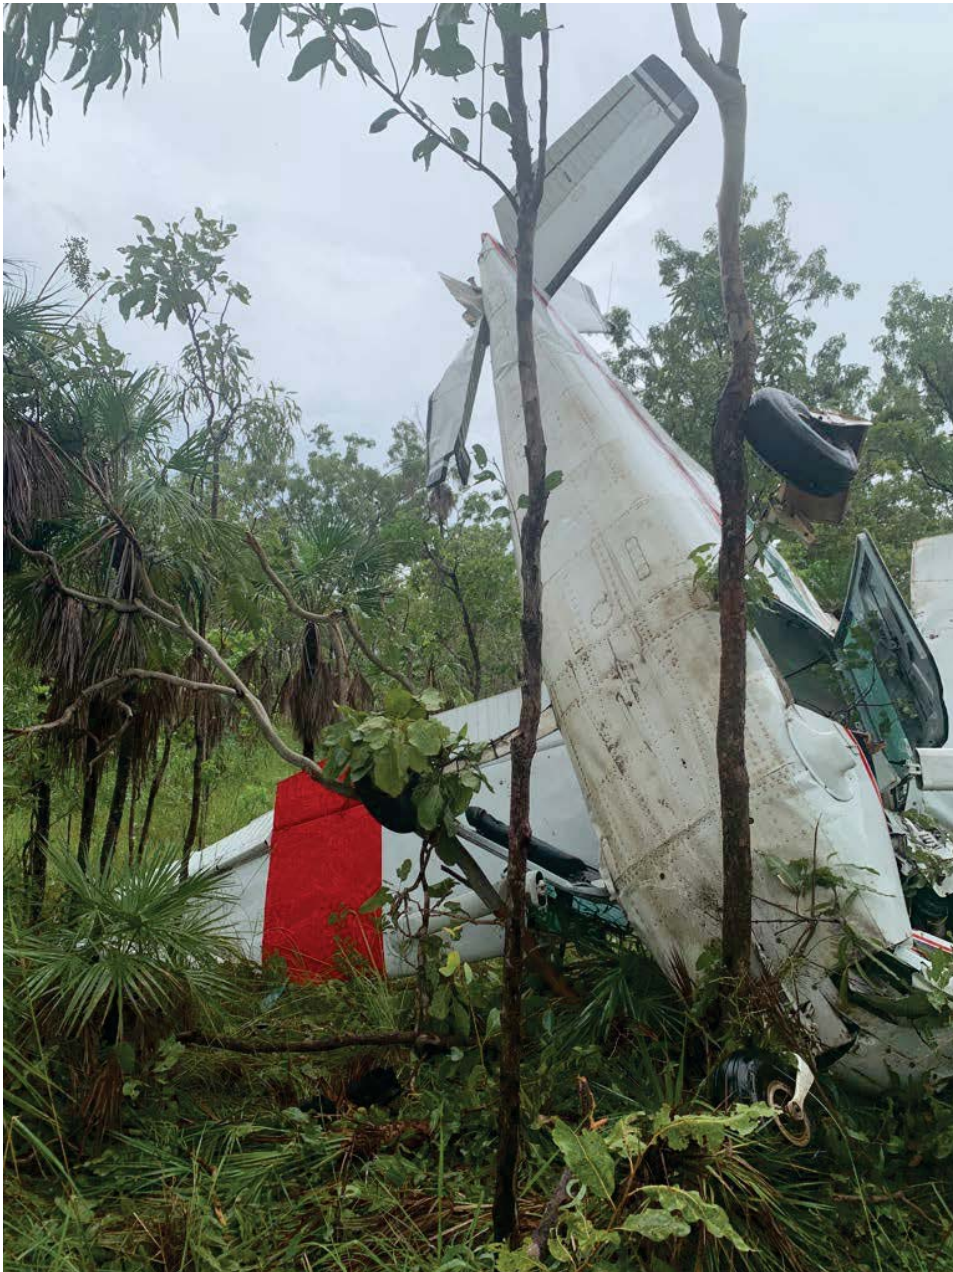
Please see attached photos from NT Police re

As discussed, we are interested in any photos of the accident site for [REDACTED]

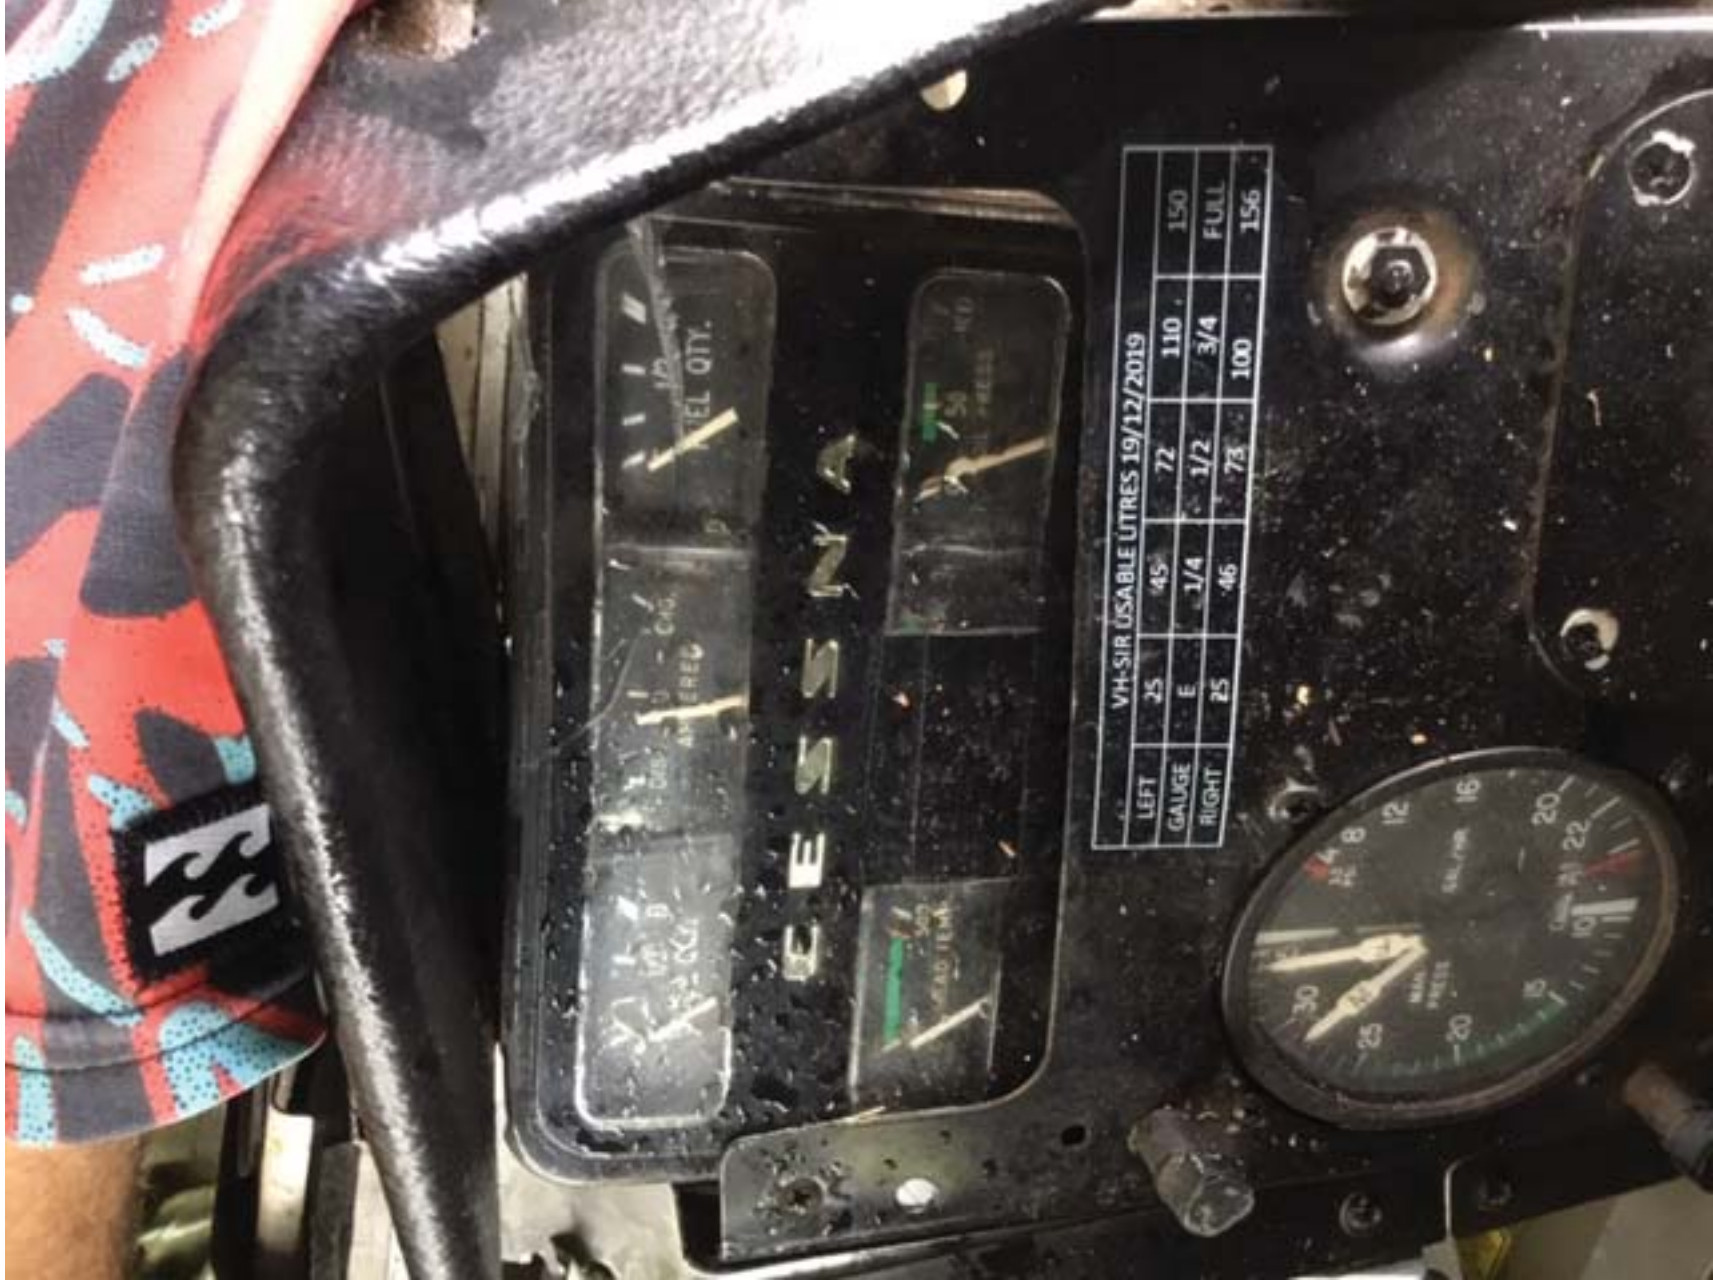
VH-SIR USABLE LITRES 19/12/2019

| LEFT | 25 | 45 | 72 | 110 | 150 |
| GALUGE | E | 1/4 | 1/2 | 3/4 | FULL |
| RIGHT | 25 | 46 | 73 | 100 | 156 |
