# Near hit with workers on track using Absolute Signal Blocking

Westmead, New South Wales, on 15 October 2019

**ATSB Transport Safety Report**  
Rail Occurrence Investigation (Defined)  
RO-2019-018  
Final – 20 December 2021

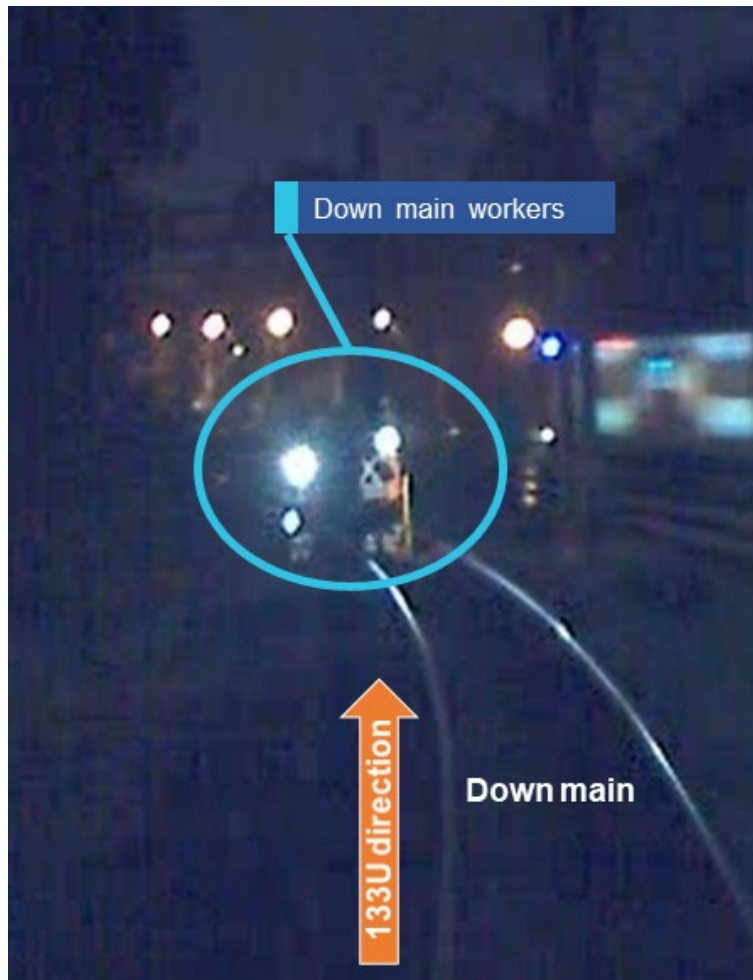
Figure 2. CCTV image from train 133U

The image at Figure 2 is taken from the CCTV on the front of train 133U and shows the three workers in the Danger Zone as the train approaches 727 points on the Down Main line. It is estimated they were approximately 20-30 m from the front of 133U when this image was recorded.

The driver of run 133U saw the workers on track on the Down Main at approximately 24.700 km and sounded the train whistle. At the same time, other workers outside the rail corridor observed the approach of 133U and shouted a warning of “Train on”. The workers on track quickly vacated the Down Main line to the down cess area. The driver made an emergency brake application and the train stopped just past the location where the workers had been.
