# **Collision with terrain involving Robinson R22 Beta, VH-8BW**

29 km north of Southport Aerodrome, Queensland, on 26 February 2025

**ATSB Transport Safety Report**

AO-2025-011

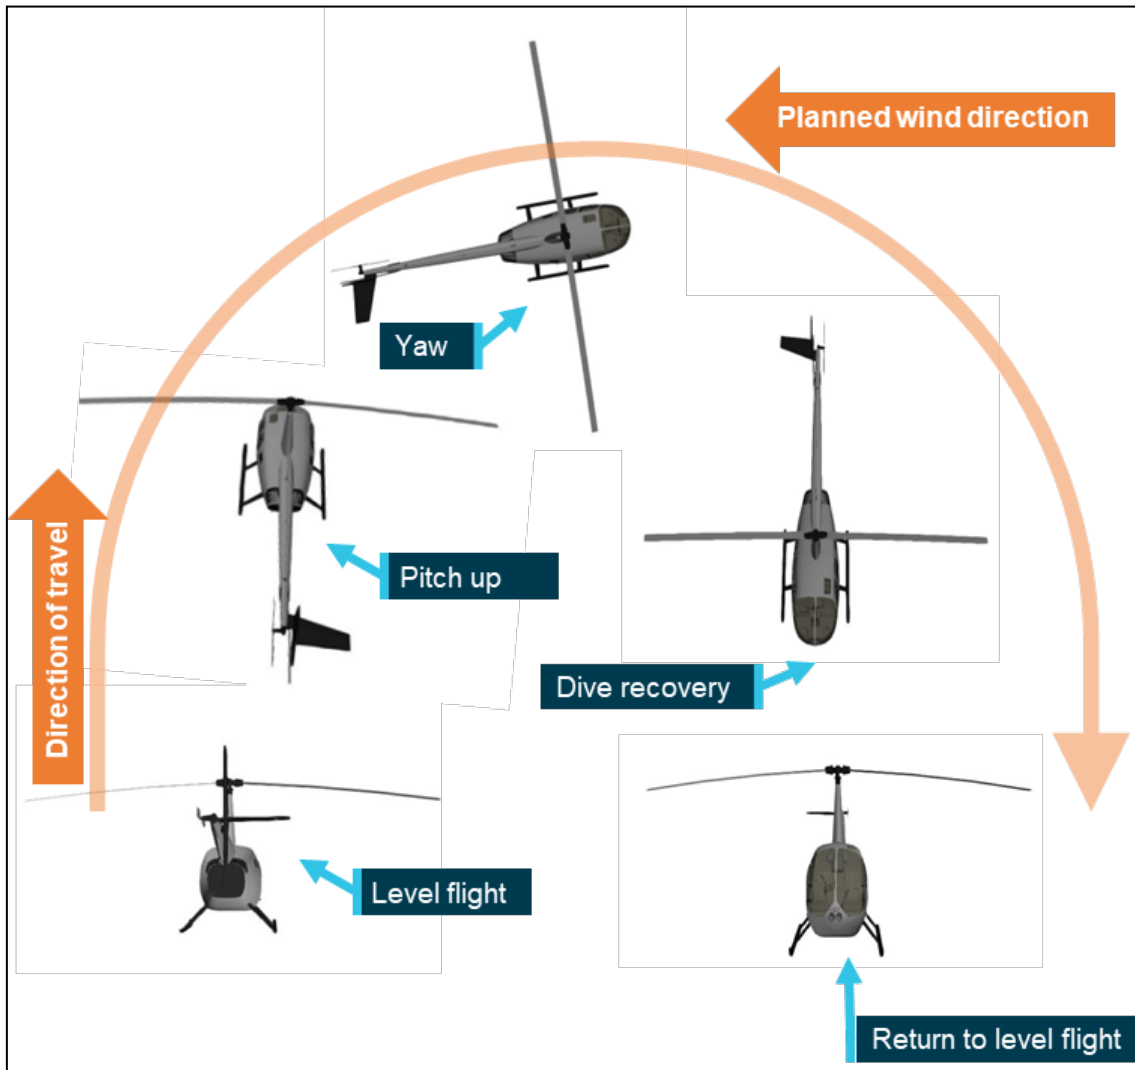
**Figure 6: Helicopter torque turn flight sequence**

A torque turn is an advanced manoeuvre to quickly complete a 180° change in direction of flight (Figure 6). The manoeuvre begins with a pitch upwards to reduce forward airspeed followed by an application of power to increase altitude. As airspeed decreases, aerodynamic stability is reduced and the increased torque induces yaw.<sup>8</sup> This yaw is used to initiate the turn which continues until the helicopter is facing the opposite direction. Once the turn is complete, the pilot regains airspeed, eases out of the dive and resumes level flight in the new direction.
