Runaway and derailment of TasRail freight train no. 604

Devonport, Tasmania, on 21 September 2018

Rail Occurrence Investigation (Systemic)

RO-2018-014

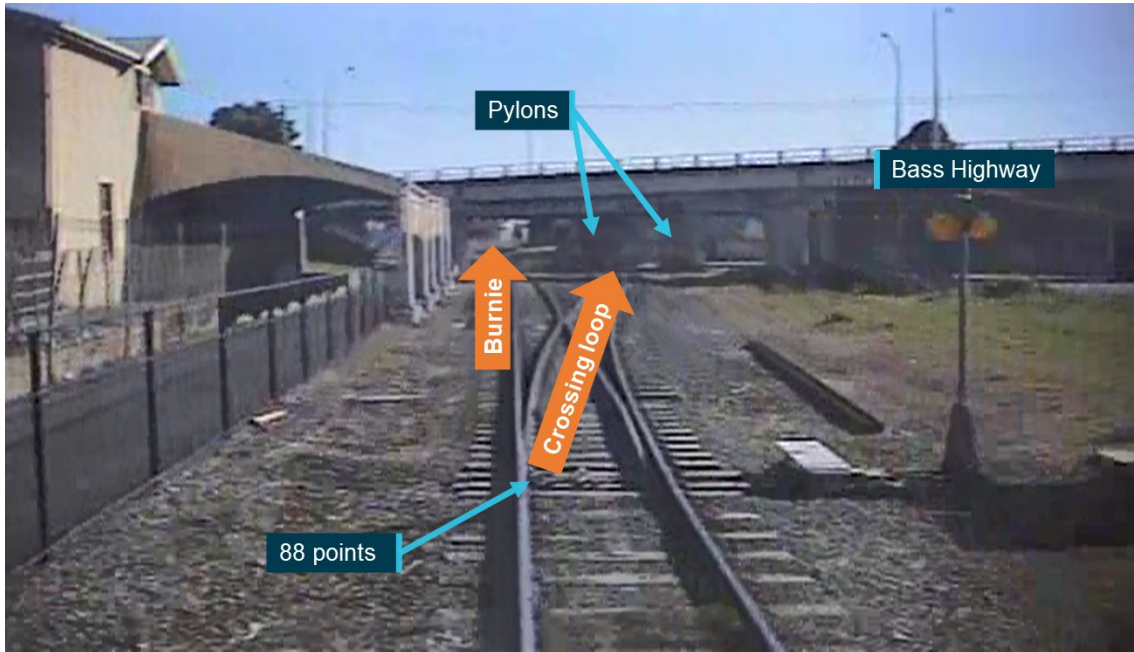
Figure 5: Devonport Yard, no. 88 points

Diversion point from the main line (towards Burnie) via no. 88 points into Devonport crossing loop. The Bass Highway passed over the line shortly after the points. The speed limit for no. 88 points was 'restricted speed' (maximum 25 km/h). The runaway train was travelling at 48 km/h at this point.
 Source: TasRail, annotated by the ATSB

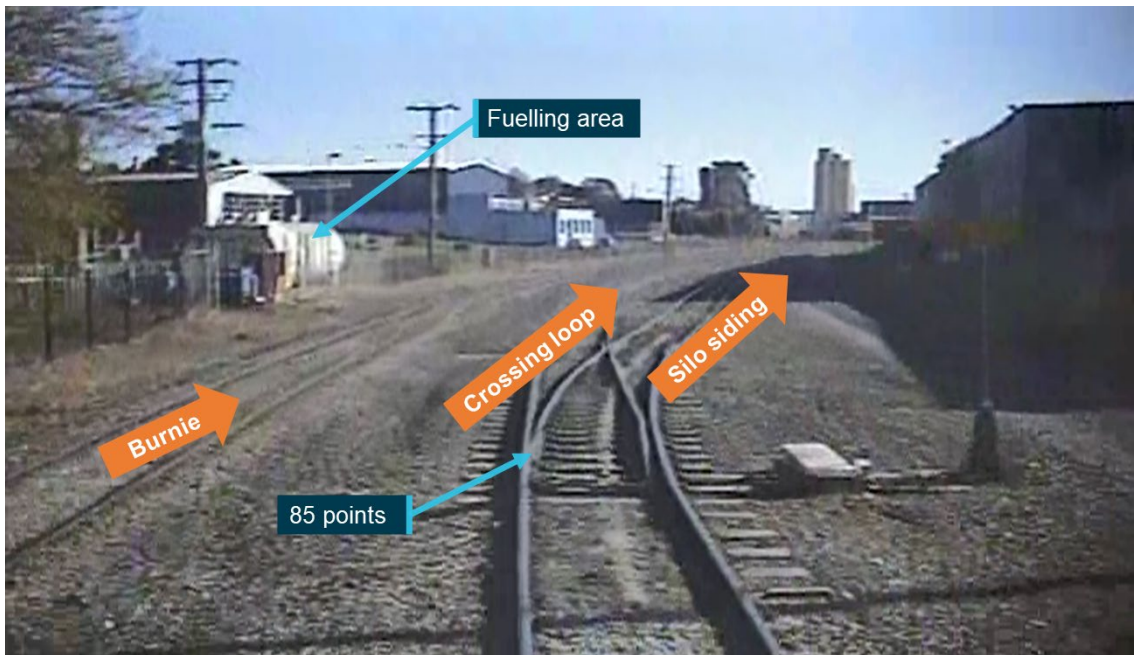
Figure 6: Devonport Yard, no. 85 points

Diversion point from the Devonport crossing loop via no. 85 points into no. 2 road (silo siding). A fuelling area was located on the left, shortly after the points. The speed limit for no. 85 points was 'restricted speed' (maximum 25 km/h). The runaway train was travelling at 51 km/h at this point.
 Source: TasRail, annotated by the ATSB

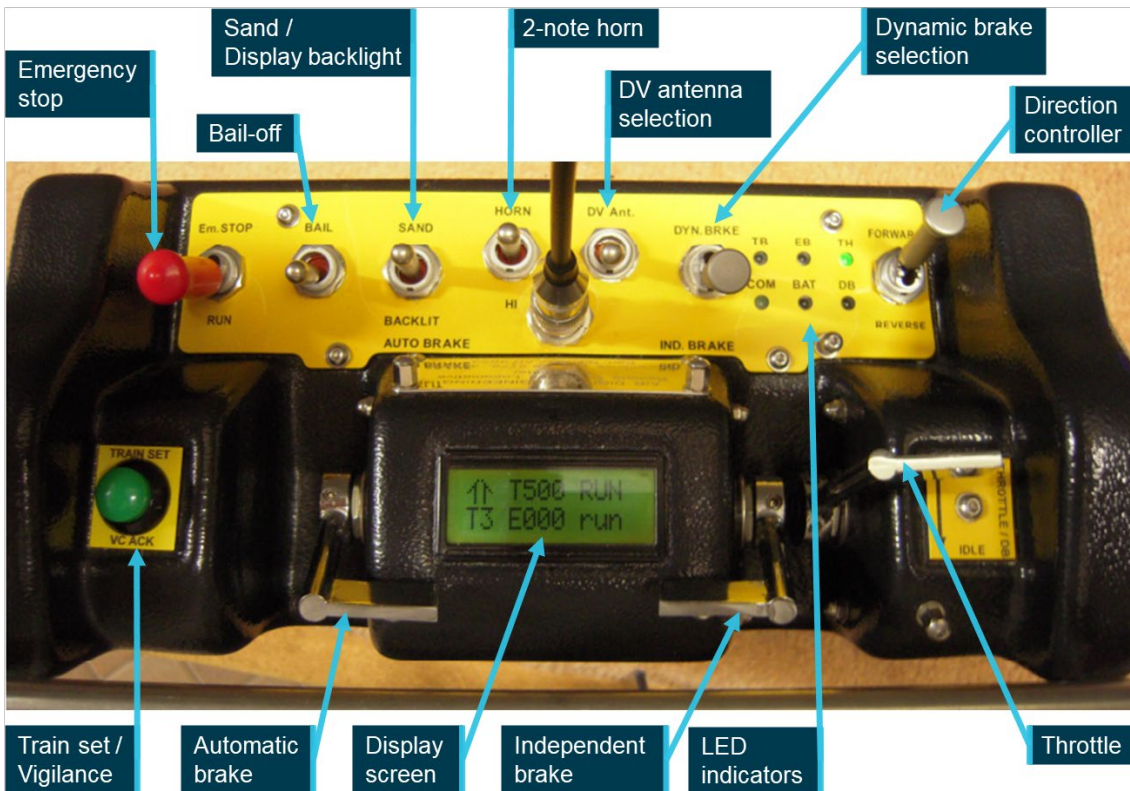
Figure 13: Generation 3 RCE transmitter

Image shows the RCE transmitter as initially supplied to TasRail for generation 3 RCE. Differences to generation 2 RCE's transmitter included reversal of the emergency stop position, and the addition of the dynamic brake switch. The transmitter's key switch was located on the left side of the transmitter (not shown).
Source: Air Digital Engineering, annotated by the ATSB

TasRail identified that the dynamic brake selection switch and direction controller looked and operated the same and were adjacent to each other on the transmitter (see Figure 13). In response, the use of dynamic brake on the cement train was suspended until changes were made to the RCE by ADE to prevent recurrence (see *Changes to remote control equipment prior to project completion*). Although the changes were made by June 2018, the drivers were not advised. As such, at the time of the 21 September 2018 runaway accident, dynamic brake was still not in use.
