ACCIDENT INVESTIGATION REPORT

BELL 204B HELICOPTER VH-UTW AT
BARRACOUTA PLATFORM ON 22nd MARCH 1968

AIR SAFETY INVESTIGATION BRANCH
DEPARTMENT OF CIVIL AVIATION

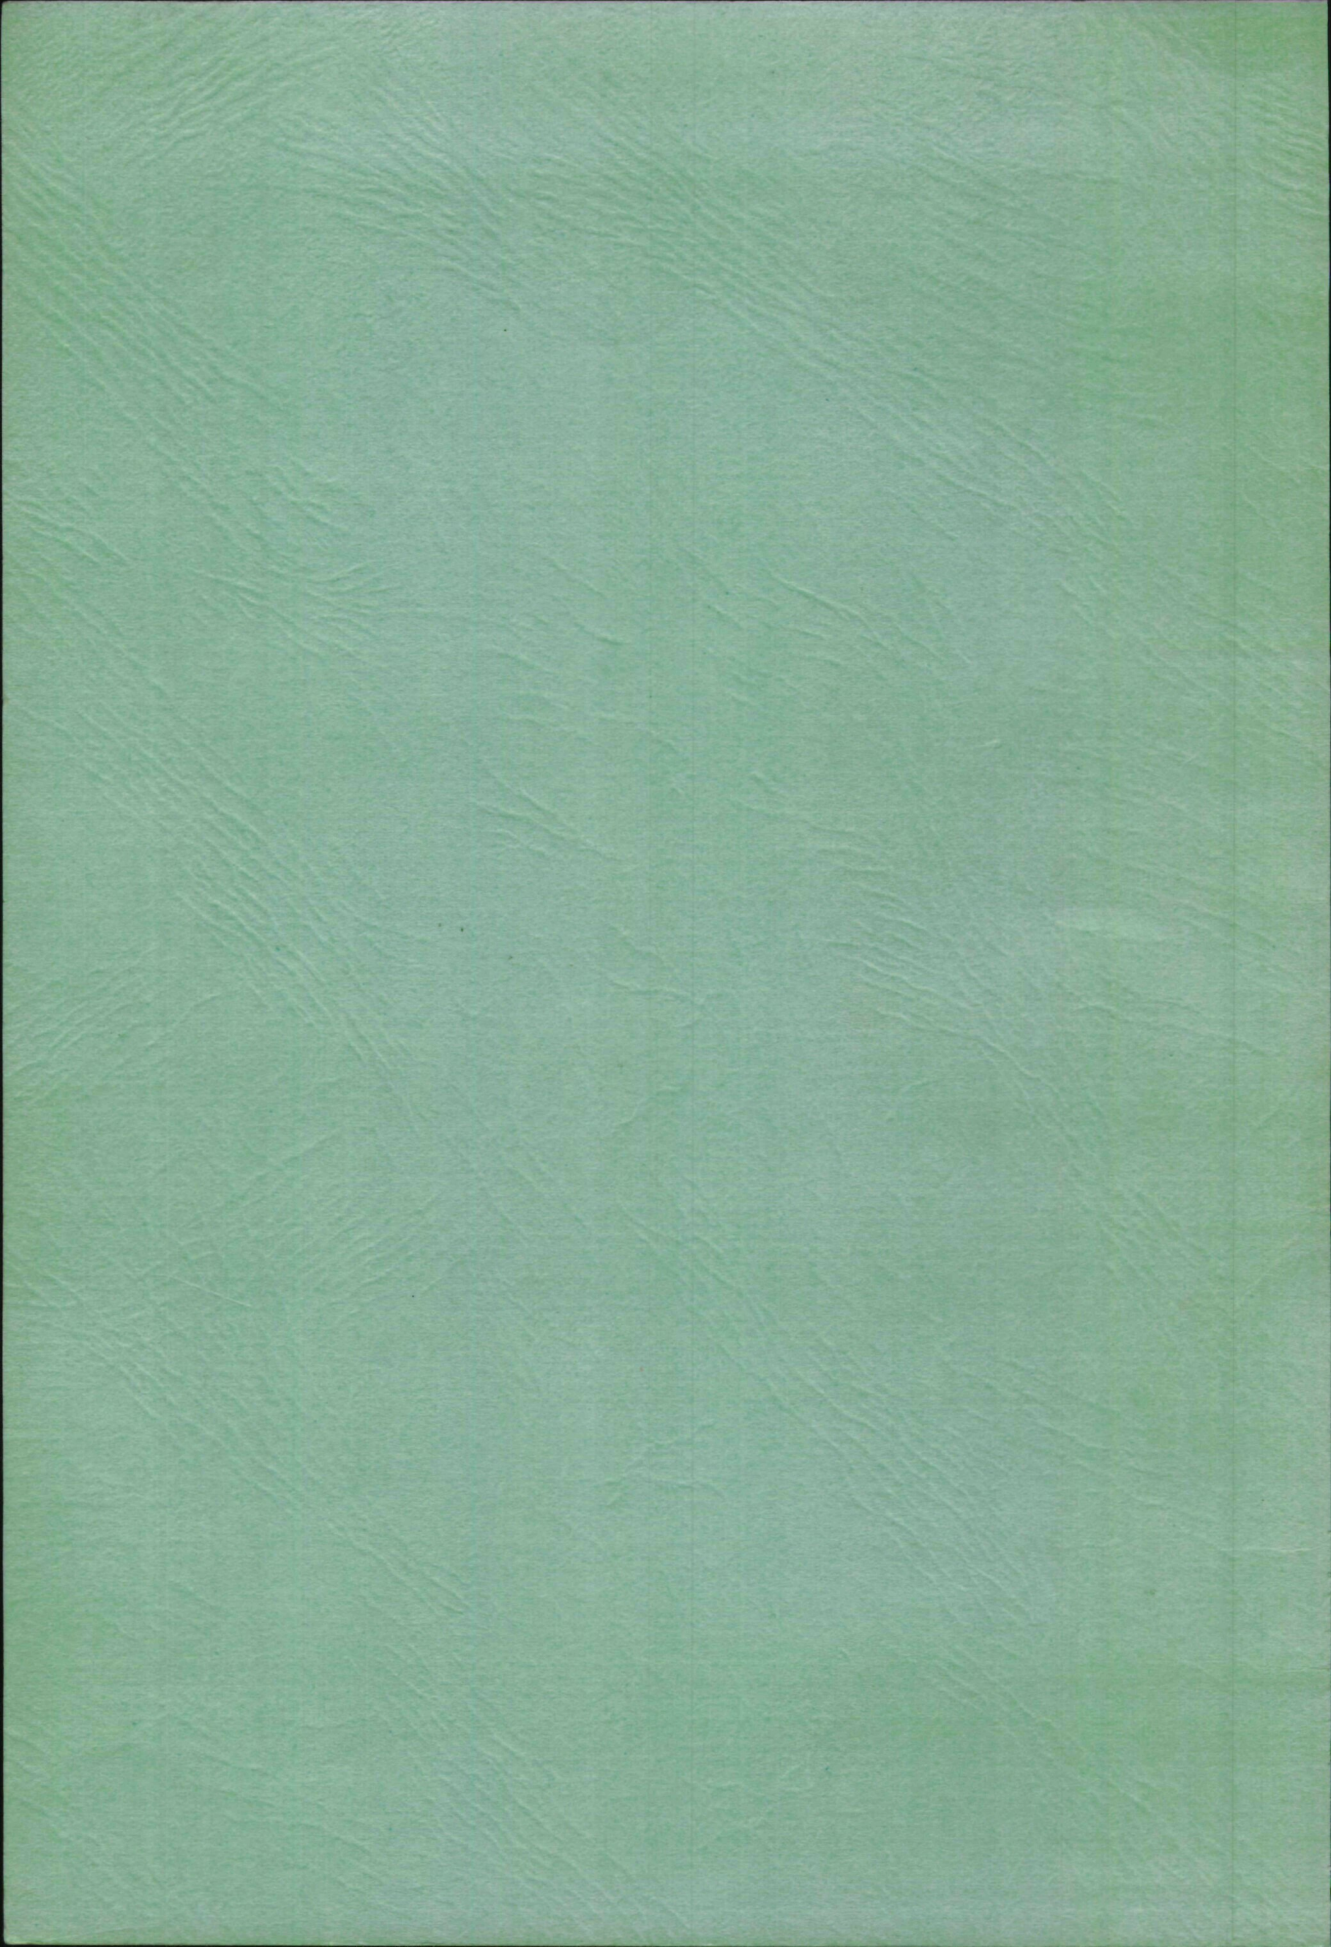
2.2.4 Although the engineering personnel responsible for the assembly of the tail rotor on 28 February 1968 in the Helicopter Utilities Pty. Ltd., workshops at Mascot, had previously dismantled and assembled tail rotors for this type of aircraft, this was the first occasion on which they had to do more than re-assemble the components of the previous assembly. Because a difficulty was experienced in balancing the tail rotor after the first assembly, it was decided to replace the tail rotor yoke with a new one drawn from store and, because of dimensional differences, this involves a re-assessment and adjustment to achieve the required fits and tolerances. Although the engineer supervising the assembly referred to the Manufacturer's assembly instructions, it is apparent that the trunnion bearing shims were adjusted in an attempt to achieve the proper blade grip spacing instead of the blade grip bearing shims (Item 13 in Appendix E) as the instructions require.

- 3.10 These assembly errors and, in particular, the omission of the thrust washer, led to a gross tail rotor unbalance which induced abnormal loads in the tail fin resulting in substantial cracking of the tail fin structure. In this condition it was unable to withstand the loads imposed when the aircraft came into the hover position for this landing. The tail fin then failed, allowing the rear section of the tail rotor drive shaft to uncouple and thus the pilot was deprived of directional control at a critical stage of the landing.

Assembly drawing of the tail rotor hub showing the several component parts and their proper positioning relative to each other.
