Drive system failure and forced landing, involving Robinson Helicopter Company R44 Clipper II, VH-SXC

11 km west of Hamilton Island, Queensland on 3 February 2021

ATSB Transport Safety Report

AO-2021-007

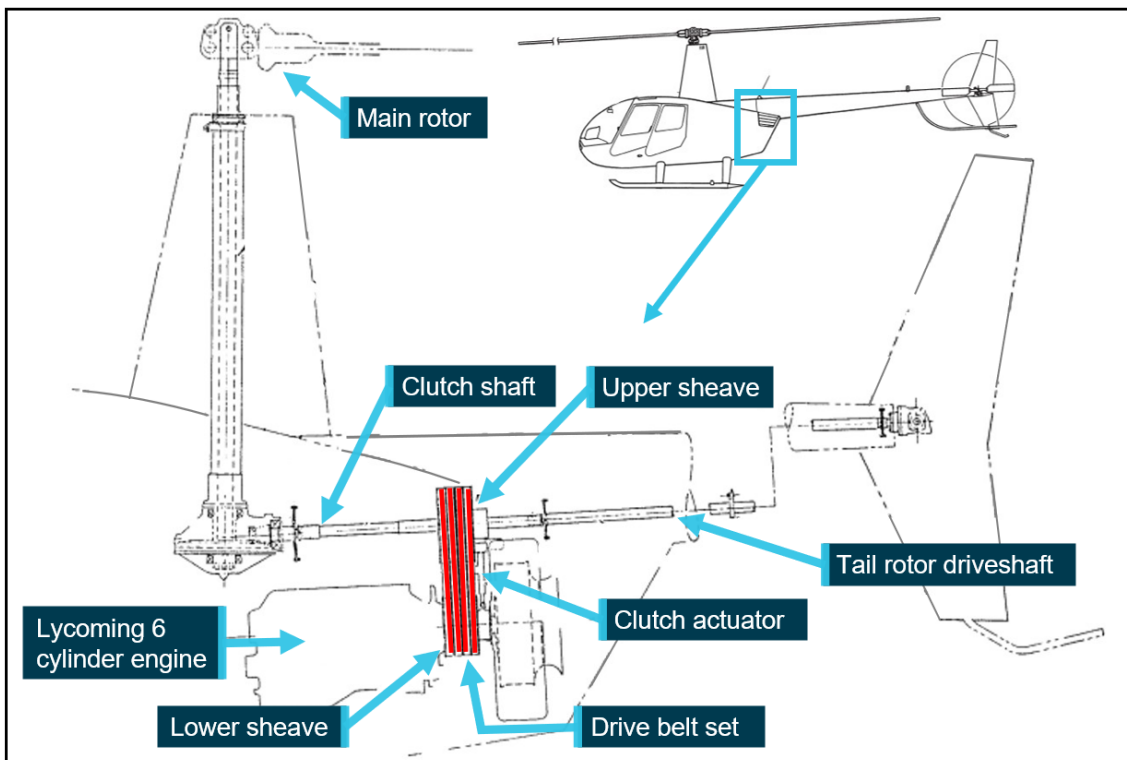
Figure 3: Robinson R44 rotor drive system

When engaged, the clutch actuator extends and moves the upper sheave upwards a small amount, which applies tension to the drive belts, transmitting engine power to the rotors (Figure 3). When the drive belts are properly tensioned, the clutch actuator senses the compressive load (drive belt tension), and the clutch actuator switches off.

During engine start, the drive belts are not under tension to reduce the load on the starter motor that would otherwise attempt to turn both the engine and the entire rotor system. After start, the pilot selects the clutch actuator to ENGAGE, tensioning the drive belts within the sheave grooves. The POH stated, that after engaging the clutch actuator switch, the rotors should be turning within 5 seconds. Also, Safety Notice SN-33, Drive Belt Slack states that if:
