Collision with terrain involving Kubicek Balloons BB78Z, VH-RJR

Elwood, Victoria on 20 April 2022

ATSB Transport Safety Report

AO-2022-028

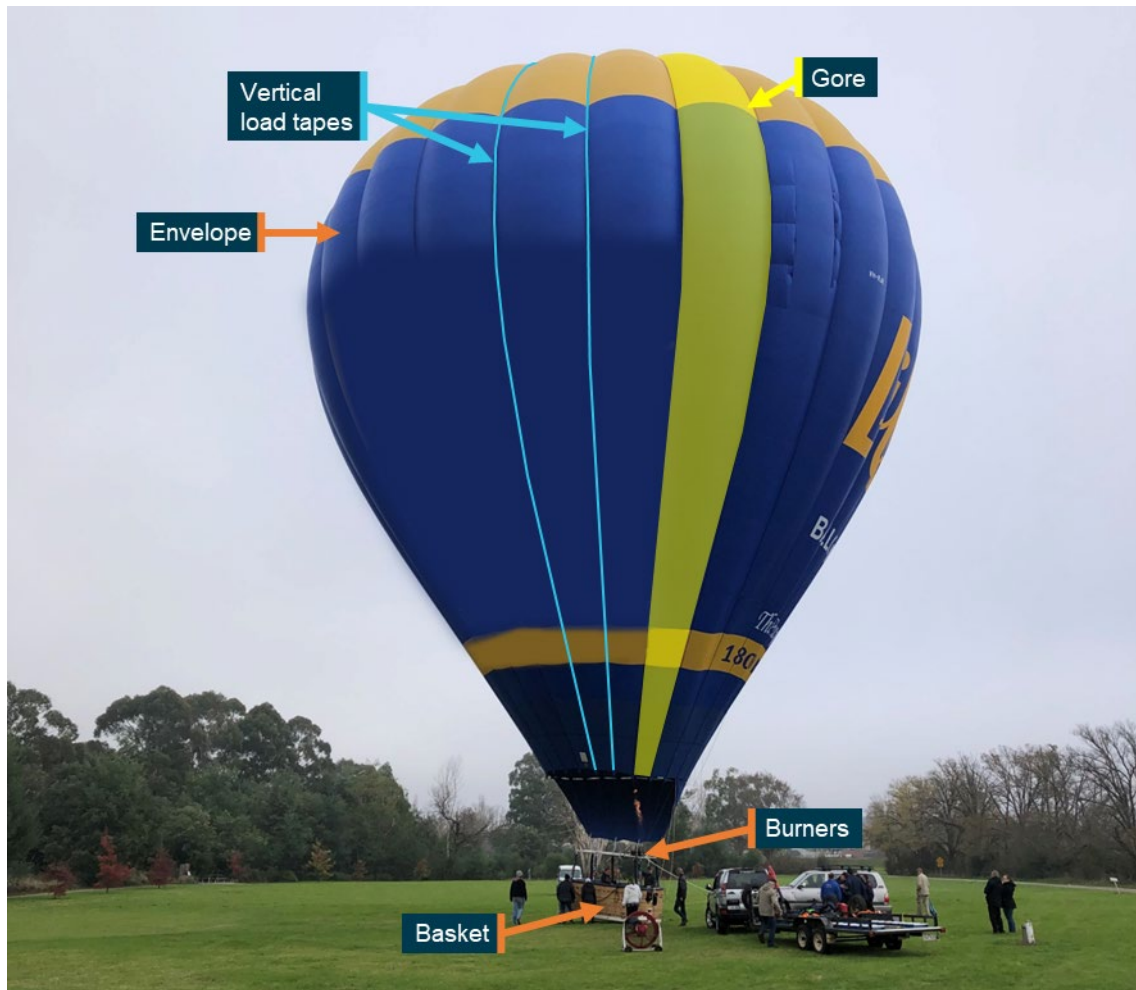
Figure 4: VH-RJR

The BB78Z is a 275,000 cubic feet hot-air balloon produced by Kubicek Balloons, a balloon manufacturer based in Czechia. The incident balloon (VH-RJR) was manufactured in 2021 (Figure 4) and included a T-partitioned basket with two passenger compartments fitted with rope handles, and a triple burner system. The envelope has vertical load tapes which transfer the internal envelope forces to carry the basket, and 24 gores (vertical fabric panel sections between vertical load tapes).

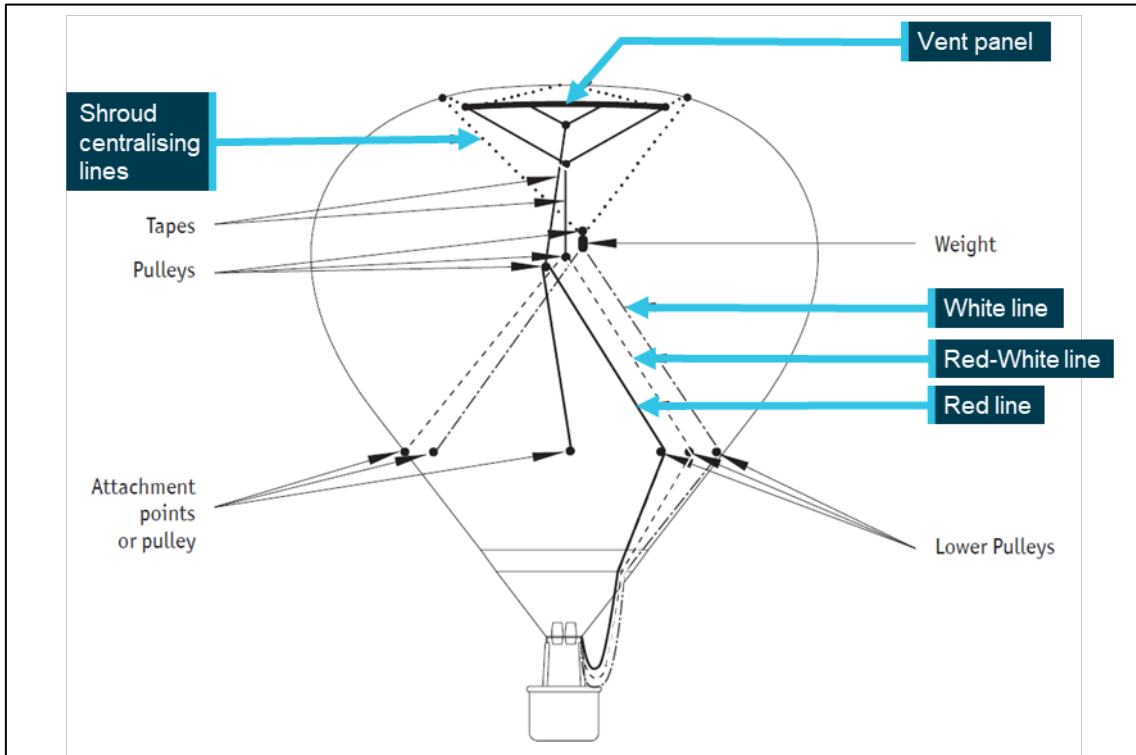
Figure 5: VH-RJR deflation system

The balloon was equipped with a Kubicek 3-line deflation system (Figure 5). In-flight venting was achieved by pulling on the red-white line (parachute vent line) which in turn pulled the vent panel (Figure 6) at the top of the balloon for a controlled release of air through a circular opening (vent aperture). Releasing the parachute vent line allowed the vent panel to close.

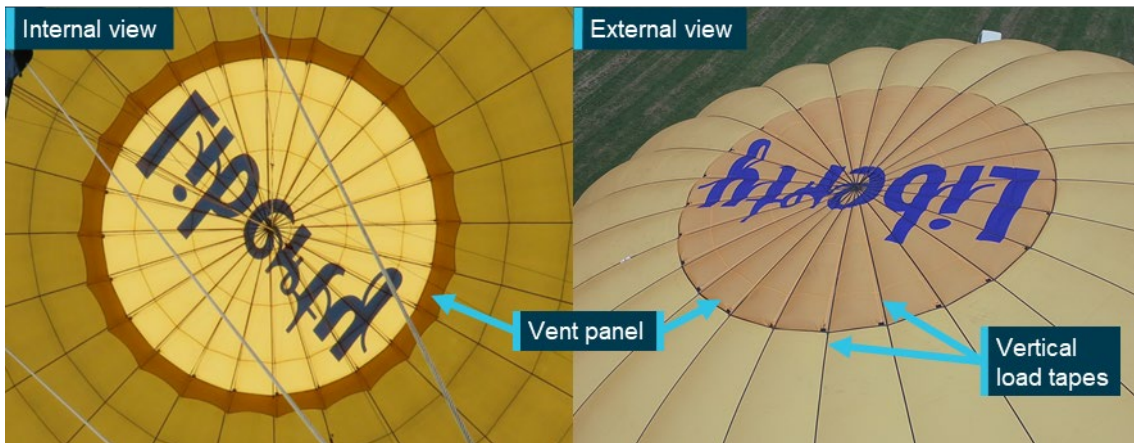
Figure 6: Vent panel

The images indicated vent panel behaviour similar to that observed in the passenger's video (Figure 1) during the incident flight. The pilot, who attended the test, also reported that the vent gaps were very similar to those observed during the incident flight.

After the test, the manufacturer designed a repair to fix the vent panel sealing issue and evaluated whether the spacing between the vertical load tapes at the edge of the vent panel was adversely affecting the seal. Another balloon test was conducted which showed that the repair improved the seal, however the balloon was not considered airworthy. The balloon envelope was subsequently shipped back to the manufacturer’s headquarters for further examination.
