ATSB TRANSPORT SAFETY REPORT
Aviation Occurrence Investigation AO-2008-053
Final

Oxygen cylinder failure and depressurisation
475 km north-west of Manila, Philippines
25 July 2008
Boeing Company 747-438, VH-OJK

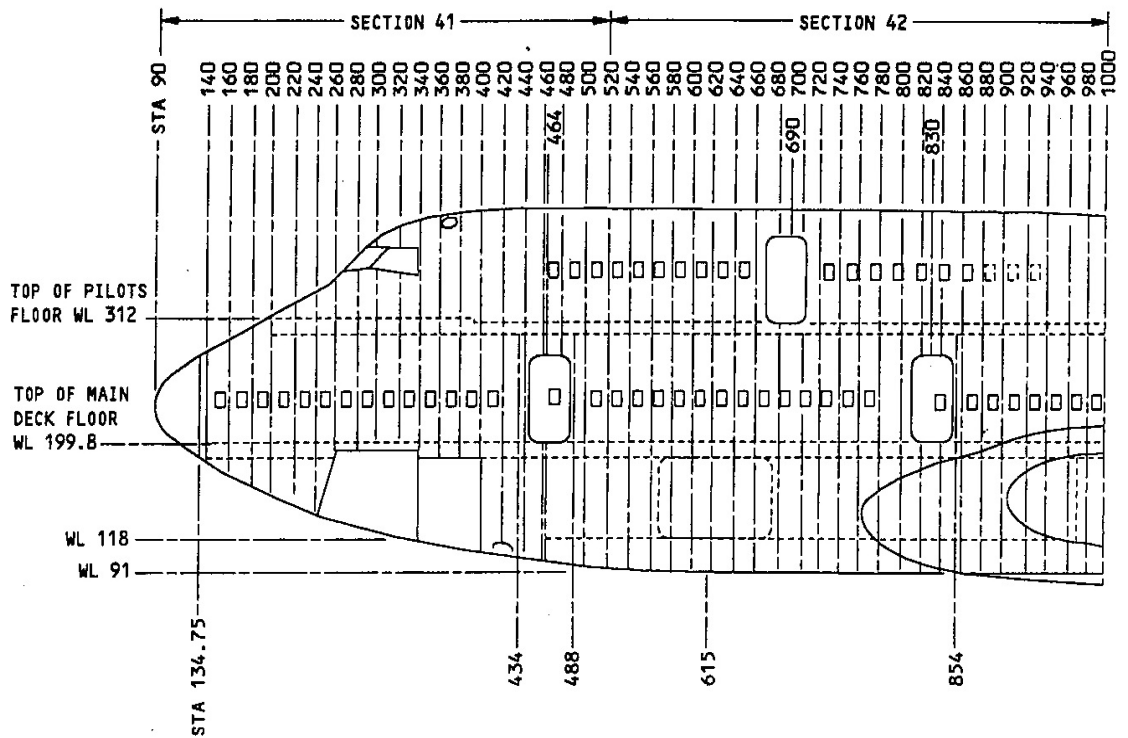
An examination of the rupture profile and fuselage skin damage found that all fractures were typical of a ductile tearing mechanism, with no evidence of corrosion, prior cracking or pre-existing defects in any of the areas examined. Along the forward edge of the rupture void, an area of skin presented a sharply folded appearance, with an outward curvature that appeared to match the profile of the breathing oxygen cylinders installed internally along the fuselage wall (Figure 5 and Figure 6).

Figure 5: Sharply folded area of fuselage skin

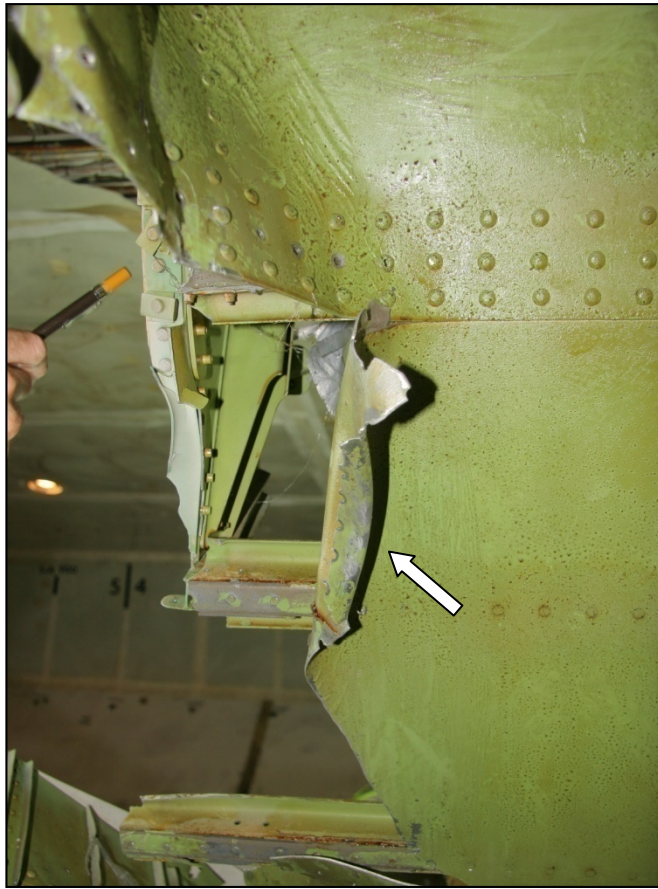
Figure 6: Oxygen cylinder held against skin fold to illustrate conformance

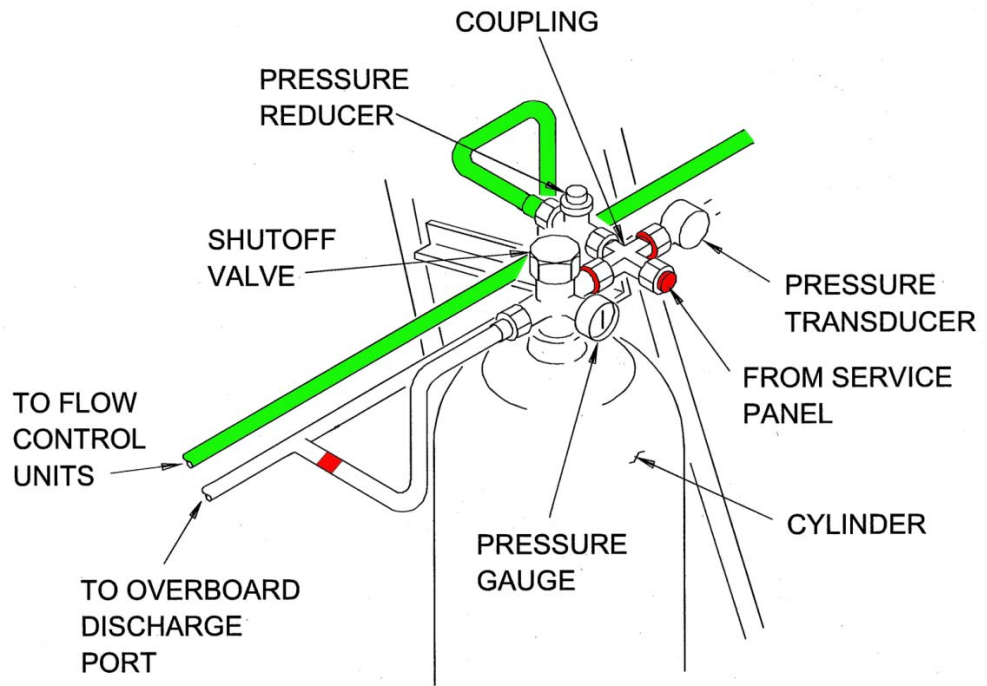
- the service/delivery T-piece had fractured from the cylinder valve outlet, with the damaged and partly intact pressure reducer remaining connected to the delivery line (Figure 13)
- the service line had fractured through the thermal compensator fitting at the service/delivery T-piece (Figure 14)
- the overpressure relief vent line had fractured immediately before its connection into the common line for the cylinder bank (Figure 15). The green indicator disk within the overboard discharge port at the end of the common vent line (refer to the Oxygen system description) was found intact and in-place.

Figure 13: Number-4 cylinder pressure reducer and tee-piece - fractured away from cylinder valve at arrowed connection

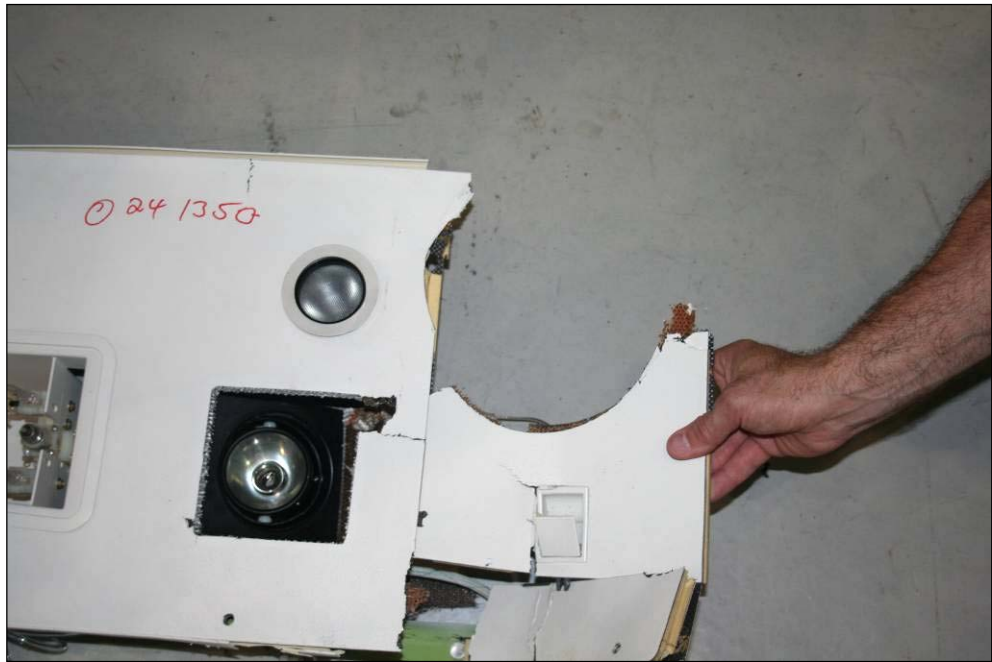
Figure 24: Overhead panel cut-out section recovered from the structure above the R2 door

Cylinder impacts overhead panelling end-on, producing circular cut-out type damage – see Figure 23 to Figure 25

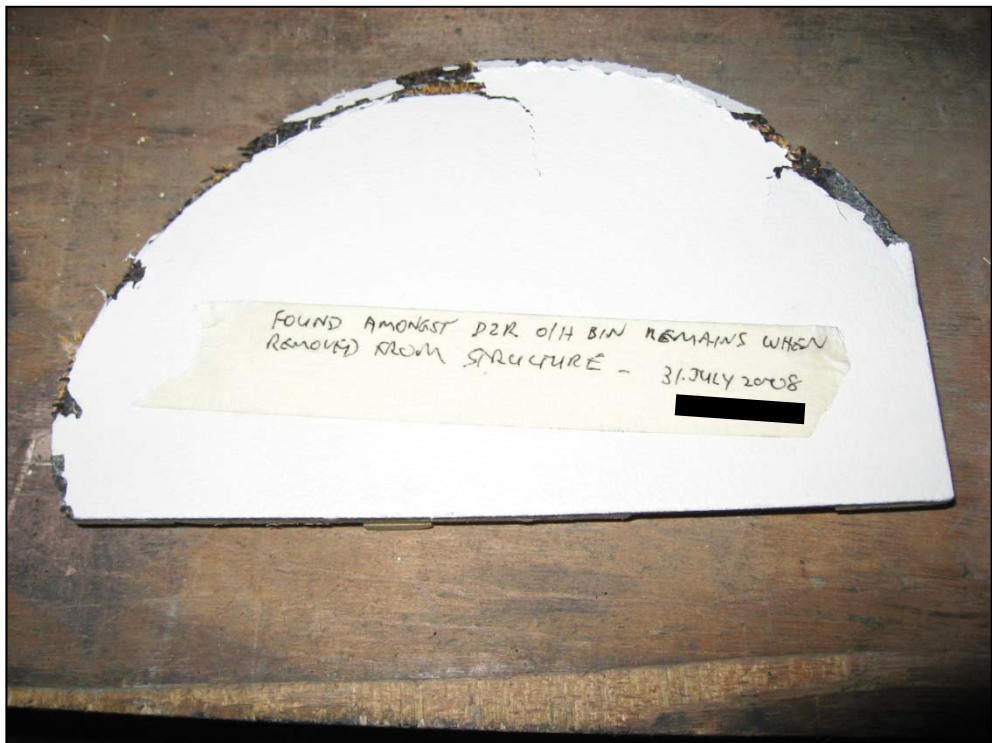
Figure 25: Panel with cut-out placed against another oxygen cylinder to illustrate the conformance in diameter

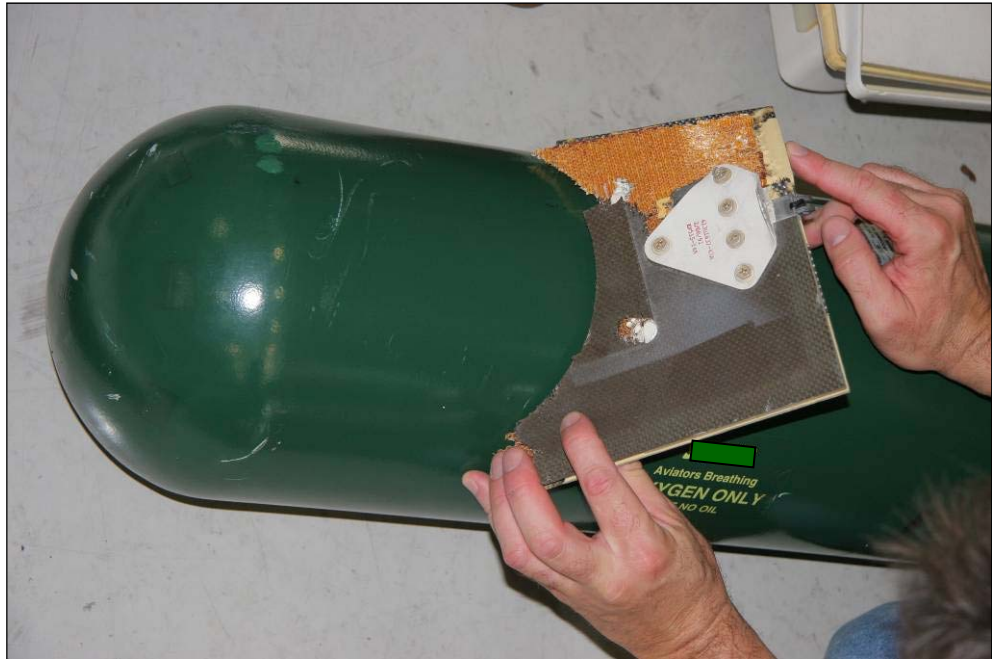
Figure 26: Semi-circular damage in partition of compartment above R2 door

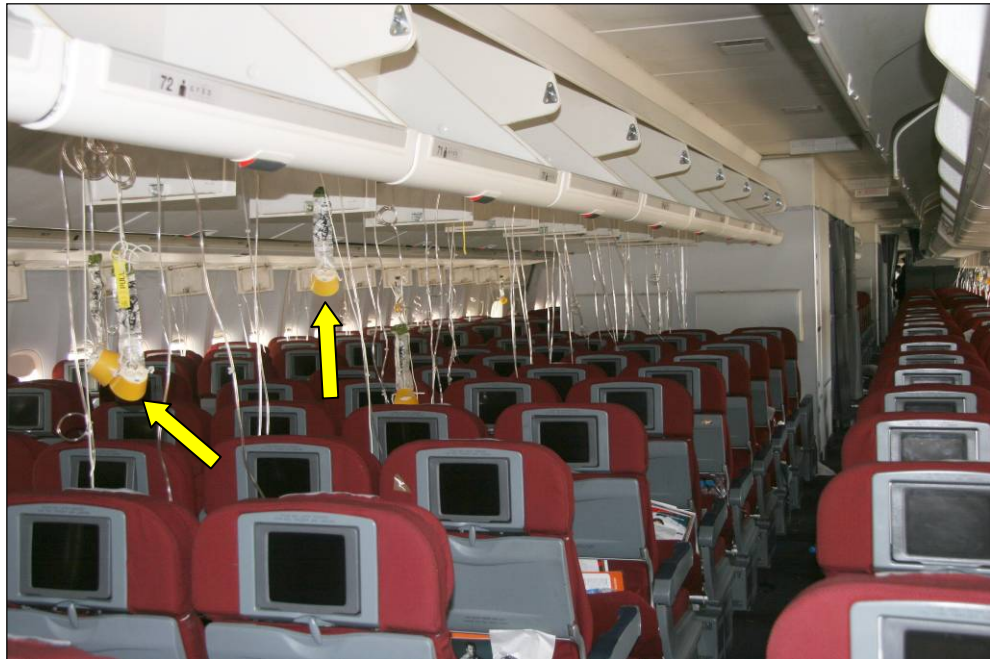
In the cabin crew positions, a total of 26 masks were found deployed, with 16 activated. Of the 19 portable oxygen cylinder/mask units, six were found with indications of use; the cylinders being either empty or with pressures less than their 'full' value of 1,850 psi.

Figure 26: Typical appearance of the cabin after arrival in Manila. Note the passenger masks dropped and activated, and those dropped and not activated (arrowed)

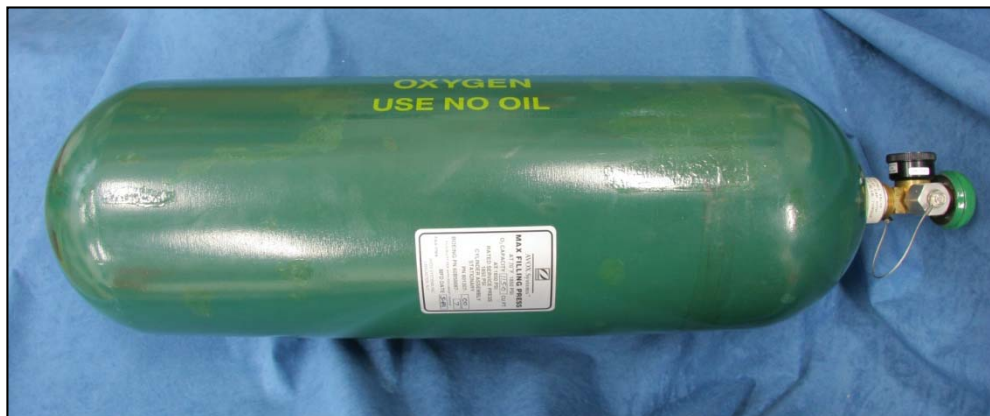
In general, most cylinders presented only isolated light external surface abrasions, scrapes and rub marks, with localised paint removal and superficial corrosion in some areas. Most also showed evidence of touch-up painting in isolated areas where the original paint coating had been previously scratched or damaged (Figure 43). Damage to the underlying steel in those areas was not evident. The largest of the individual (unrepaired) marks measured approximately 10 x 10 mm (0.4 x 0.4 in), although multiple such marks were sometimes evident in clusters or lines (Figure 44).

Figure 42: Cylinder S/N 883198 showing typical external condition and labelling

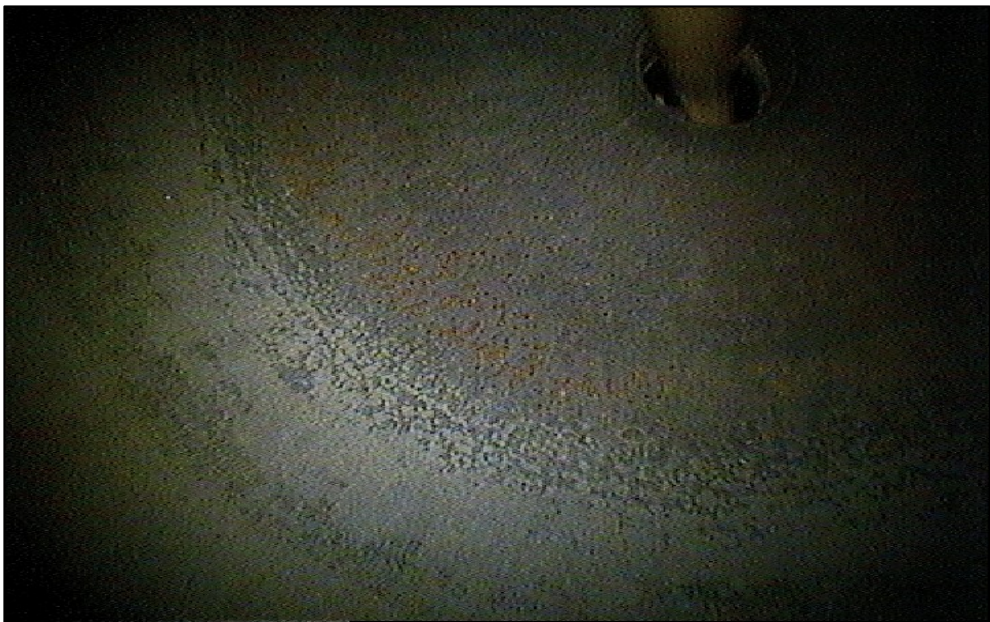
Internally, all cylinders were essentially free from any visible evidence of active pitting or general corrosion attack. Superficial corrosion staining and/or light surface deposits were evident in some cylinders (Figure 47), with the most visible areas around the upper dome and neck transition regions. One cylinder (S/N 535626) showed an irregular linear feature extending from the upper dome to part way along the cylindrical body (Figure 48). That cylinder was subsequently selected for sectioning and destructive examination to facilitate the characterisation of that feature and the general metallurgical condition.

Figure 47: Internal endoscopic view of the upper dome and neck region of cylinder S/N 535571

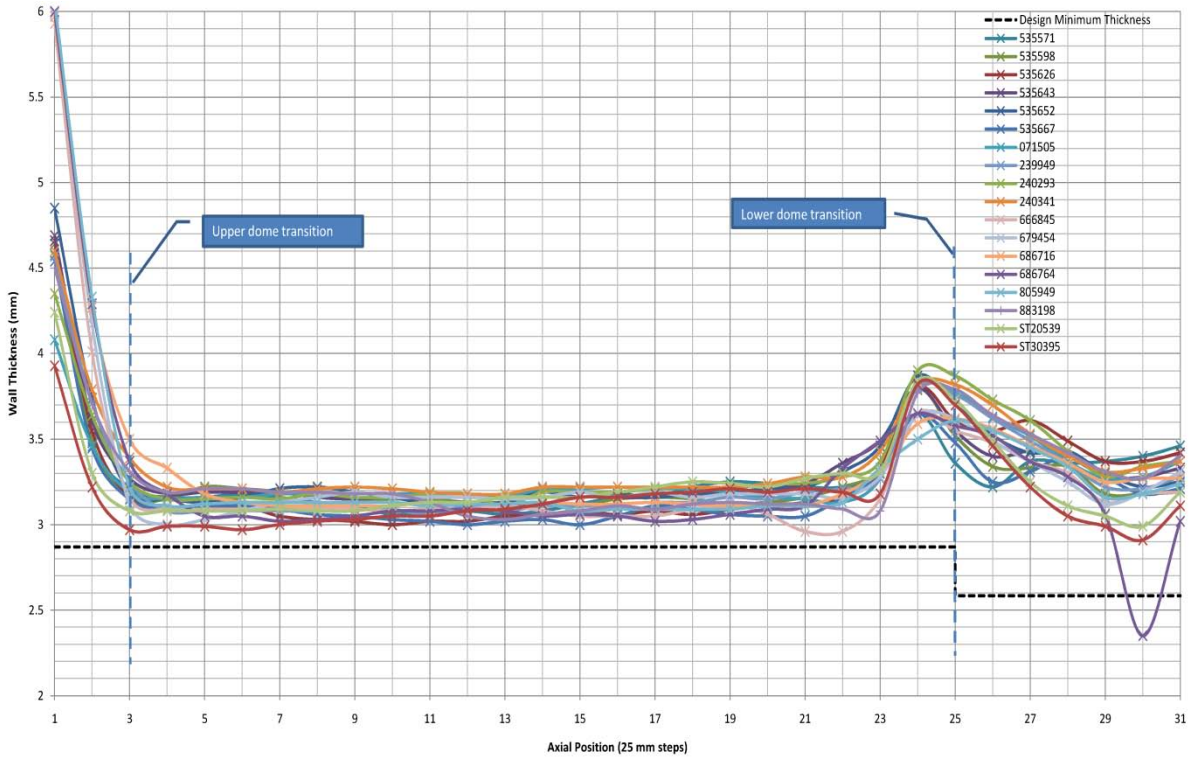
Figure 49: Graphical presentation of cylinder wall thickness measurements

Of the cylinders examined, only cylinder S/N 686764 showed a thickness value below the specified minima – a single location towards the centre of the lower dome. To further evaluate, a comprehensive survey was subsequently conducted over 100% of the lower dome surfaces of this cylinder. From that work, it was evident that the non-compliant area was restricted to a partial ring-shaped region approximately 20 to 40 mm (0.79 to 1.57 in) from the centre of the dome. Figure 50 and Figure 51 present the results of this work in conditionally-formatted tables.

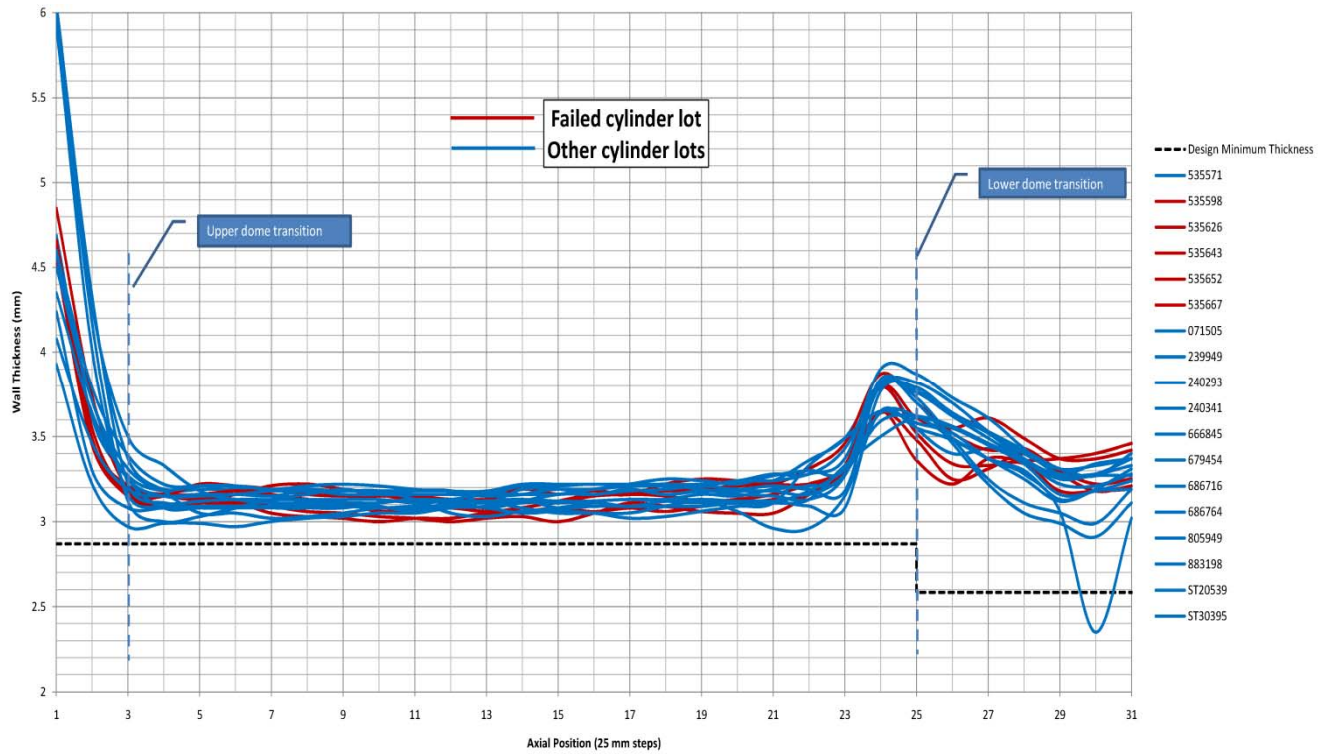
A comparison of the measured thicknesses of the cylinders from the same production batch as the failed item, against the other examined cylinders (various batches) showed no notable variation from the range of typical values presented (Figure 52).

Figure 52: Comparison of thicknesses from the failed cylinder batch, against the total lot examined

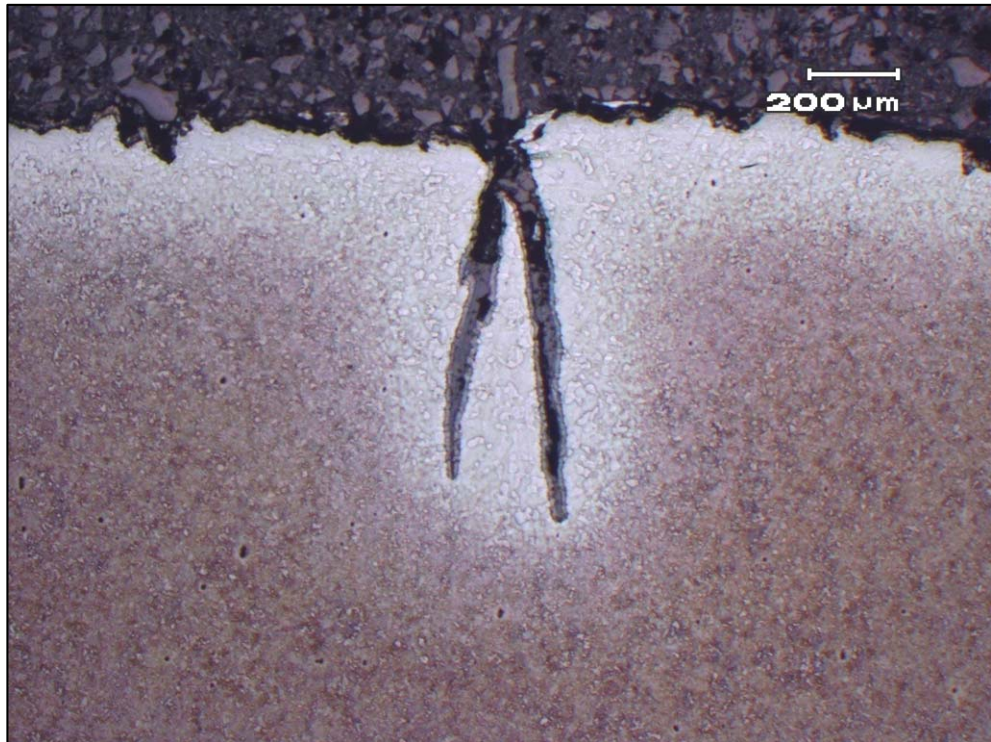
Figure 56: Largest of the internal surface intrusions identified around the cylinder neck transition

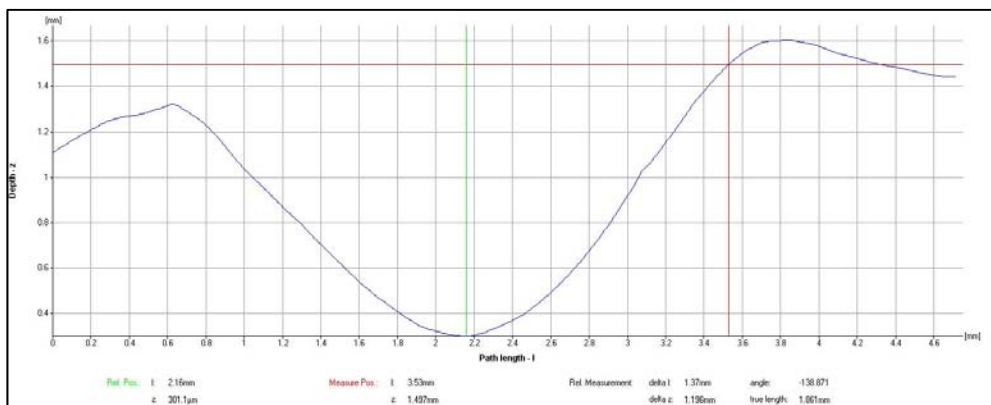
Of the stamped areas examined after removal of the surface paint coatings, the deepest impression (Figure 58) measured 1.196 mm (0.047 in), and presented a smooth, uniformly curved base profile (Figure 57). The typical depth of impression ranged from 0.4 to 0.8 mm (0.016 to 0.031 in), and all were smooth and uniformly formed in profile.

Figure 57: Profile form and measurements of a cylinder stamp marking

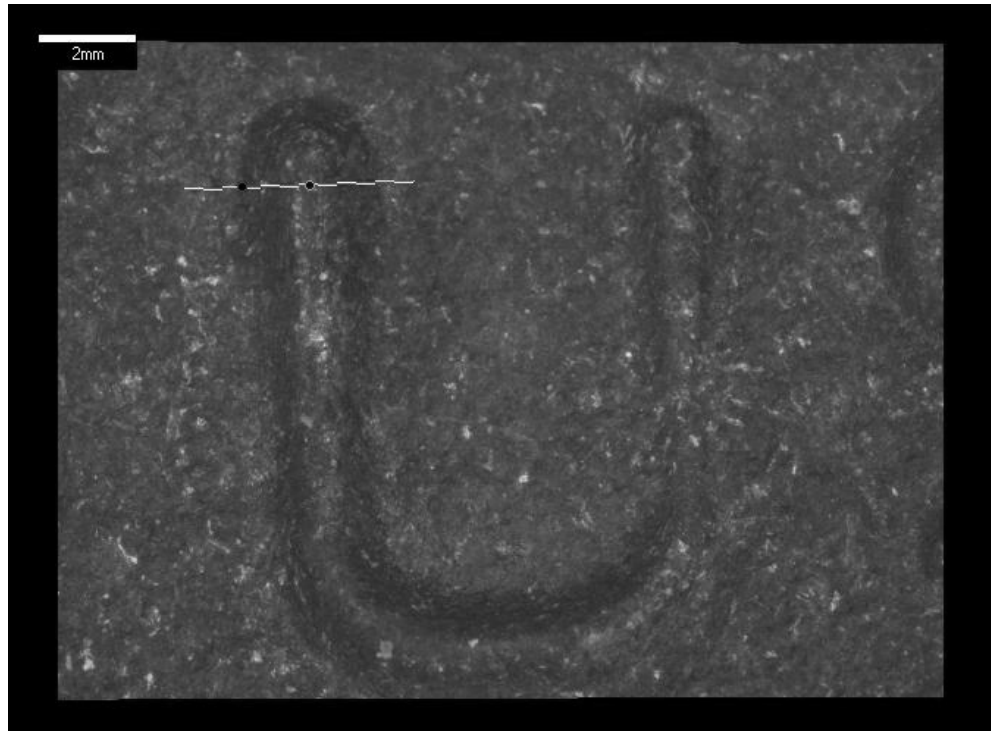
Figure 58: Cylinder stamp marking (letter 'U') with plane of profile measurement shown

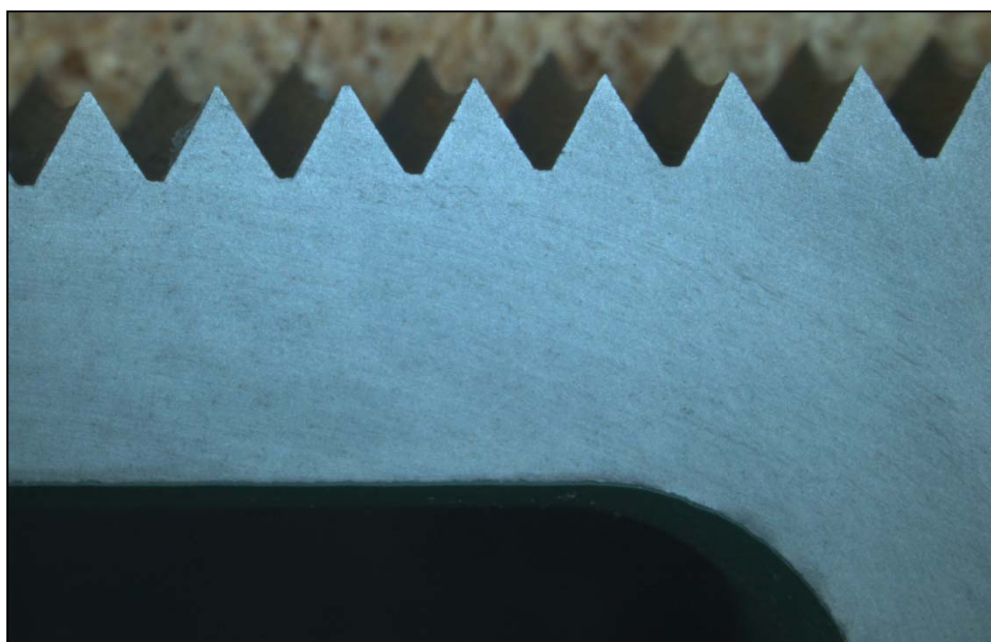
The cylinder manufacturing specification required the neck threads to be even, clean-cut and without cracks. To assess, a series of sections were taken longitudinally through the threaded neck of cylinder S/N 535626 and prepared for microscopic study. When examined in profile (Figure 59), the cylinder threads appeared fully-formed, with no evidence of cracks, tears or mal-formed areas.

Figure 59: Cylinder neck thread profile

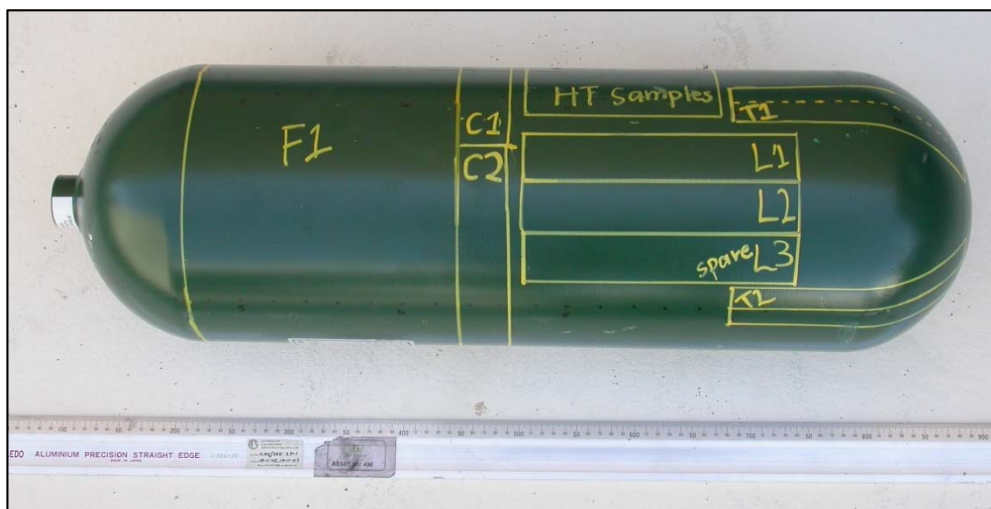
A single flattening test as described in section I of CFR Title 49 §178.44, was prepared and tested from the upper cylindrical section of the cylinder (the location marked F1 in Figure 60). When flattened between opposing knife edges having a 60° included angle and 12.5 mm (0.5 in) edge radii, the specimen cracked longitudinally (Figure 61) at a knife edge separation of approximately 60 mm (2.4 in). As such, the test did not comply with the requirements specified by CFR Part 49 §178.44 section (p)(1), which stipulated ‘flattening required without cracking to ten times the wall thickness of the cylinder’ (28 mm / 1.13 in).

A repeat of the flattening test (using a non-standard 25 mm / 1 in wide specimen) also failed to comply with the specification requirements – exhibiting cracking and surface tearing across one of the stressed surfaces.

Figure 60: Cylinder S/N 535652 with locations of mechanical test specimens marked. L, T & C are the longitudinal, transition and circumferential tensile test specimens, F1 the flattening test specimen

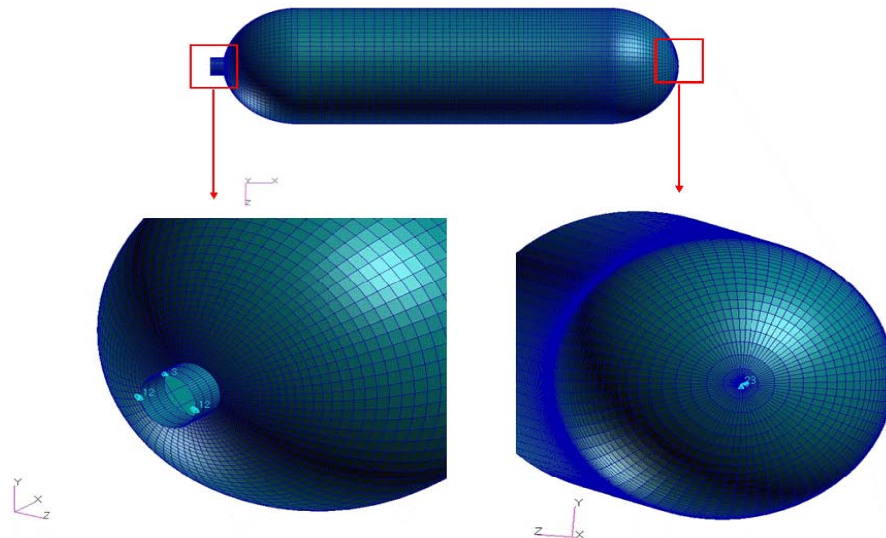
Figure 65: Finite element model of the oxygen cylinder design

The FEM analysis produced an average longitudinal cylindrical wall stress value of 36.3 ksi (250.3 MPa) and average hoop (circumferential) stress value of 72.6 ksi (499.9 MPa), for the 1,850 psi design service pressure of the cylinder. Both values compared favourably with the conventionally calculated values of 37.3 ksi (257.2 MPa) and 74.7 ksi (515.0 MPa) respectively.

Taking into consideration the allowable reduction in wall thickness within the lower hemisphere (90% of the minimum cylindrical thickness), the FEM analysis revealed the presence of elevated peaks in the longitudinal stress field associated with the transition region between the cylindrical and lower hemispherical sections (Figure 66 and Figure 67). The peak longitudinal stress in this region was 45.9 ksi (316.5 MPa); a factor of 1.3 times the average longitudinal stress in the main body of the cylinder.

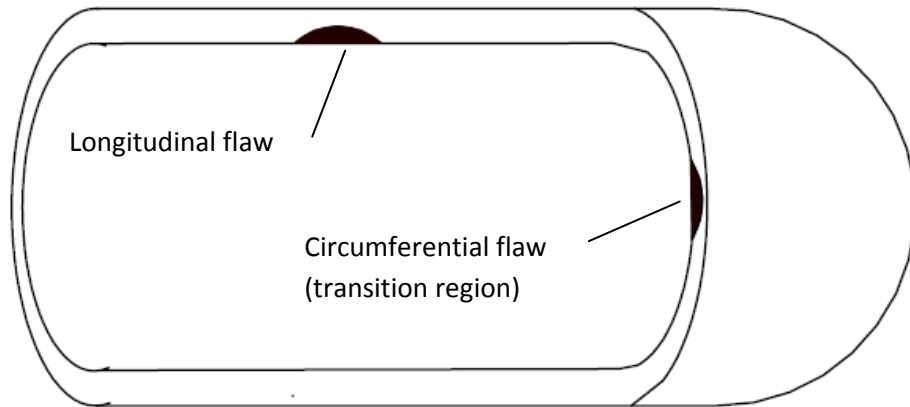
Figure 68: Cylinder flaw locations considered

Two potential locations were considered for the possible presence of critical semi-elliptical flaws within the failed cylinder (Figure 68):

- the inner surface longitudinal flaw within the cylindrical (main body) of the cylinder
- the inner surface circumferential flaw within the transition region between the main body and the lower hemispherical end of the cylinder.

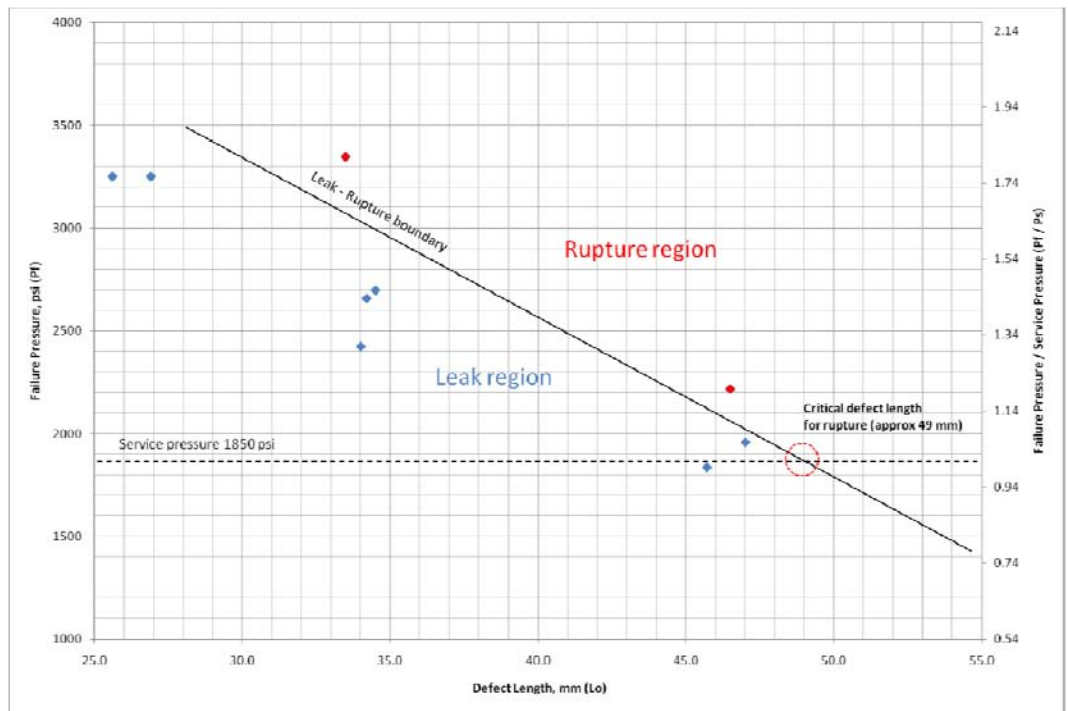
Figure 71: Graphical representation of failure pressure against defect length and failure mode

Table 20 presents a summary of the test results (failure pressure and failure mode) against the dimensions of the flaw at which failure occurred. Figure 71 and Figure 72 present the test results graphically, with the Leak – Rupture boundary fitted to the data set.

From an extrapolation of the Leak – Rupture boundary, the critical defect length for failure by rupture at 1,850 psi was estimated at approximately 49 mm (1.93 in). A similar technique applied to assess critical flaw aspect ratio returned a nominal value of 0.096, which represents a flaw depth of around 2.3 mm (0.09 in).

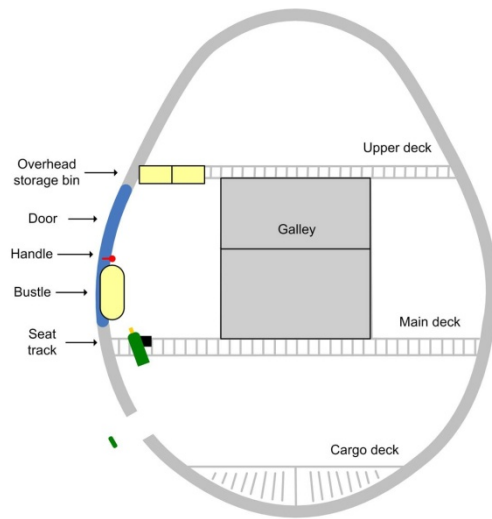
Figure 75: Trajectory sequence 2

Cylinder failure produces fuselage rupture, with the bulk of the cylinder length propelled upward through the cabin floor - see Figure 19

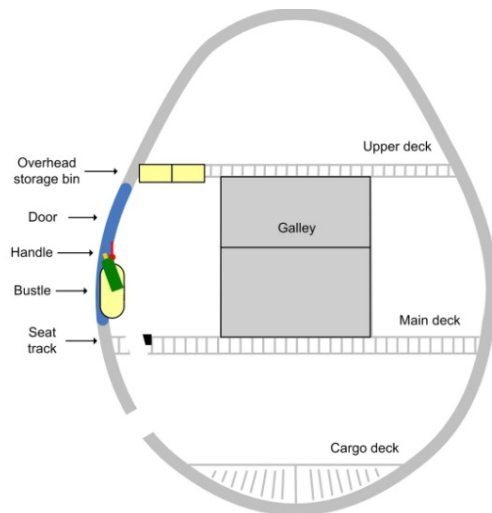
Figure 76: Trajectory sequence 3

Cylinder impacts R2 door frame and internal door handle - see Figure 20

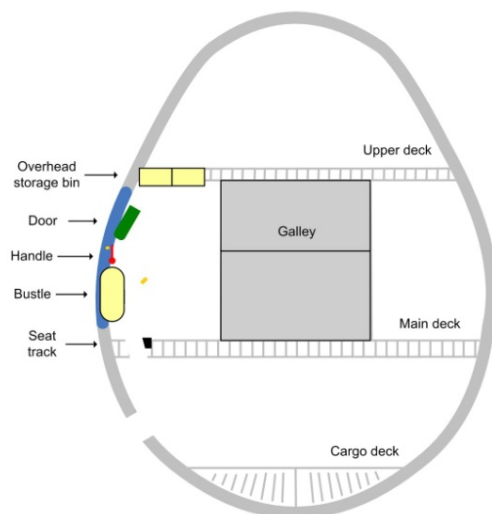
Figure 77: Trajectory sequence 4

Door frame impact breaks off cylinder valve and causes cylinder to invert while continuing to travel upward

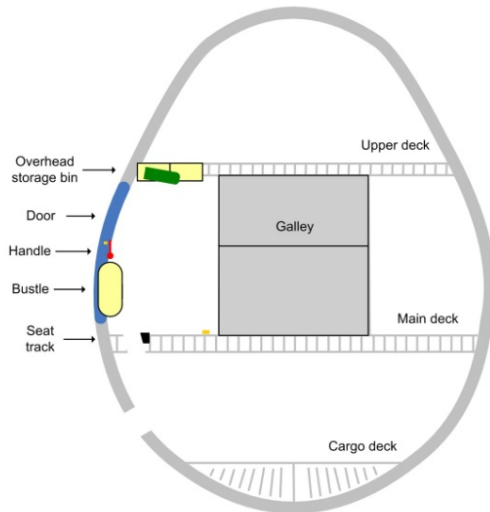
Figure 79: Trajectory sequence 6

Still rotating cylinder impacts overhead storage bin, producing semi-circular crushing damage – see Figure 26

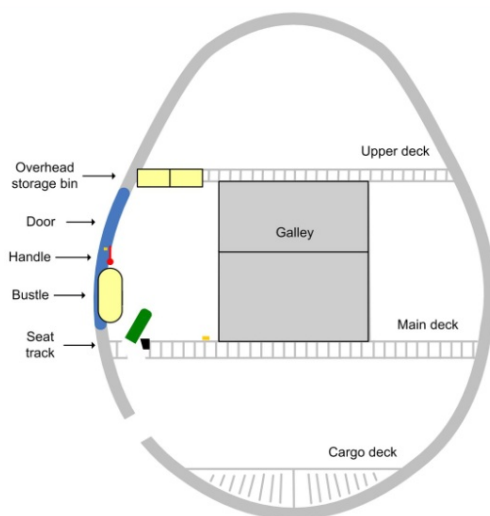
Figure 80: Trajectory sequence 7

Cylinder falls to cabin floor and exits the aircraft through the ruptured fuselage

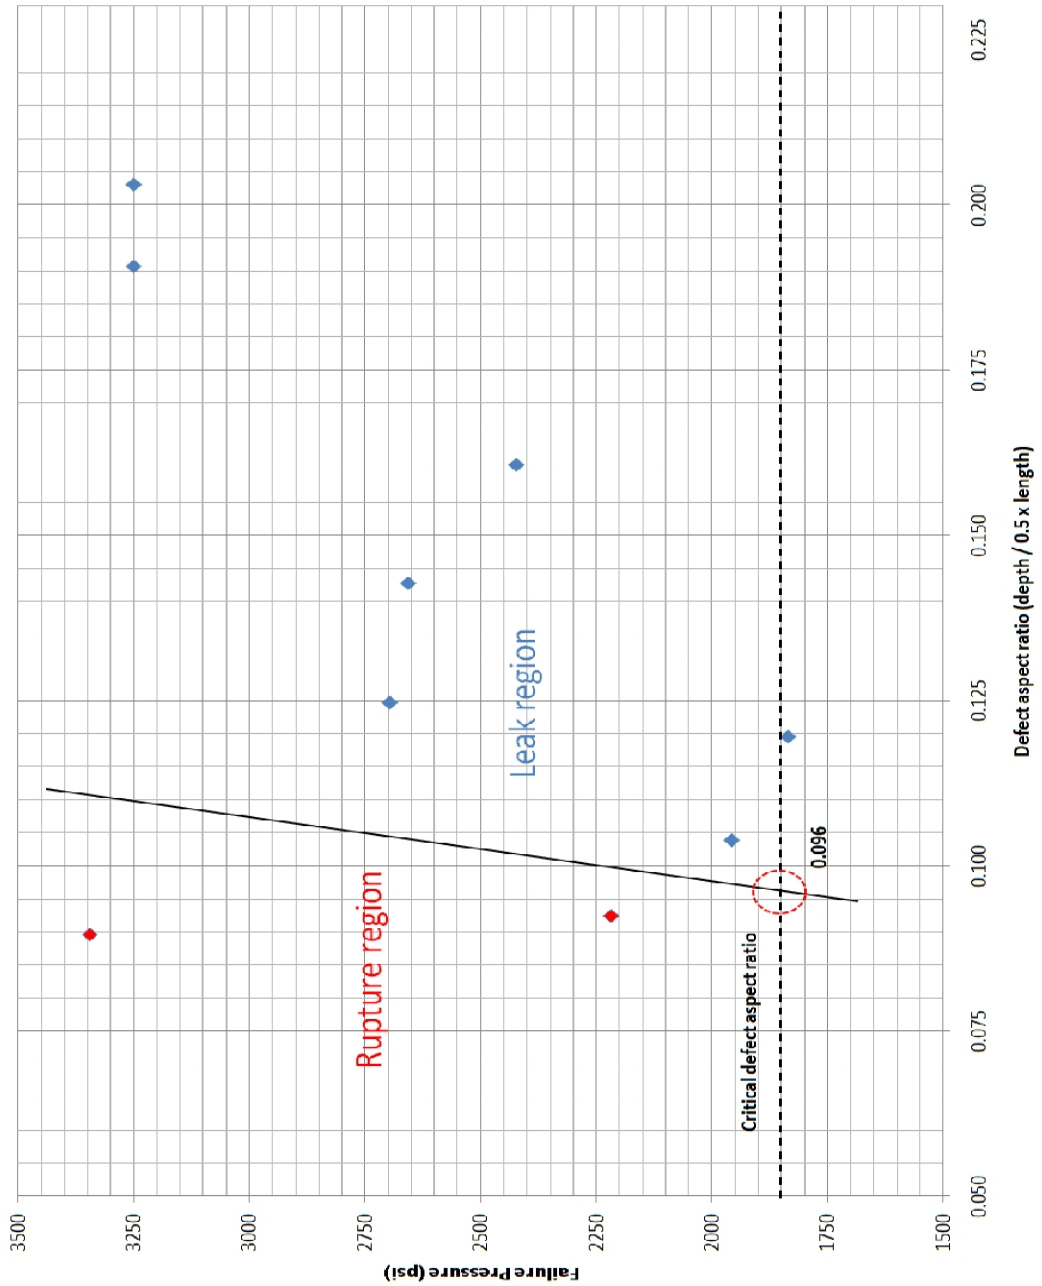
Figure A9: Graphical representation of flaw aspect ratio against failure pressure and mode

While the number of data points available has limited the accuracy of the Leak-Rupture boundary line fitted to the Flaw Length and Aspect Ratio graphs, the estimates obtained for those parameters at the nominal service (operating) pressure of the cylinder type (1,850 psi) were considered valid, and indicative of the magnitude of a physical flaw that could produce failure by rupture at that pressure.

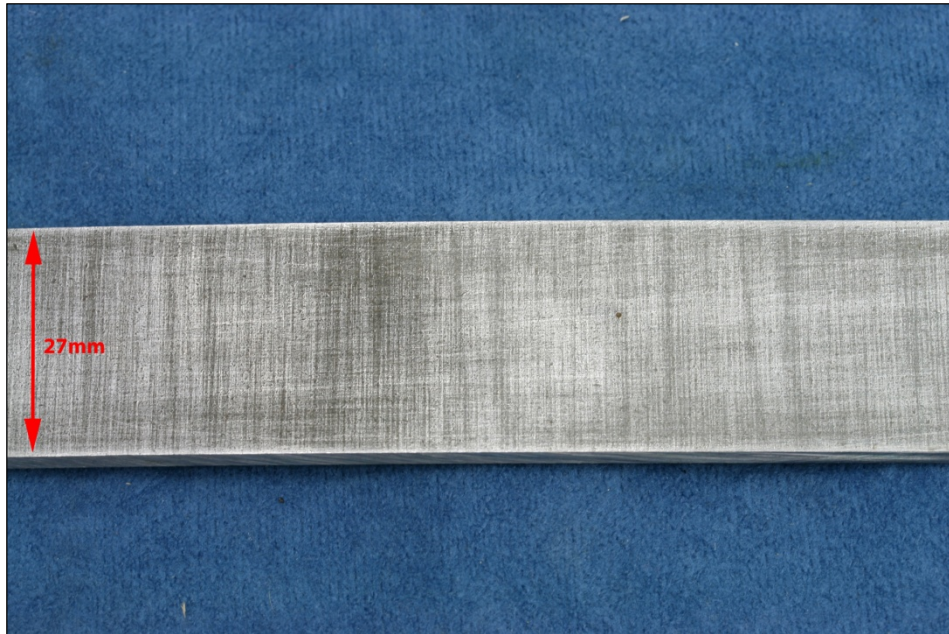
Figure B5: Centre of de-coated sample removed from the A-Gasol[®] solution. Samples from all test solutions displayed similar characteristics

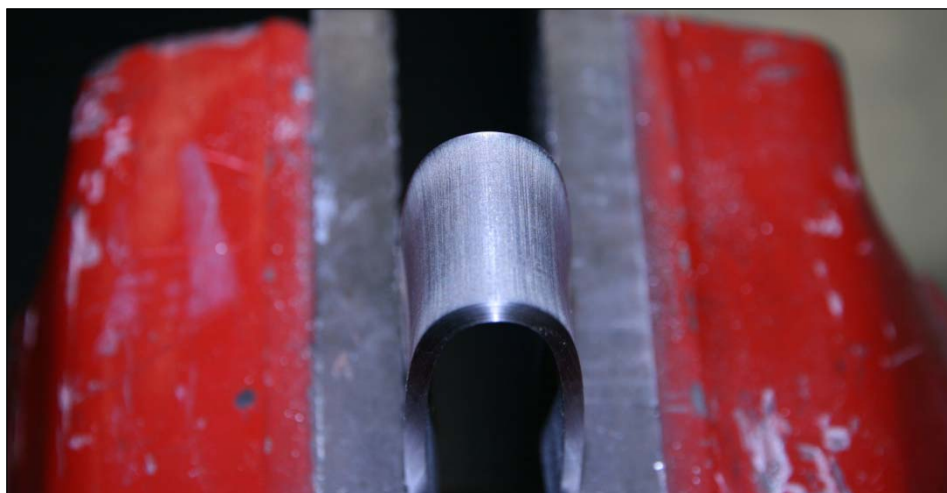
Figure B10: A-Gasol[®] sample during bend testing

All samples tested achieved the full bend, (Figure B10) with no cracking, tearing or other indications of reduced ductility, when observed both unaided and under the stereo-binocular microscope.
