# Partial separation of Express Passenger Train (XPT) ST24

Broadmeadows, Victoria | 11 August 2011

## **ATSB Transport Safety Report**

RO-2011-012

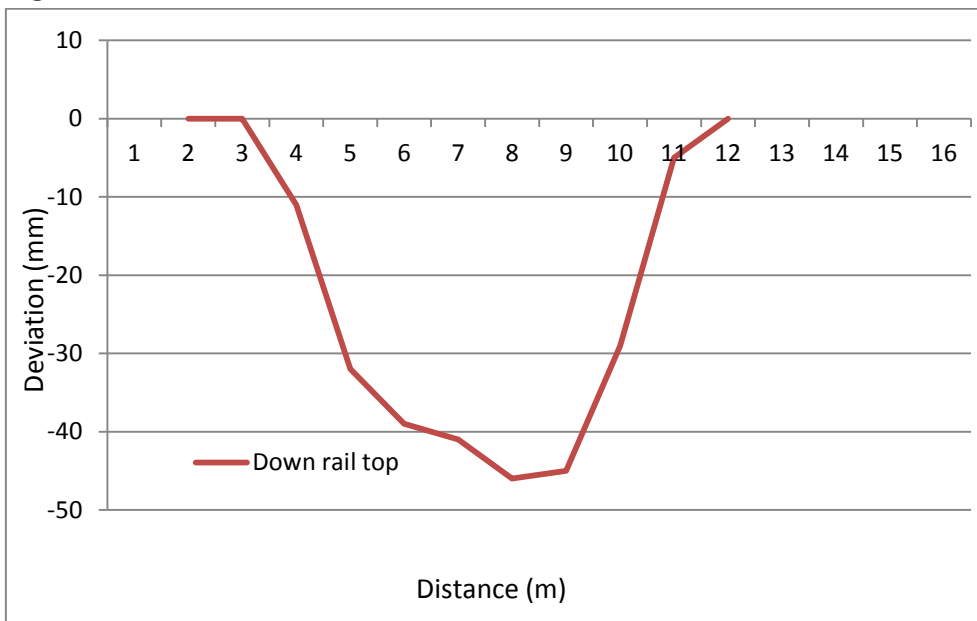
**Figure 4: Twist measurement**

Following the incident, an inspection of the track was conducted by investigators from the Chief Investigator Transport Safety Victoria (CITS)<sup>9</sup> and a twist was identified in the down rail of the track at the 16.790 km point on the approach to the Broadmeadows platform (Figure 3). The twist was examined and a maximum deviation of 46 mm was recorded (Figure 4).
