Collision with rake of wagons and derailment of ore train R1006

Andoom (near Weipa), Queensland, 22 September 2019

ATSB Transport Safety Report

RO-2019-017 (Systemic)

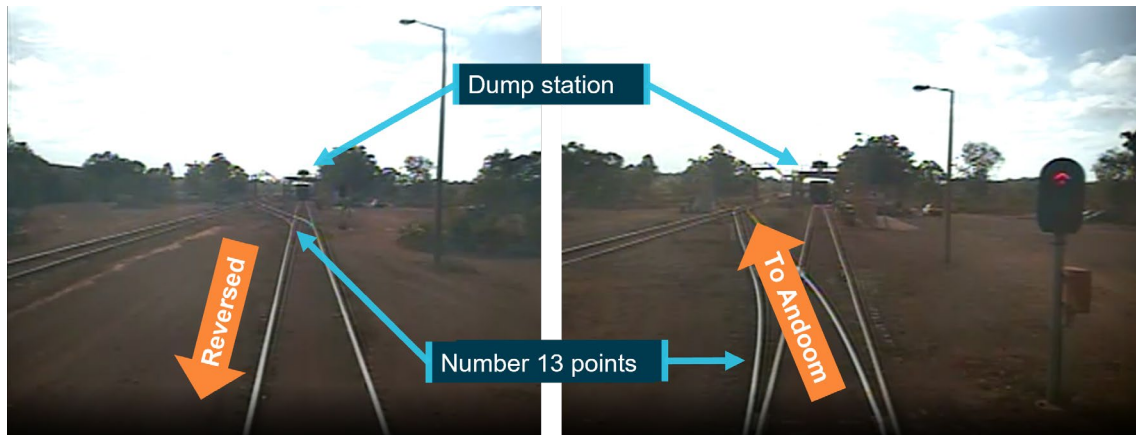
Figure 3: Empty train stopped further beyond the number 13 points (left) and moving forward to Andoom (right)

After receiving the thumbs up from the fixed plant crew leader, the driver reported they checked the brake pipe pressure was as expected via the in-cabin gauge on the functionality integrated railroad electronics screen. Shortly following this, the driver released the brakes and the train was pushed back from the dump station clear of the number 13 points. Ordinarily, when past the number 13 points, the driver would stop the train with the locomotive just clear of the points and associated signal. The driver would then drive forward (pulling the rake) to Andoom on the adjacent main line via the number 13 points. On this occasion, the driver made a (more than expected) train brake application to stop the train, but had to supplement this with the locomotive independent brake as the train brake was not sufficient. Subsequently, the train stopped further beyond the number 13 points than normal (Figure 3 left).

The driver moved the train forward (pulling the rake) to the usual standing position just clear of number 13 points and signal (Figure 3 right). At this time, the driver dismissed the braking anomaly as a consequence of an auxiliary compressor issue that had not fully recharged the braking system on the rake. The driver deduced that, since the rake was connected to the locomotive, the locomotive compressor would fully recharge the rake brakes (auxiliary reservoir) and it would be checked at Andoom.

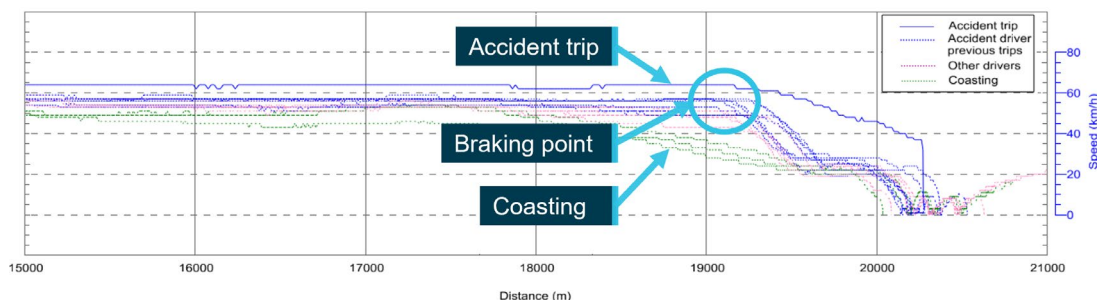
Figure 8: Comparison of braking point on multiple trips - distance base

Twenty empty trips (the occurrence and 19 prior) were extracted from the data and compared by distance. Those that had the same distance travelled as the accident trip were considered for comparison, which equated to 16 trips.¹² The data (Figure 8) showed that the braking point on 13 of the trips was consistent with the brake application from the accident. In these cases, the initial brake application was made at between about 18.95 and 19.31 km. In a further 3 trips, the train had not braked but instead reduced speed by coasting over a much longer distance.

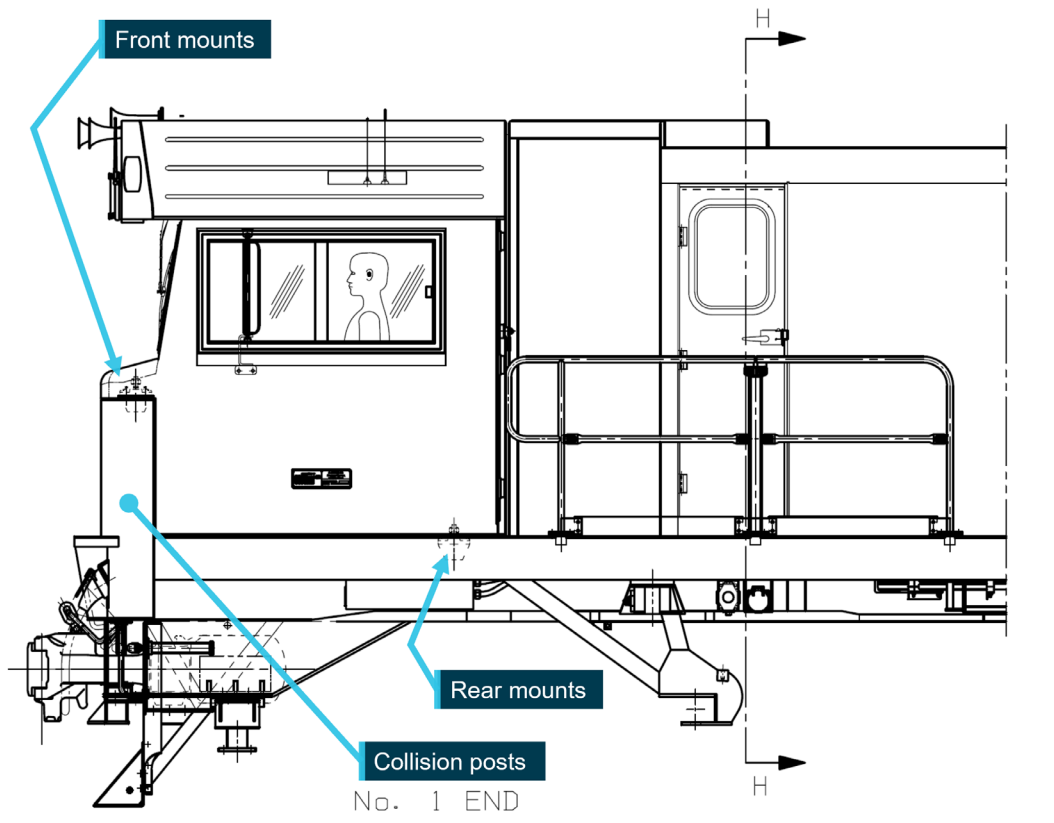
Figure 14: Position of the cabin isolating resilient mounts

The 2 modular driver cabins in the JT42C locomotive (one at either end) had 4 isolating resilient mounting points (Figure 14) that connected the cabin to the superstructure of the locomotive. The rear mounting points were on each side underneath the floor approximately 250 mm from the rear of the modular cabin unit. The front mounting points were situated on each side midway up the front face of the cabin. These front mounts sat on top of the collision posts.

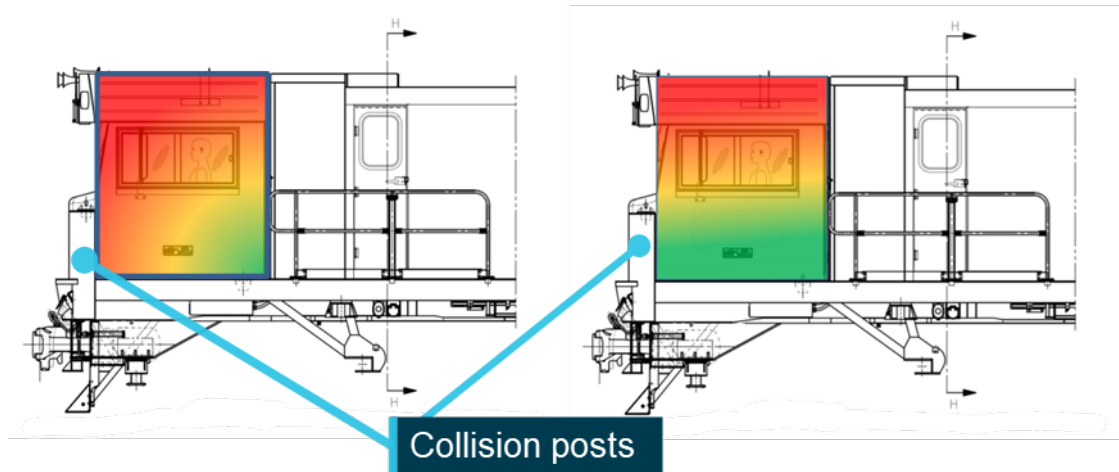
Figure 16: Locomotive cabin survivable space

Although the CTT investigation focussed on reduced survivable space due to lateral loads, the same observations can be made in relation to the accident at Andoom involving longitudinal and vertical loads, the engineered protection provided by the collision post, and movement of the modular cabin away from that protection. In the context of this investigation, Figure 16 illustrates the potential survivable space of a modular cabin that has separated (left) versus remained fixed behind the collision posts (right).

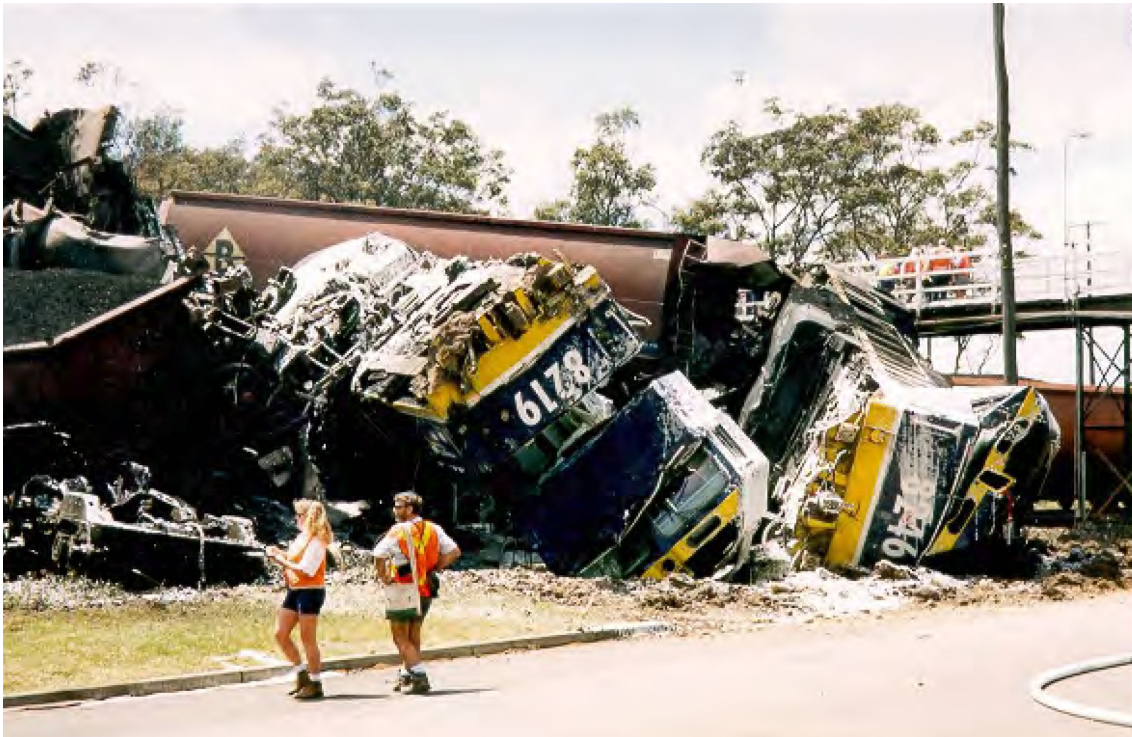
Figure 19: Locomotive 8219 inverted with cabin disconnected

On 23 October 1997, a loaded coal train struck the rear of a stationary coal train at Beresfield, New South Wales. A total of 3 locomotives and 13 coal wagons were derailed and destroyed. The second locomotive (8219) ended inverted with the driver's cabin disconnecting from the main structure (Figure 19). It was not occupied at the time. A New South Wales Department of Transport independent inquiry was conducted by the Bureau of Air Safety Investigation (BASI).
