Grounding of *Trinity Bay*

Harrington Shoal, Queensland on 19 January 2021

ATSB Transport Safety Report

MO-2021-001

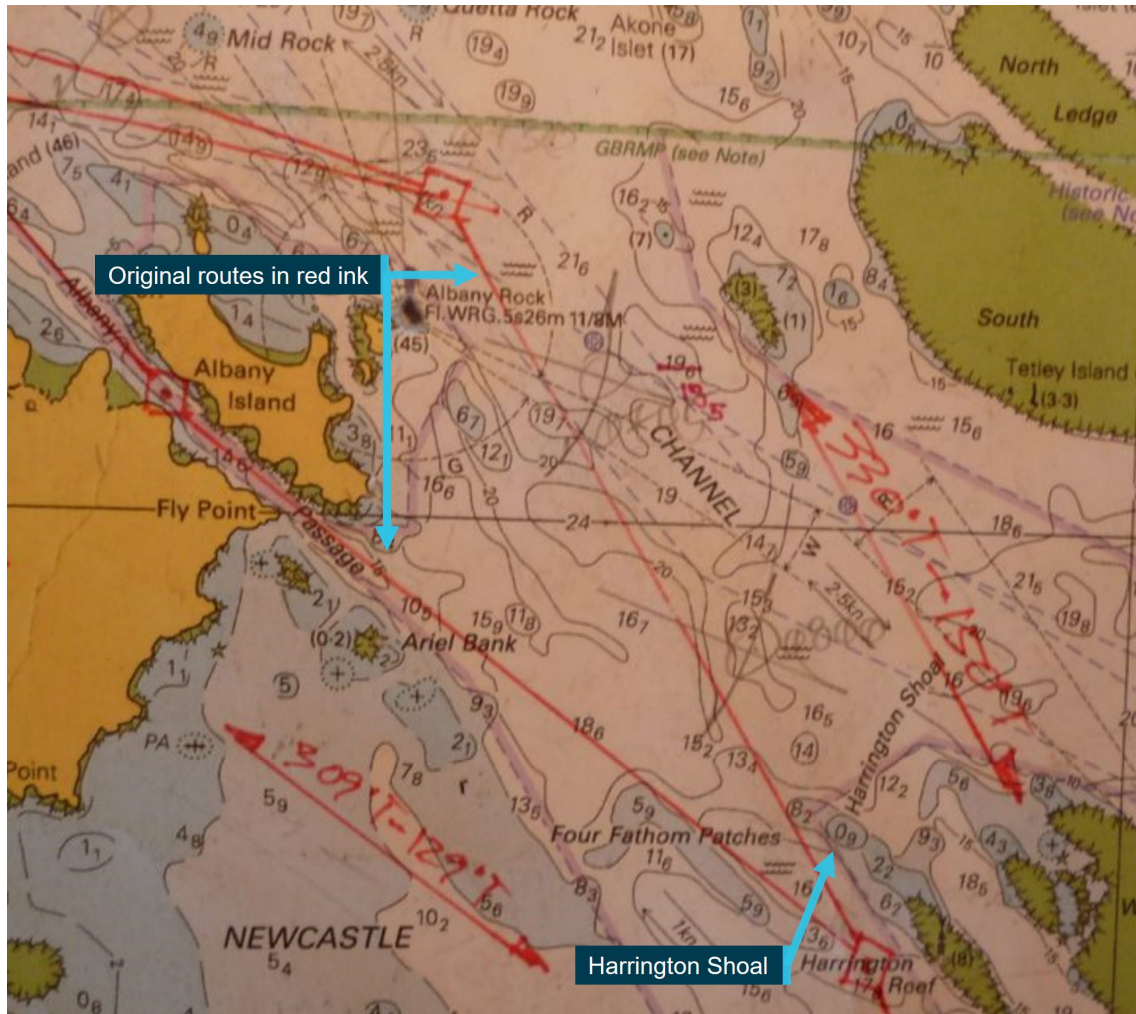
Figure 2: Section of *Trinity Bay's* chart Aus 839 showing original routes

On 12 January, *Trinity Bay* departed Thursday Island for Cairns to complete the second return voyage using a route plan that had been regularly used over the previous 10 years. This original route was marked on the ship's paper charts² in permanent red ink (Figure 2) and was also saved and displayed on the ship's TRANSAS electronic chart system (ECS) program.³ On this occasion, the master also directed the ship's watchkeeping officers to evaluate a newly created route plan

Trinity Bay had been operating to the same ports of call for about 10 years utilising the same routes that were marked in permanent red ink on paper charts (Figure 2) and saved on the ECS. Both northbound and southbound routes between Cairns and Thursday Island were generally laid outside of the two-way route between the mainland and Harrington Reef, to avoid larger shipping traffic.
