Grounding of *Hagen Oldendorff*

Port Hedland, Western Australia on 9 April 2022

ATSB Transport Safety Report

MO-2022-007

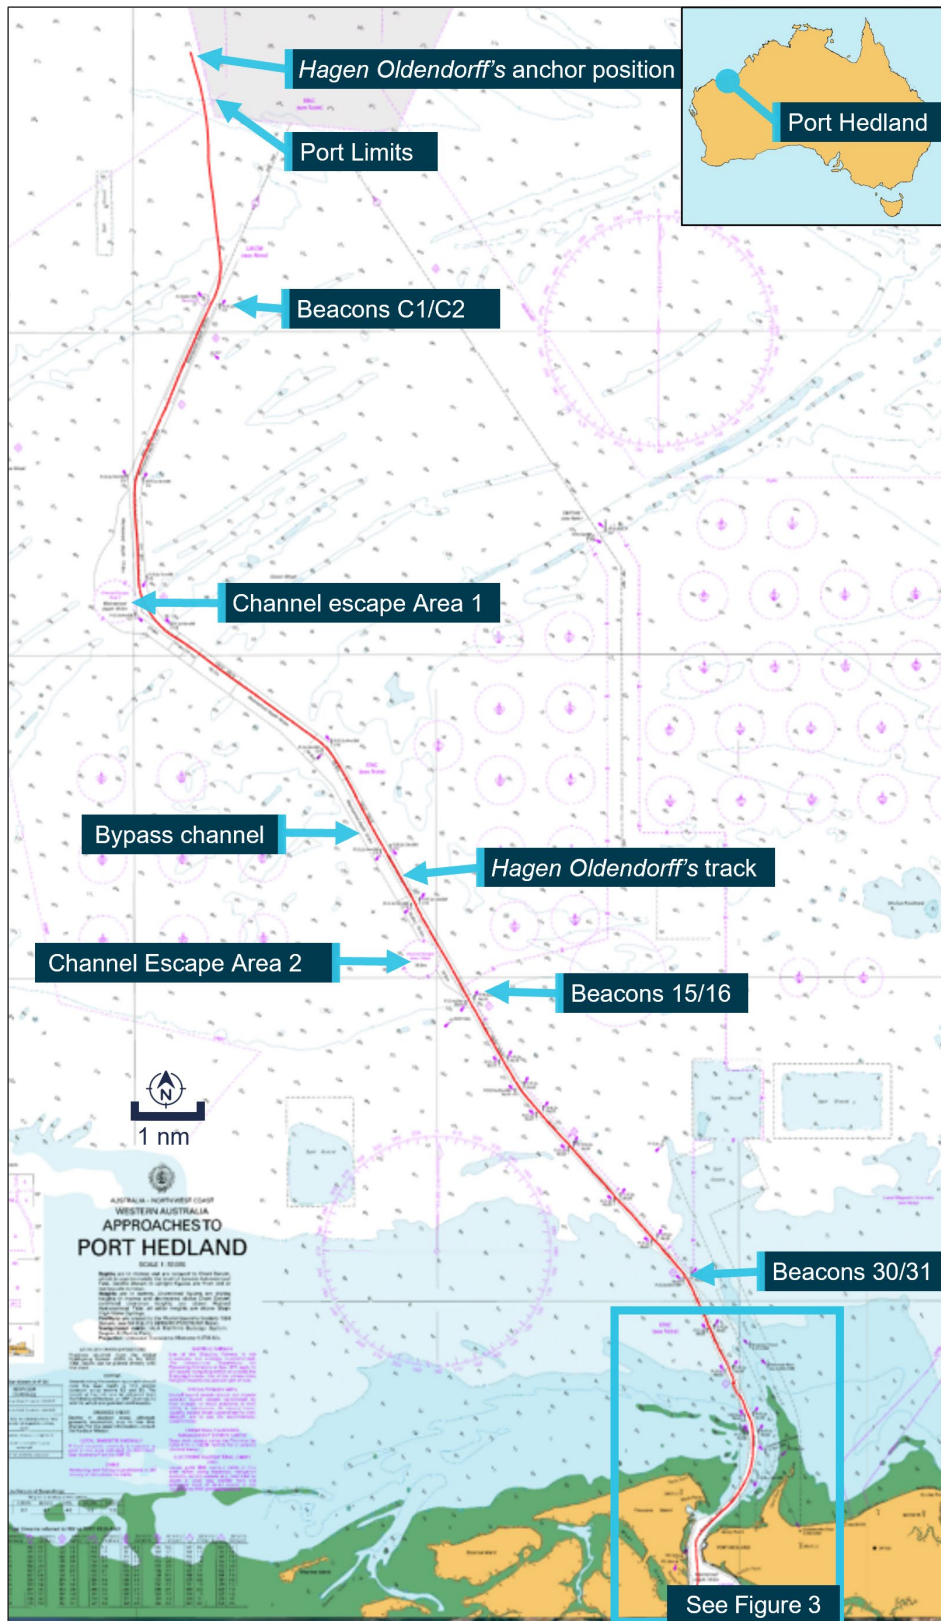
Figure 2: *Hagen Oldendorff's* track overlaid on chart of Port Hedland channel

At about 0118, when *Hagen Oldendorff* was about 3.5 cables³ (648 m) south of Hunt Point (Figures 2 and 3), *RT Darwin*, was cast off and dismissed. The ship proceeded north-east along the channel. The pilot then offered *RT Clerke*'s master a training opportunity in helping turn the ship into Goldsworthy channel using 'indirect towing'⁴ (a method employed regularly in the port for the ongoing training of tug masters). The tug master accepted the pilot's offer.

Shortly after 0430, the ship cleared the channel (beacons C1-C2) and all tugs, except *RT Clerke*, were dismissed. By 0530, the ship had anchored outside the port limits in a position 24 miles north-north-west of Hunt Point (Figure 2). Soon after, *RT Clerke* was cast off and dismissed and the pilots left the ship via helicopter.

The port's unidirectional channel is divided into 6 zones to mitigate channel blockage risk. Zones 1 and 2 form part of the inner harbour, while zone 3 extends from Hunt Point to beacons 36-37 and features a 110° turn, lining up with the Goldsworthy leads. Zone 4 extends from beacons 36-37 to 30-31 (Figure 2). Both zones 3 and 4 have steep channel batters, which become shallower from zone 5 onwards. Zone 5 extends from beacons 30-31 to beacons 15-16. Zone 6 extends from beacons 15-16 to beacons C1-C2 (Figure 2 and Figure 3). The channel has a minimum width of about 162 m in the Goldsworthy and Newman sections of the channel (zones 4 and 5). *Hagen Oldendorff* grounded on the western side of the channel in zone 4, between beacons 37 and 35.
