# Loss of control and near collision with terrain involving Leonardo Helicopters AW139, VH-TJH

Near Katoomba, New South Wales on 26 March 2021

**ATSB Transport Safety Report**

AO-2021-018

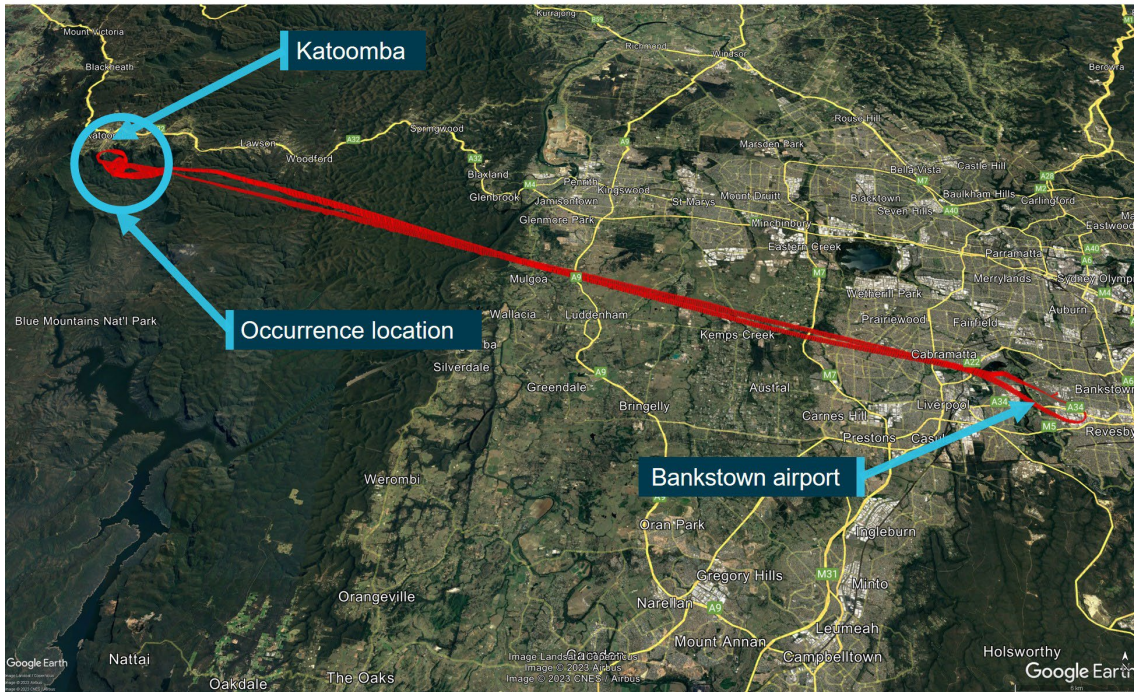
**Figure 3: Flight data for VH-TJH on 26 March 2021**

The crew shift started at 1930 on the evening on 25 March. The shift began routinely with a debrief and hand-over with the crew from the previous shift. This was followed by a check of the aircraft and equipment, including the NVG system and a review of weather conditions. Later in the shift, shortly before 2200, the pilot was notified of a possible task in the Blue Mountains, and they began some initial preparations. At 2241 the formal tasking for the job was received and preparations continued, including a pre-departure risk assessment. The helicopter departed from Bankstown Airport at 2329 and transited to Katoomba (Figure 3).

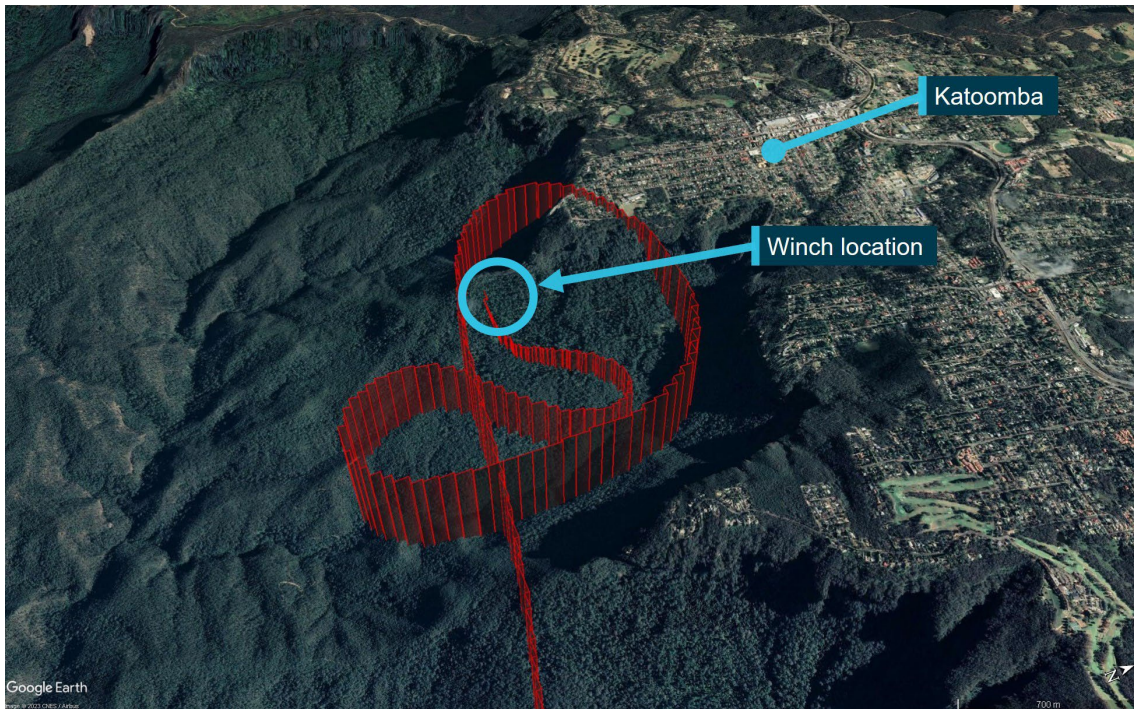
**Figure 4: Flight data showing VH-TJH overflying the bushwalker and staging point before approaching the winch location.**

Approaching Katoomba at about 2355, the pilot identified the location of the bushwalker via a first responders' strobe light. They then overflew the pre-determined staging point, a car park at Echo Point at the top of the mountain that could be used as a landing site if required (Figure 4).
