Collision with terrain involving Robinson Helicopter Company R22 Beta, VH-LOS

36 km south of Ramingining, Northern Territory, on 14 November 2022

ATSB Transport Safety Report

AO-2022-057

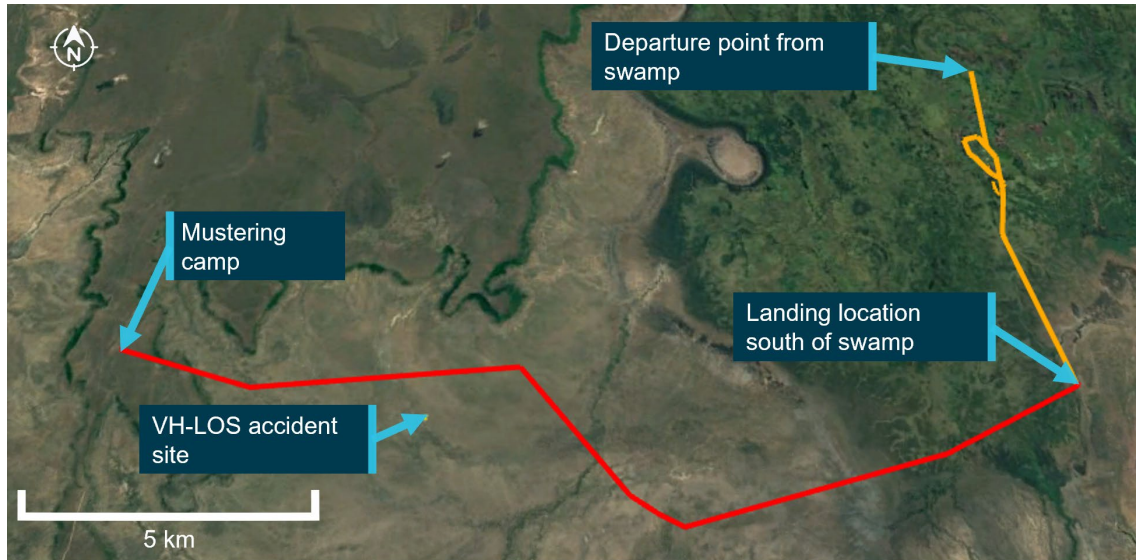
Figure 2: Map of Arafura Swamp and key locations, and track of VH-LOS

then started at 1837, and tracked to the mustering camp, landing and shutting down at 1854. The track of these flights is shown in Figure 2. The flight tracking information showed the helicopter was started again at 1921, before the flight tracking record ended about 1 minute later while the helicopter was still at the camp. The flight tracking device deactivated at 1925 after the helicopter had remained idle at the camp location and the device had lost external power (see *Recorded information*).

The yellow track shows the flight departing from Arafura Swamp at 1803 and shutting down south of the swamp at 1818. The red track shows the flight from the edge of the swamp to the mustering camp departing at 1837 and landing at 1854.
Source: Google Earth, with aircraft tracking plots overlaid by ATSB based on records obtained from recorder onboard VH-LOS
